Figure A-69b (Revised)
Visual Simulation
for KOP-Center-6
Southbound Upper Big Tujunga
Canyon Road
(Alternative 6, Segment 6)

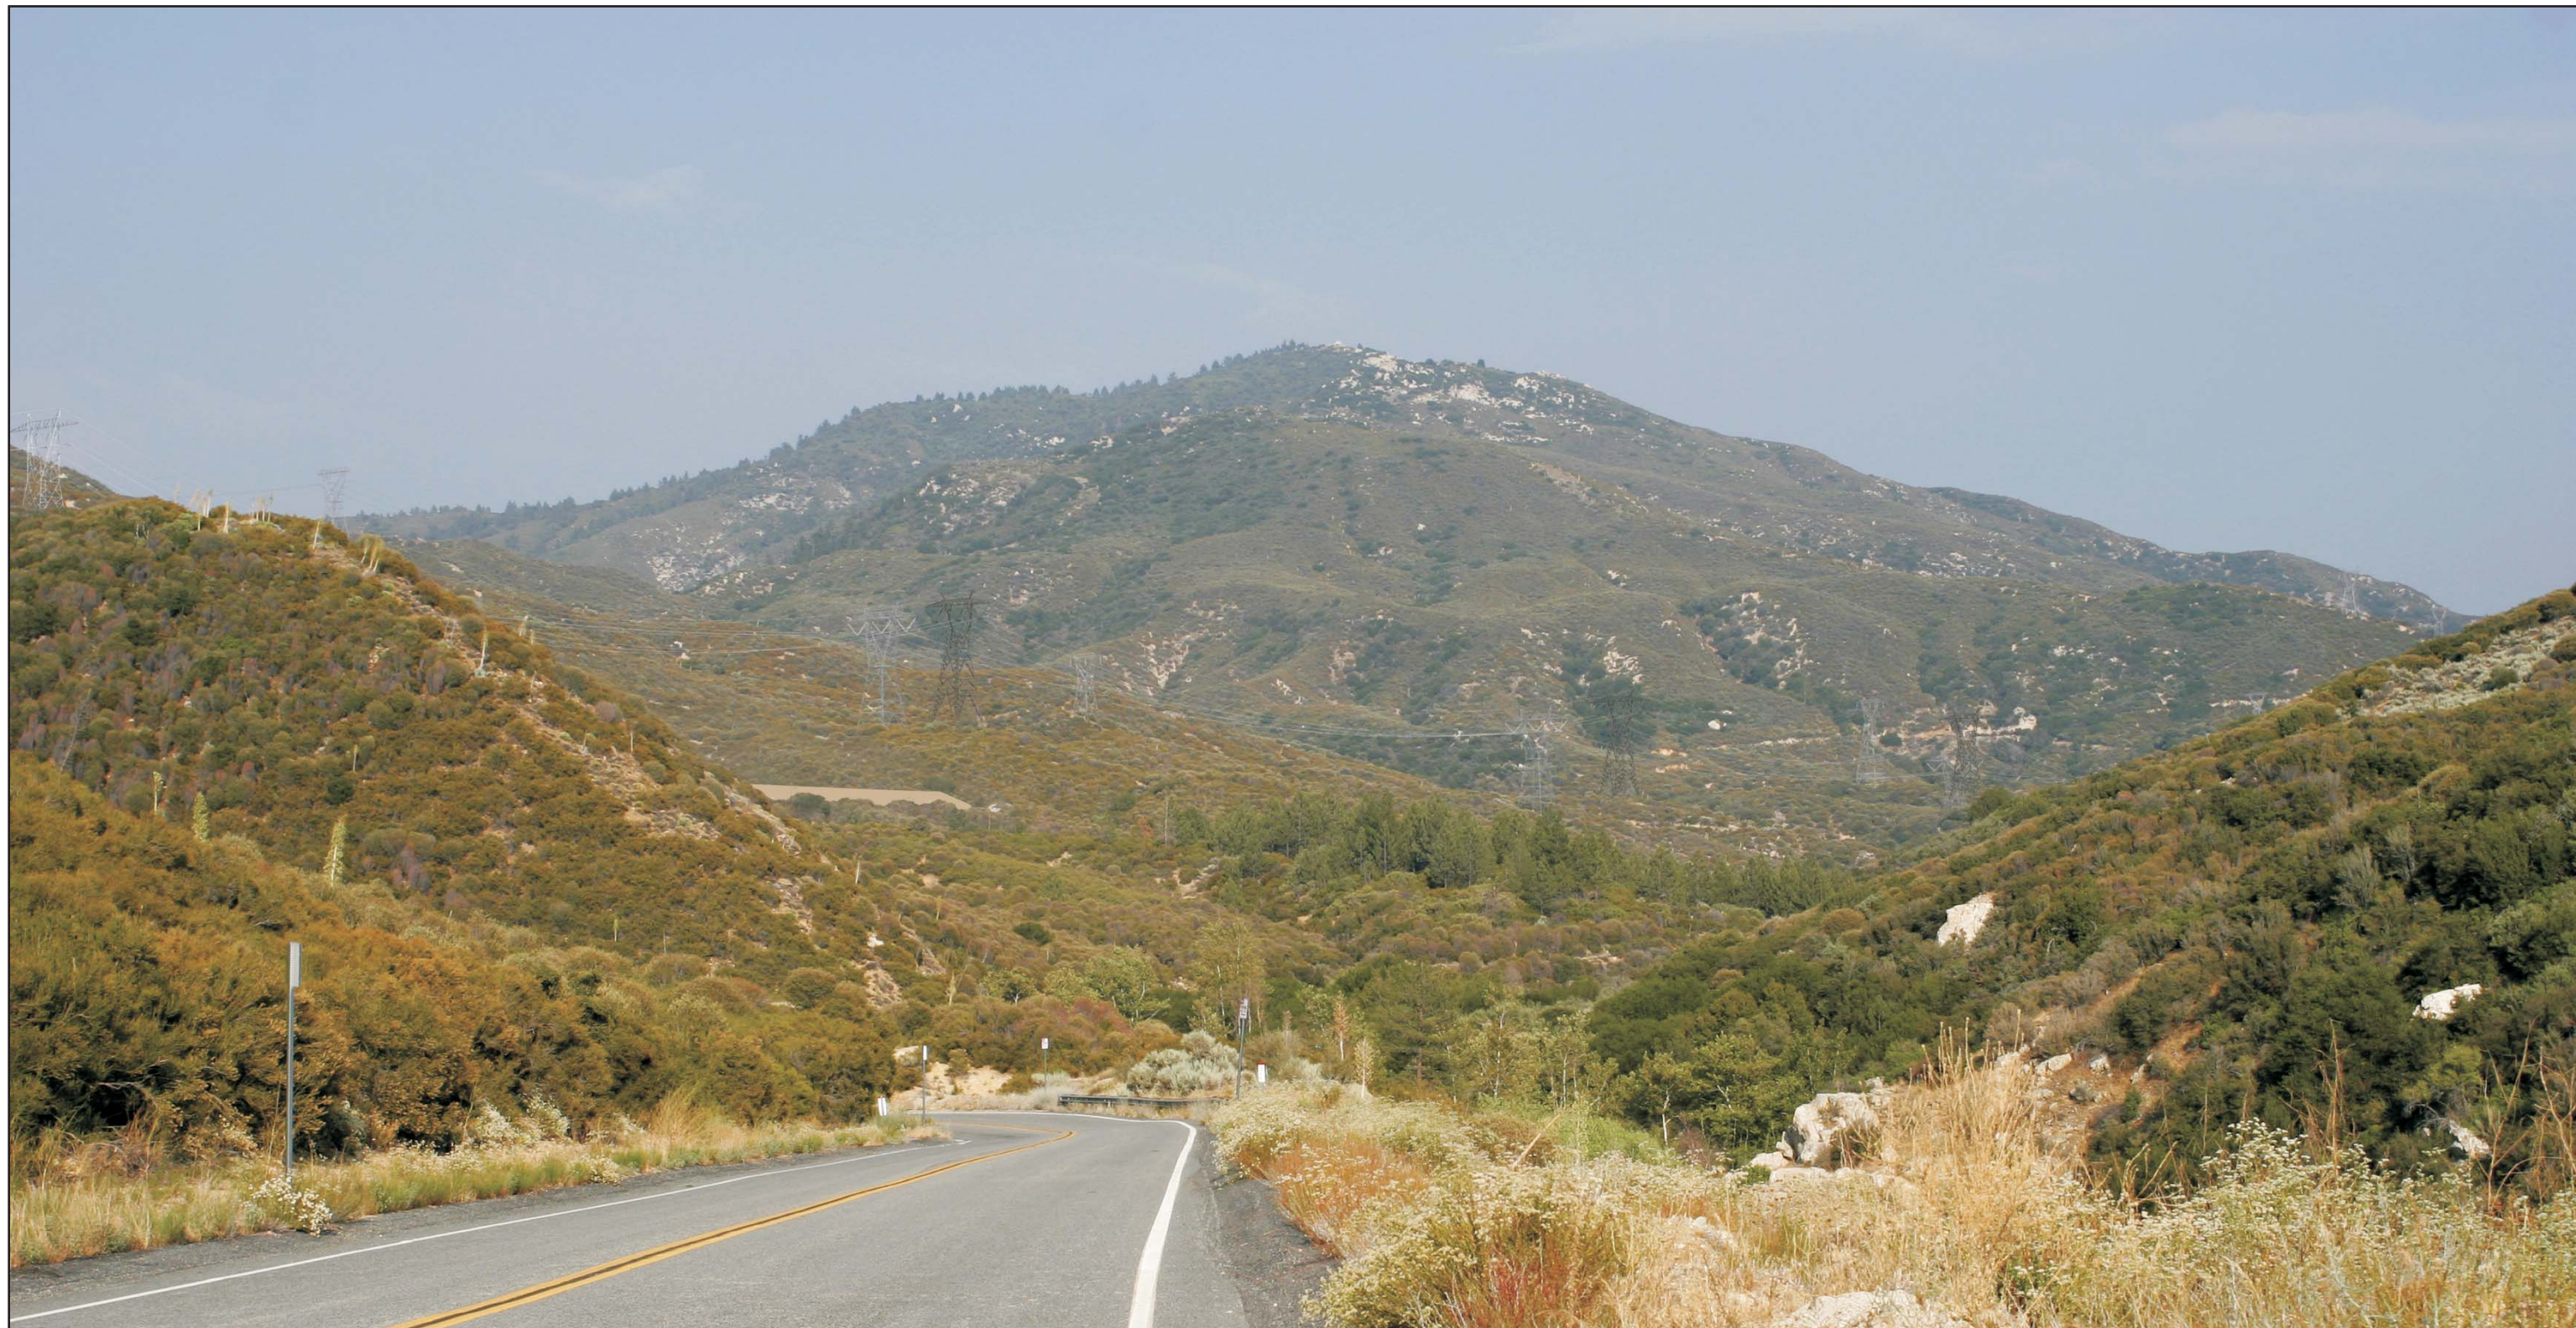
Future Scenic Integrity: High, with Areas of Low. The Maximum Helicopter Alternative (Alternative 6, Segment 6) would construct a large helicopter staging area on a flat area near the Upper Big Tujunga Canyon Road, separated by a steep hillside that has an existing fuelbreak on top. In this area of Segment 6, the Alternative 6 transmission line would be constructed by helicopters, and existing access roads and spur roads would not be re-opened. Other than the transmission line corridor, the landscape has predominantly natural-appearing existing landscape character and achieves High SIO. After revegetation of the helicopter staging area, and because LSTs would be medium or dark colored steel, the new transmission line would achieve low scenic integrity.

Adverse Visual Impacts. In the vicinity of KOP-Center-6, implementation of the Project would result in adverse visual impacts V-1, V-3, V-4, V-5, and V-7, as detailed in Table 6-1.

Mitigation Measures. Implementation of Mitigation Measures (MMs) would reduce adverse visual impacts to a certain degree, but the Project would create strong adverse contrasts of form, line, color, texture, and scale. It would continue to not meet the High SIO established for this area. MMs would include: V-1 – Clean up staging areas, storage areas, marshalling yards, access and spur roads, and structure locations on a regular periodic basis; V-2b – Treat surfaces with appropriate colors, textures, and finishes; V-3b – On NFS lands, provide restoration/compensation for impacts to landscape character and visual quality; V-4b – Slope-round and re-contour in areas as prescribed; V-4c – Avoid locating new roads in bedrock on NFS lands; and V-4d – Dispose of excavated materials as prescribed.
