**Figure A-74a**  
**Existing Conditions**  
**for KOP-Center-11**  
**Silver Moccasin Trailhead**  
**(Alternative 6, Segment 6)**

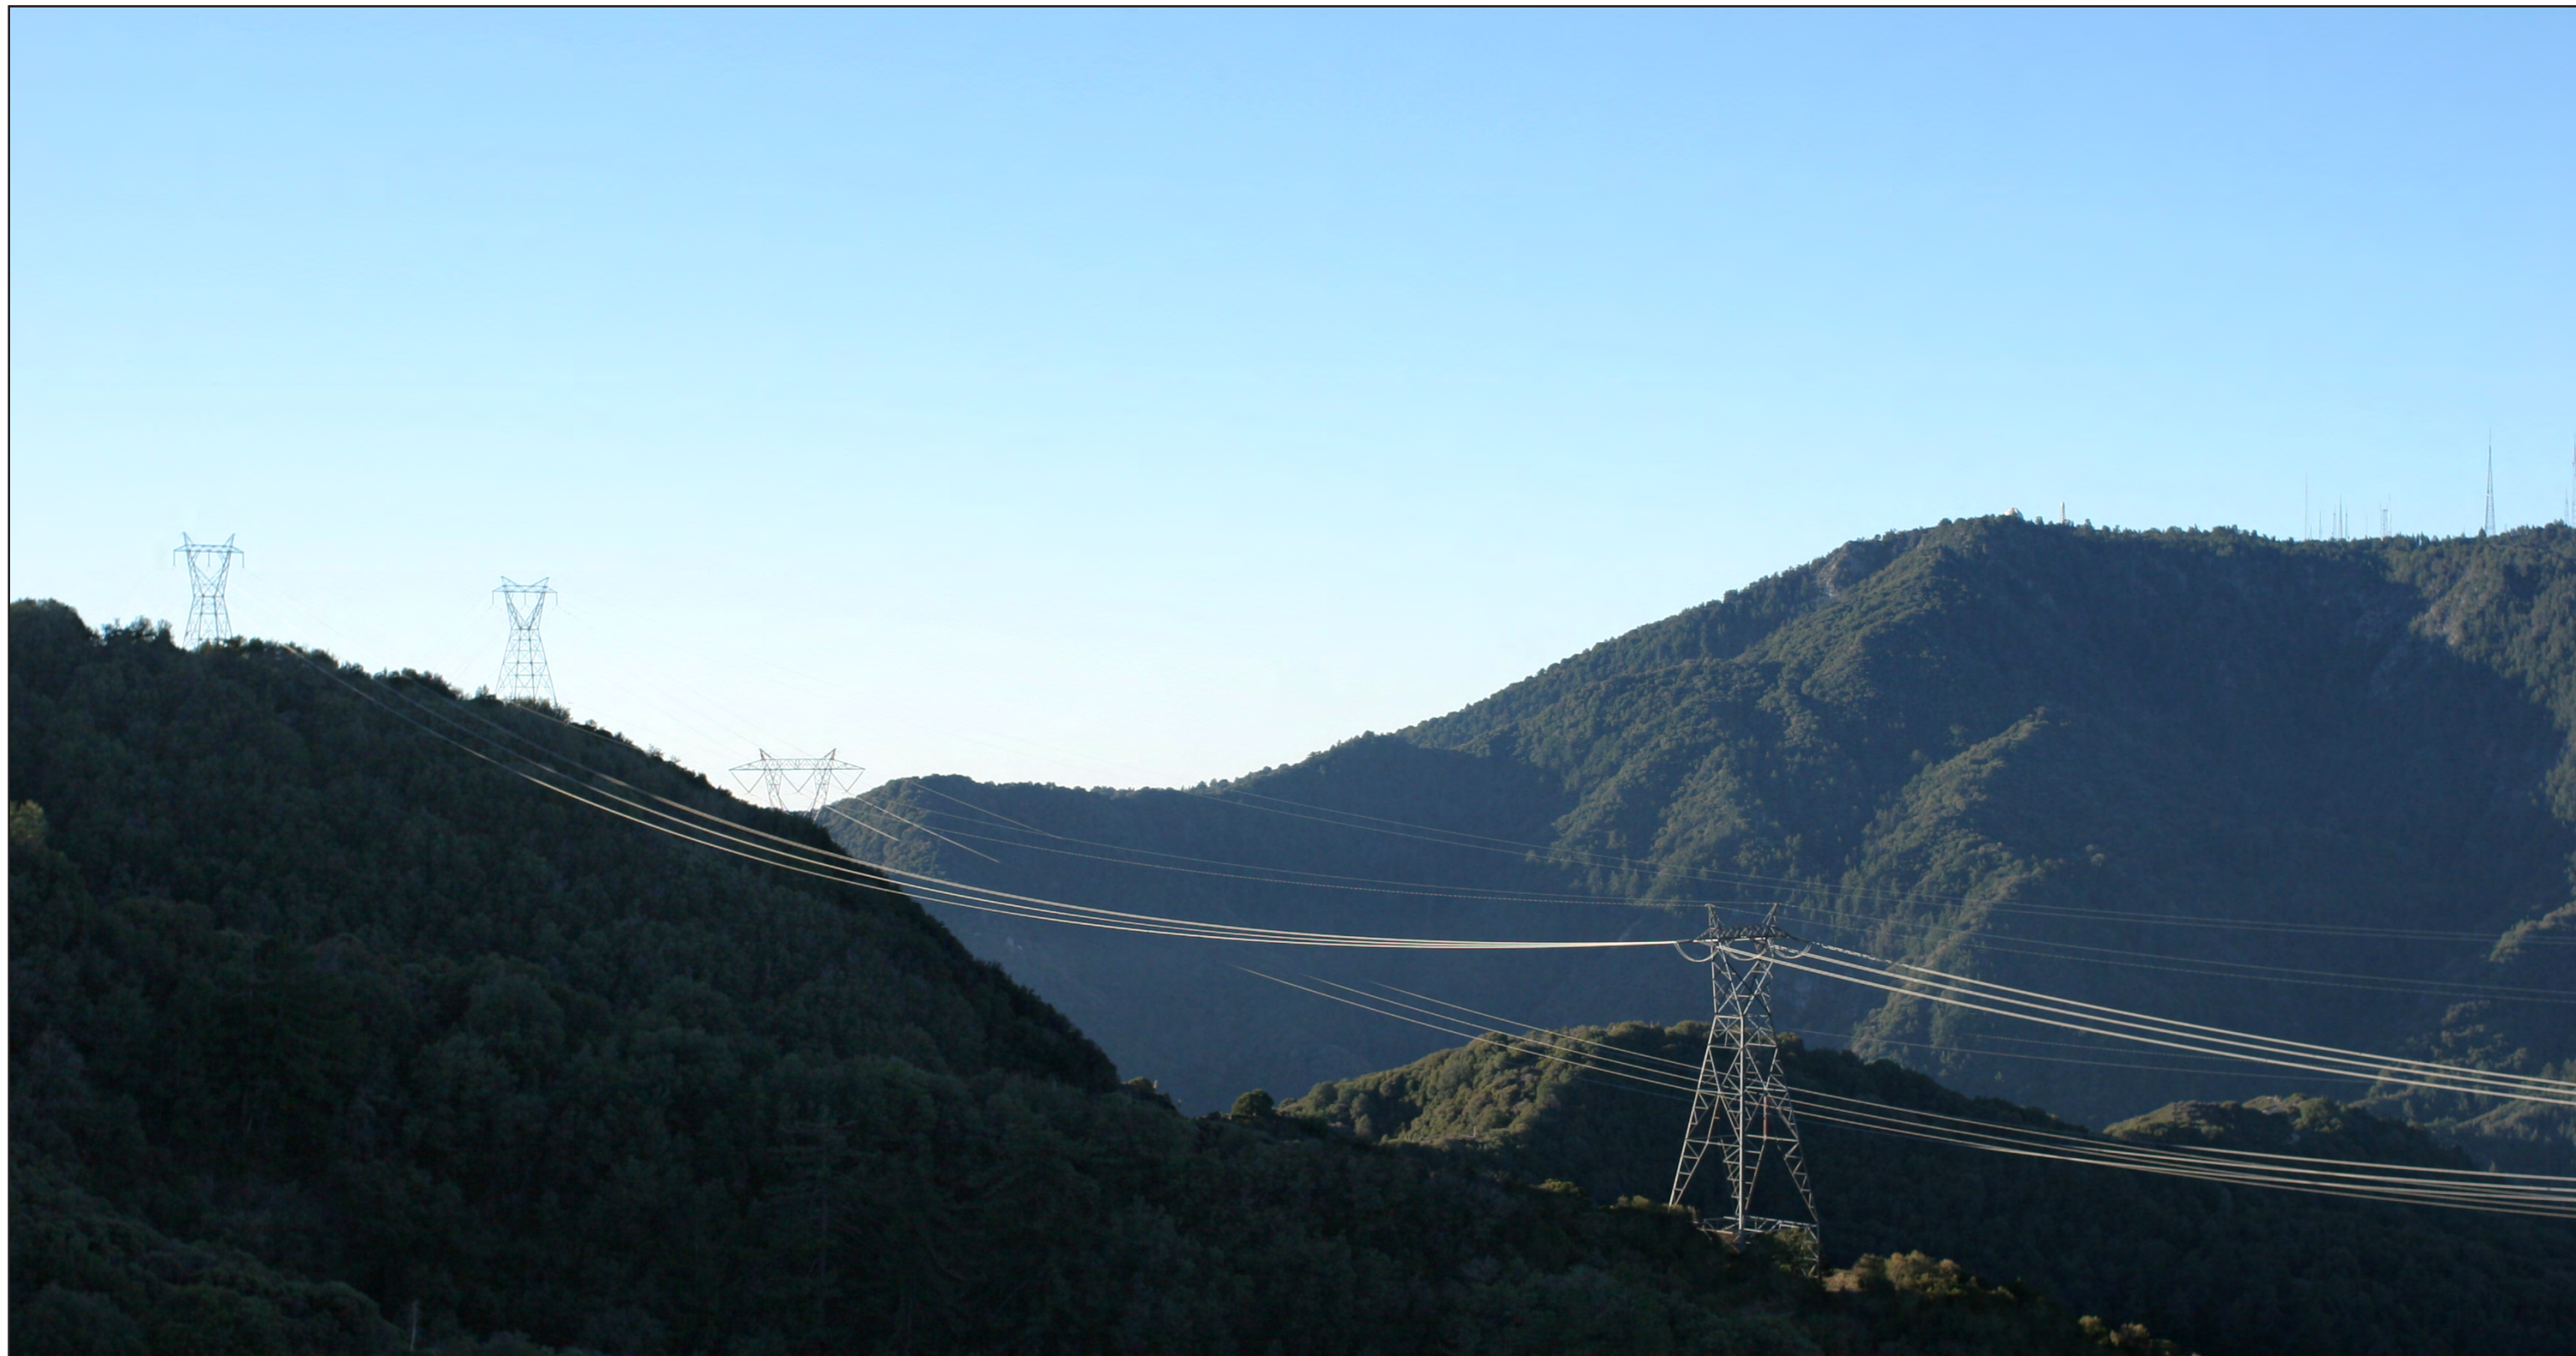
**Existing Scenic Integrity: High, with Areas of Unacceptably Low.** KOP-Center-11 is located on the Angeles Crest Scenic Byway at the Shortcut Saddle Area, looking southwest from the Silver Moccasin Trailhead at an elevation of approximately 4,750 feet. This area is adjacent to and just east of the Rincon-Shortcut OHV Trailhead. Existing lattice steel towers and conductors are very visible in this view as they cross over the saddle and proceed south along the southwestern border of the San Gabriel Mountain Wilderness, which is situated to the left of the structures. The landscape visible from the Silver Moccasin Trailhead in general, and KOP-Center-11 specifically, is predominantly natural-appearing, consisting of foreground and middleground landscapes with dense, dark green chaparral and evergreen tree-covered mountainsides. There are interesting vegetative patterns in this landscape view that are created by the folded terrain and shadows in the landscape. The natural landscape exhibits a high degree of intactness and scenic integrity, except for the highly discordant transmission line structures. These manmade features are visually excessive and begin to totally dominate the landscape character, leading to a rating of unacceptably low scenic integrity for the utility corridor.

**Scenic Integrity Objective: High.** In the 2005 Forest Plan, the entire landscape in this vicinity is mapped as High SIO, where the management direction states that human activities should not be visually evident. Human-caused deviations may be present but must repeat the form, line, color, texture, and pattern common to the natural landscape character so completely and at such a scale that they are not evident.
