Figure A-75a (Revised)
Existing Conditions
for KOP-Center-12
Cogswell Reservoir &
National Scenic Bikeway
(Alternative 6, Segment 6)

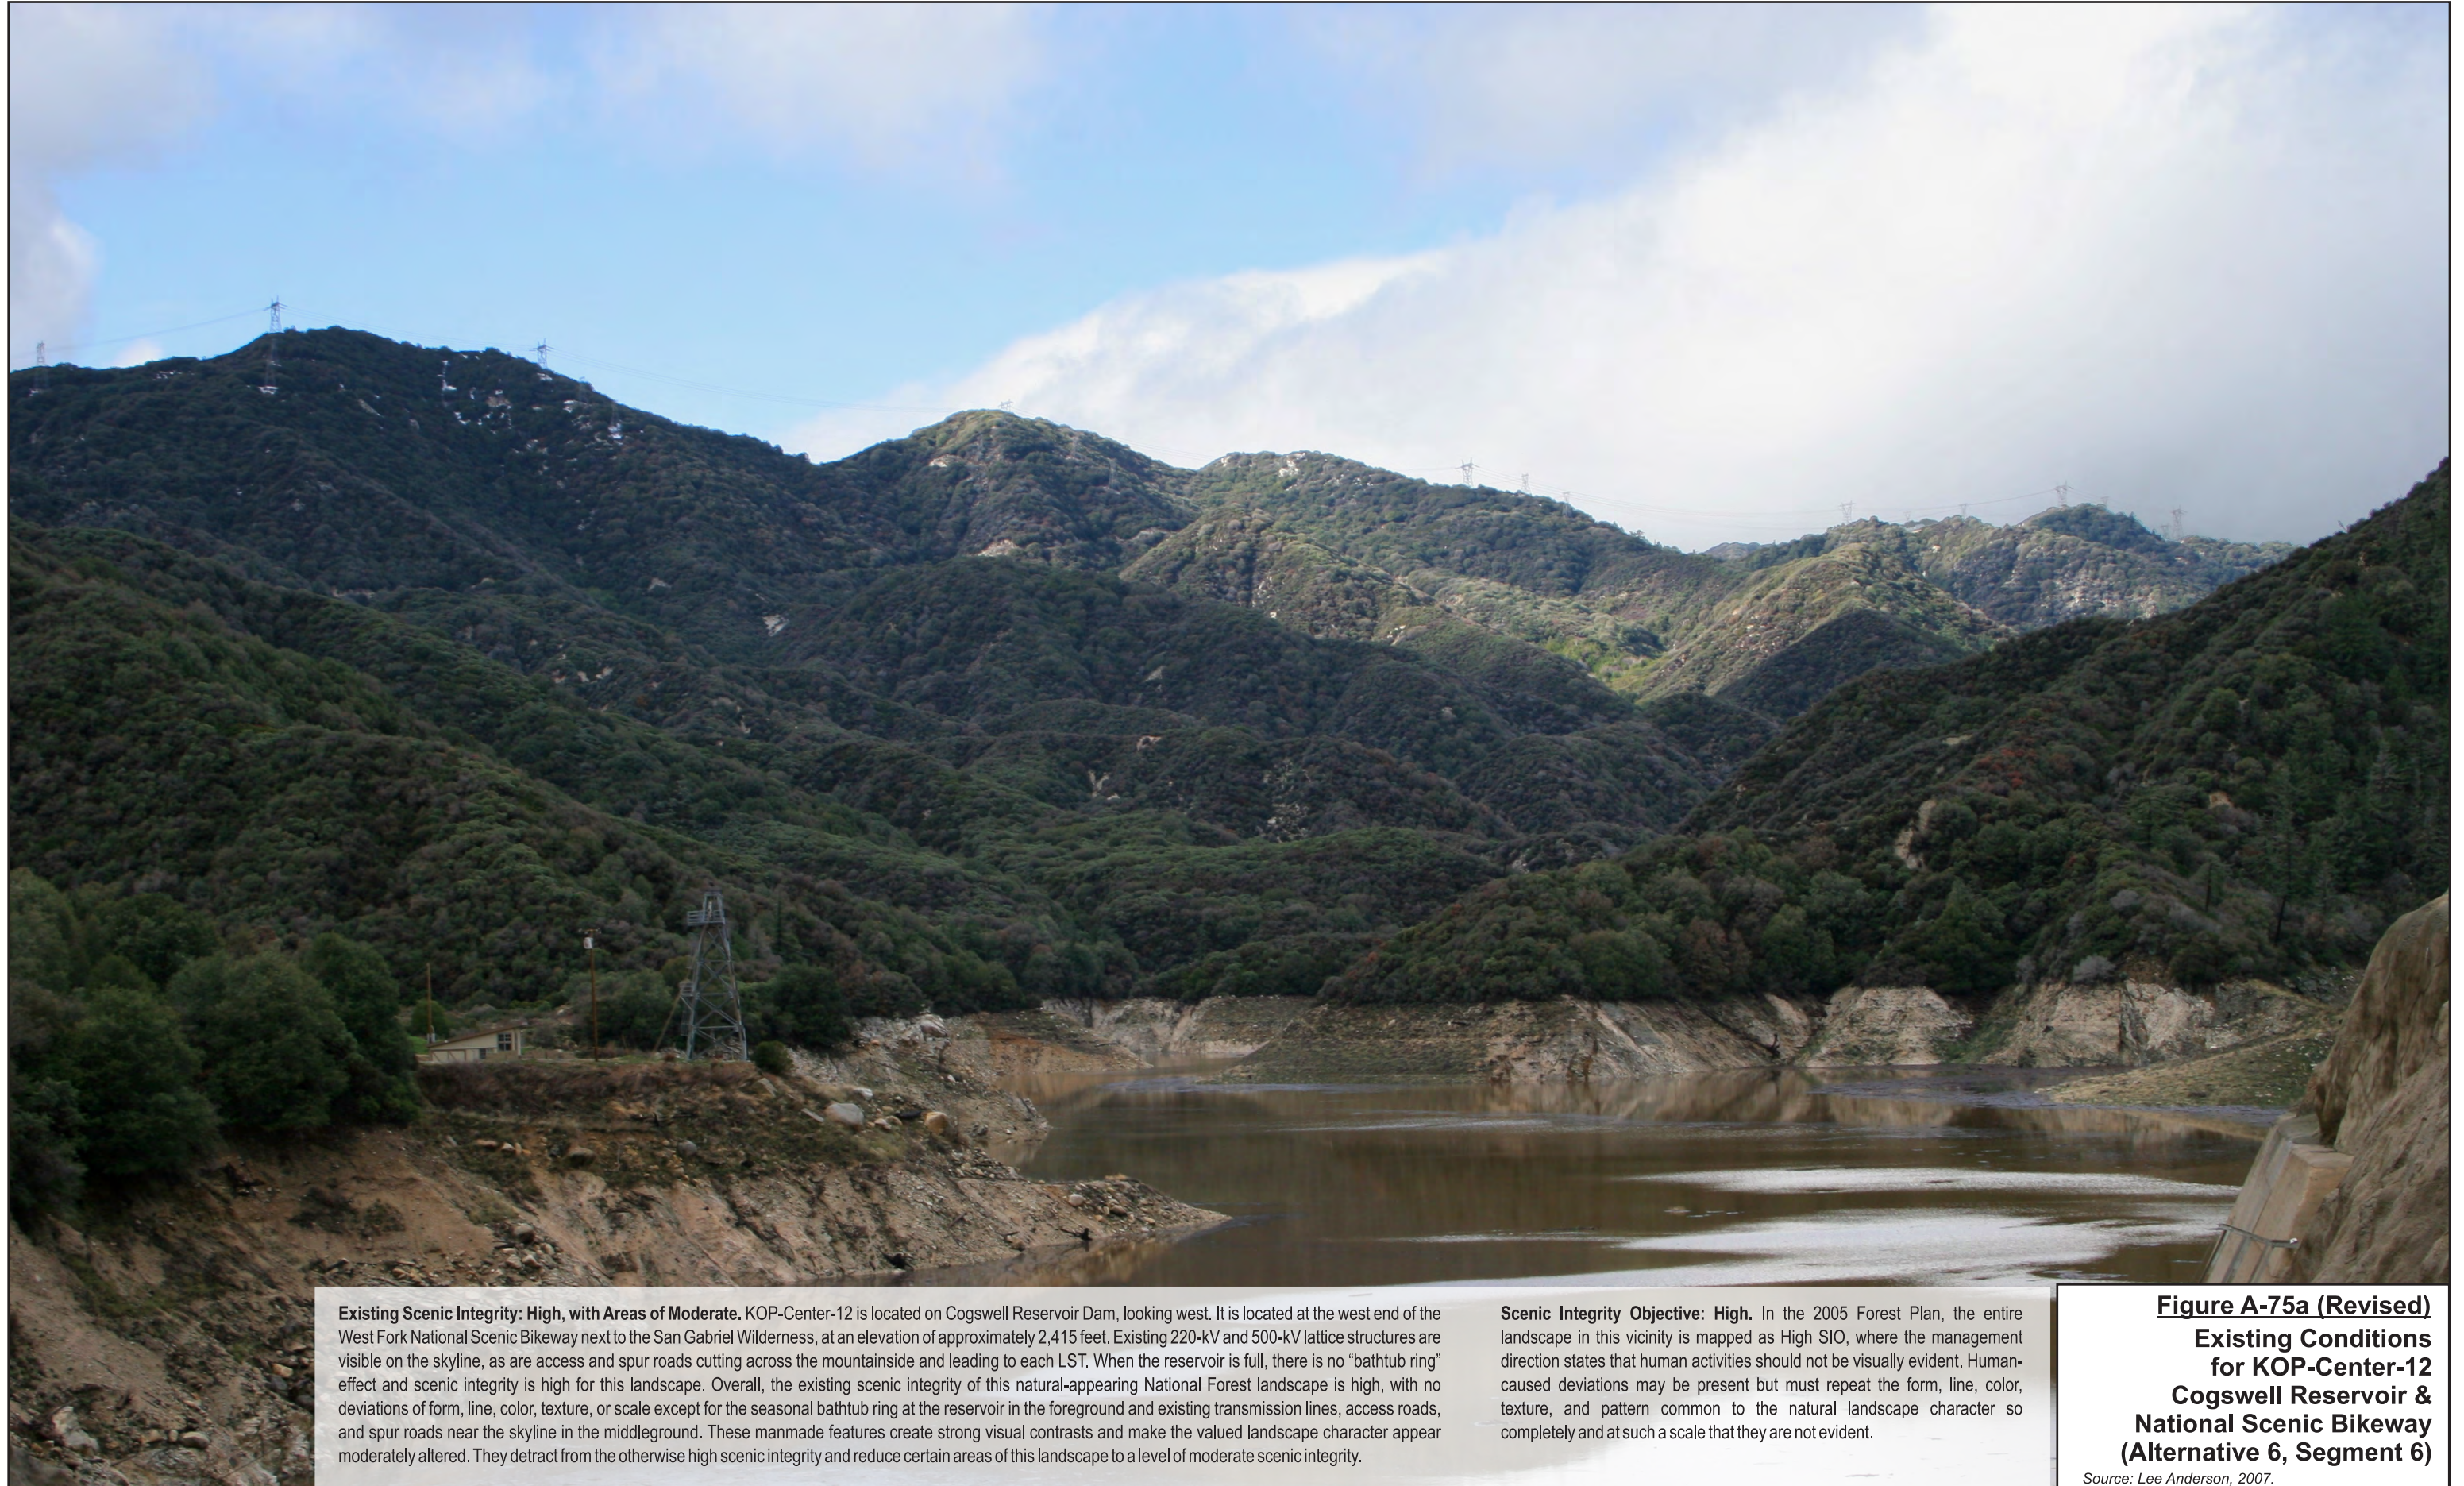
Existing Scenic Integrity: High, with Areas of Moderate. KOP-Center-12 is located on Cogswell Reservoir Dam, looking west. It is located at the west end of the West Fork National Scenic Bikeway next to the San Gabriel Wilderness, at an elevation of approximately 2,415 feet. Existing 220-kV and 500-kV lattice structures are visible on the skyline, as are access and spur roads cutting across the mountainside and leading to each LST. When the reservoir is full, there is no “bathtub ring” effect and scenic integrity is high for this landscape. Overall, the existing scenic integrity of this natural-appearing National Forest landscape is high, with no deviations of form, line, color, texture, or scale except for the seasonal bathtub ring at the reservoir in the foreground and existing transmission lines, access roads, and spur roads near the skyline in the middleground. These manmade features create strong visual contrasts and make the valued landscape character appear moderately altered. They detract from the otherwise high scenic integrity and reduce certain areas of this landscape to a level of moderate scenic integrity.

Scenic Integrity Objective: High. In the 2005 Forest Plan, the entire landscape in this vicinity is mapped as High SIO, where the management direction states that human activities should not be visually evident. Human-caused deviations may be present but must repeat the form, line, color, texture, and pattern common to the natural landscape character so completely and at such a scale that they are not evident.
