**Figure A-81a**  
**Existing Conditions**  
**for KOP-Center-18**  
**Clear Creek Outdoor**  
**Education Camp**  
**(Alternative 6, Segment 11)**

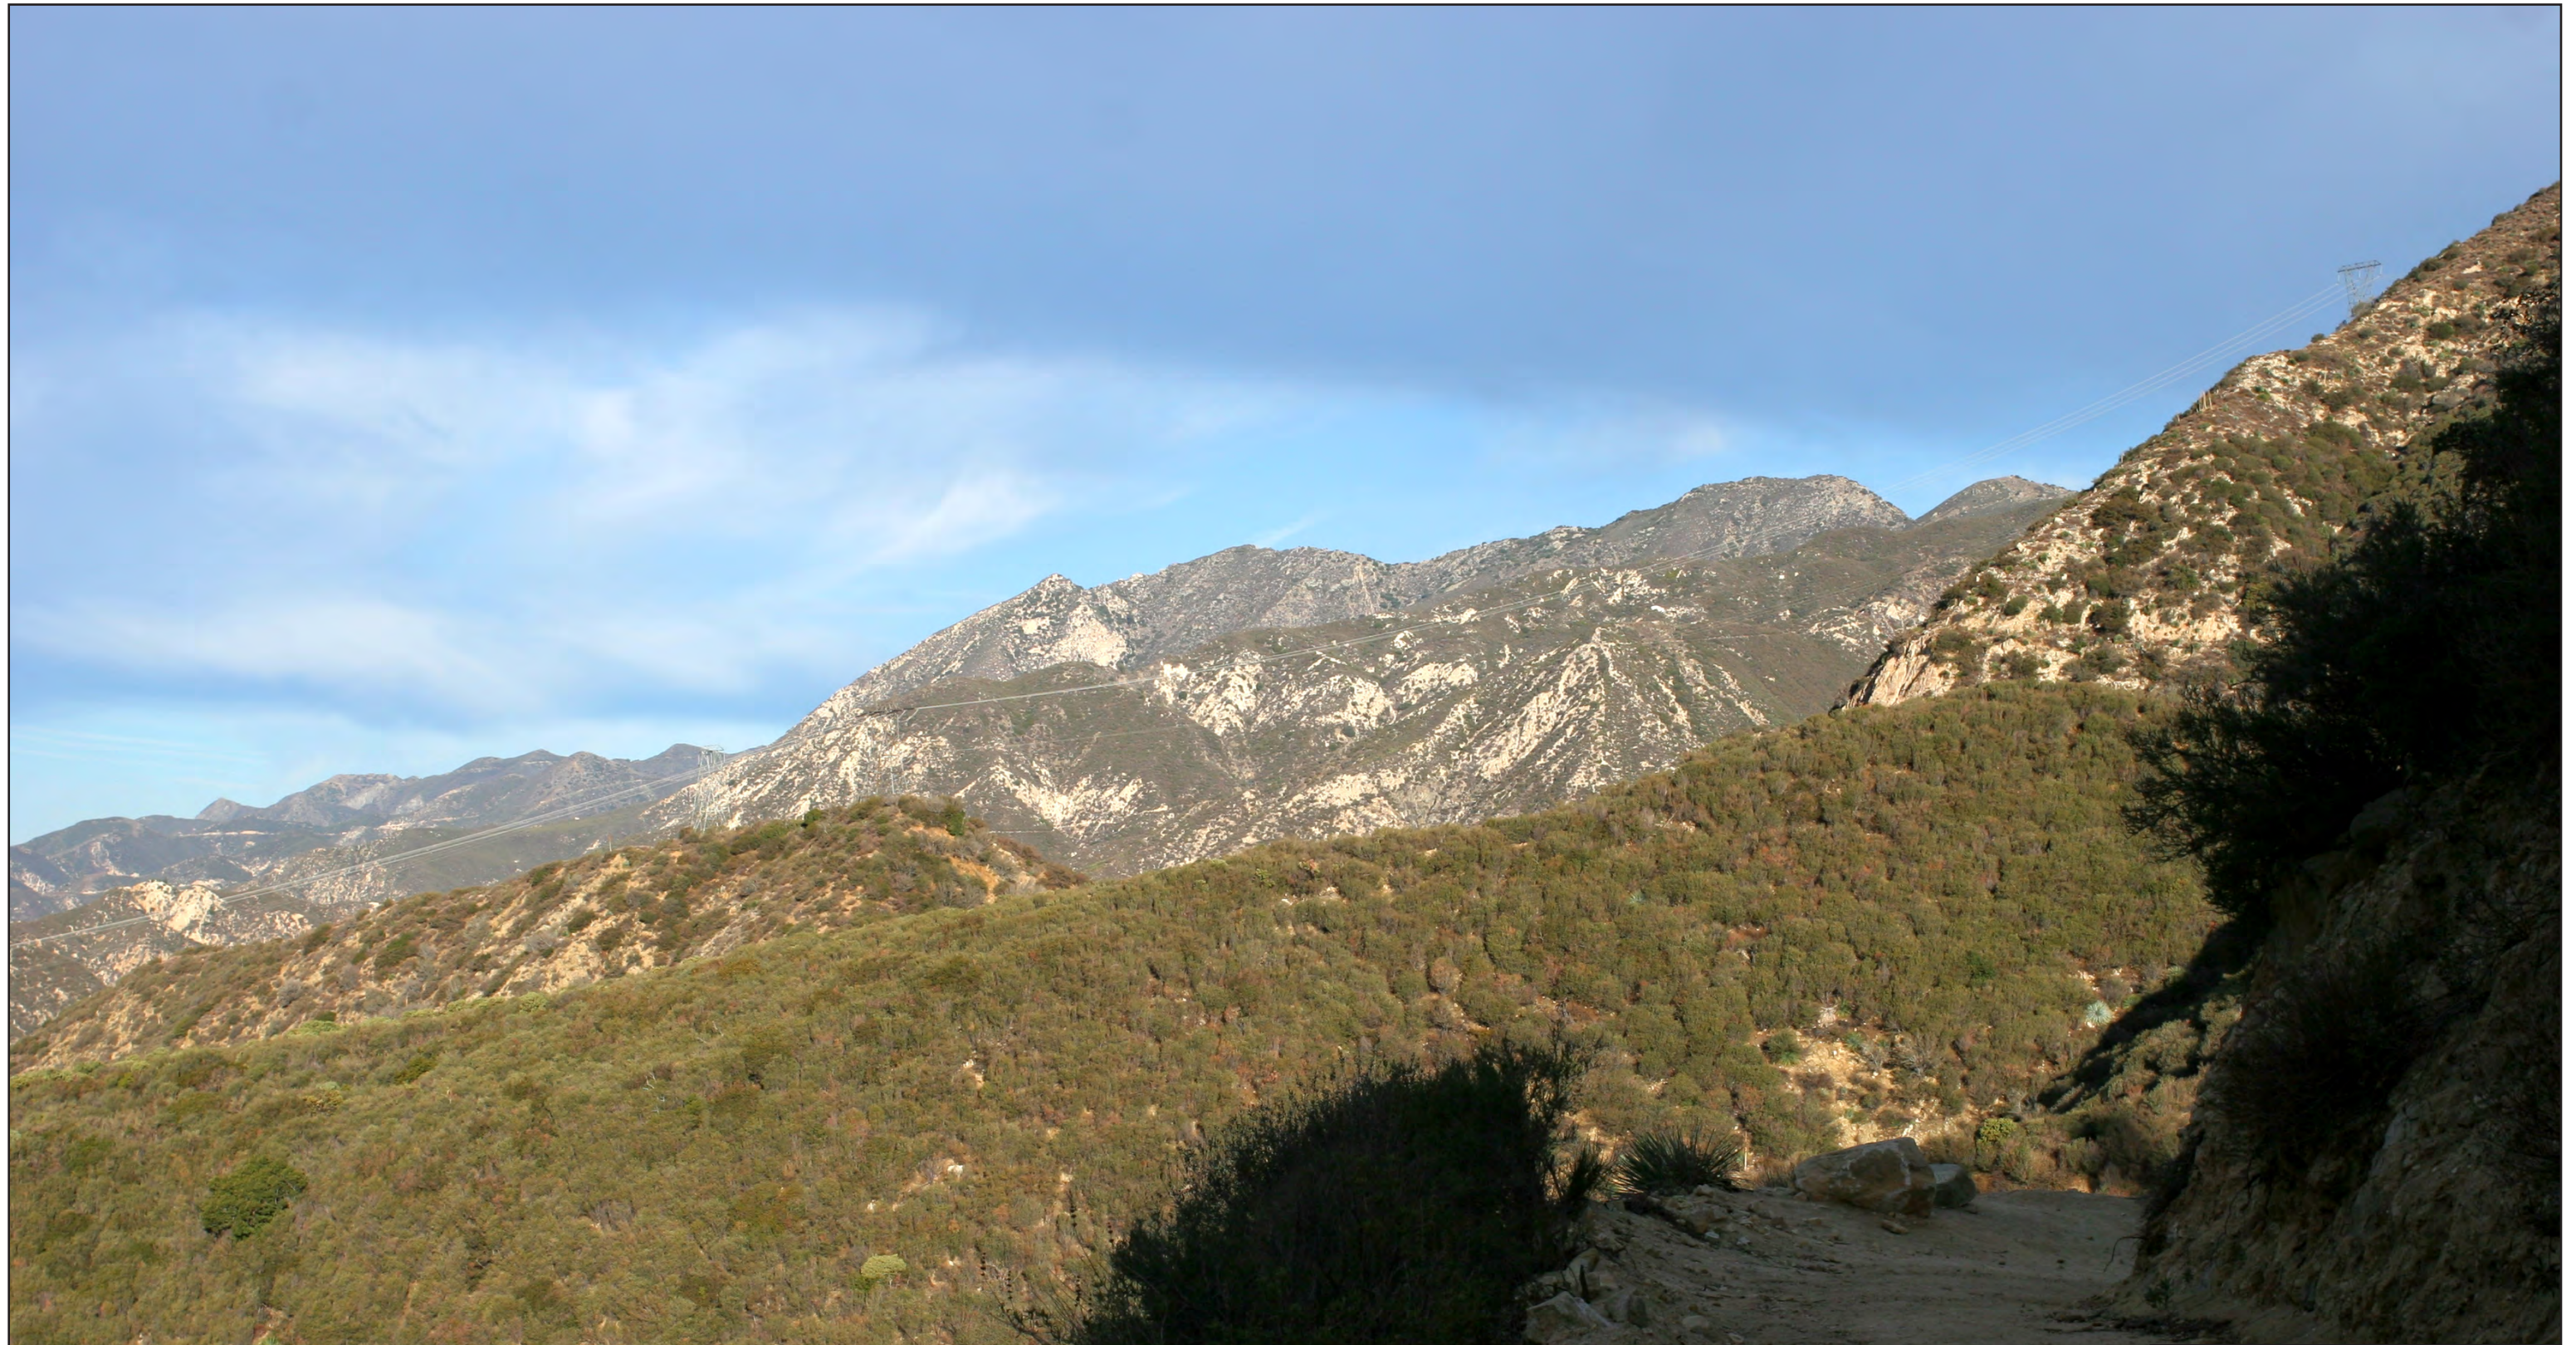
**Existing Scenic Integrity: High, with Areas of Low.** KOP-Center-18 is located on a nature trail just west of the Clear Creek Outdoor Education Camp. The landscape visible from the Clear Creek Outdoor Education Center in general, and KOP-Center-18 specifically, is predominantly natural-appearing, consisting of foreground, middleground, and background landscapes with interesting tan rock patterns and mottled, dark green chaparral-covered mountainsides, leading the eye to a jagged skyline in the background. The folded terrain and shadows create high visual interest in this landscape view. The natural landscape exhibits a high degree of intactness and scenic integrity, except for the discordant transmission line conductors that lead viewers' attention to the lattice steel tower on the right skyline. The existing LST in the middle of this view blends almost completely with the mottled background landscape patterns, and if it were not for the horizontal lines created by the conductors, this LST would meet the definition of moderate scenic integrity. However, the existing transmission line begins to dominate the valued landscape character and detracts from scenic integrity, leading to a rating of low scenic integrity for the utility corridor.

**Scenic Integrity Objective: High.** In the 2005 Forest Plan, the entire landscape in this vicinity is mapped as High SIO, where the management direction states that human activities should not be visually evident. Human-caused deviations may be present but must repeat the form, line, color, texture, and pattern common to the natural landscape character so completely and at such a scale that they are not evident.
