## PROJECT MEMORANDUM

#### TEHACHAPI RENEWABLE TRANSMISSION PROJECT

Subject: TRTP Post-Construction Monthly Report #2, February 2017

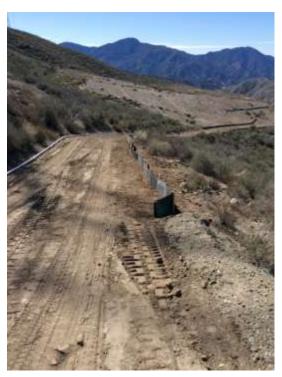
Figure 1: Rabbit Peak Helicopter Assembly Yard (HAY) entrance before hydroseeding.
Photo courtesy of SCE.

- 3. Hydroseeding occurred at one site on Segment 6 and at 3 sites on Segment 11 (see Figures 1 and 2).
- 4. Weed abatement (hand pulling and herbicide use) occurred at 11 sites on Segment 6 and at 5 sites on Segment 11 (see Figure 3).
- 5. No container planting occurred on Segments 6 and 11 during the month of February. Container plant installation on the Angeles National Forest (ANF) was on hold pending the U.S. Forest Service (USFS) decision on whether to allow SCE to install container plants given the risk of *Phytopthora sp.* introduction (see below).

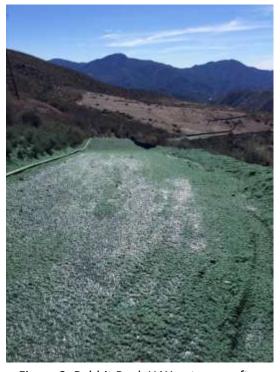
Figure 2: Rabbit Peak HAY entrance after hydroseeding. Photo courtesy of SCE.

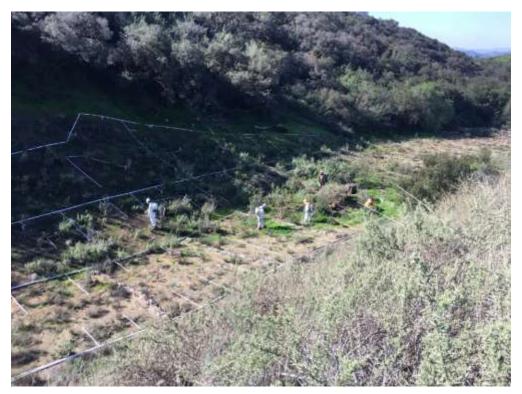
Figure 3: Weed abatement activies at Cheney Trail restoration site, Segment 11b.

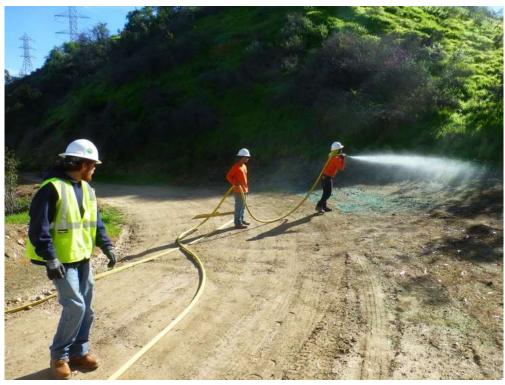
Figure 4: Hydroseeding at Restoration Site R035, Segment 8 Phase 4. Photo courtesy of SCE.

- 1. Hydroseeding occurred at 13 restoration sites on Segment 8 Overhead (see Figure 4).
- 2. Weed abatement (hand pulling and herbicide use) occurred at 21 sites on Segment 8 Overhead (see Figure 5).

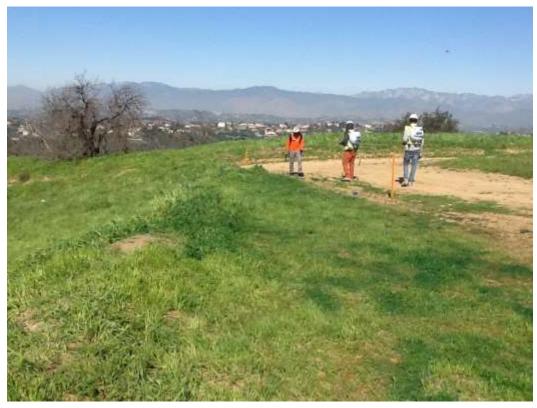
Figure 5: Herbicide application at Tower M58-T3, Segment 8 Phase 1.

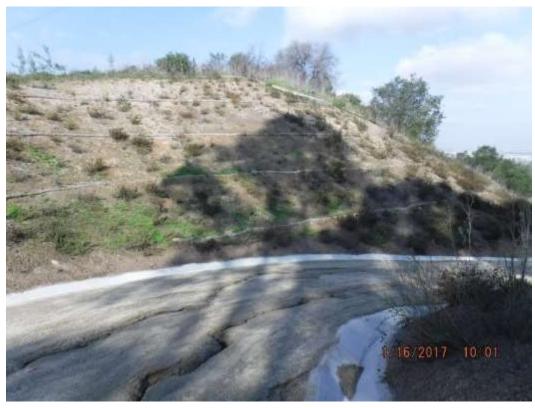
Figure 6: Erosion of access road at Tower 49-T12, Segment 8 Overhead. Photo courtesy of SCE.

- 2. Rainfall totals for the month of February were as follows: Segment 7 3.79", Segment 8 Phase 4 4.02", and Segment 8 Phase 1 (includes Underground) 3.5".
- 3. Pre- and post-storm SWPPP inspections took place for the Segment 7 and 8 disturbance areas still open under the SWPPP (see Figure 6). BMP maintenance and repairs are being conducted by crews on a daily basis as weather conditions allow.
