R.11-02-019: Hearings on PG&E's Implementation Plan

Analysis of the Effects of Pressure-Cycle-Induced Fatigue-Crack Growth on the Peninsula Pipeline

Michael J. Rosenfeld, P.E. and Kolin M. Kolovich, P.E.

March 19, 2012

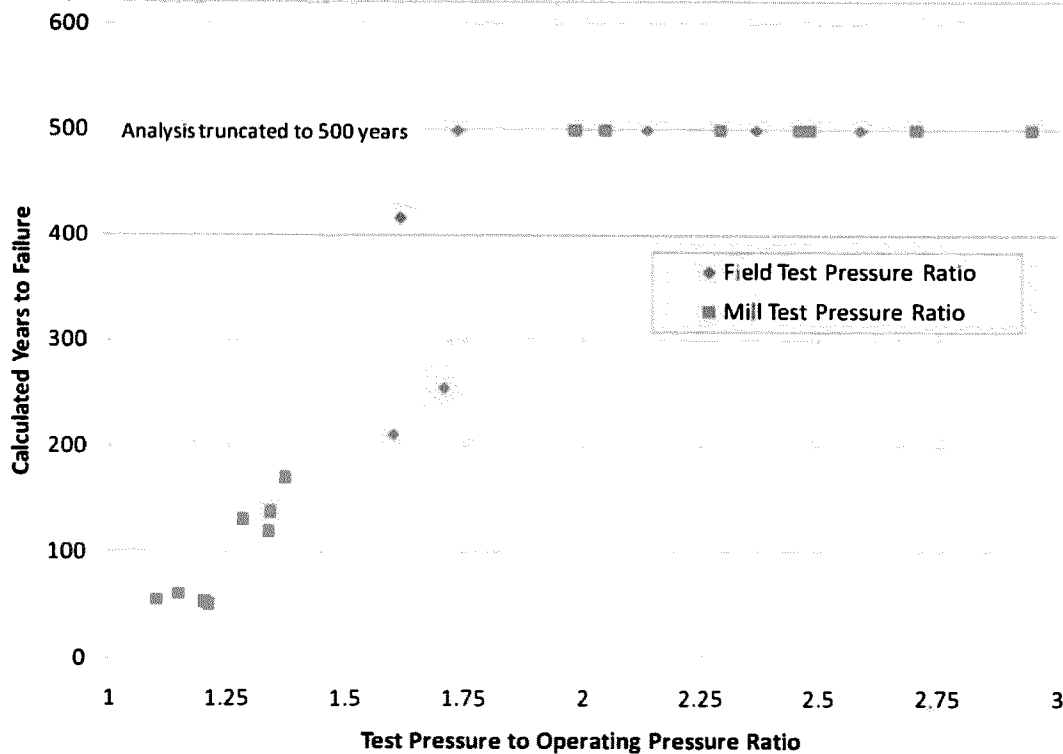
Figure 1. Summary of Predicted Fatigue Lives for Lines 101, 109, and 132 and the Test Pressure to Operating Pressure Ratio

To summarize the results of the fatigue analysis presented in the following sections, the level of hydrostatic test pressure is very important for estimating a specific pipe segment's susceptibility to pressure-cycle-induced fatigue-crack growth. Figure 1 shows that for pipe tested to levels corresponding to 1.75 x the MAOP or more, the calculated fatigue life is in excess of 500 years. Pipe tested to a level of 1.5 x MAOP has a fatigue life of 200 years or more, and pipe tested to 1.25 x MAOP has a fatigue life of at least 100 years. Pipe that was not tested to at least 1.25 x MAOP has a limited calculated fatigue life.

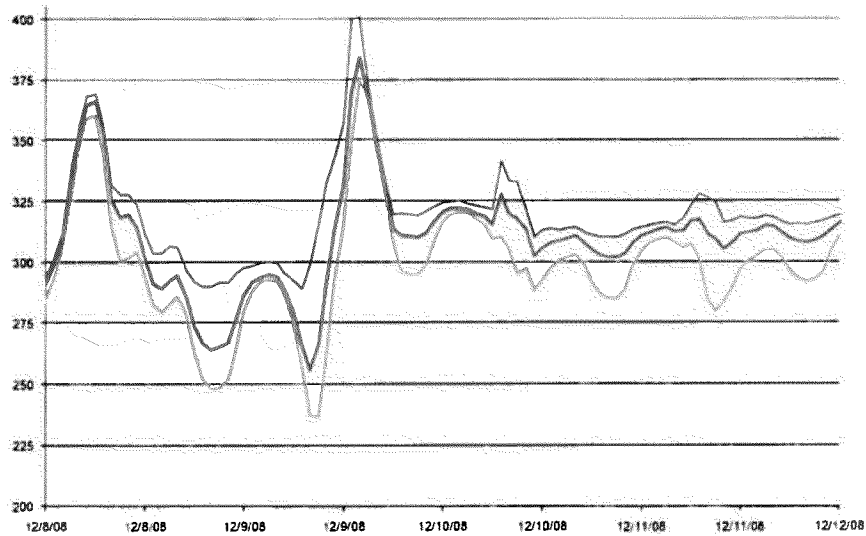
**Figure 2. L132 Pressure Data Exhibiting an Excursion above MAOP**

From the fatigue analyses performed to examine the sensitivity of the calculations to wall
thickness, strength, and toughness, it was observed that different cases had identical or very
similar fatigue lives. Further inspection of these cases showed that failure was predicted at the
same pressure cycle in the spectrum, namely the cycle that contained the maximum pressure in
the spectrum. The maximum pressure in the original L132 spectrum was 404 psig (a 7.7%
excursion above the 375 psig MAOP) as shown in Figure 2. Figure 3 shows a similar
overpressure event where the pressure at one location exceeded 400 psig. Figure 4 shows a
suspected overpressure event that was ruled to be erroneous data since it was a single data point
(rather than a gradual increase over hours as observed in the other events) and the other locations
on the line did not experience an increase at all, either abruptly or otherwise.
