**Moss Landing Tower Collapse
Root Cause Analysis**

Prepared for

Pacific Gas & Electric
6111 Bollinger Canyon Road
San Ramon, CA 94583

April 4, 2016

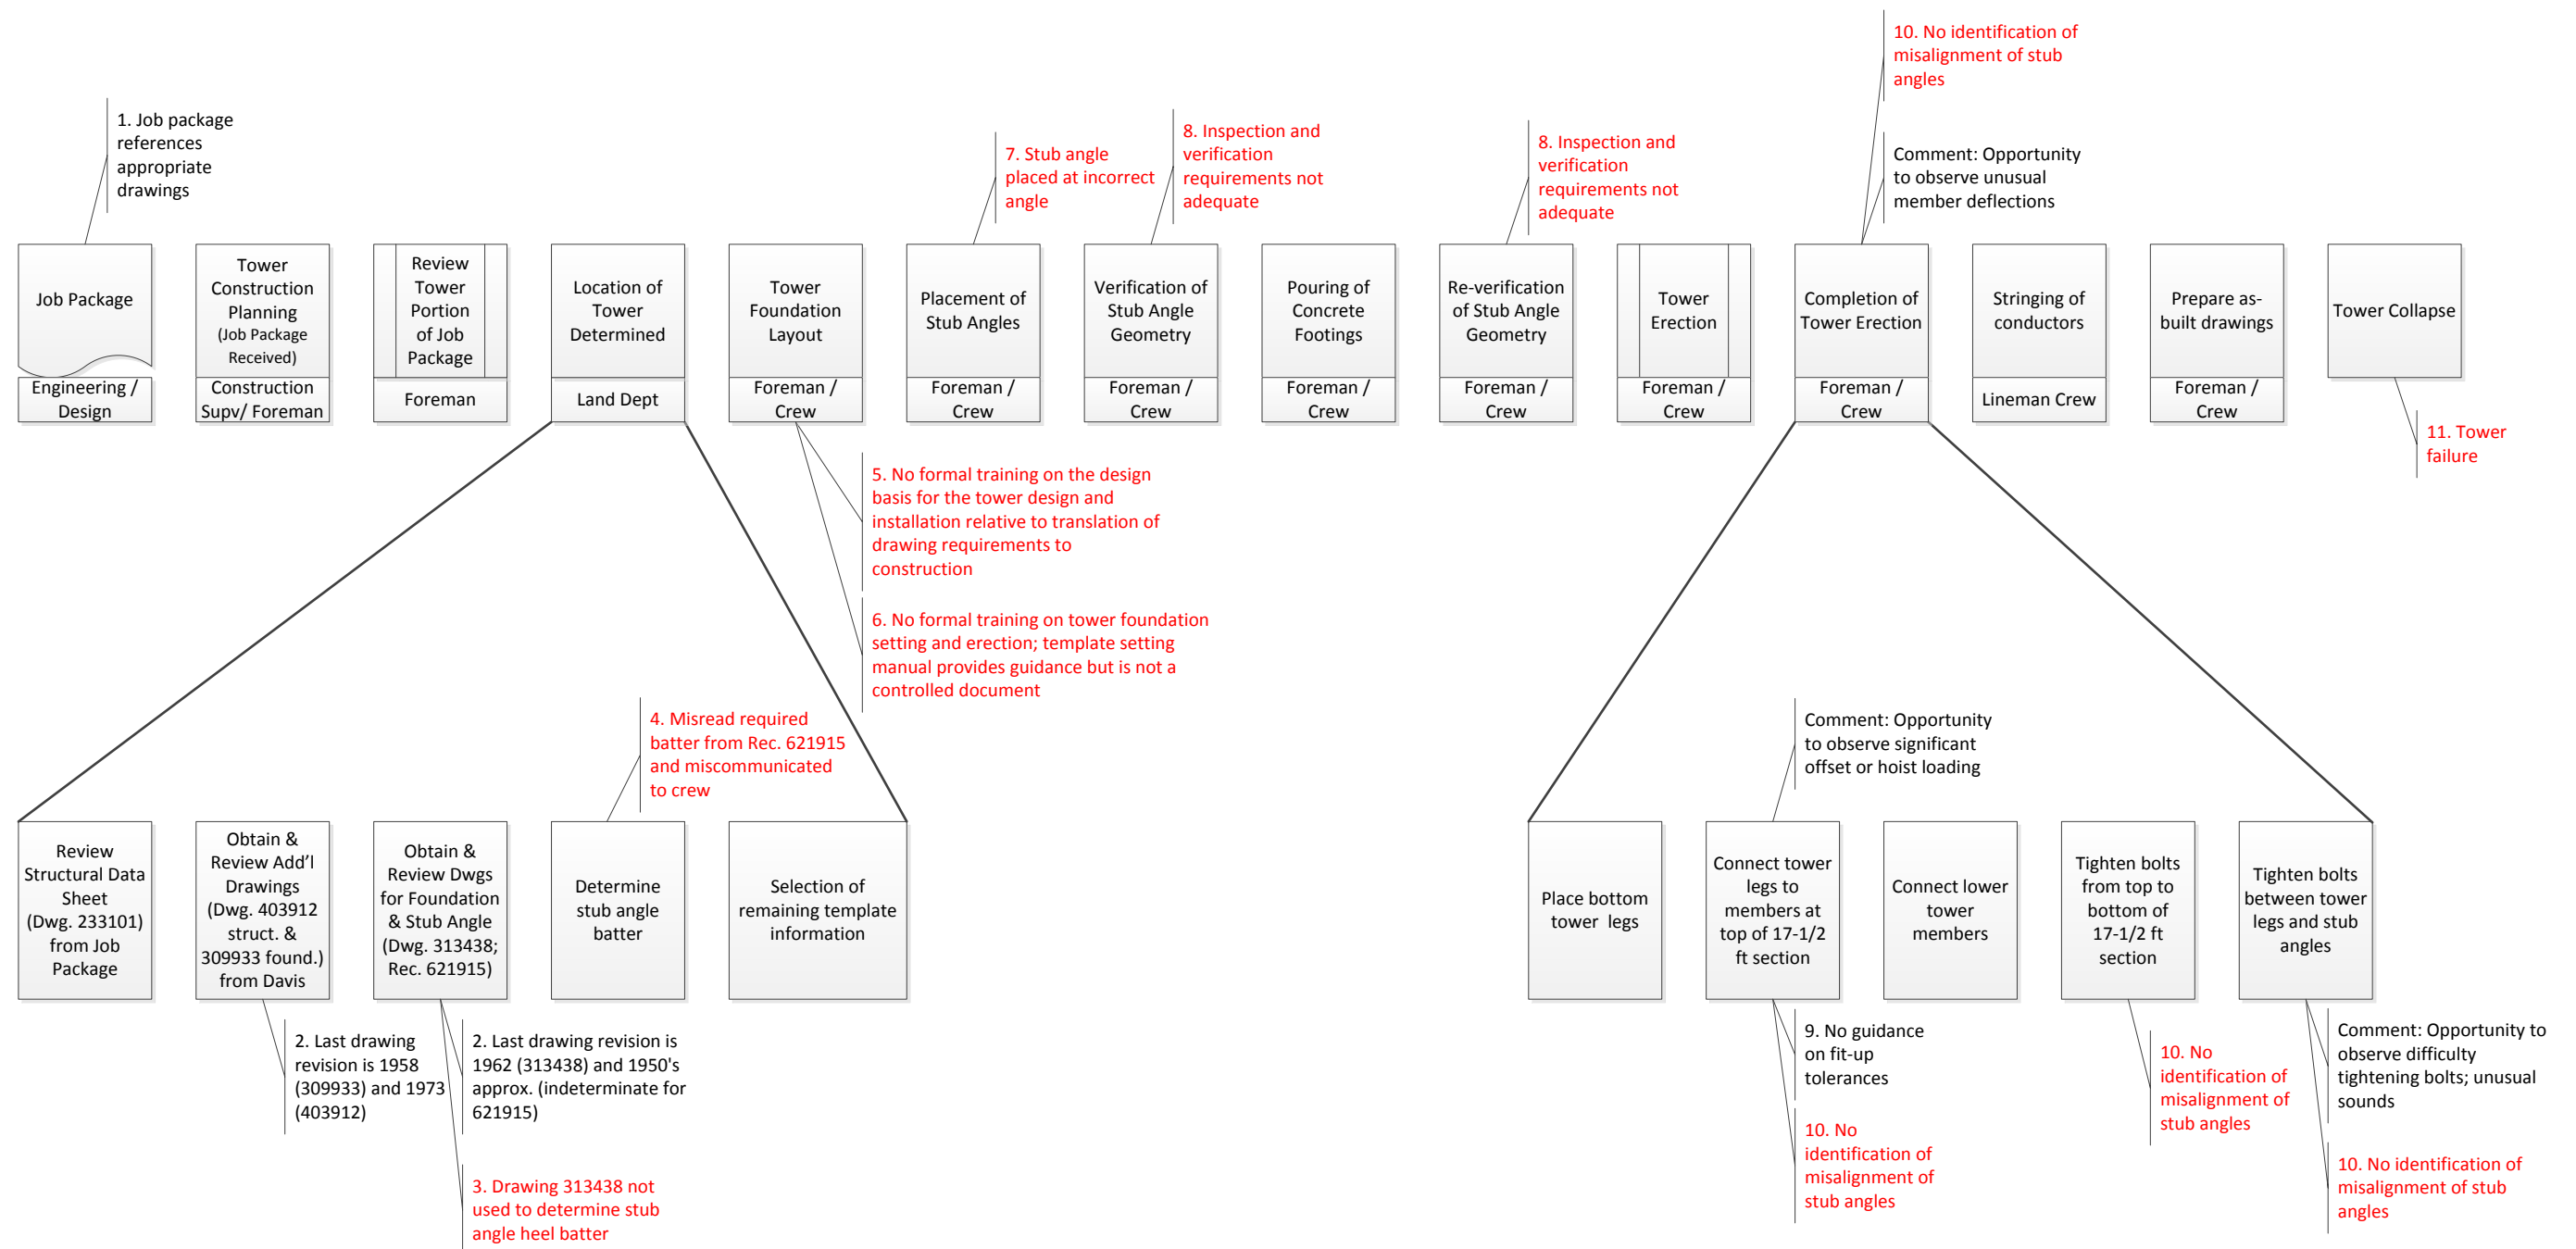
Event Timeline and Process Comparison

1. Numbered comments in “red” represent findings that will be used in the causal analysis.
2. Numbered comments in “black” represent observations that are consistent with requirements and expectations.
3. Un-numbered comments are for information only.

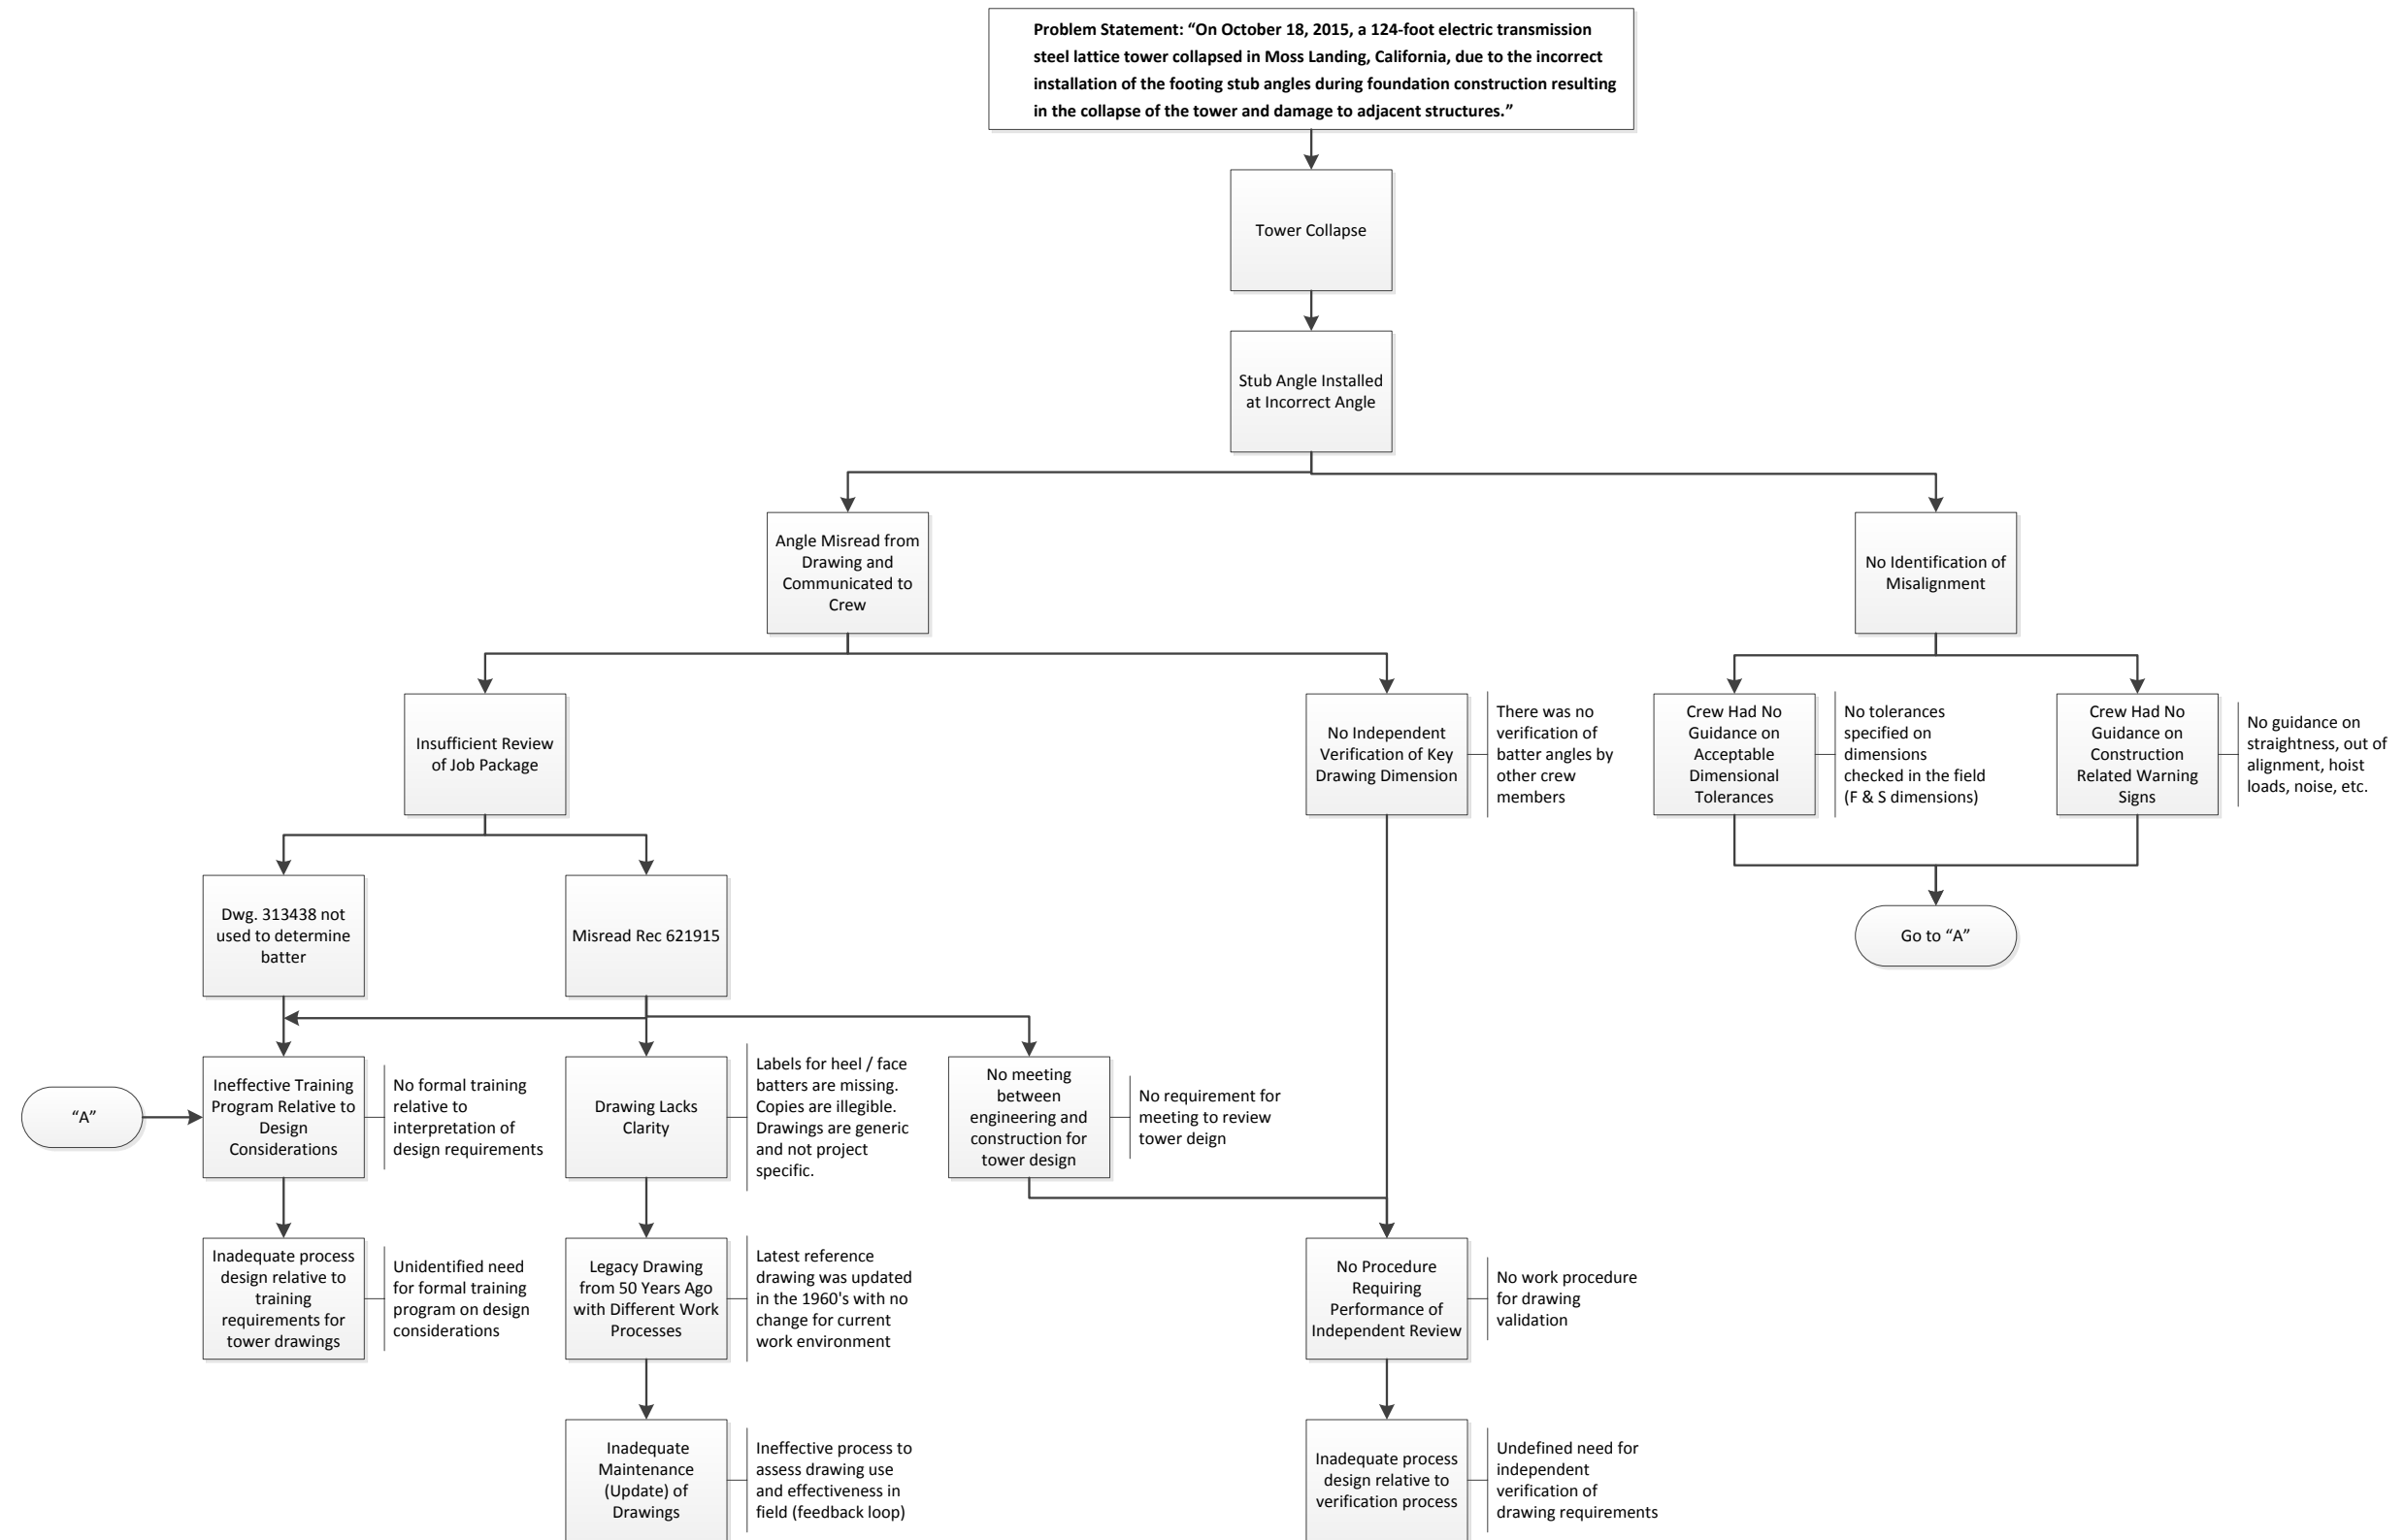
Event and Causal Factors Chart

The Event and Causal Factor Analysis (ECFA) is used to evaluate the cause for each of the findings previously determined. The analysis is performed by looking at the causal chain for each finding, based on the evidence and facts gathered during the data collection activities. The ECFA is presented in the causal diagram shown in Appendix D. This section describes the results of the ECFA.

From the findings identified and described in Section 5, the tower collapse event was initiated by the incorrect settings of the stub angle due to a human error in reading the drawing heel batter; and the subsequent communication of this incorrect heel batter to the crew, for use in setting the stub angles. Based on Figure 7, this human error represents an unintentional action (error or slip). Human errors may occur for a variety of reasons, but work processes and programs are put in place to prevent human errors from having significant consequences. Typical human error barriers include; training, procedures, clear documents and communication, and independent verification. Since the human error relative to the stub angle alignment with the tower legs resulted in a significant occurrence, the causal analysis will include a review of these barriers and their failure to prevent the event.
