# **FINAL REPORT ON THE AUDIT OF THE ALAMITOS POWER PLANT**

**CONDUCTED UNDER GENERAL ORDER 167  
TO DETERMINE COMPLIANCE WITH  
OPERATION, MAINTENANCE, AND LOGBOOK STANDARDS**

ELECTRIC GENERATION PERFORMANCE BRANCH  
CONSUMER PROTECTION AND SAFETY DIVISION  
CALIFORNIA PUBLIC UTILITIES COMMISSION  
505 VAN NESS AVENUE  
SAN FRANCISCO, CA 94102

October 10, 2008

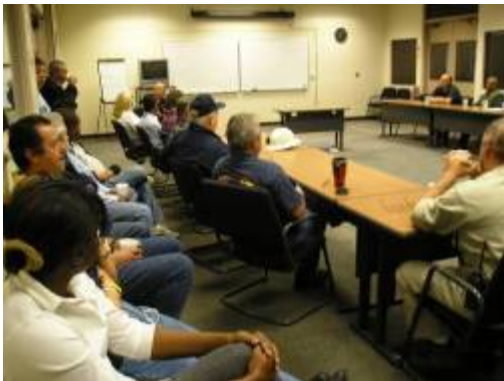
Figure 15. Plant holds meetings for all staff twice weekly.

The plant schedules twice-weekly, early morning meeting for all employees to discuss plant activities and the outlook for the future. Management encouraged open communications (Figure 15). On the other three days of the week, the unit groups conduct unit early morning meetings to discuss more detailed unit specific matters. Before leaving work, each shift meets with the incoming shift to brief them on conditions at the plant.

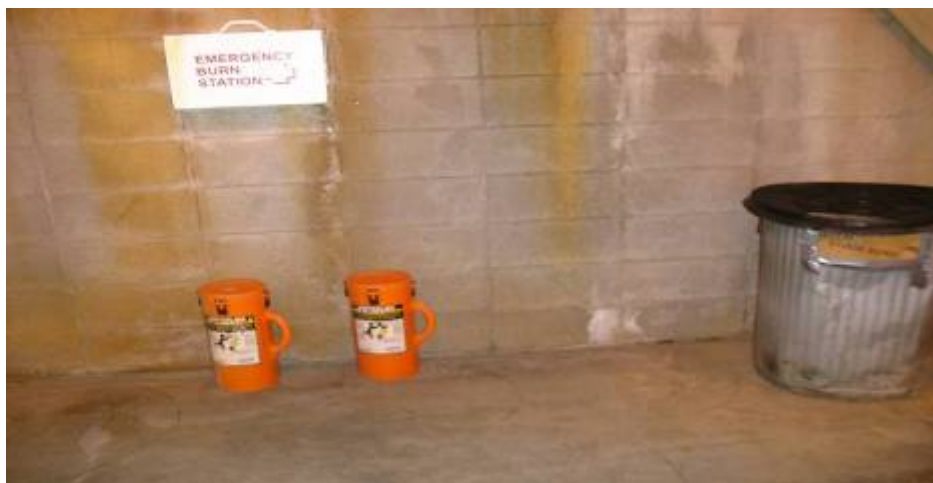
Figure 16. Plant appears orderly and clean.

With some exceptions, such as the concrete shown in Figure 13, the auditors observed the plant to be clean and orderly during the on-site visit (see Figure 16). Staff use a housekeeping checklist that the plant manager reviews and signs weekly. The auditor reviewed and verified completed housekeeping checklists for July 2005. Space heaters ran in several plant locations to keep important equipment dry. During a plant tour, two CPSD auditors noted that team leaders collected rubbish.

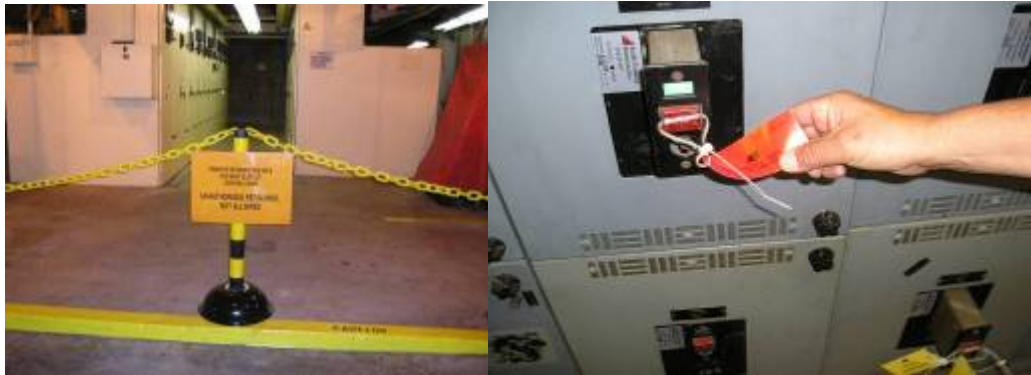
**Figure 17. Auditors saw warning signs and equipment clearance tags throughout the plant.**

Auditors observed clearance tags as well as warning and information signs and throughout the plant (Figure 17). At the main gate, a safety sign reminds workers that safety is a priority, and lists the number of days that the plant has been free of accidents. The auditor

noted that although plant records show two injuries during 2005, the sign shows 2137 “safe days worked”. The plant responded that the sign refers only to lost-time accidents.
