California Public Utilities Commission

**INVESTIGATION REPORT  
OF THE  
JUNE 19, 2012 FATALITY AT THE  
KERN POWER PLANT OWNED BY  
PACIFIC GAS AND ELECTRIC COMPANY**

**PUBLIC REPORT**

**PREPARED BY THE SAFETY AND ENFORCEMENT DIVISION  
ELECTRIC SAFETY AND RELIABILITY BRANCH**

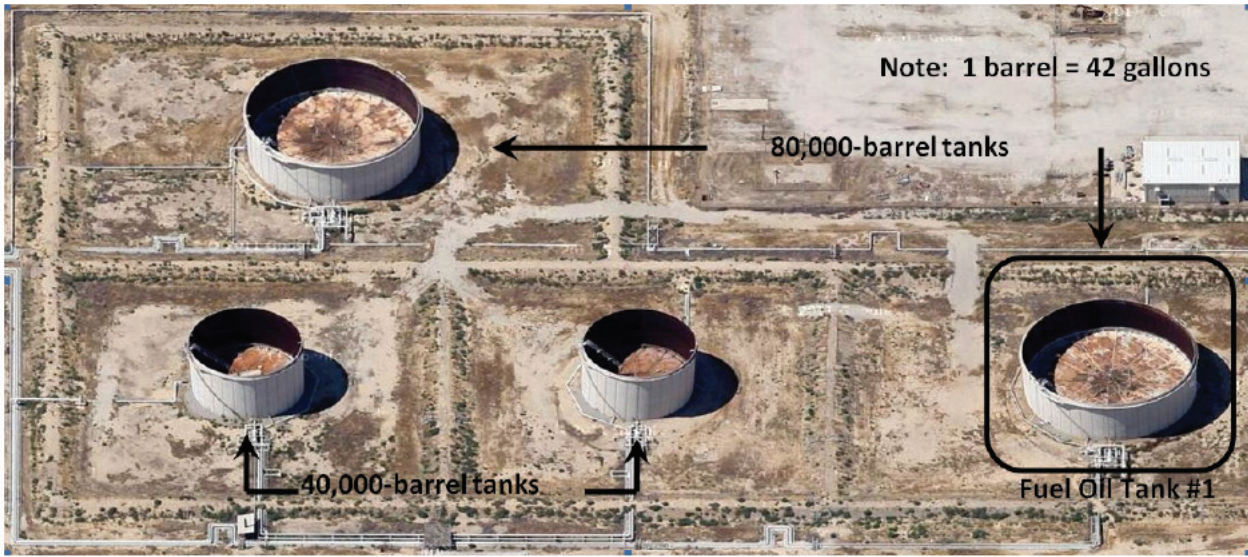
Figure 4: Fuel oil tank farm at Kern Power Plant. *Source: Google Maps.*

On the following day, workers began to demolish Fuel Oil Tank #1 (Figure 4). The 80,000-barrel tank was approximately 40 feet tall and 120 feet in diameter. From inside the tank, two workers stood on elevated man lifts to torch-cut the top half of the 40-foot-high tank wall in 20-foot-high sections. Once the workers finished a vertical section cut, a third worker in an excavator pushed the top wall section from outside the tank to fold it into the tank, reducing the tank section height by half (Figure 5).
