Subject: Rock Fall Hazard Evaluations
Sunrise Powerlink Project
San Diego and Imperial Counties, California
URS Project No. 27661033.00010

**Subject: Sunrise Mountain Springs Grade
Rockfall Hazard Evaluation:
Towers 261A, 263A-2, 263B-2, 266-2, and 272-3**

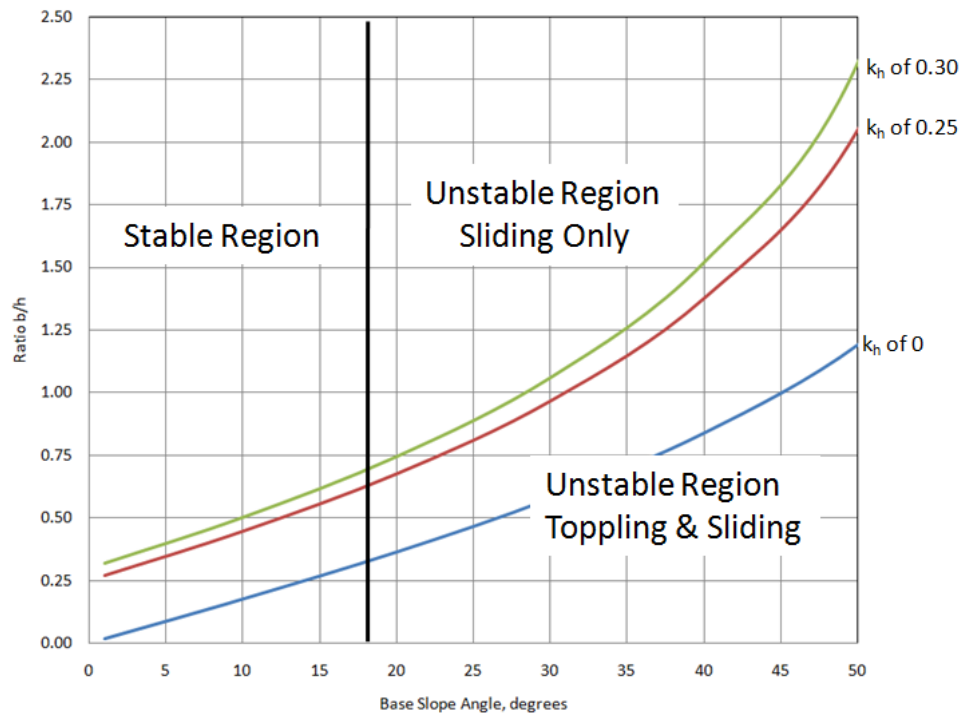
Figure 4.3: Results of the Toppling and Sliding Evaluation

Figure 4.3 graphically shows the results of the sliding and toppling analysis for Sunrise Mountain Springs Grade. This will be used as a screening tool while the Crux team evaluates and mitigates potential rock fall hazards prior to foundation installation.

1. Establish whether there is a slope with a grade of 2H:1V or steeper located above the transmission tower where if rockfall is generated, it can roll towards the tower.
2. Measure the height and width of rock blocks on the slope above the planned tower and compare the measured b/h ratios to Figure 4.3.
3. Where blocks have a b/h ratio less than 1.0, use expandable grout, explosives, hydroblasting or other approved methods to break rocks so that the resulting fragments have acceptable b/h ratios or (if possible) tip the rocks over so that the b/h ratio is increased.

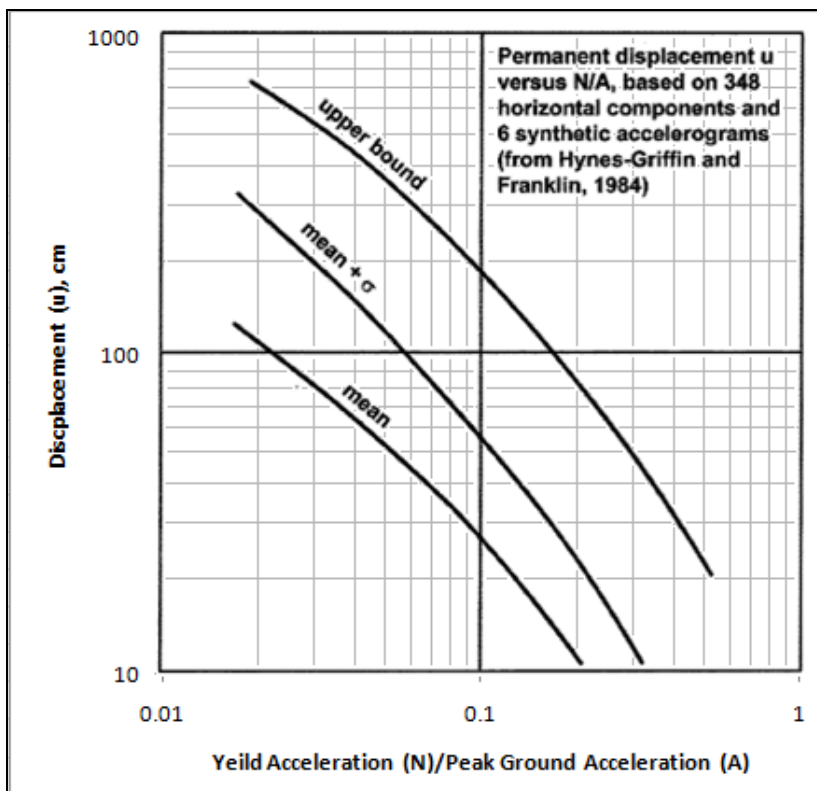
Figure 4.4: Permanent displacement of sliding rock blocks during an earthquake

Comparison of the N/A ratios of Table 4.1 and Figure 4.4 suggests that during the design-based earthquake, translational sliding of blocks could approach 107 inches (9 feet) where slope angles approach 35 or 40 degrees. Translational sliding of rock blocks at a radius of more than 9 feet from the tower legs are not considered a risk to the tower.

1. Establish whether there is a slope as steep as about 2H:1V or steeper located above the transmission tower where rock may slide towards the tower foundations. On slopes shallower than 2H:1V, translational sliding will be minimal.
2. Where rock slopes are greater than 2H:1V, rocks within a uphill radius of 9 feet will be moved from an uphill position (this may require breaking the blocks) so that they do not impact a transmission tower during the design-based earthquake.

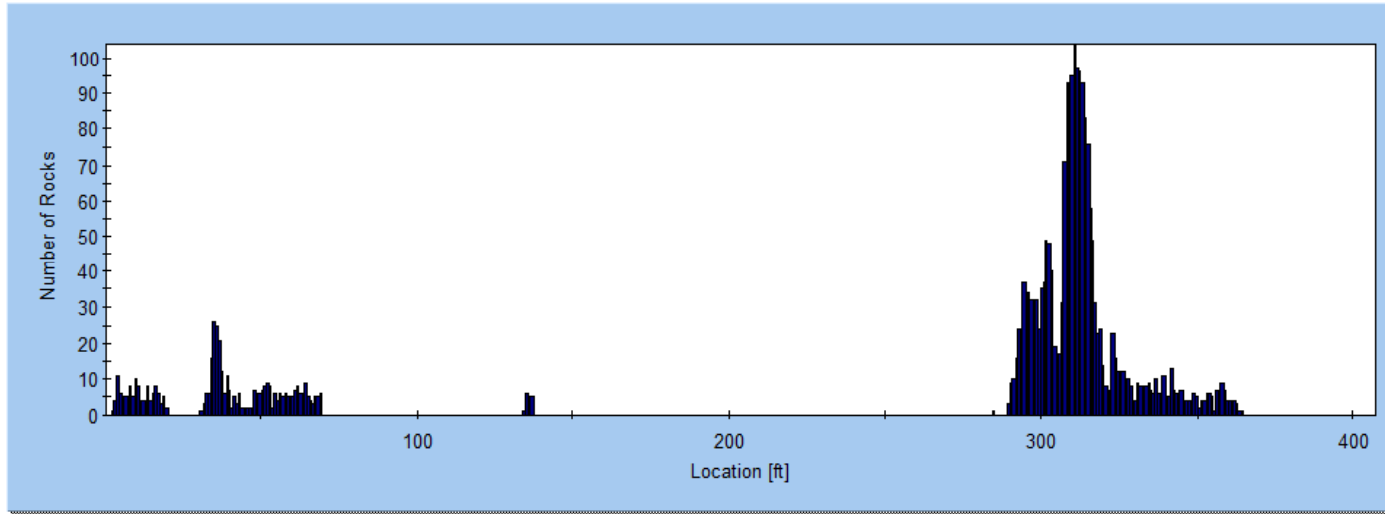
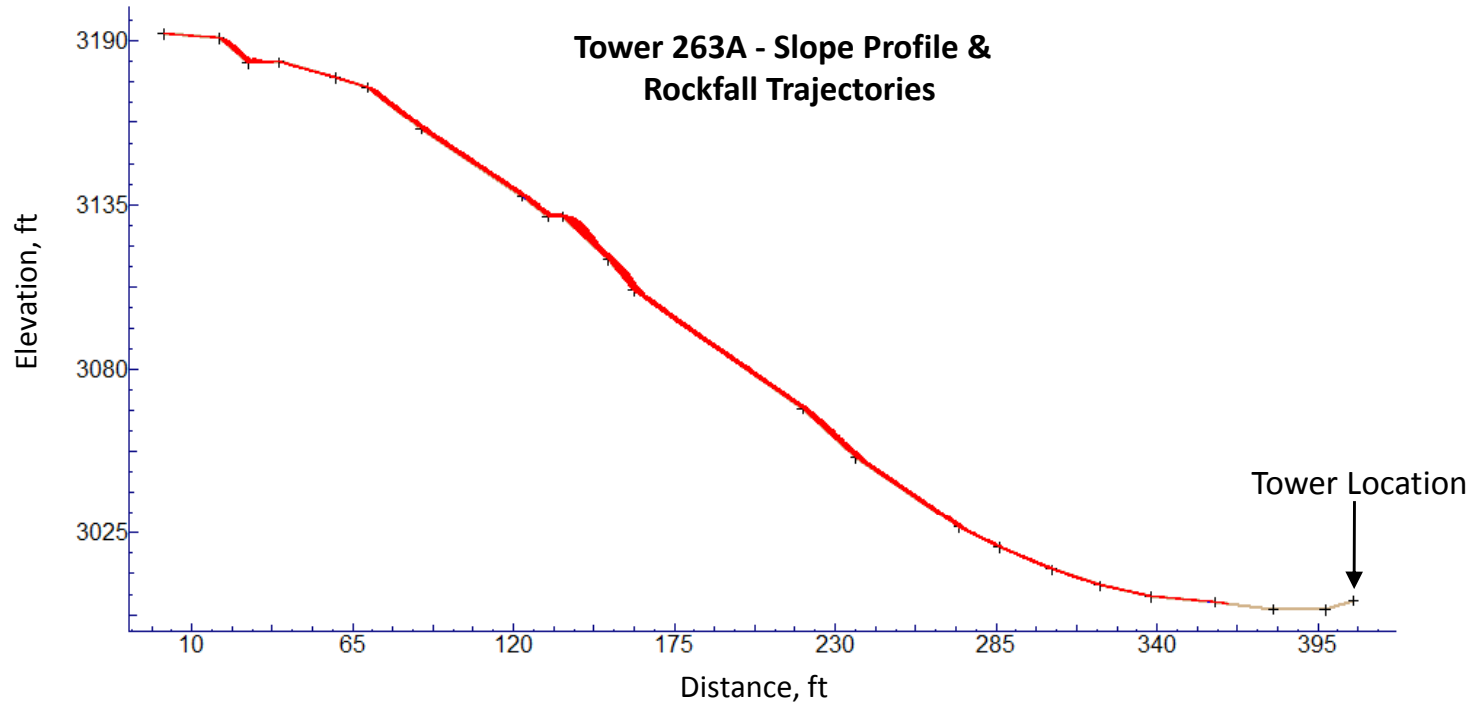
Figure D-2

Rockfall Simulation Results for Tower 263A-2
