**SAN DIEGO GAS & ELECTRIC COMPANY
CLEVELAND NATIONAL FOREST
POWER LINE REPLACEMENT PROJECTS
ACCESS ROAD CONDITION EVALUATION AND
REPAIR DESIGN REPORT**

JUNE 2017

TL682 Access Road Evaluation Summary

TL682 Access Road Improvement Recommendation

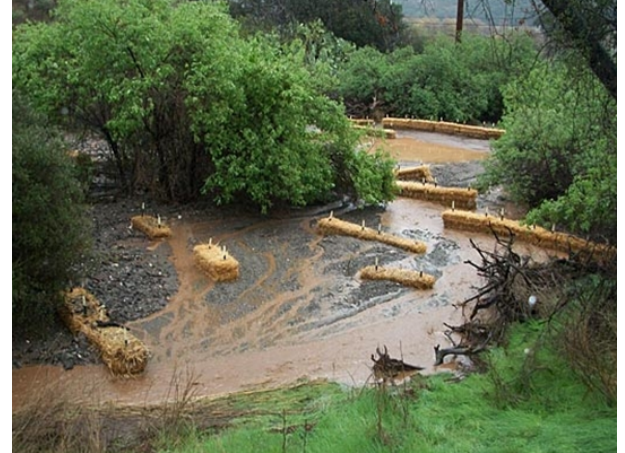
Example of rice hay bales effectively reducing runoff velocity and settling out debris and sediment.

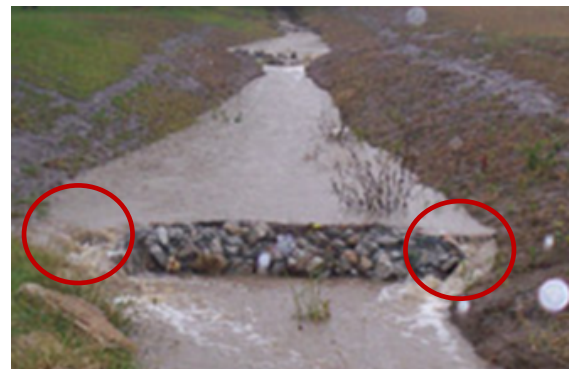
Velocity controls and energy dissipaters should generally not be used in existing rills or gullies. This is somewhat counter intuitive however think of this, runoff drainage during rain events will always use the path of least resistance. If the runoff comes in contact with a strong gravel bag berm and native soil, the water will create eddies at the corners of the berm and begin to erode away the native soil. Over time the berm will remain in place and the native soil will be eroded around the berm, see photo right.

Example of eddies causing erosion around the rock berm.
