Re: Monthly Report Summary #24 for Aliso Canyon Turbine Replacement Project

Aliso Canyon Turbine Replacement Project CPUC Site Inspection Form

| Project: | Aliso Canyon Turbine Replacement | Date: | March 1, 2016 |

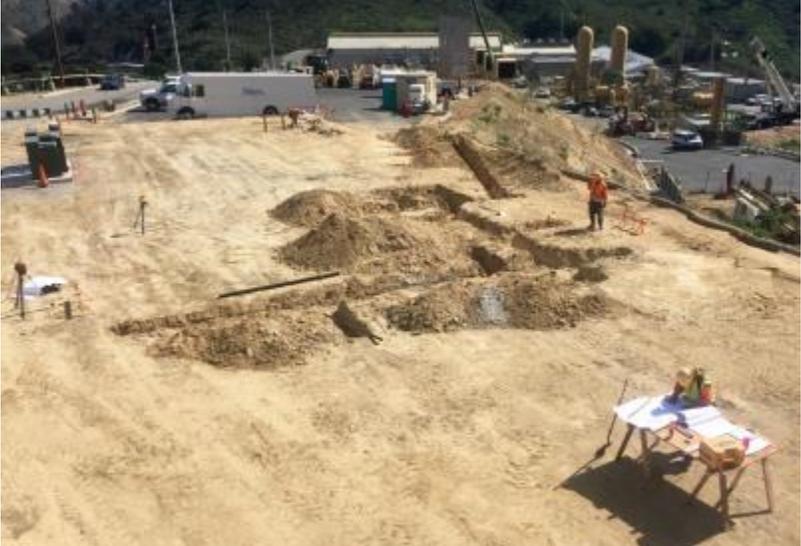
| Date | Location | Photo | Description |
|---|--|--|--|
| 3/01/16 | New Admin/IM Building | | Trenching for landscape irrigation lines continues. |

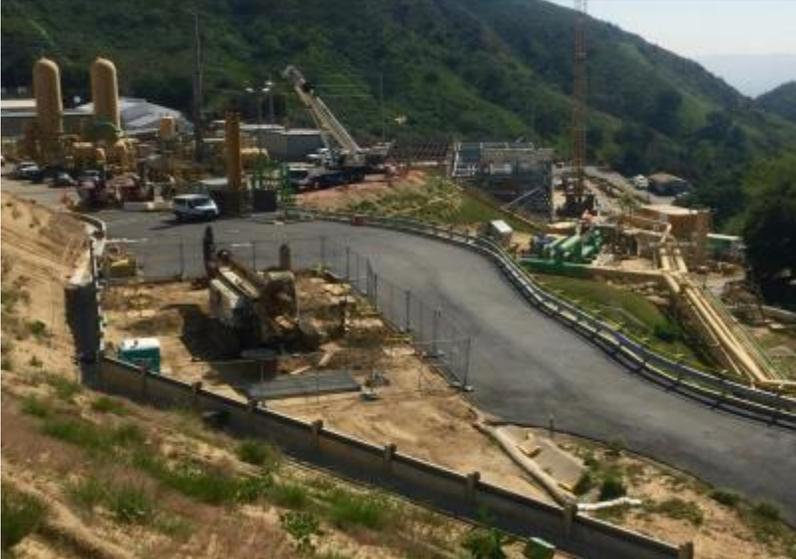
| Date | Location | Photo | Description |
|---|---|---|--|
| 3/01/16 | New Admin/IM Building | | Drilling for caissons. |

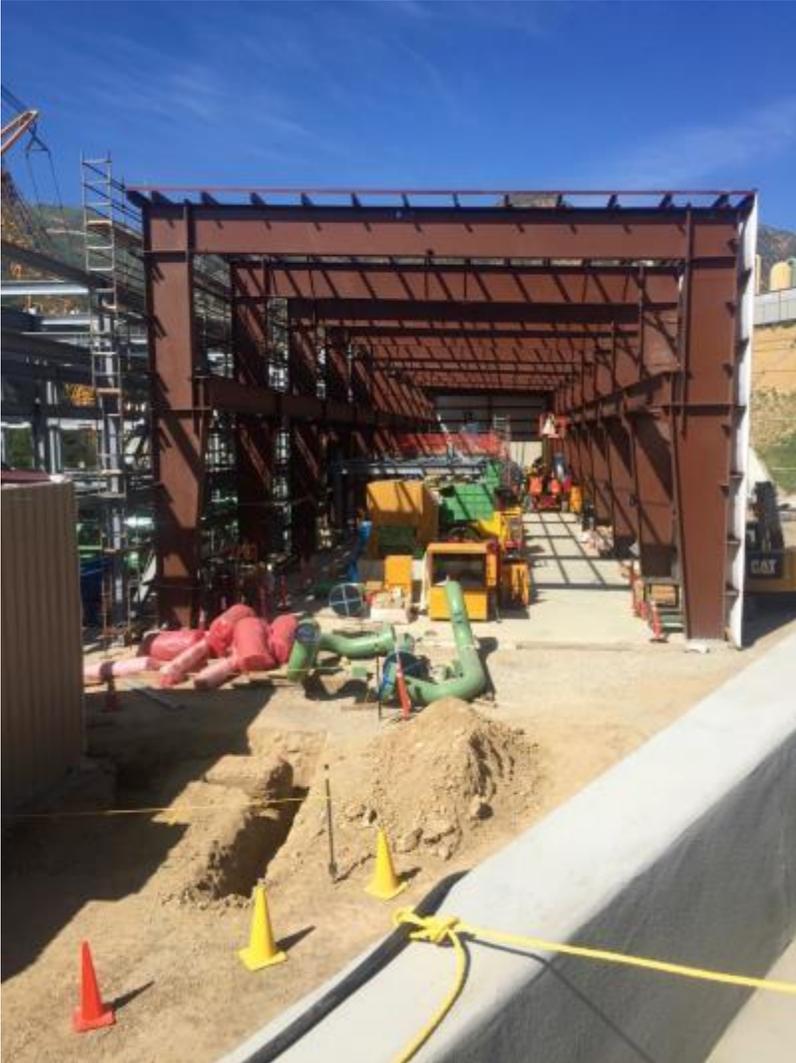
| Date | Location | Photo | Description |
|---|---|---|--|
| 3/01/16 | CCS | | Some trenching continues within the CCS. |

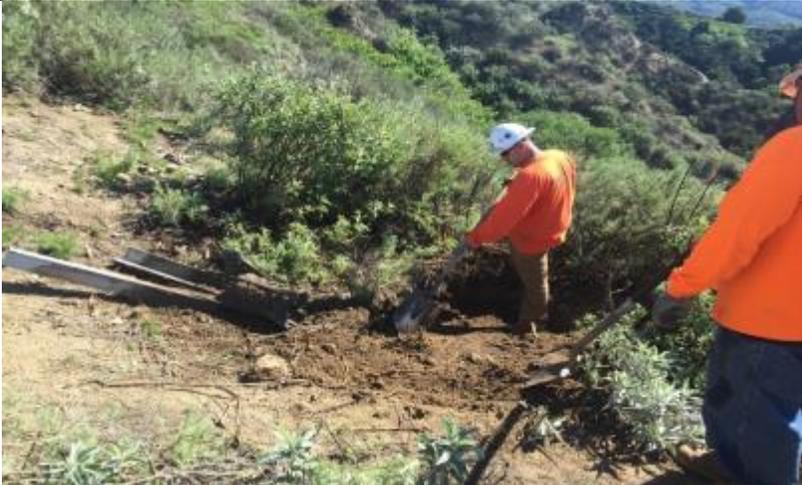
| Date | Location | Photo | Description |
|---|---|--|---|
| 3/10/16 | TSP 30 | | <p>Crews are conducting hand-removal of the old tower foundations.</p> |

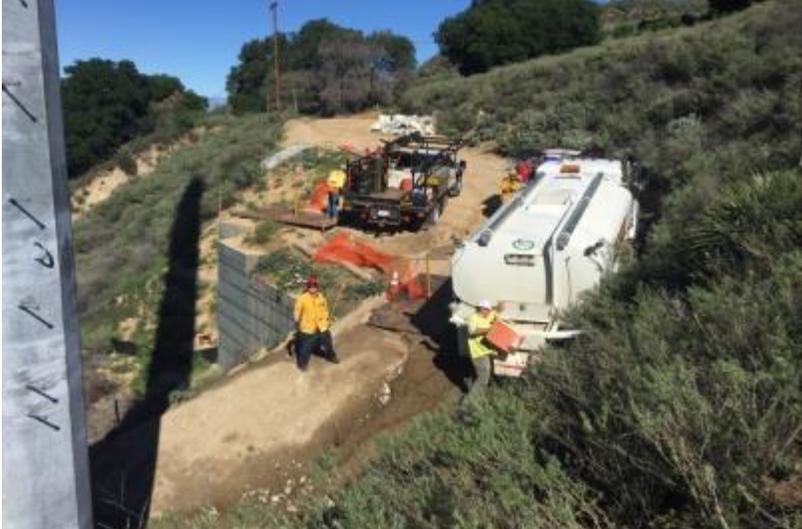
| Date | Location | Photo | Description |
|---|---|--|---|
| 3/10/16 | TSP 30 | | <p>The crew onsite at TSP 30 includes a work truck, a water truck, and a fire crew.</p> |

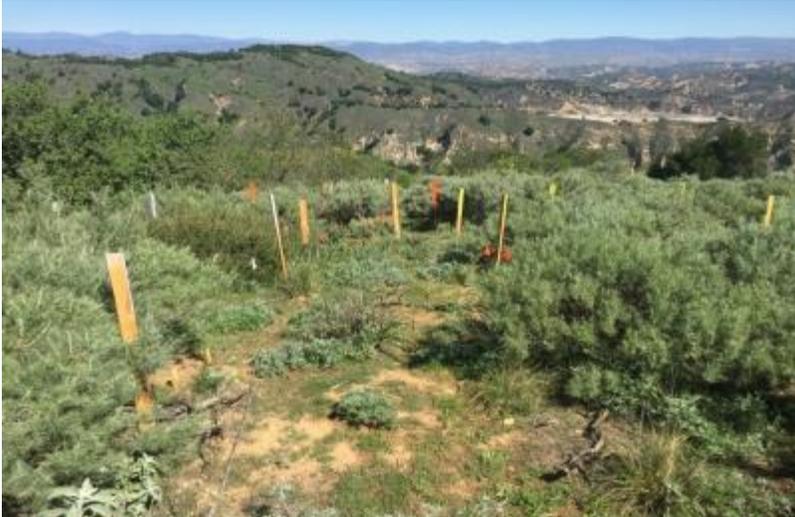
| Date | Location | Photo | Description |
|---|---|--|--|
| 3/10/16 | TSP 40 | | Revegetation plots along the access road down to TSPs 39 and 40 |

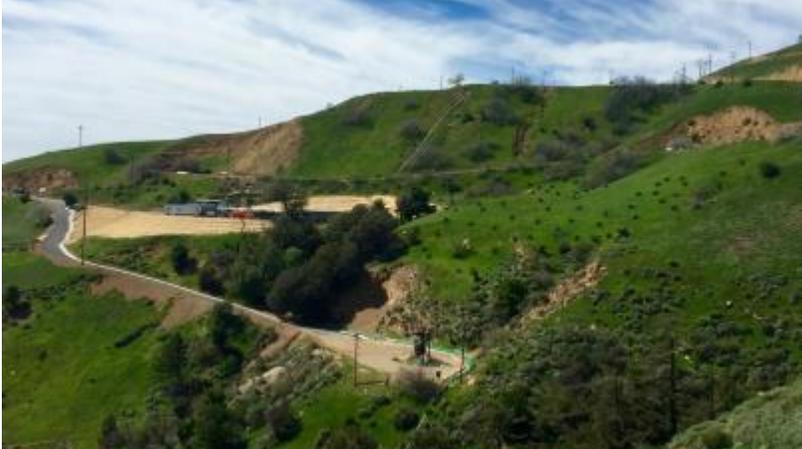
As I travelled down the mountain, I stopped to take a photo of the Oak Tree Mitigation Site and the second relief well site (for a previous well leak not associated with the ACTR Project) – see photo. I scanned the site with

binoculars and saw no erosion issues. A biologist was walking around the oak tree cages and taking notes (MM BR-15). I then stopped to examine the PS-42 Fill Site where water remained ponded on top of the site – see photo; the slopes of the PS-42 Fill Site were in good condition and no rilling was noted.

| Date | Location | Photo | Description |
|---|---|--|---|
| 3/10/16 | Oak mitigation area | | <p>Overview.</p> |

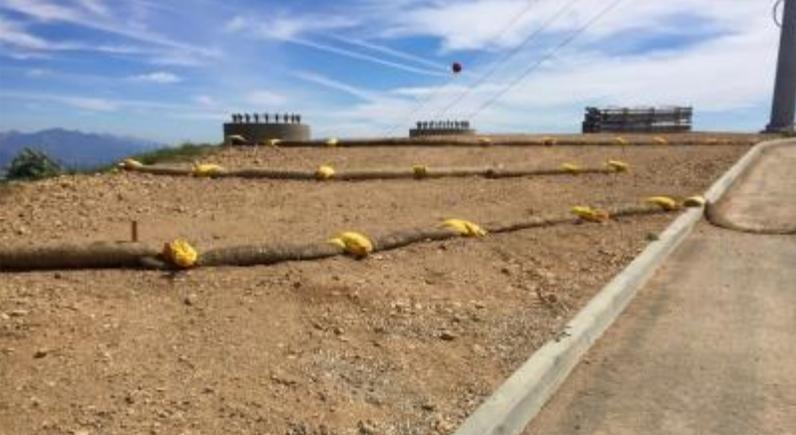
| Date | Location | Photo | Description |
|---|--|--|--|
| 3/10/16 | Natural Substation | | <p>Final clean up after completion of the 12-kV plant power line foundation installation activities.</p> |

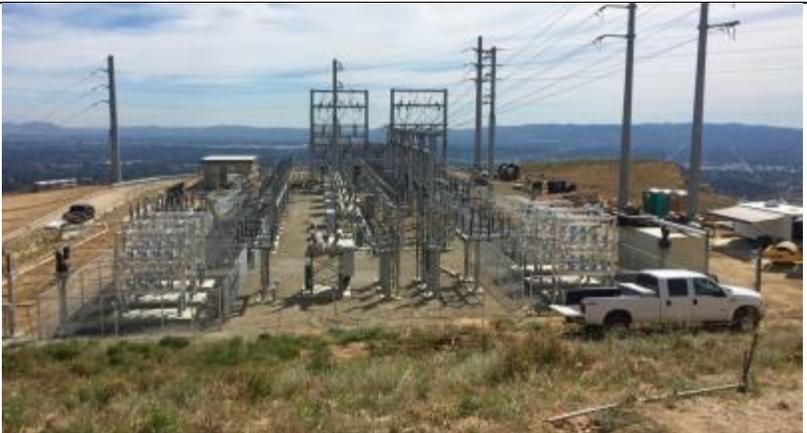
| Date | Location | Photo | Description |
|---|---|---|---|
| 3/10/16 | Natural Substation | | Overview. |

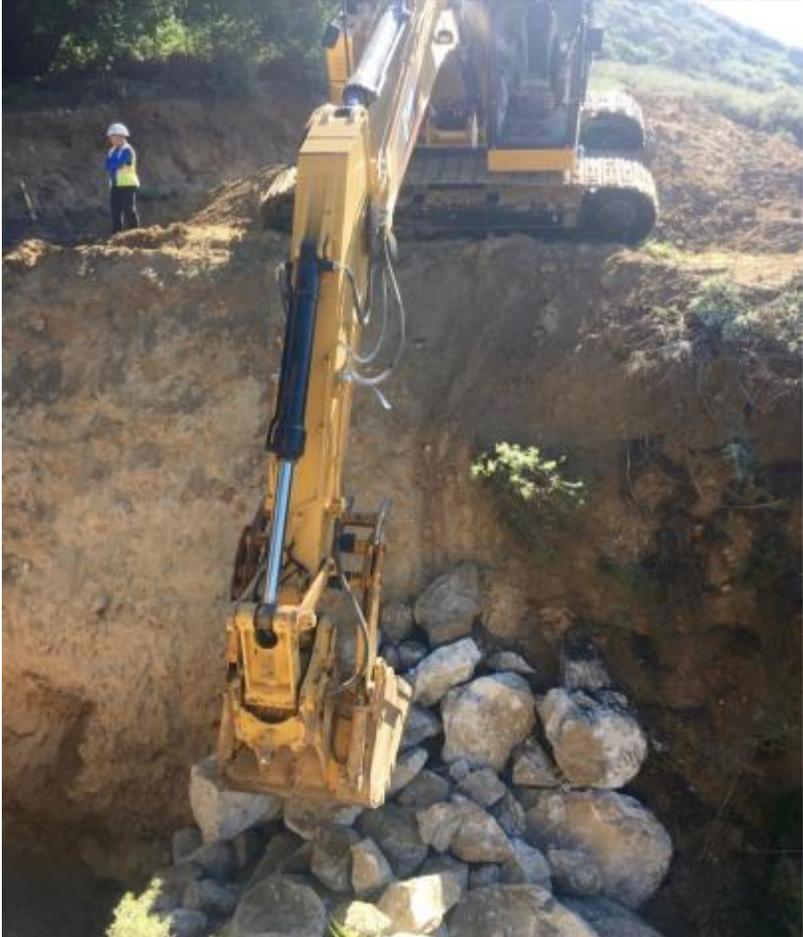
| Date | Location | Photo | Description |
|---|---|--|---|
| 3/18/16 | TSP 30 | | <p>Rock being placed downstream of the new road culvert.</p> |

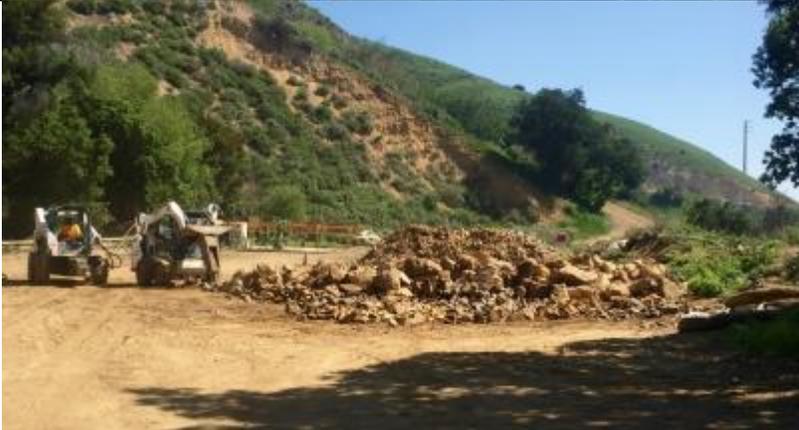
| Date | Location | Photo | Description |
|---|--|--|---|
| 3/18/16 | SS-30 staging area | | <p>Stockpiled rock is being broken up.</p> |

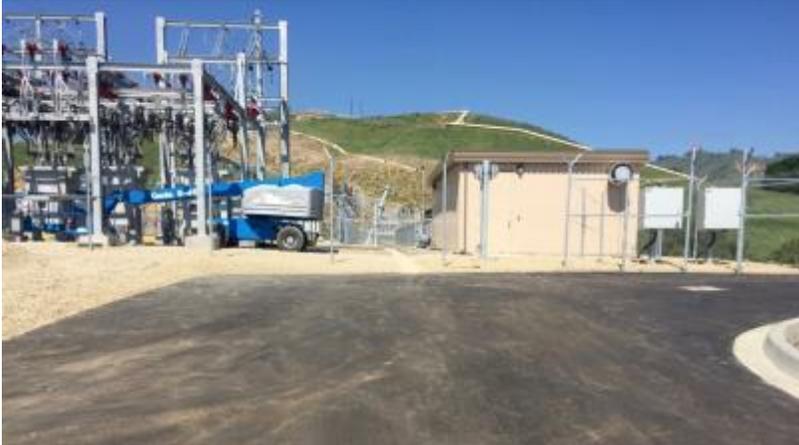
| Date | Location | Photo | Description |
|---|--|--|--|
| 3/18/16 | Natural Substation | | Parking area has been paved and gravel was laid within the facility. |

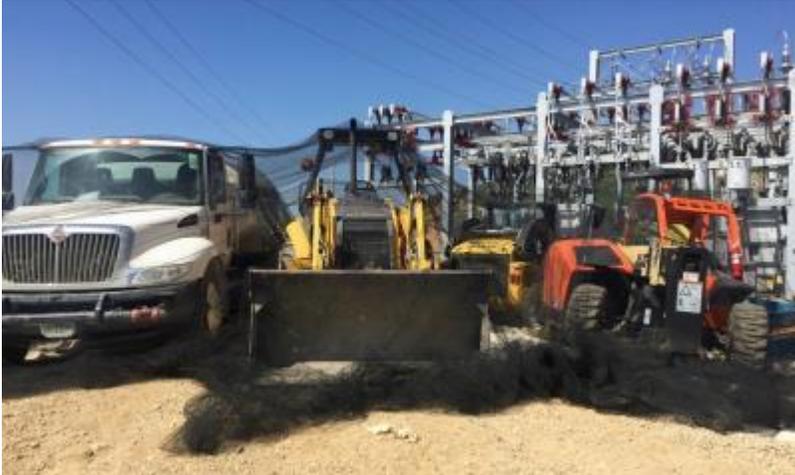
| Date | Location | Photo | Description |
|---|---|---|---|
| 3/18/16 | Natural Substation | | Bird netting is placed over the equipment vehicles. |

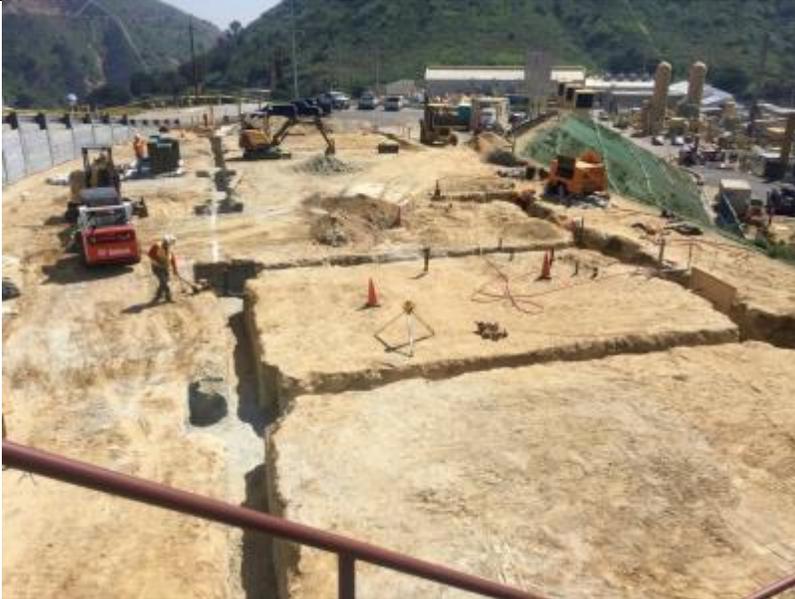
| Date | Location | Photo | Description |
|---|---|---|---|
| 3/18/16 | New Admin/IM Building | | Crews are continuing to excavate within the site. |

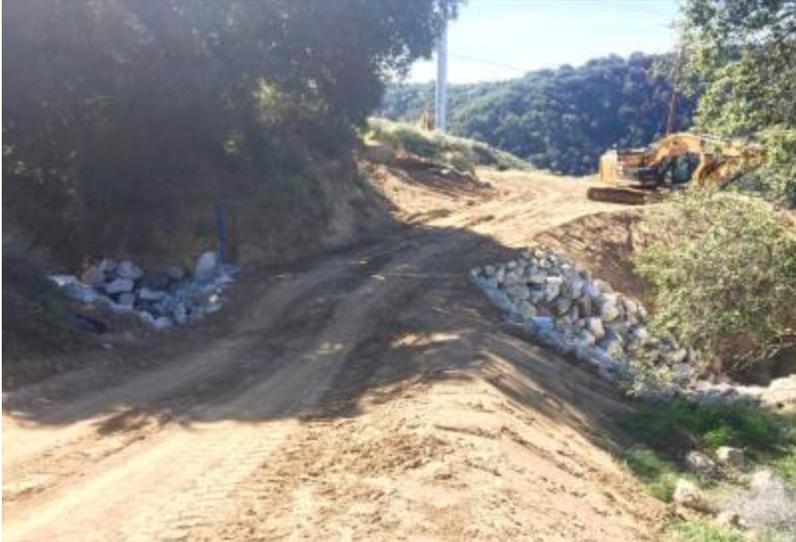
| Date | Location | Photo | Description |
|---|---|--|--|
| 3/25/16 | TSP 30 | | Jurisdictional drainage work at TSP 30 is nearly complete. |

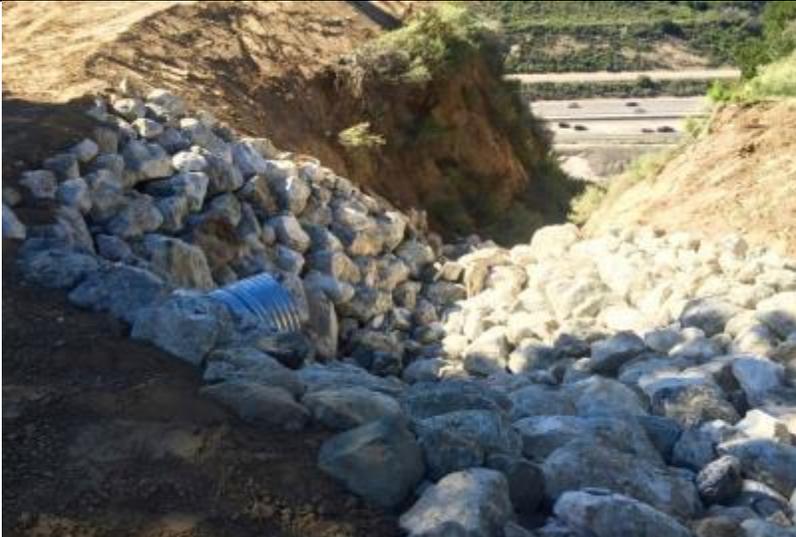
| Date | Location | Photo | Description |
|---|---|--|--|
| 3/25/16 | TSP 30 | | Rock placed downstream of the road culvert. |

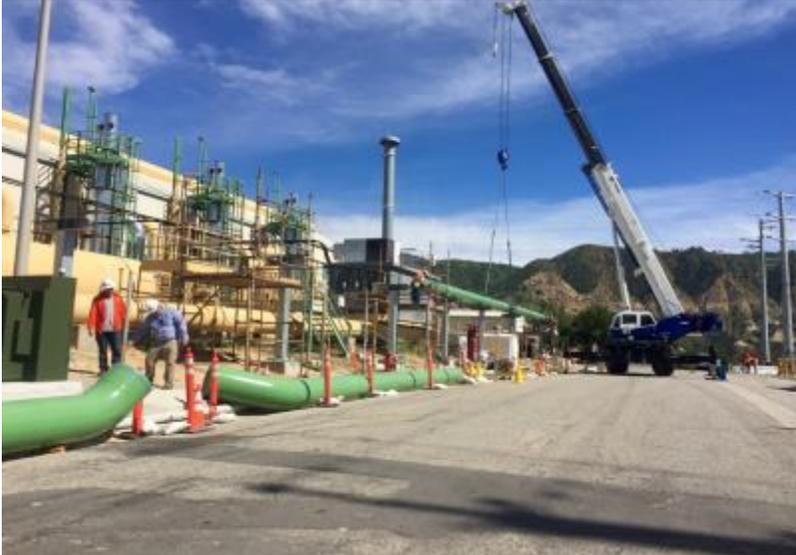
| Date | Location | Photo | Description |
|---|---|--|---|
| 3/25/16 | CCS | | Installation of the blowdown pipeline. |

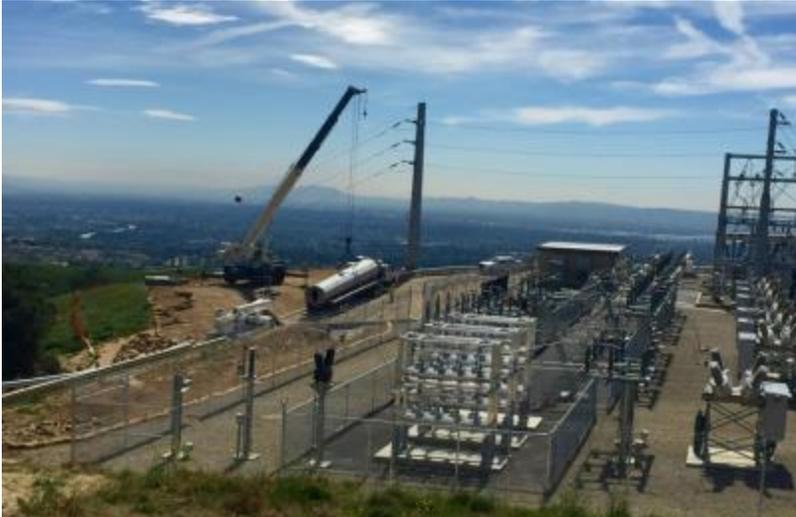
| Date | Location | Photo | Description |
|---|---|--|---|
| 3/25/16 | Natural Substation | | Installation of the 12-kV plant power line towers. |

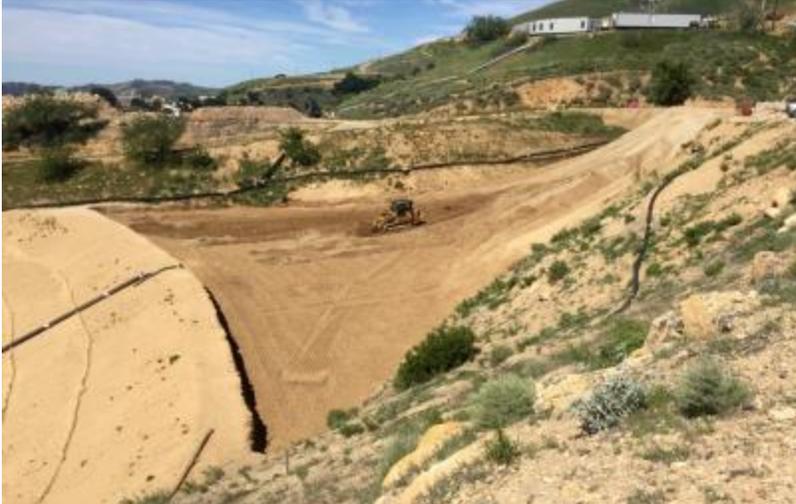
| Date | Location | Photo | Description |
|---|---|--|---|
| 3/25/16 | PS-42 Fill Site | | Soil is being delivered to the PS-42 Fill Site and is spread and compacted by equipment. |

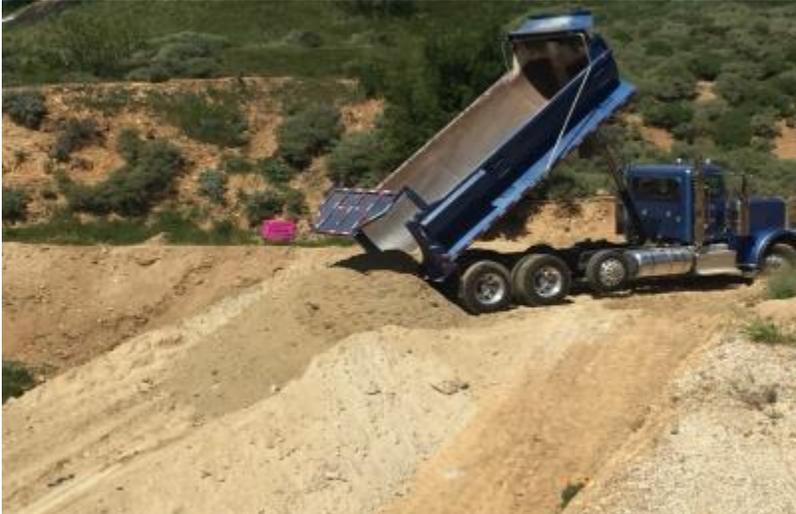
| Date | Location | Photo | Description |
|---|---|--|---|
| 3/25/16 | PS-42 Fill Site | | Trucks bringing in soil to the PS-42 Fill Site; note the pink nesting bird buffer signage near the truck. |

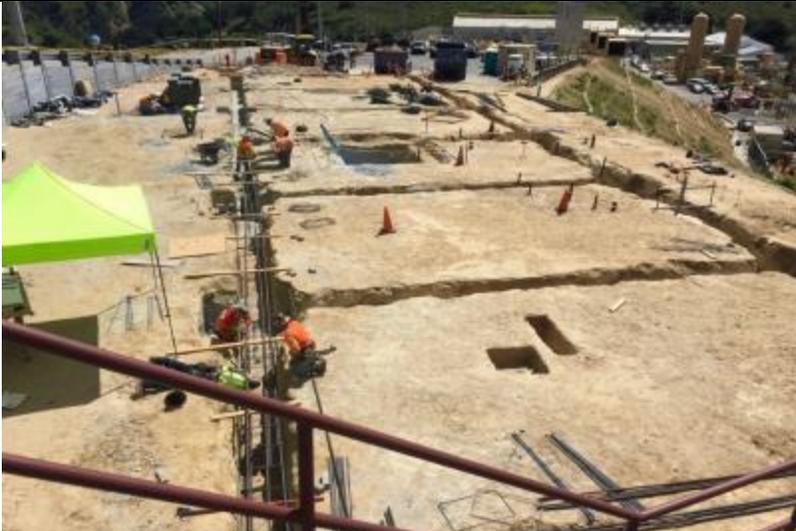
| Date | Location | Photo | Description |
|---|---|--|---|
| 3/25/16 | New Admin/IM Building | | Trenching and installation of rebar continues. |

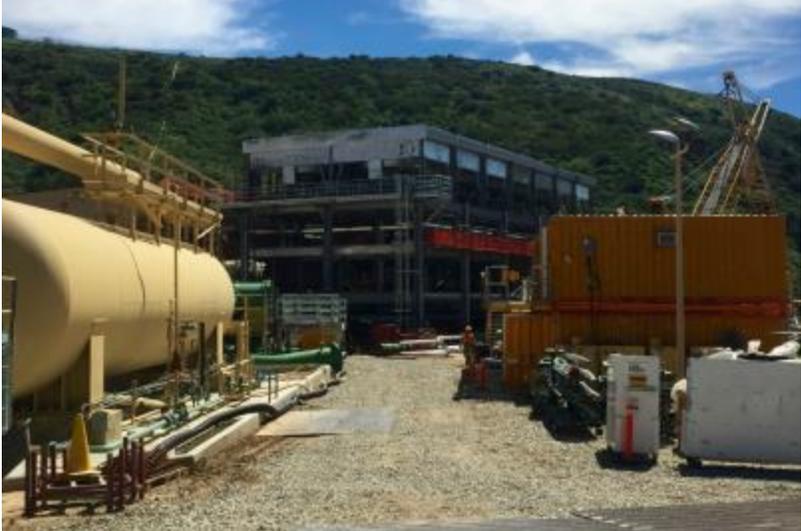
| REPRESENTATIVE SITE PHOTOGRAPHS | | | |
|---|---|--|--|
| 3/25/16 | CCS | | Work on the infrastructure continues. |

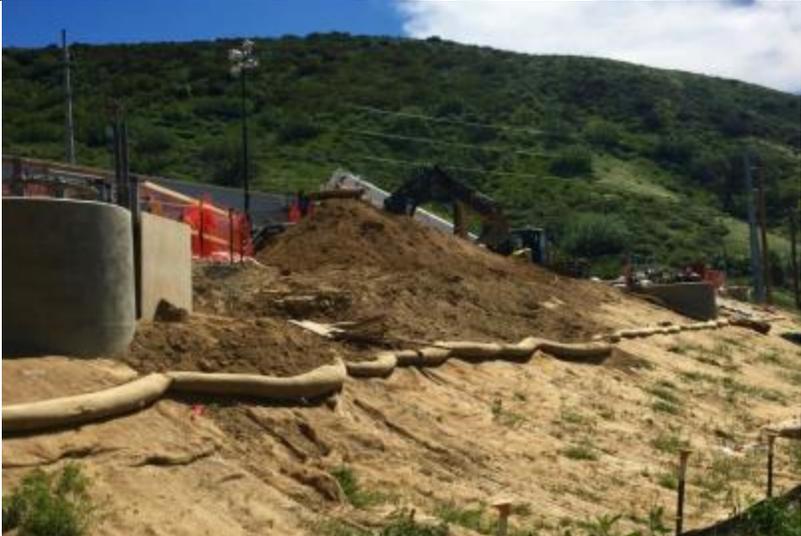
| REPRESENTATIVE SITE PHOTOGRAPHS | | | |
|---|---|--|--|
| 3/25/16 | CCS | | Crews are continuing to excavate for the 12-kV plant power line ductbank. |

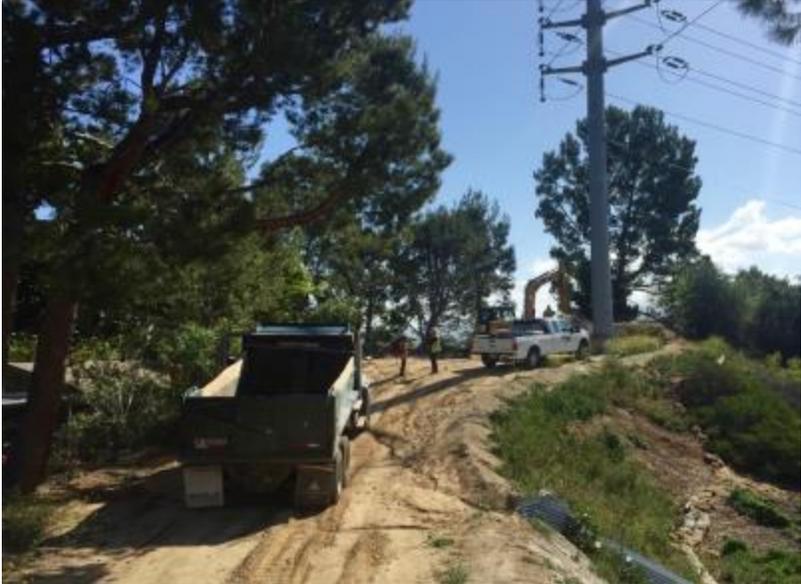
| REPRESENTATIVE SITE PHOTOGRAPHS | | | |
|---|---|--|--|
| 3/30/16 | TSP 2 | | Crews onsite removing the old tower foundation. |

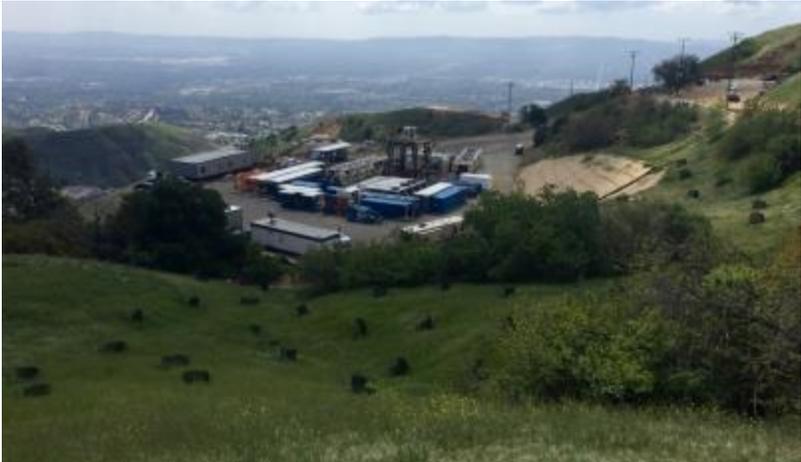
| REPRESENTATIVE SITE PHOTOGRAPHS | | | |
|---|---|--|--|
| 3/30/16 | Oak Tree Mitigation Site | | Overview of the Oak Tree Mitigation Site. |

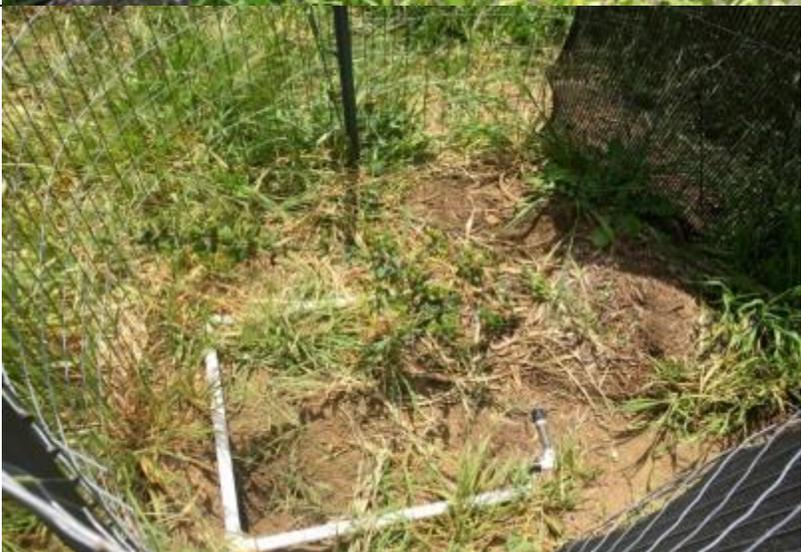
| Date | Location | Photo | Description |
|---|---|--|--|
| 3/30/16 | Oak Cage | | Looking inside an oak cage; note the lack of grasses. |

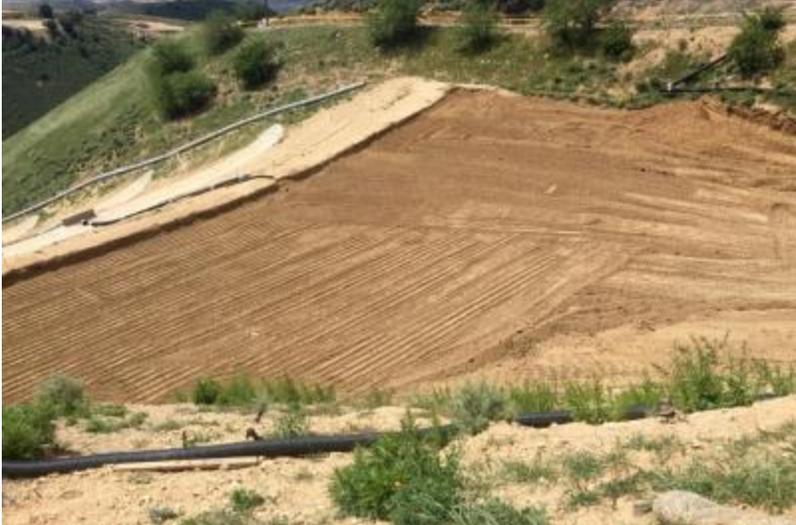
| Date | Location | Photo | Description |
|---|---|--|---|
| 3/30/16 | PS-42 Fill Site | | Soil delivered to the PS-42 Fill Site is being spread and compacted by equipment. |

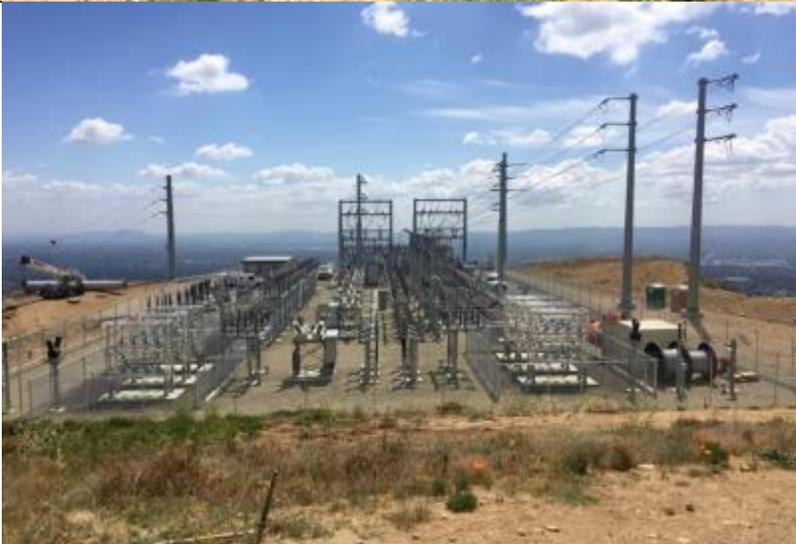
| Date | Location | Photo | Description |
|---|---|--|---|
| 3/30/16 | Natural Substation | | Overview. |

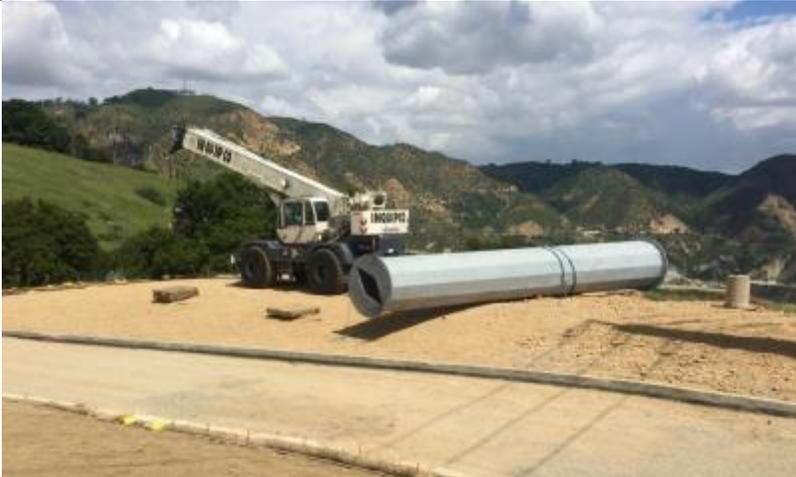
| Date | Location | Photo | Description |
|---|---|--|---|
| 3/30/16 | Natural Substation | | Tower installation continues for the 12-kV plant power line. |

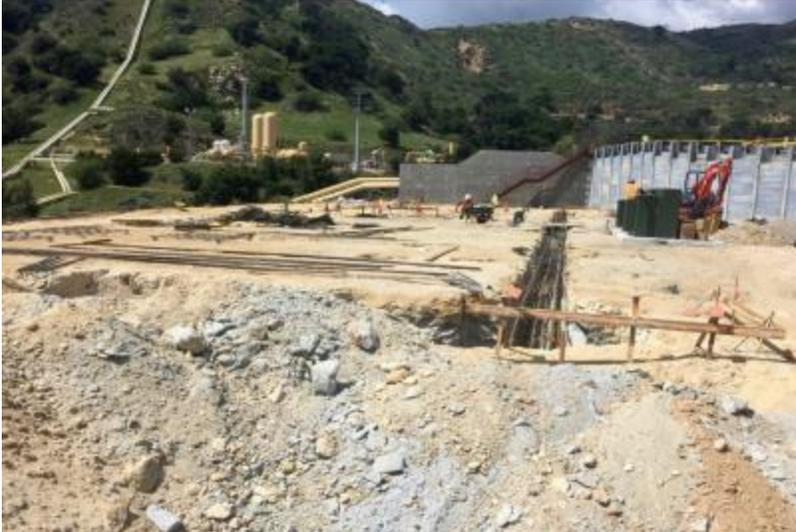
| Date | Location | Photo | Description |
|---|---|--|--|
| 3/30/16 | New Admin/IM Building | | Trenching and foundation work continues. |

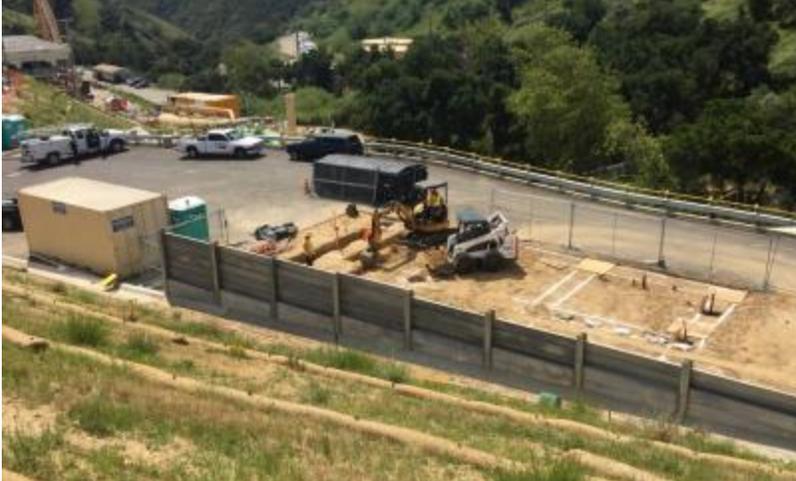
| Date | Location | Photo | Description |
|---|---|--|--|
| 3/30/16 | New Admin/IM Building | | Trenching continues in the lower portion of the new Admin/IM Building. |

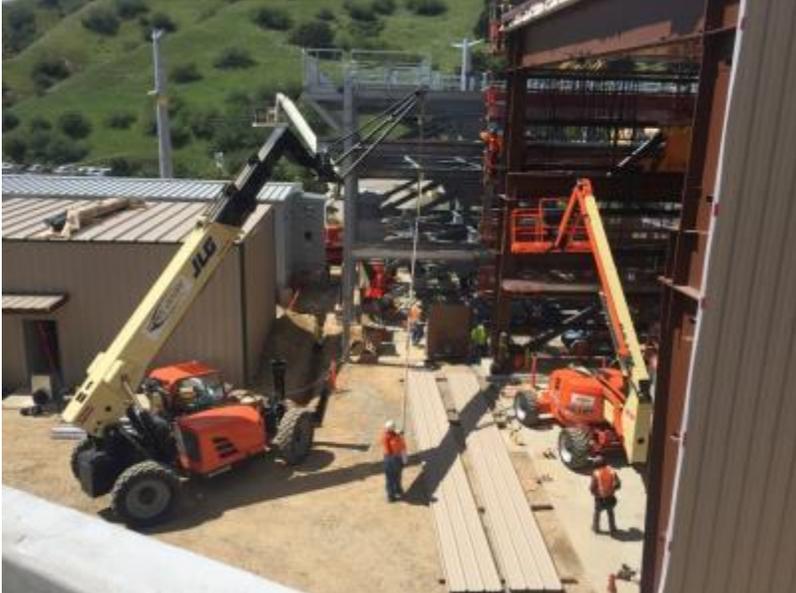
| Date | Location | Photo | Description |
|---|---|--|--|
| 3/30/16 | CCS | | Crews within the site. |

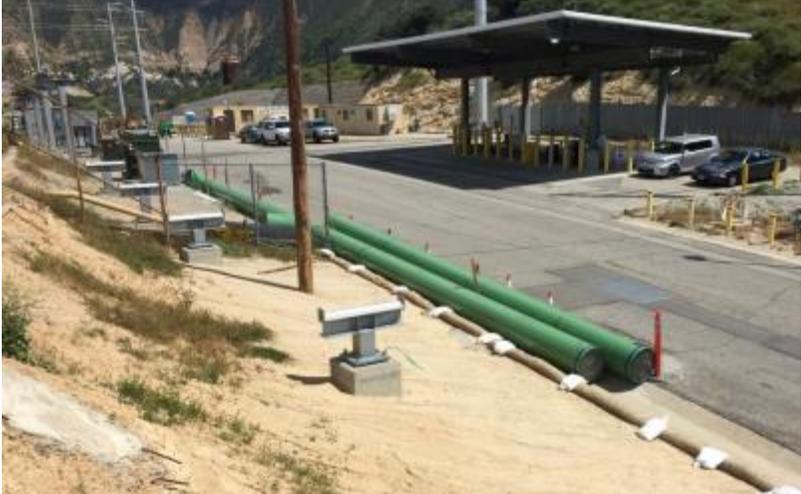
| Date | Location | Photo | Description |
|---|---|---|---|
| 3/30/16 | CCS | A photograph showing two parallel green pipes (blowdown line piping) laid out on a dirt and gravel area. The pipes are supported by concrete blocks. In the background, there is a paved area with a canopy structure, possibly a gas station or service area, and some vehicles. The terrain is hilly and appears to be a construction or industrial site. | Blowdown line piping |
