Re: Monthly Report Summary #16 for Aliso Canyon Turbine Replacement Project

Aliso Canyon Turbine Replacement Project CPUC Site Inspection Form

| Project: | Aliso Canyon Turbine Replacement | Date: | July 2, 2015 |

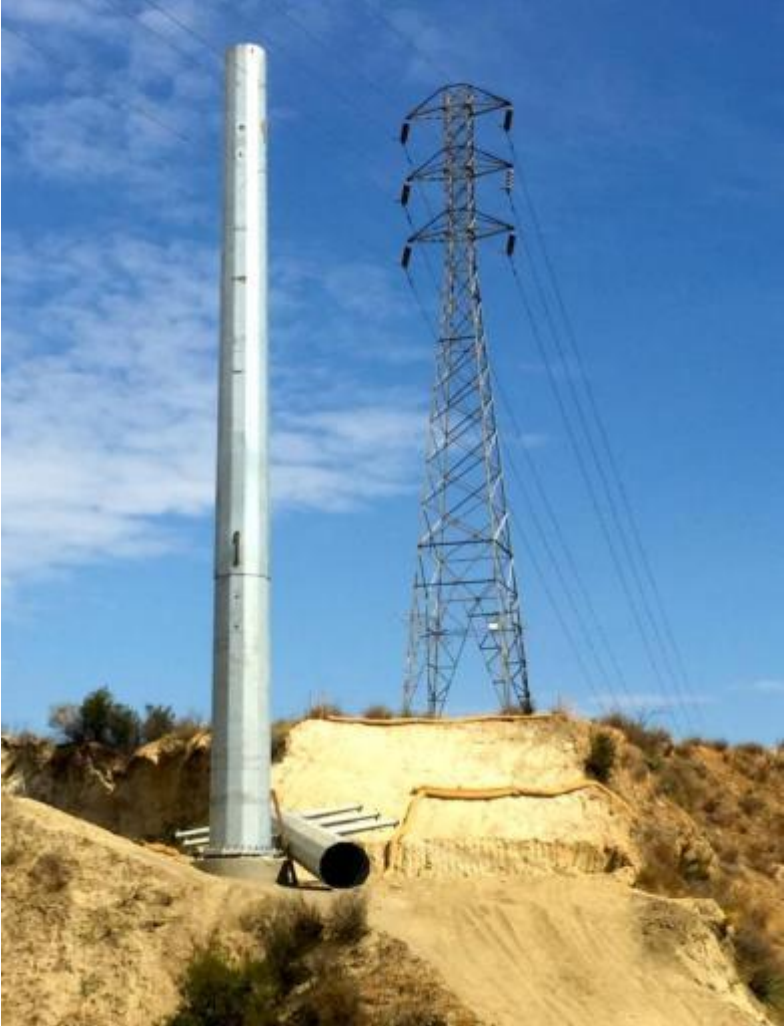
| Date | Location | Photo | Description |
|---|---|--|---|
| 7/02/15 | TSP 13 | | A portion of the TSP has been installed. |

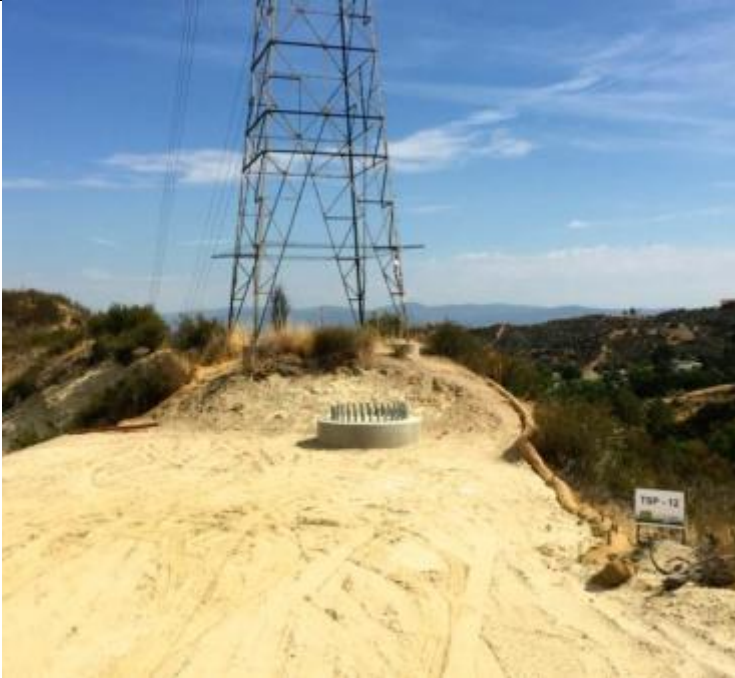
| Date | Location | Photo | Description |
|---|---|--|---|
| 7/02/15 | TSP 12 | | The foundation has been poured |

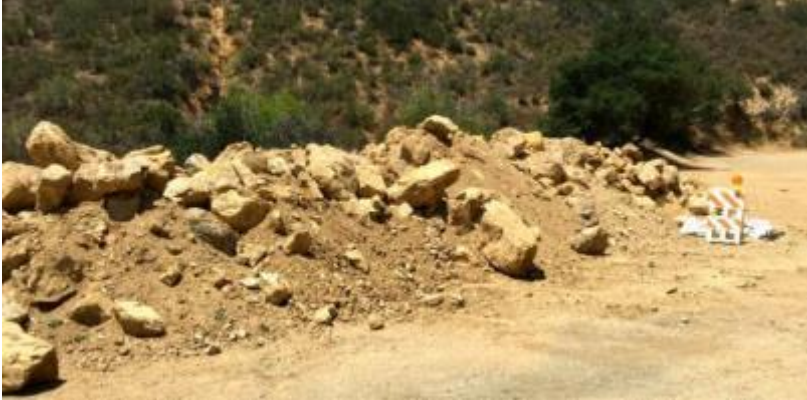
| Date | Location | Photo | Description |
|---|---|--|---|
| 7/02/15 | PS-42 Fill Site | | Stockpiled native rock to be used to stabilize the base of the fill site. |

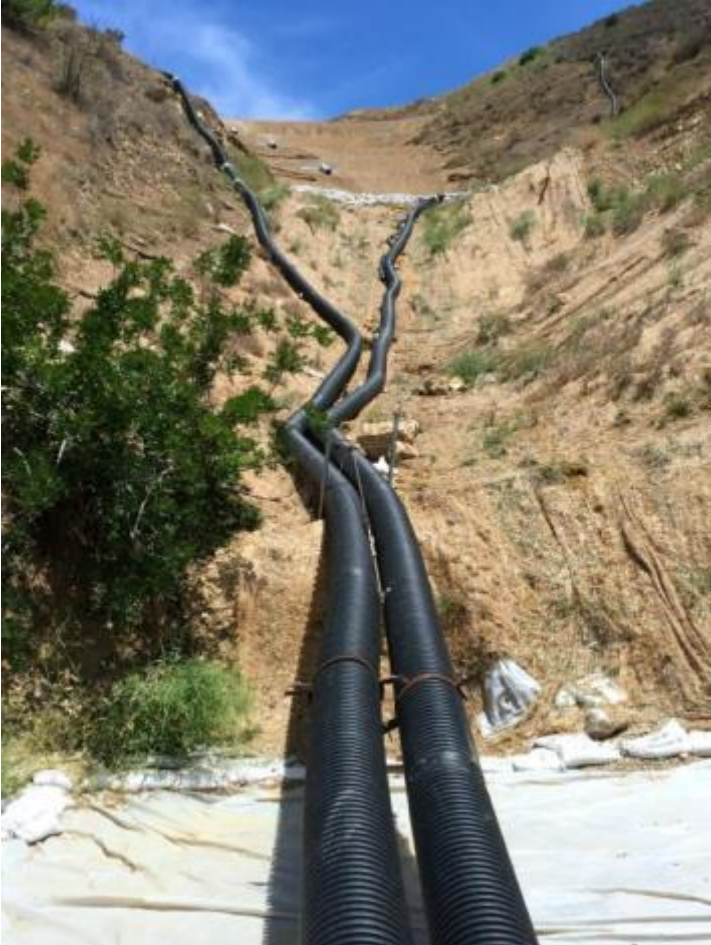
| Date | Location | Photo | Description |
|---|---|--|--|
| 7/02/15 | PS-42 Fill Site | | Looking up the slope from the lower access road. |

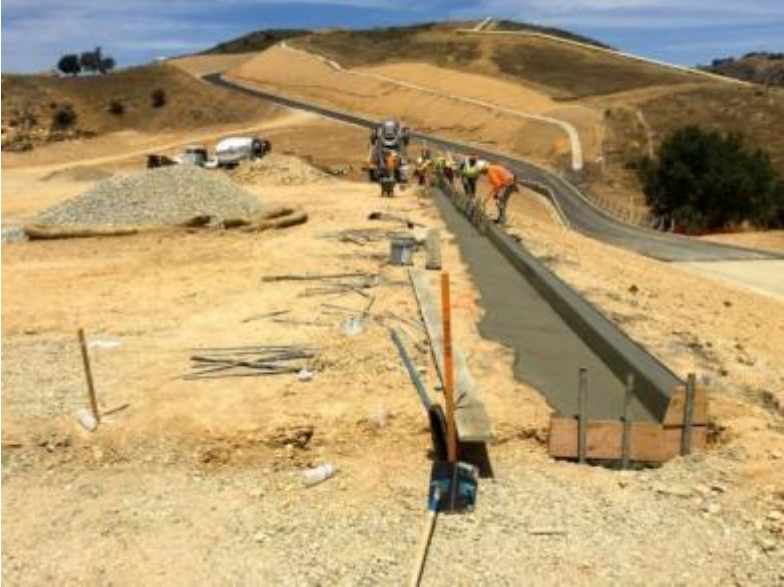
| Date | Location | Photo | Description |
|---|---|--|--|
| 7/02/15 | Natural Substation | | Crews are pouring the concrete curb. |

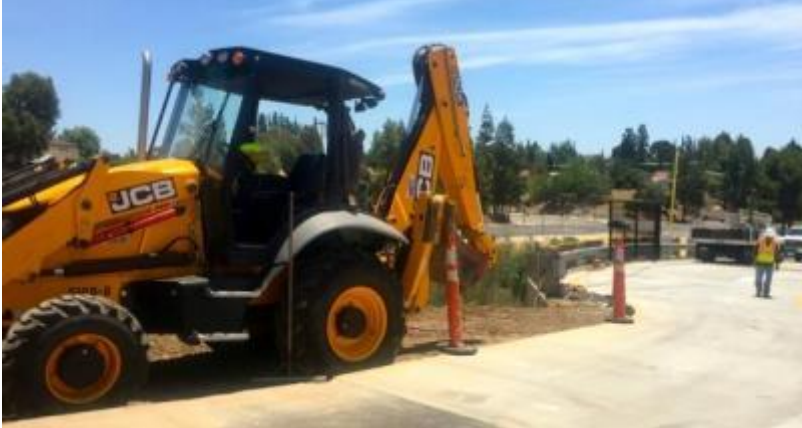
| Date | Location | Photo | Description |
|---|---|---|---|
| 7/02/15 | Guard House | | Minor excavation work is taking place at the Guard House. |

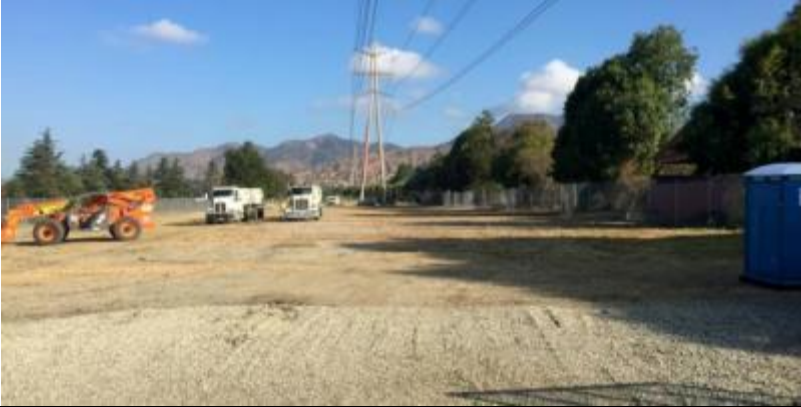
| Date | Location | Photo | Description |
|---|---|--|---|
| 7/10/15 | SCE 210 Freeway Yard | | The new expansion area for the 210 Freeway Yard. |

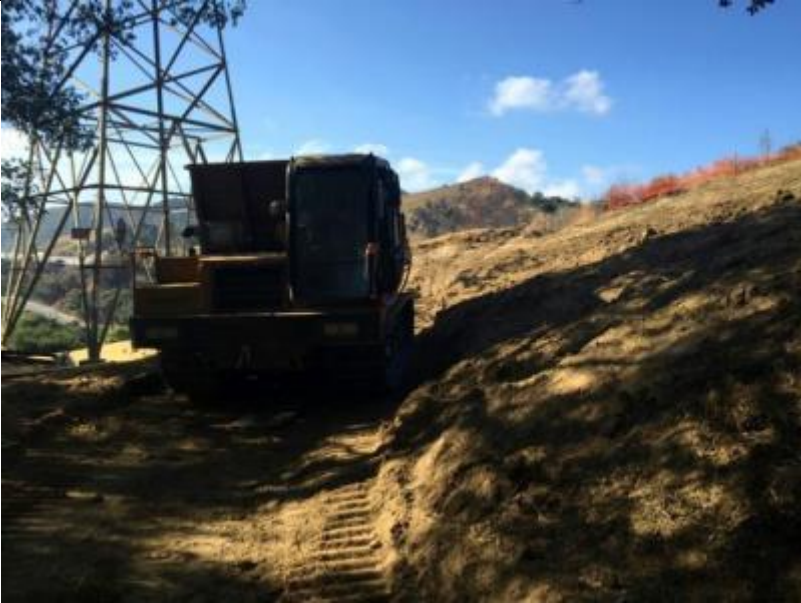
| Date | Location | Photo | Description |
|---|---|--|---|
| 7/10/15 | TSP 22 | | Work continues on the pole site. |

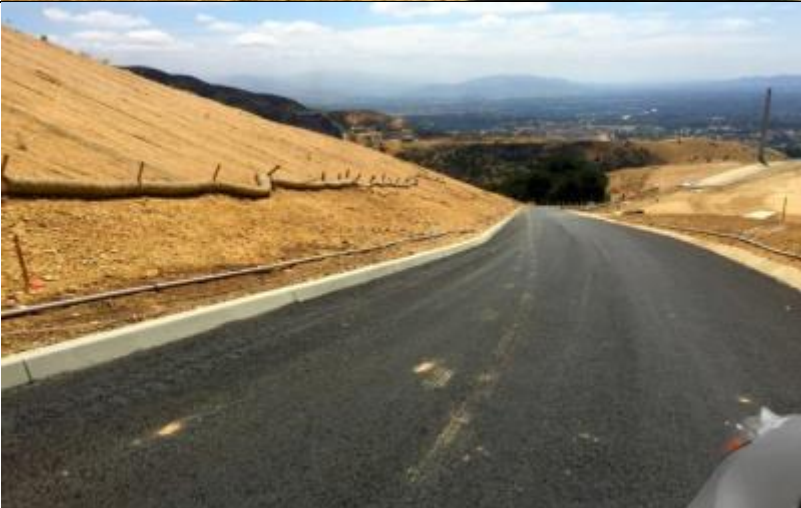
| <p>7/10/15</p> | <p>Natural Substation access road</p> | | <p>The irrigation system is being installed.</p> |

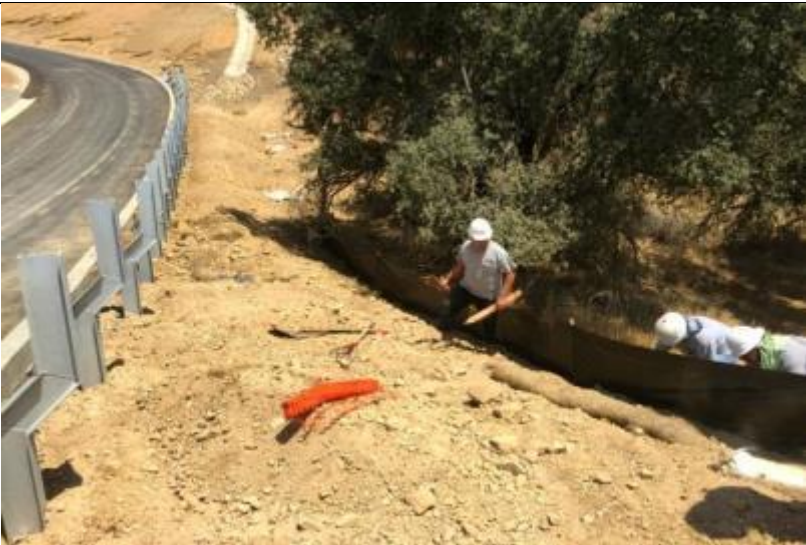
| 7/10/15 | Natural Substation | | A crew is installing BMP materials near the oak swale area below the access road. |

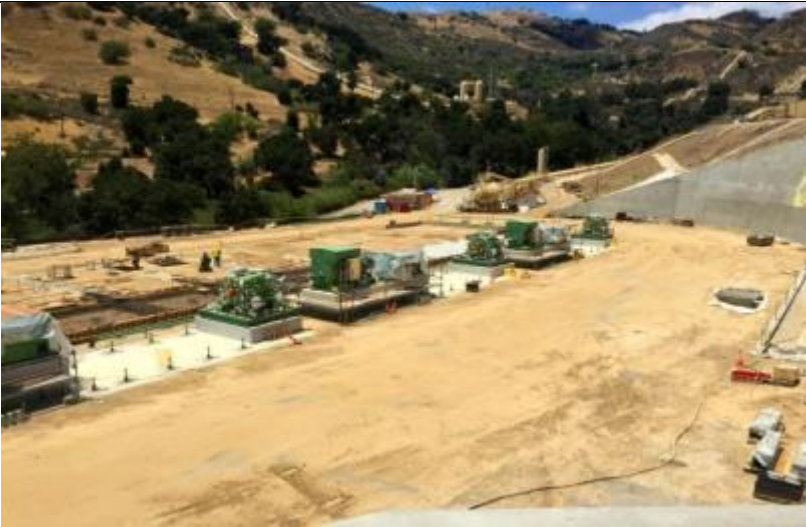
| 7/10/15 | CCS | | Ongoing equipment installation. |

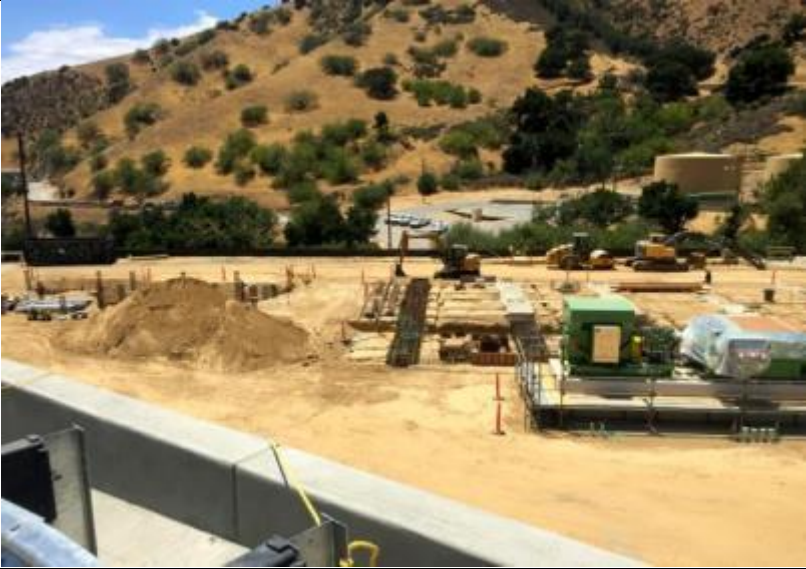
| 7/10/15 | CCS | | Southern end of the CCS area. |

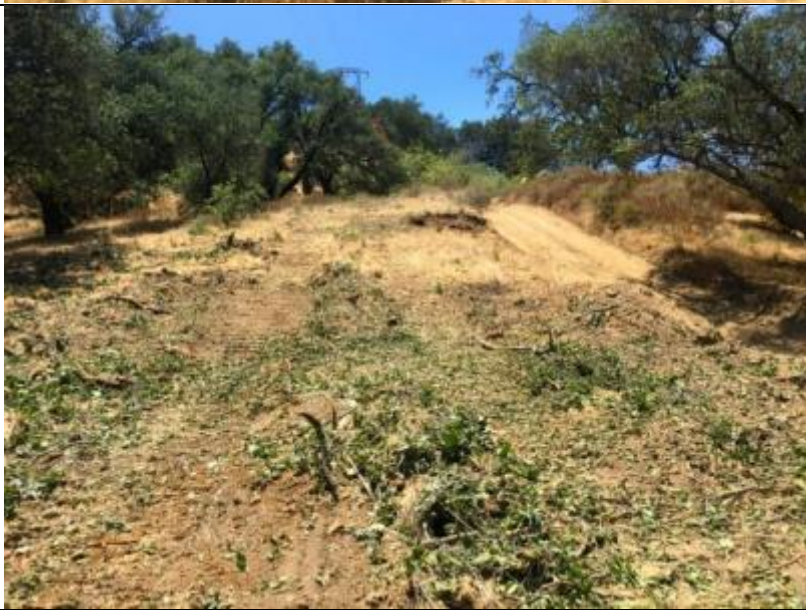
| <p>7/10/15</p> | <p>Access road between TSP 40 and TSP 42</p> | | <p>Newly cleared section of the access road – looking up the hill toward TSP 42.</p> |

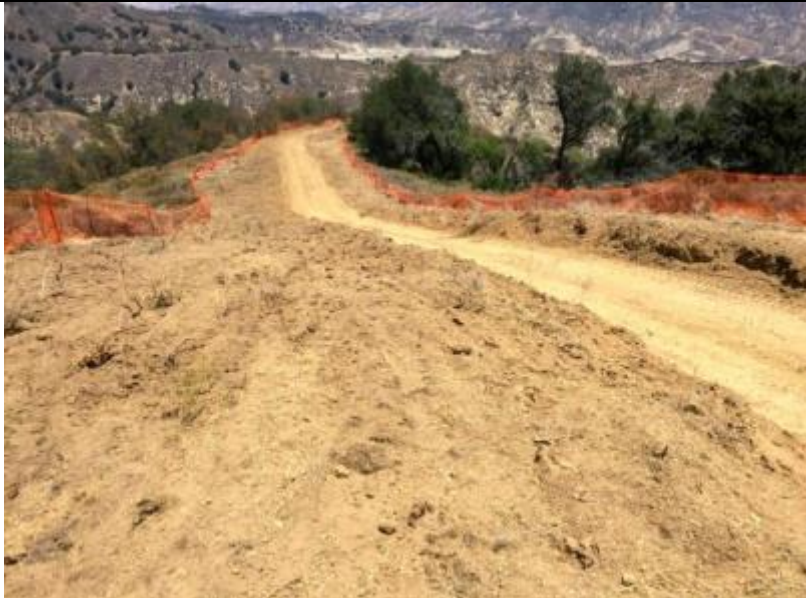
| <p>7/10/15</p> | <p>Access road between TSP 40 and TSP 42</p> | | <p>Cleared area that has now been fenced.</p> |

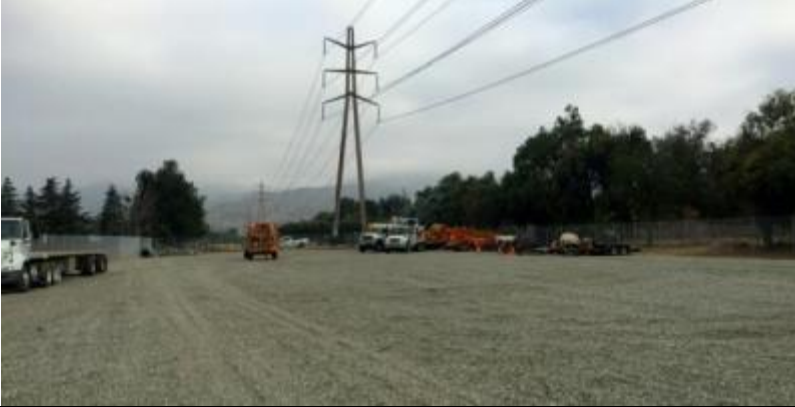
SCE has cleared, fenced, and laid gravel in the expanded 210 Freeway Yard. SCE is now using the site – see photo. The piece of equipment (a bobcat) that burned during the June fire is stored in the yard – see photo.

| Date | Location | Photo | Description |
|---|---|--|--|
| 7/15/15 | SCE 210 Freeway Yard | | <p>After being cleared, fenced, and having gravel laid down, the new expansion area is now being used.</p> |

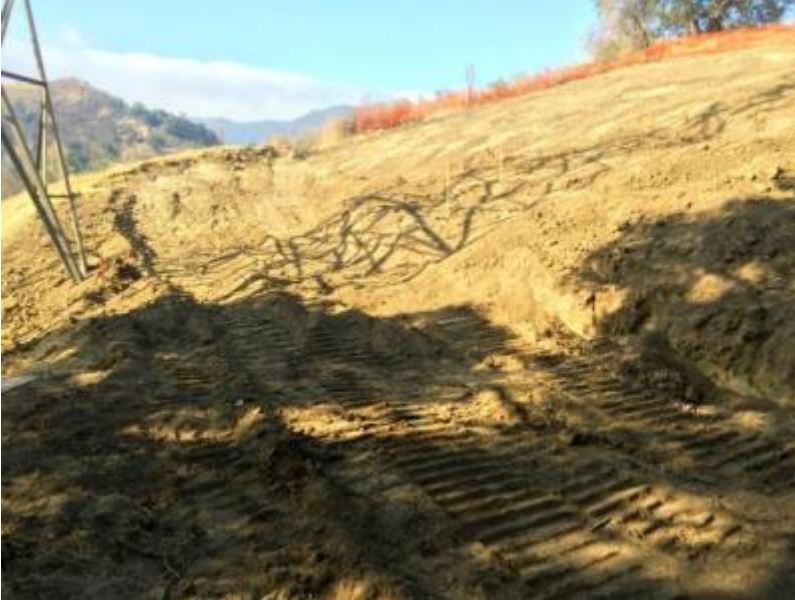
| Date | Location | Photo | Description |
|---|---|--|--|
| 7/15/15 | TSP 22 | | <p>Work continues on the pole site.</p> |

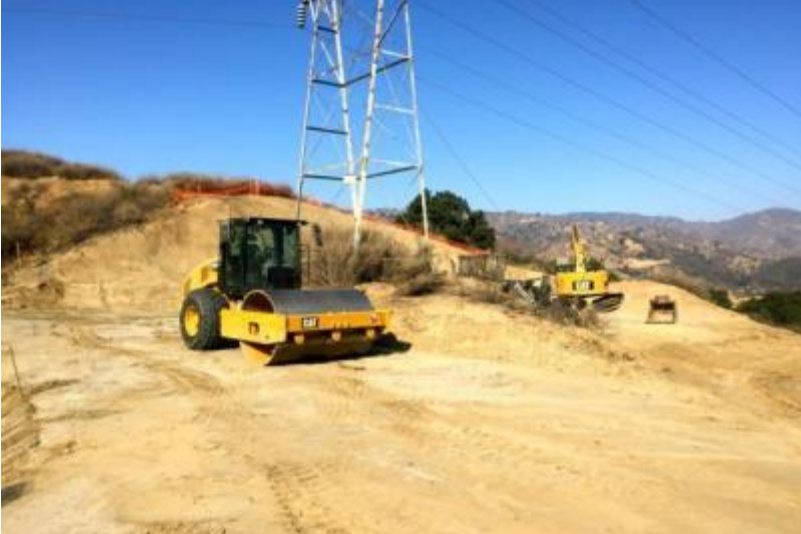
| Date | Location | Photo | Description |
|---|---|--|--|
| 7/15/15 | TSP 21 | | Grading and site preparation is nearly complete for the pull site and pad at TSP 21. |

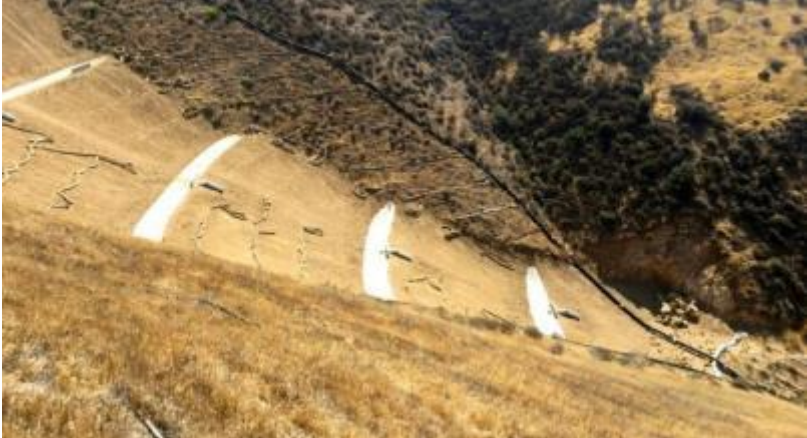
| Date | Location | Photo | Description |
|---|---|--|---|
| 7/15/15 | PS-42 Fill Site | | Fill slope with "V" ditches and BMP materials in place. |

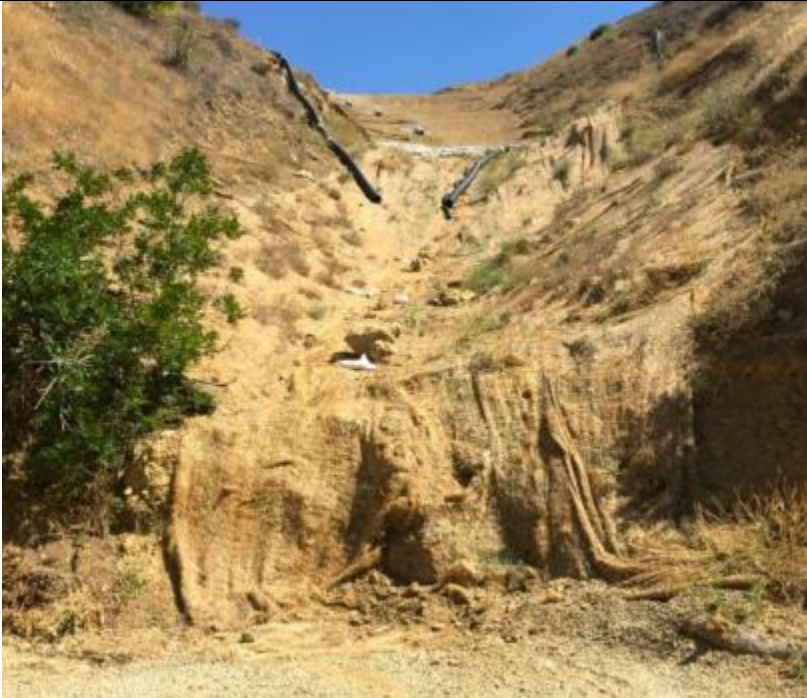
| Date | Location | Photo | Description |
|---|---|--|---|
| 7/15/15 | PS-42 Fill Site | | Fill slope looking up from the lower access road. |

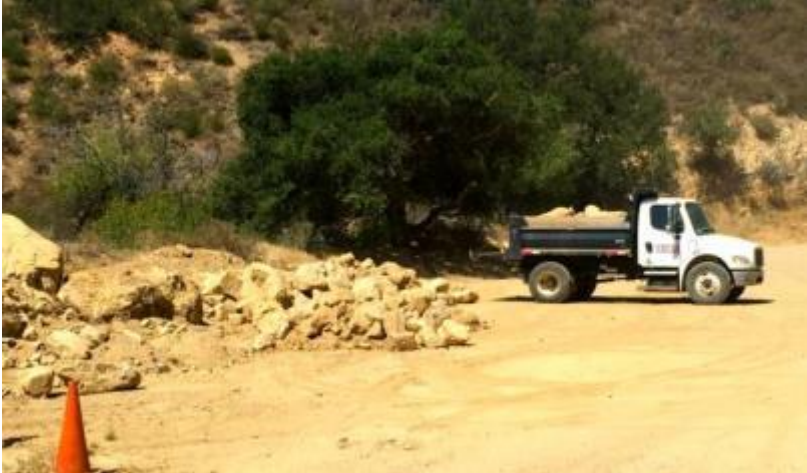
| Date | Location | Photo | Description |
|---|---|--|---|
| 7/15/15 | PS-42 Fill Site | | Rock is being brought to the well pad below the fill site in preparation for use at the site. |

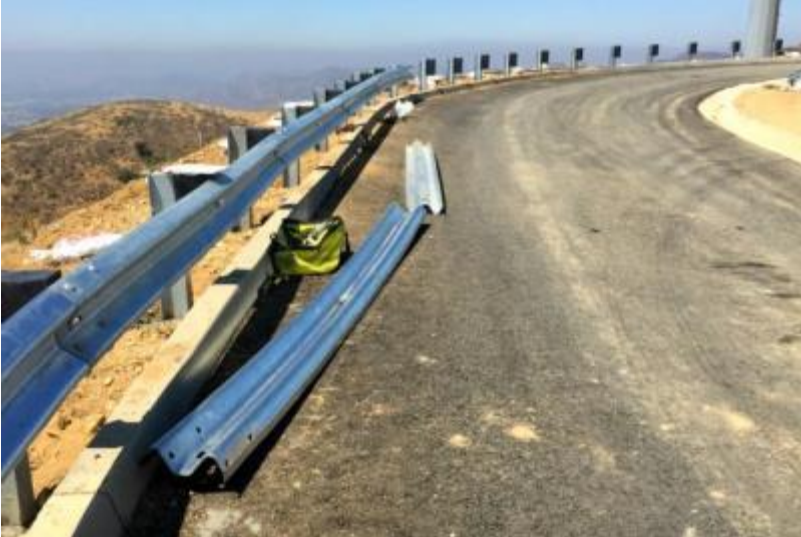
| Date | Location | Photo | Description |
|---|---|--|--|
| 7/15/15 | Natural Substation access road | | Installation of the guard rail. |

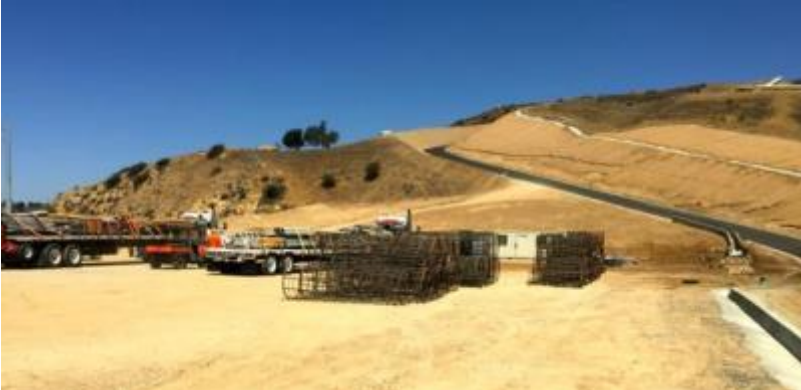
| Date | Location | Photo | Description |
|---|---|--|--|
| 7/15/15 | Natural Substation | | Materials are being brought in and stockpiled at the site. |

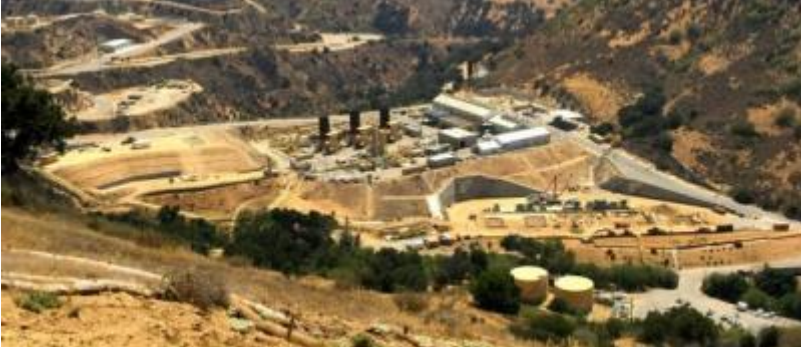
| Date | Location | Photo | Description |
|---|---|--|--|
| 7/15/15 | Project overview | | Project overview looking from the Natural Substation |

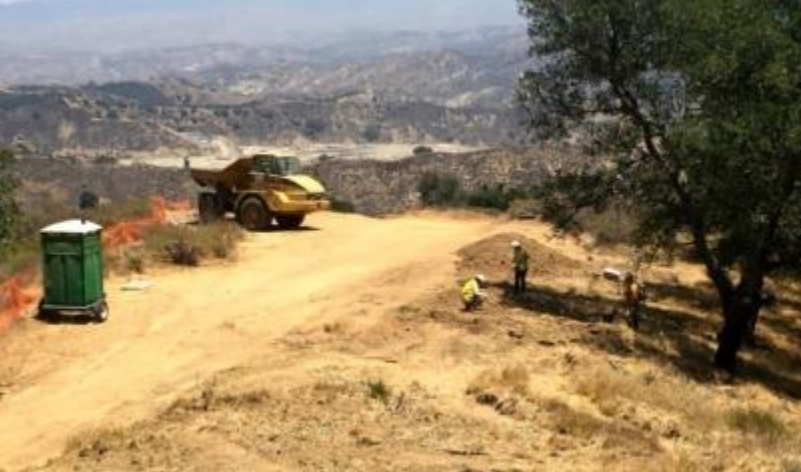
| Date | Location | Photo | Description |
|---|---|---|---|
| 7/15/15 | Access road between TSP 40 and TSP 41 | | Biological monitoring crew is raking through the topsoil looking for Mariposa lily bulbs. |

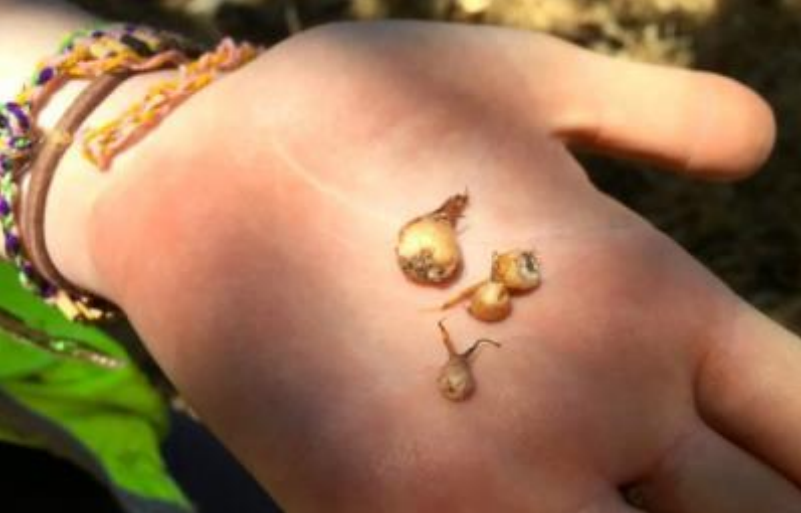
| Date | Location | Photo | Description |
|---|---|---|---|
| 7/15/15 | Access road between TSP 40 and TSP 41 | | Mariposa lily bulbs. |

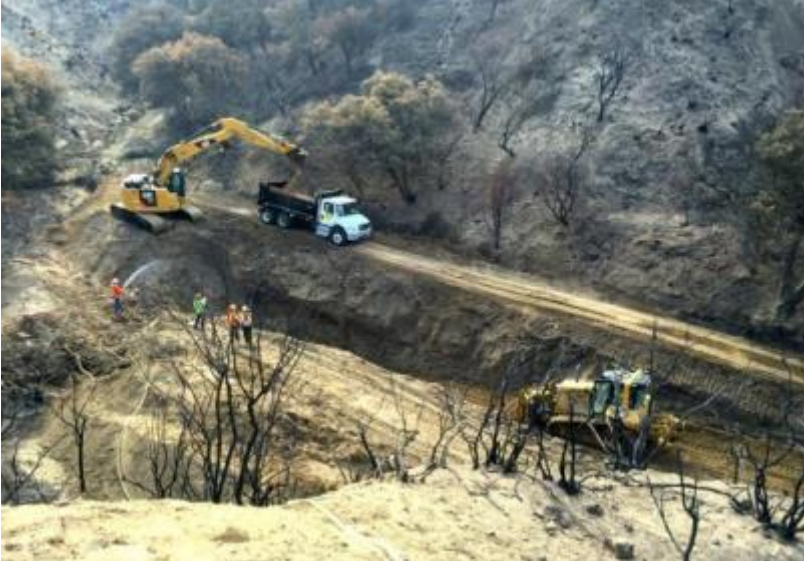
| Date | Location | Photo | Description |
|---|---|--|--|
| 7/23/15 | Access road to TSP 25 | | Equipment is working along the access road and preparing the area for a long Hillfiker wall. |

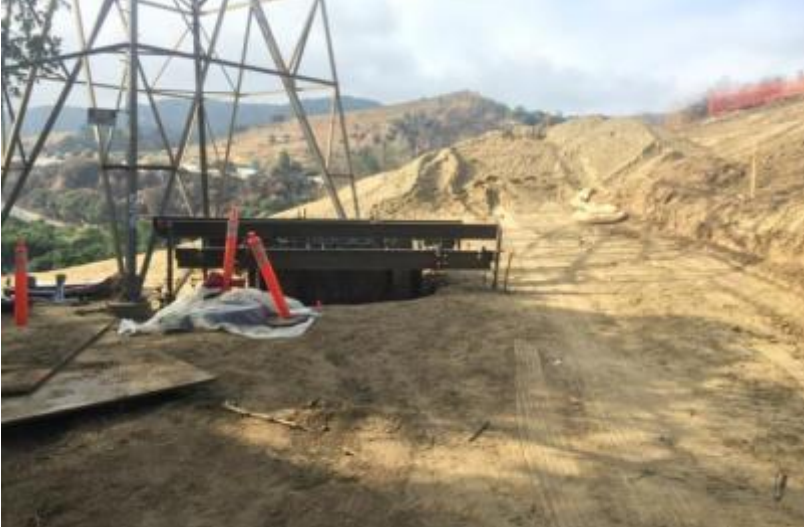
Drove to TSP 22 where the site was newly drilled and poured – see photo. Crews still need to excavate the pull site near the pole. The pull site between TSPs 21 and 22 has been graded and BMP materials have been installed; however, crews still need to replace the stockpiled topsoil and reseed the site – see photo. At TSPs 21, 18, and 16, the pole foundations have been newly drilled and poured – see photo. The forms are still on the foundation at TSP 16. None of the poles at these sites have been installed. At TSP 12, a crew was working on the wires and appeared to also be removing the old lattice work tower – see photo. The access road from TSP 22 out to TSP 12 was in good shape with very little dust.

| Date | Location | Photo | Description |
|---|---|--|--|
| 7/23/15 | TSP 22 | | The foundation for TSP 22 was newly poured; forms remain to be stripped. |

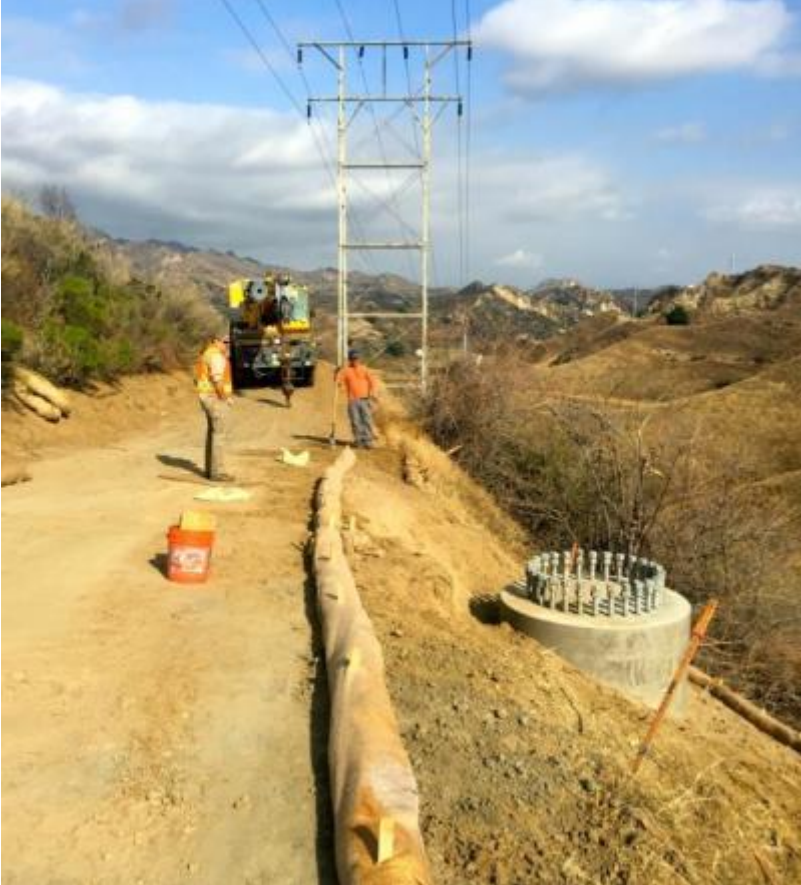
| Date | Location | Photo | Description |
|---|---|---|--|
| 7/23/15 | TSP 18 | | The foundation has been drilled and poured. |

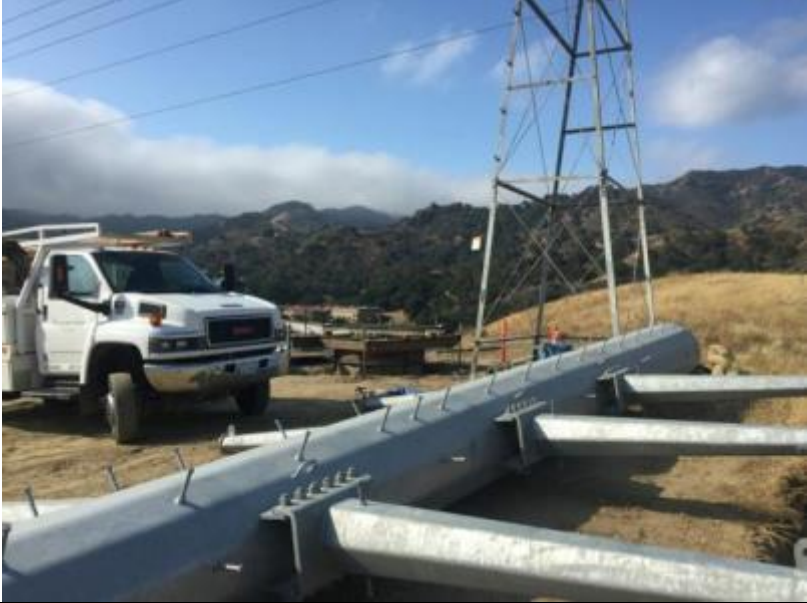
| Date | Location | Photo | Description |
|---|---|---|---|
| 7/23/15 | TSP 16 | | <p>The pole foundation has been drilled and recently poured.</p> |

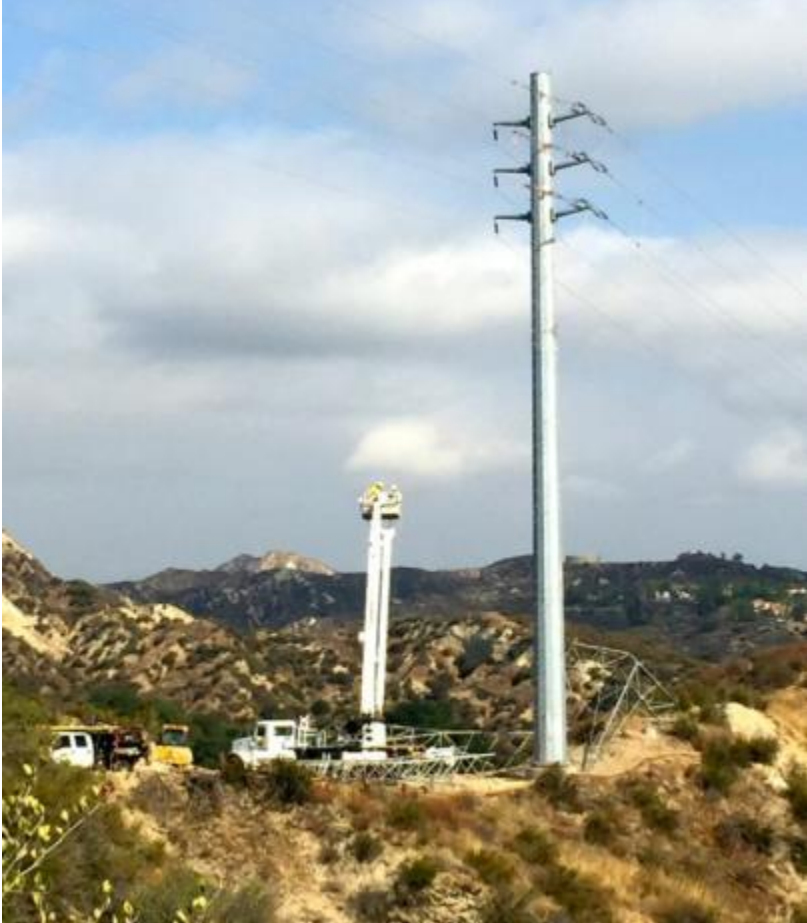
| Date | Location | Photo | Description |
|---|---|---|---|
| 7/23/15 | TSP 12 | | <p>A crew is working on the wires and taking down the old lattice work tower.</p> |

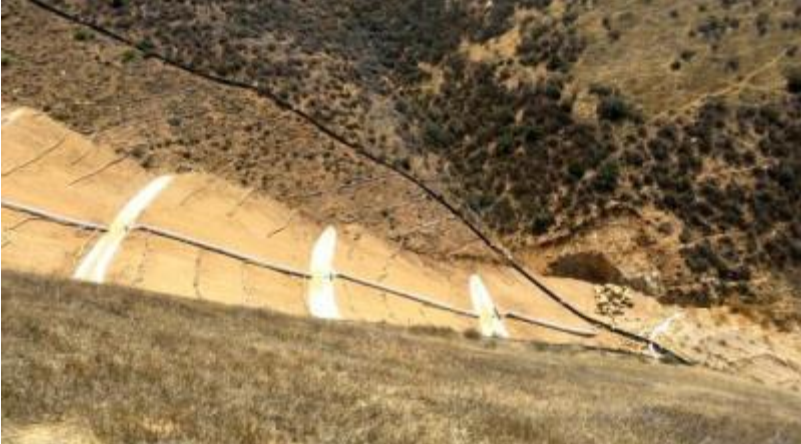
| Date | Location | Photo | Description |
|---|---|---|---|
| 7/23/15 | PS-42 Fill Site | | Middle portion of the fill slope with "V" ditches finished and drainpipes connected. |

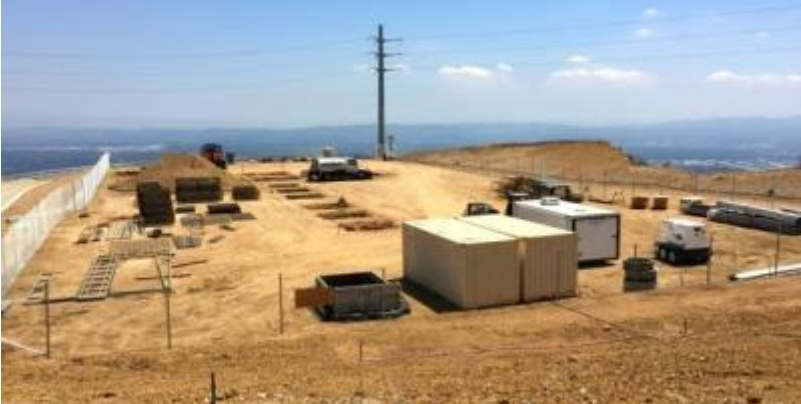
| Date | Location | Photo | Description |
|---|---|--|--|
| 7/23/15 | Natural Substation | | Materials continue to be brought in; some excavation has been completed. |

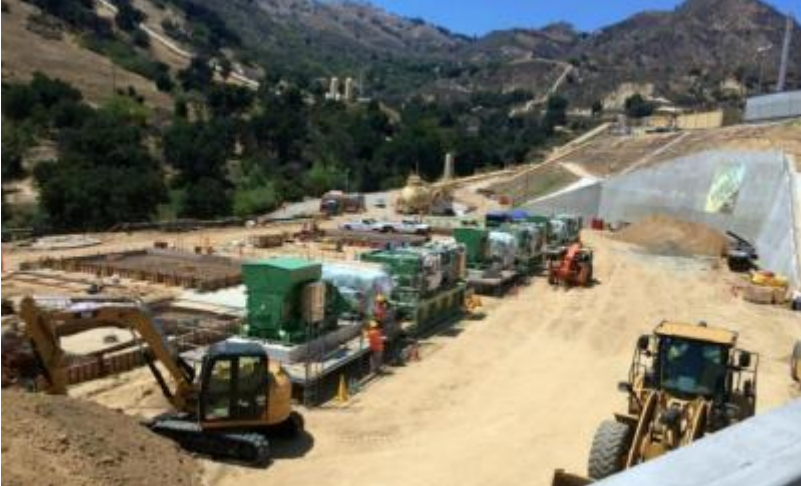
| Date | Location | Photo | Description |
|---|---|--|--|
| 7/23/15 | CCS | | Equipment is being worked on. |

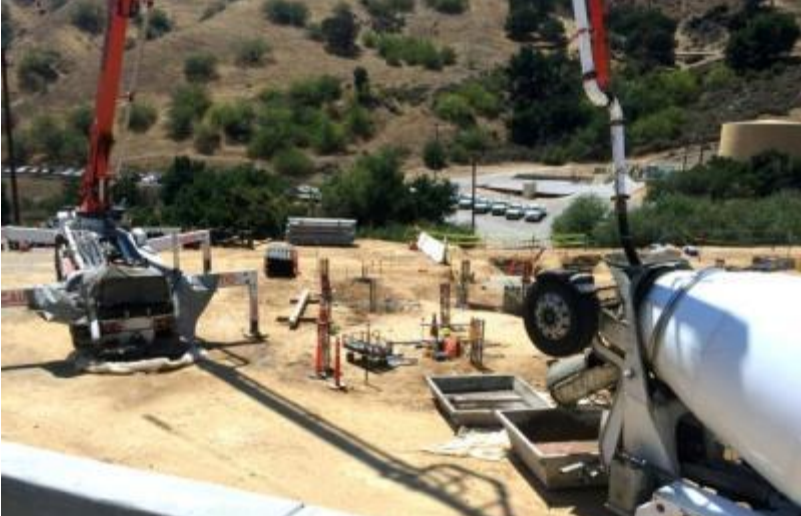
| Date | Location | Photo | Description |
|---|---|--|--|
| 7/23/15 | CCS | | Concrete and slurry pours are ongoing. |

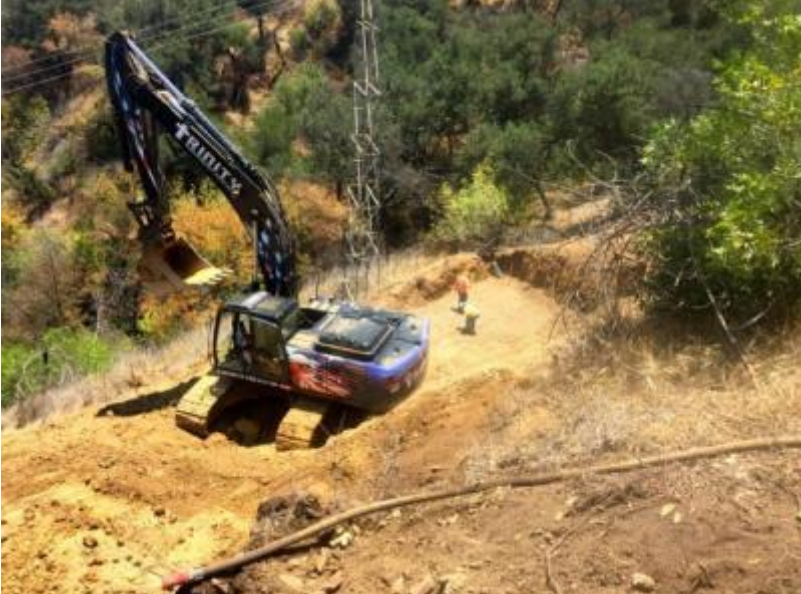
| Date | Location | Photo | Description |
|---|---|--|--|
| 7/23/15 | TSP 40 | | An excavator has cleared out the area for the Hillfiker wall and is now getting ready to begin backfilling the wall. |

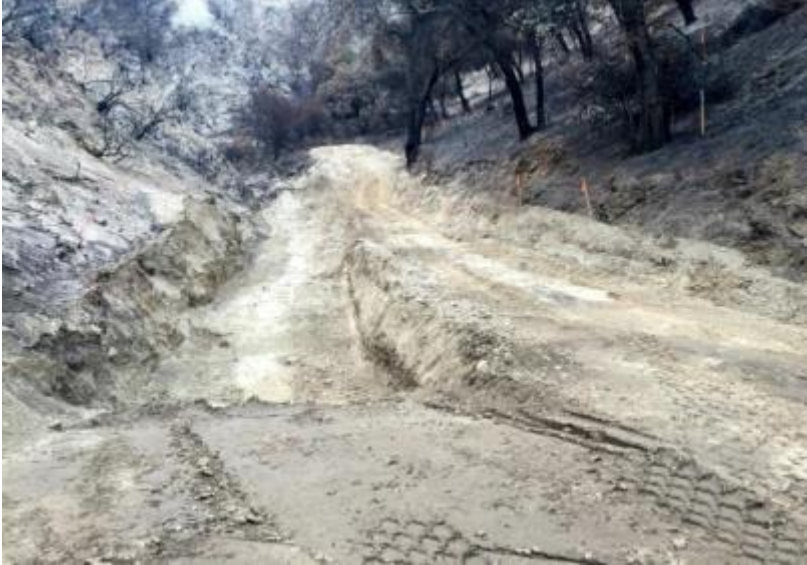
| Date | Location | Photo | Description |
|---|---|--|---|
| 7/30/15 | Access road to TSP 25 | | Looking up the access road from the jurisdictional drainage. |

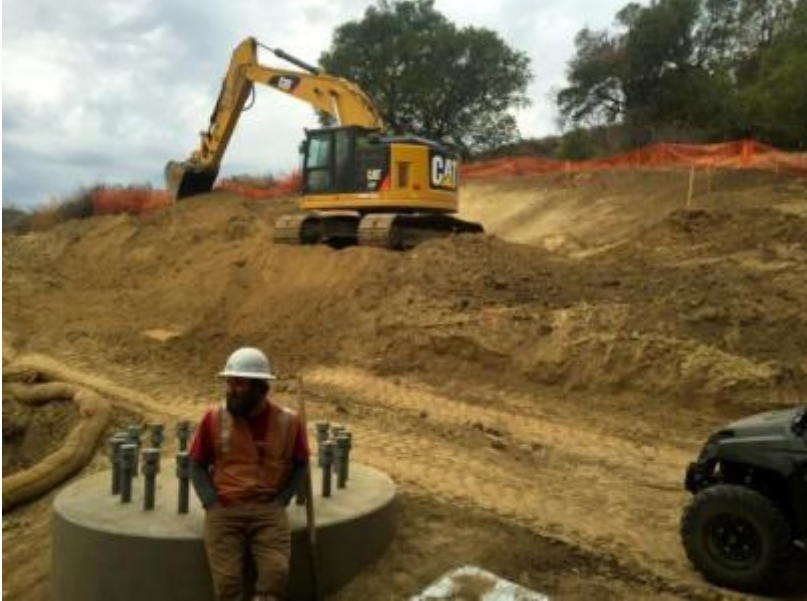
| Date | Location | Photo | Description |
|---|---|--|---|
| 7/30/15 | TSP 22 | | Excavation of the pull site is taking place with soil being transported to the TSP 25 area. |

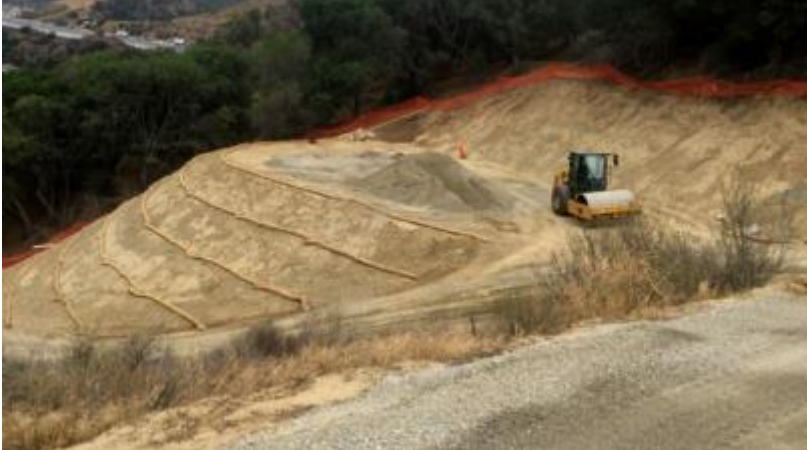
| Date | Location | Photo | Description |
|---|---|--|---|
| 7/30/15 | Pull site between TSP 21 and TSP 22 | | The location is being used to stockpile the road base that is being applied to the access road. |

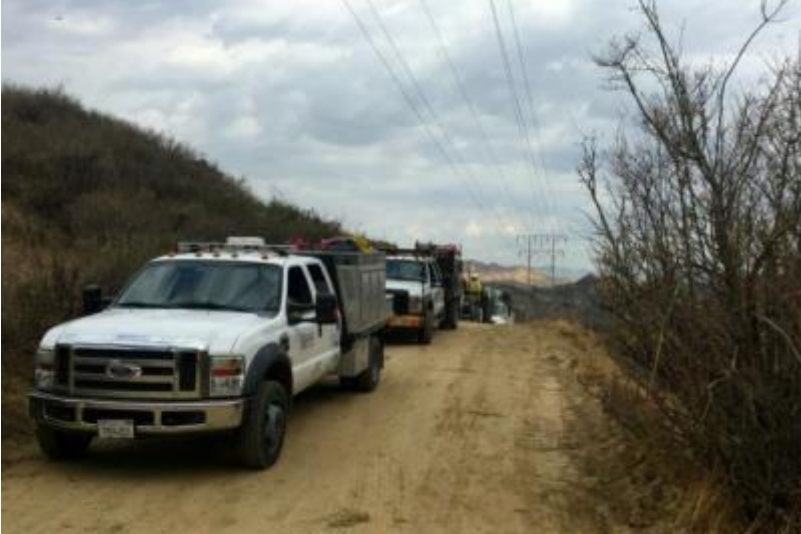
| Date | Location | Photo | Description |
|---|---|--|--|
| 7/30/15 | TSP 18 | | Pole installation and wire stringing is ongoing. |

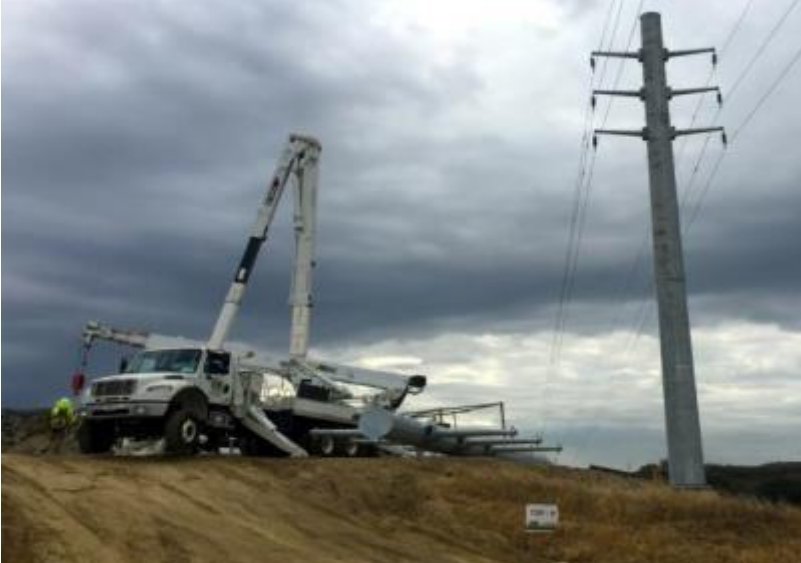
| Date | Location | Photo | Description |
|---|---|--|--|
| 7/30/15 | TSP 19 | | Pole installation and wire stringing is ongoing. |

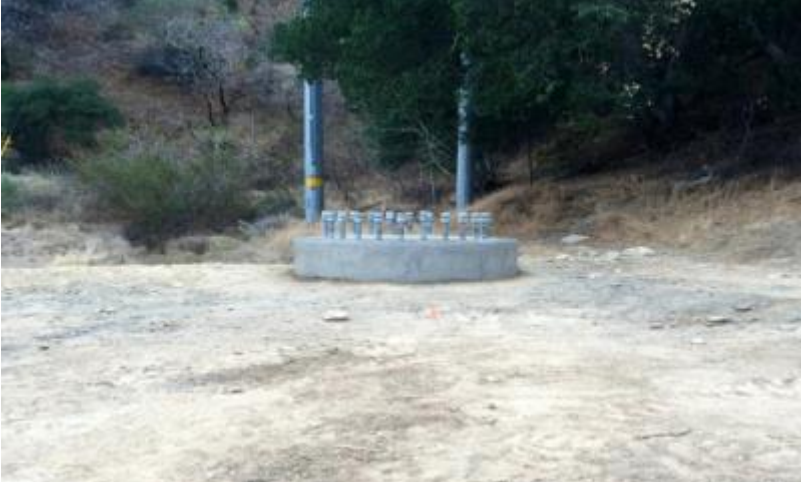
Stopped at TSP 35 at around 0715 and noted that the pole foundation has been drilled and poured – see photo. No one was onsite, and a water truck was parked within the work area. The site was extremely dusty and it appeared that no water had been sprayed on the area.

Dusty conditions were noted at TSP 35, on the access road to TSP 27, and along the access road to TSP 40. The addition of road base on the steep portions of the access roads at TSP 24/25 and at TSP 21 eliminated the dust control problems in those areas.

| Date | Location | Photo | Description |
|---|---|--|--|
| 7/30/15 | TSP 35 | | The foundation for the new pole has been drilled and poured. |

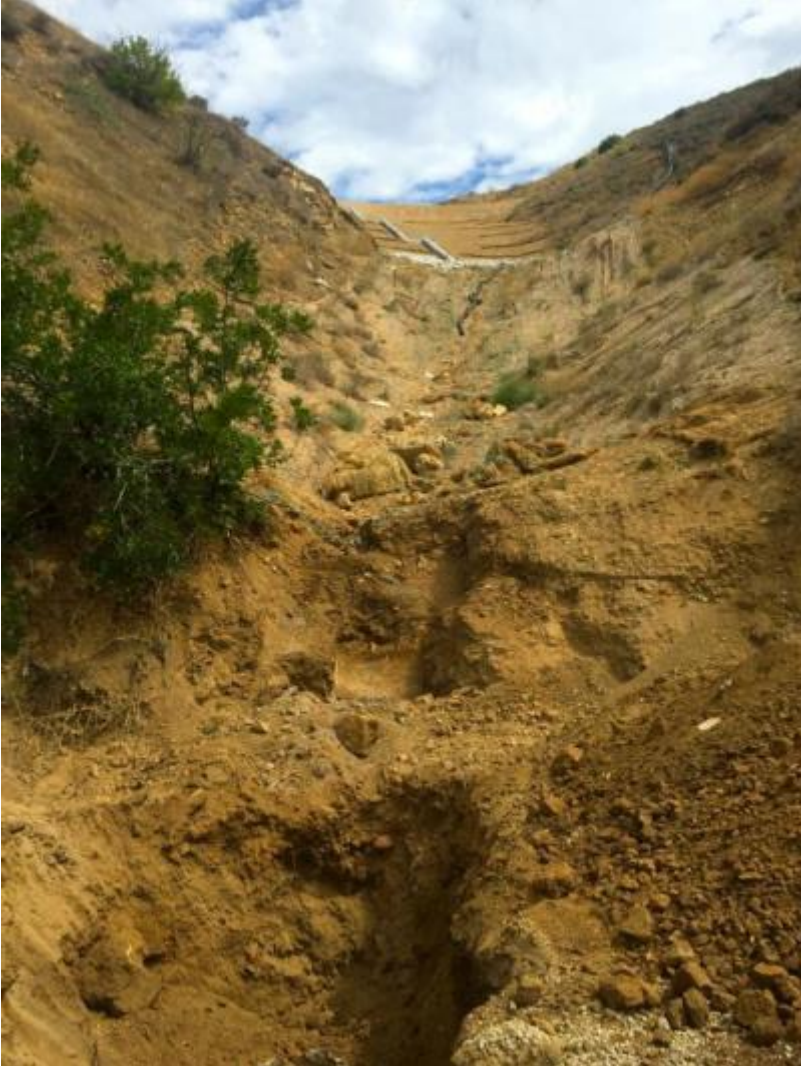
| Date | Location | Photo | Description |
|---|---|--|---|
| 7/30/15 | PS-42 Fill Site | | Lower portion of the fill site – work on the box culvert and drain pipe has been initiated. |

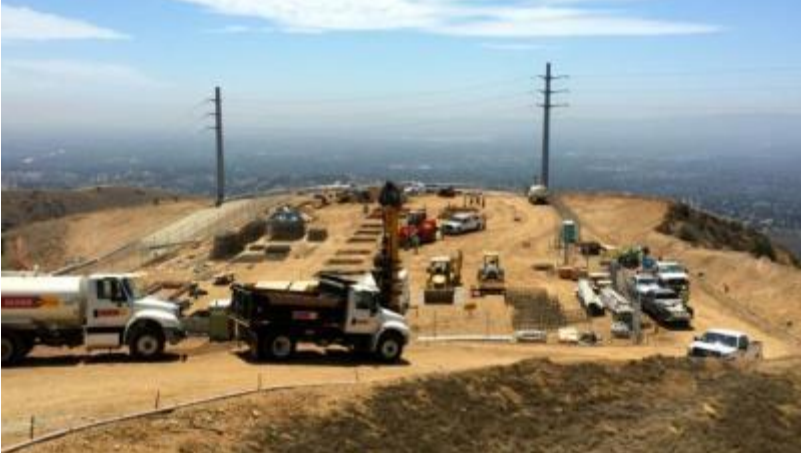
| Date | Location | Photo | Description |
|---|---|--|---|
| 7/30/15 | Natural Substation | | Materials continue to be transported to the site – some excavation has been completed. |

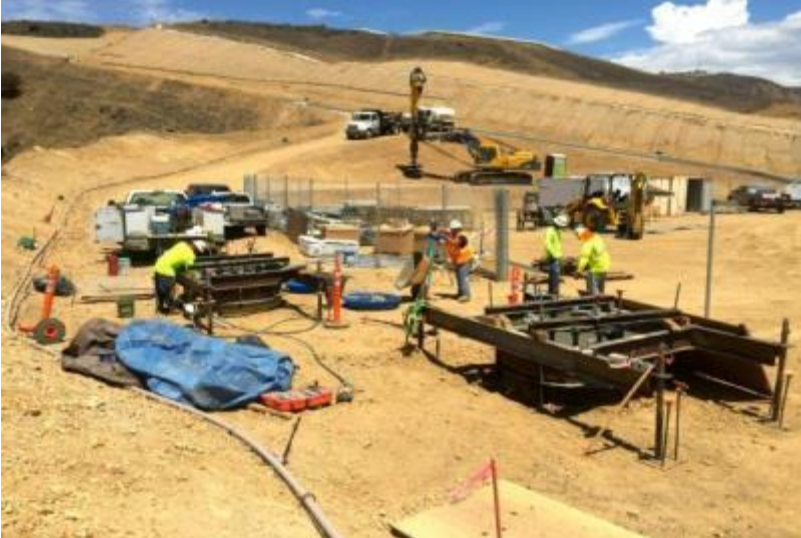
At the Natural Substation, a crew has drilled and poured the foundations for two additional poles adjacent to the Natural

| Date | Location | Photo | Description |
|---|---|--|---|
| 7/30/15 | Natural Substation | | Two additional pole foundations have been drilled and poured. |

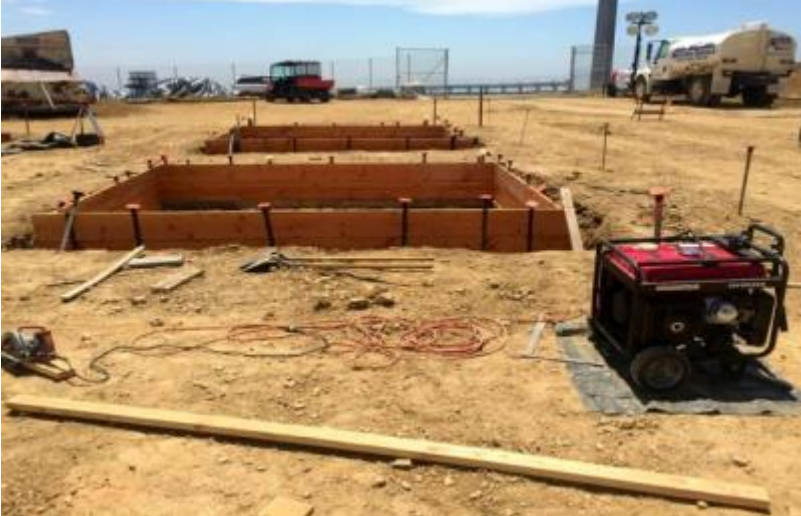
| Date | Location | Photo | Description |
|---|---|--|---|
| 7/30/15 | Natural Substation | | Forms have been built within the Natural Substation. |
