Re: Monthly Report Summary #27 for Aliso Canyon Turbine Replacement Project

Aliso Canyon Turbine Replacement Project CPUC Site Inspection Form

Project:	Aliso Canyon Turbine Replacement	Date:	June 3, 2016
Project Proponent:	Southern California Gas Company and Southern California Edison	Report #:	VS106
Lead Agency:	California Public Utilities Commission	Monitor(s):	Vince Semonsen
CPUC PM:	Andrew Barnsdale, Energy Division	AM/PM Weather:	Clear, sunny, and hot with a slight breeze.
E & E CM:	Lara Rachowicz	Start/End time:	0900 to 1200 at the Aliso Canyon Natural Gas Storage Field (Aliso Storage Field)
Project NTP(s):	The new Admin/IM Building (NTP-2), Central Compressor Station (CCS) (NTP-3), PS-42 Fill Site, and the Natural Substation (NTP-3 and NTP-A). TSPs 2 through 42 (NTPs A, C, and D) and the SCE 210 Freeway Yard. Telecommunications Route 2 (NTP-E).

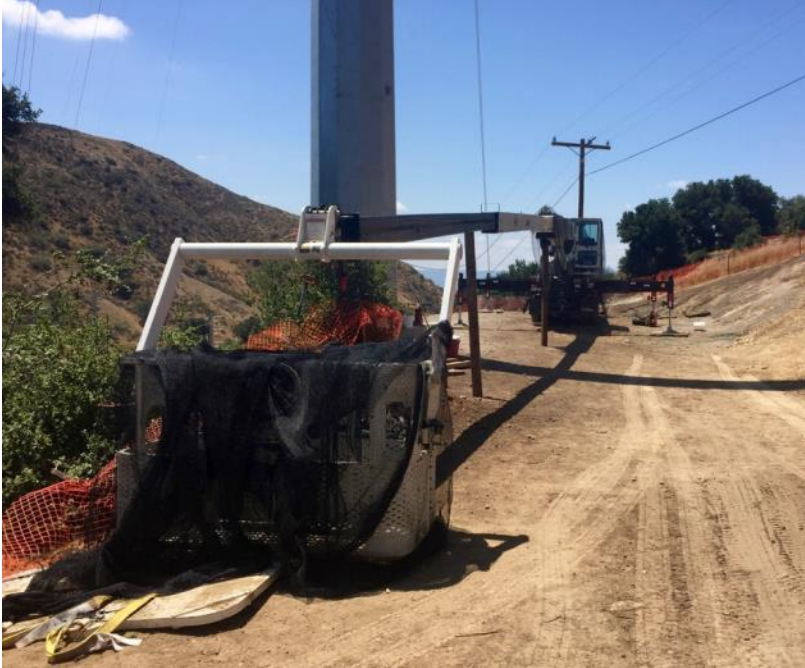
A photograph showing a man lift at a construction site. The lift's TSP (Total Suspended Platform) is covered with black plastic sheeting and orange bird netting. The lift is on a dirt path, and a large white tower is visible in the background under a clear blue sky.	Photo 11 – Man lift below the TSP covered with bird netting.
6/13/16	12 kV PPL Work

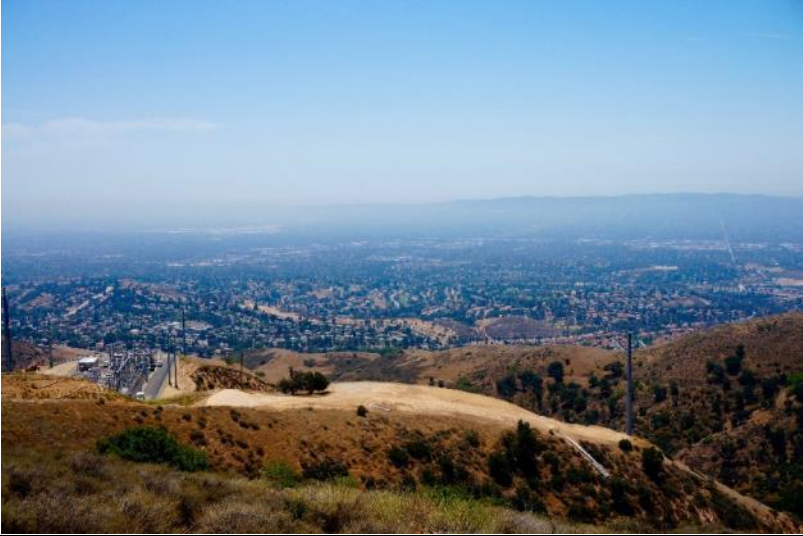
Photo 6 – Overview of the TSP 49 access road and Natural Substation.
06/27/16	P-40

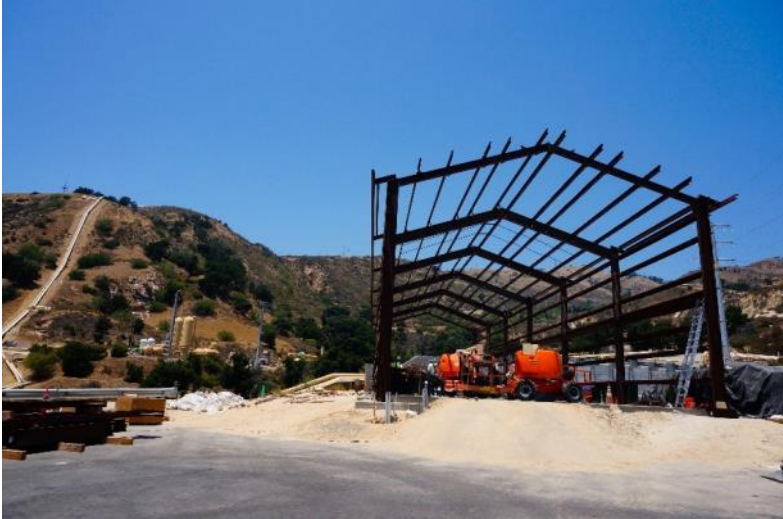
We drove to the Oak Tree Mitigation Site where the young trees appeared healthy – Photo 8. The area had been mowed about a month prior to my visit, and I noted very sporadic non-native plants. Next, we checked the new Admin/IM Building. Steel structures were up, and crews continued to work – Photo 9. The biofiltration unit was well vegetated with planted plants. There were patches of non-native plants on the slope between the new Admin and IM Buildings, as well as some natives, such as California poppy.

Photo 9 – Structural steel and crew at the new Admin/IM Building.
06/27/16	CCS
