January 14, 2020

Re: Monthly Report Summary #20 for the Mesa 500-kV Substation Project

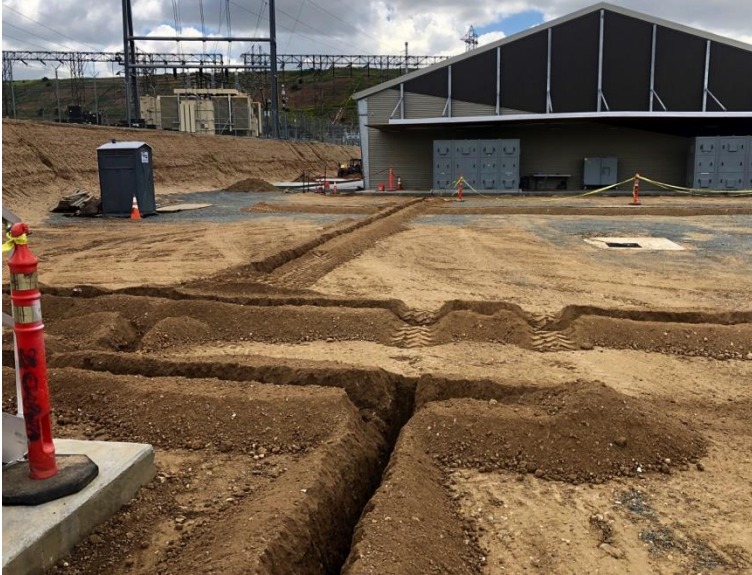
Photo 2 – Senior MEER work. Photo facing south.
5/06/19	Mesa Substation

Work continued at the Senior Mechanical Electrical Equipment Room (MEER building). Most work occurred inside the building, and some equipment was installed on the foundations around the building - Photo 2. A couple of house finches entered the building; workers expressed concern over the finches flying around and possibly trying to build a nest. They spoke to biological monitor Wayne Woodroof (Noreas) who recommended turning off the lights and leaving the doors open during their lunch break. I spoke to Wayne Woodroof later in the day about these birds; he felt they would leave the building when they got hungry. We also discussed exit ramps for the trenches and excavations.

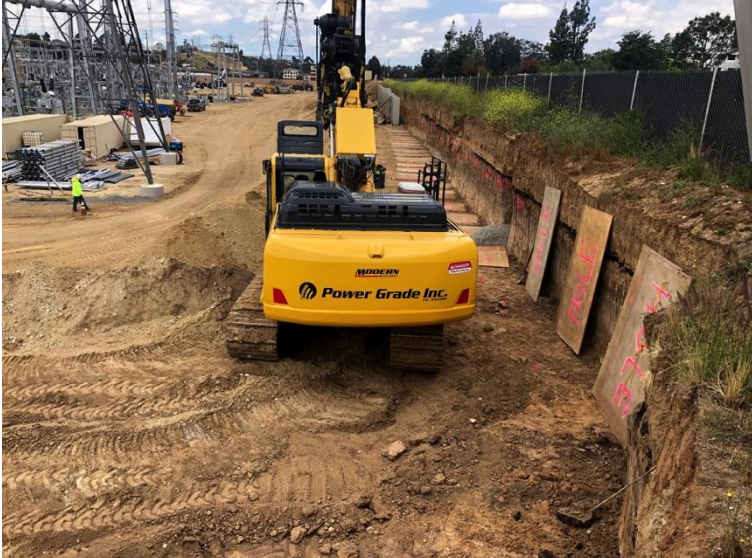
Photo 4 – Drilling “I” beam holes for the northern boundary wall. Photo facing west.
5/06/19	Mesa Substation

It appeared that all the “1” beam holes had been drilled for the northern boundary wall; they were adequately sealed – Photo 4. “1” beam installation continues, and a concrete pumper truck was onsite to pour slurry in the space between the wall and the earthen berm – Photo 5. Numerous concrete trucks were being driven onto the site; the washout location remained in the southeastern portion of the project site.

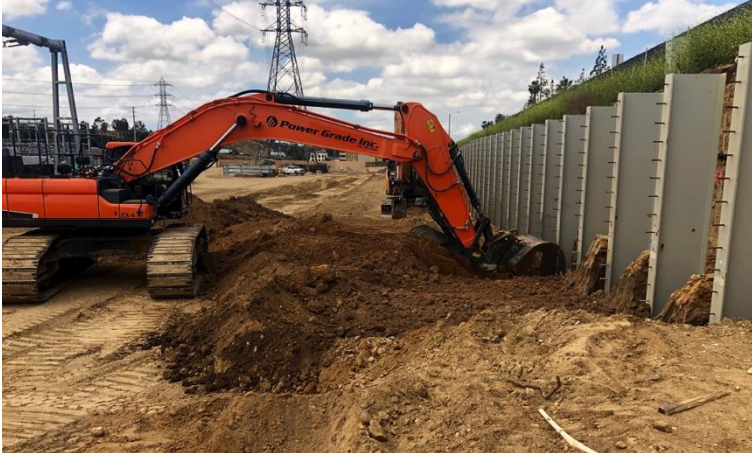
Photo 5 – Dirt work around the northern boundary wall “I” beams. Photo facing west.
5/06/19	Mesa Substation

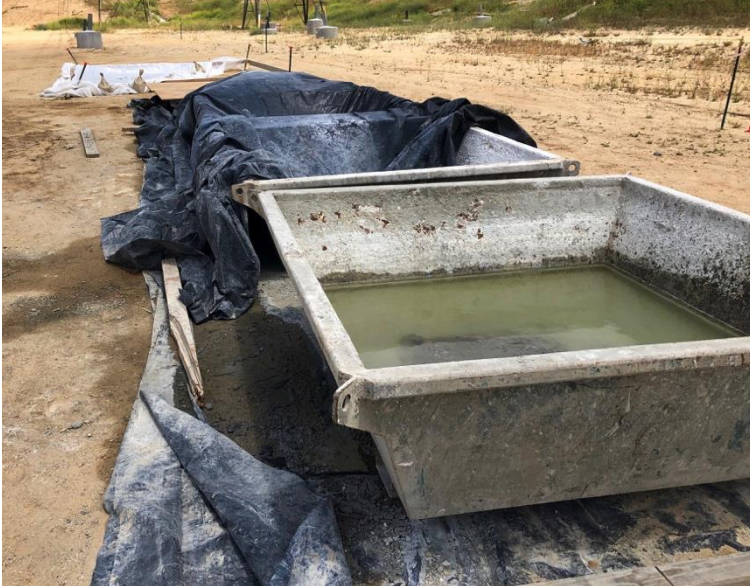
Concrete washout bins remained near the southeastern corner of the project site and were well contained – Photo 14.

Photo 14 – Concrete washout station. Photo facing east.

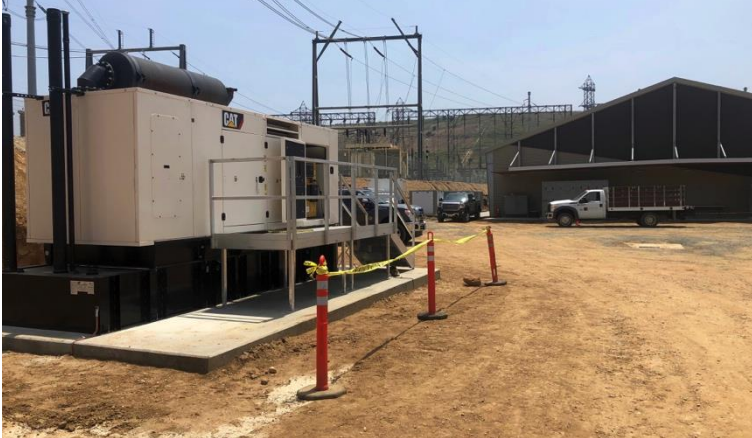
Photo 2 – Senior MEER work. the equipment was been placed on the foundations. Photo facing south.
5/14/19	Mesa Substation

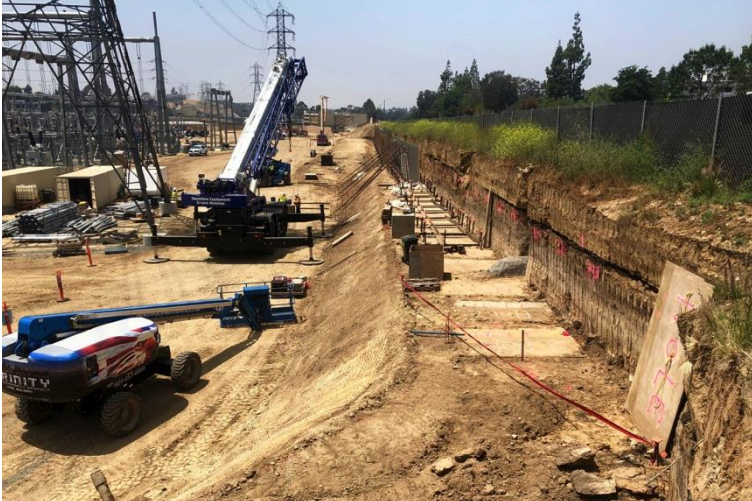
Photo 4 – Work on the northern boundary wall. Photo facing west.
5/14/19	Mesa Substation

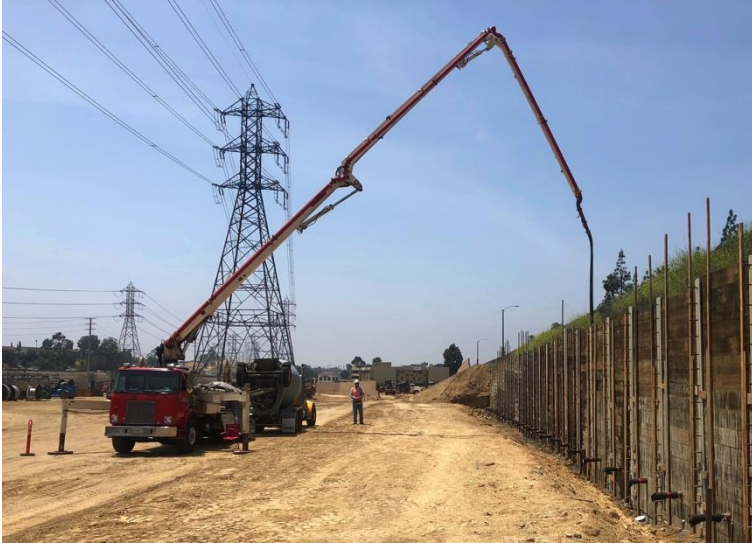
Photo 5 – A concrete pumper truck filling the space behind the northern wall with slurry. Photo facing west.
5/14/19	Mesa Substation

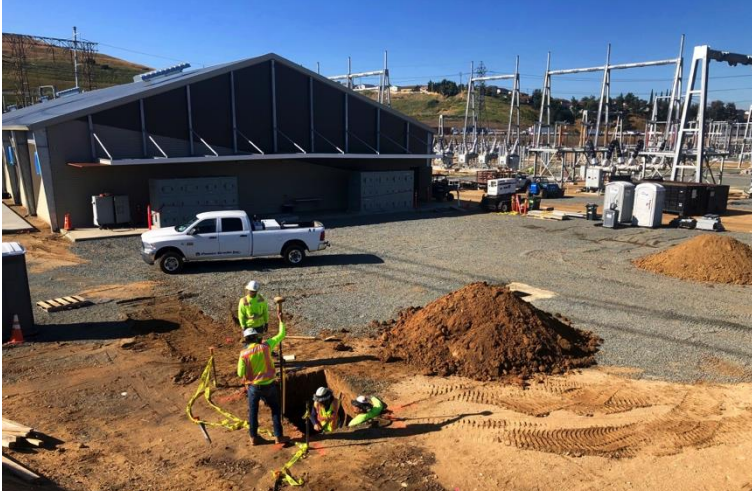
Construction work continued inside the Senior Mechanical Electrical Equipment Room (MEER) building and excavation was completed outside and north of the building - Photo 4.

Photo 4 – Excavation work around the Senior MEER. Photo facing south.
5/20/19	Mesa Substation

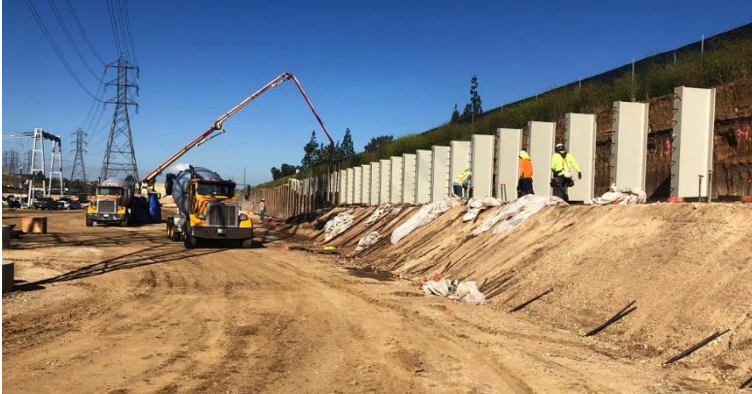
The northern boundary wall work continued. Crews were working on the “I” beams while a pumper truck was used to pour slurry behind the new wall – Photo 5. There was a constant flow of concrete trucks coming onsite; all were washing out in the established bins – Photo 20.

Photo 5 – Work on the northern wall including a concrete pumper truck filling the space behind the northern wall with slurry. Photo facing west.
5/20/19	Mesa Substation

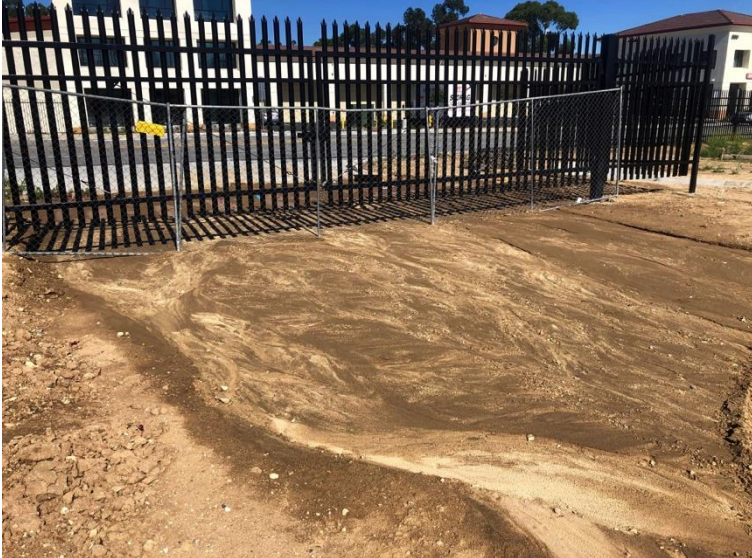
Photo 13 – Sediment dropped out near the Markland project exit. Photo facing west.
5/20/18	Mesa Substation

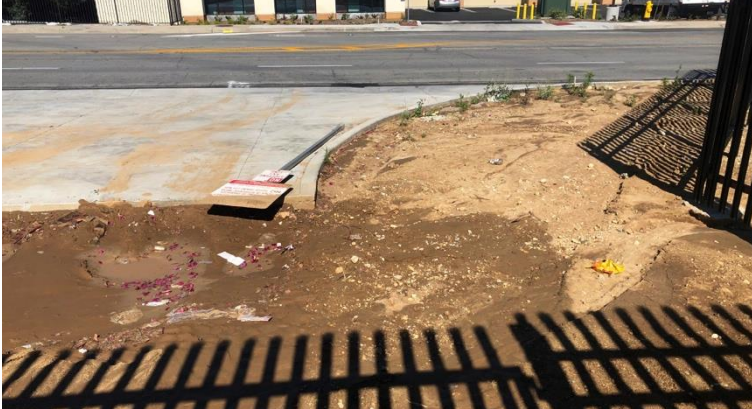
Photo 14 – Markland concrete curb diverted stormwater runoff into the retention basin to the north. Photo facing west.

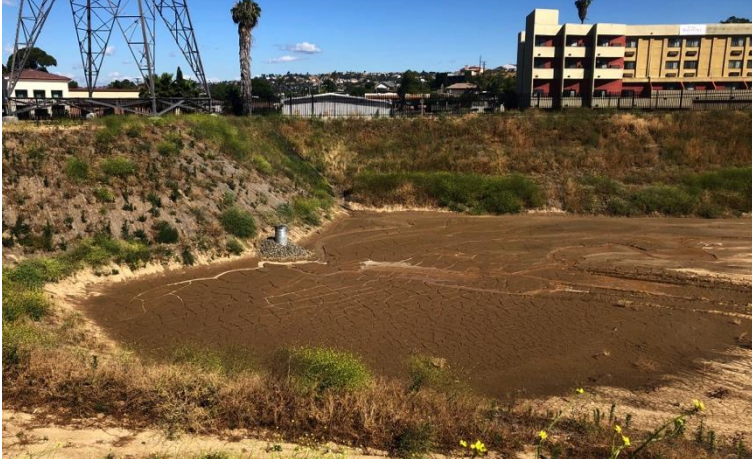
<p>Photo 16 – Detention basin. Photo facing north.</p>
5/20/19	Mesa Substation

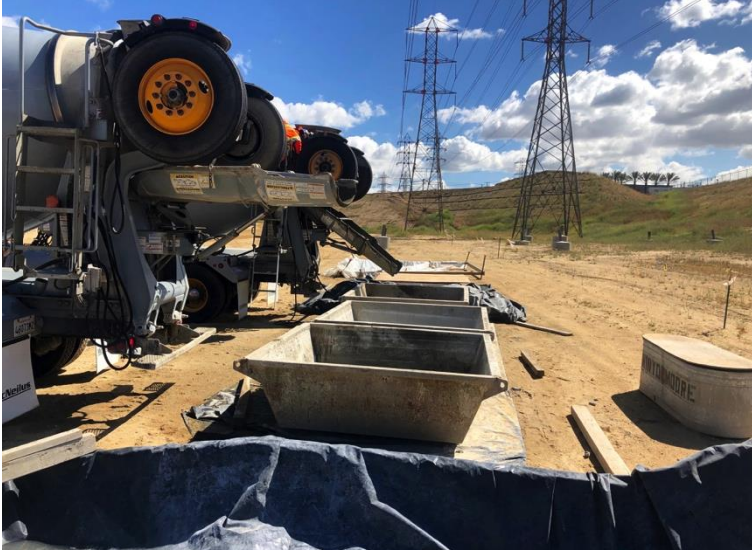
Photo 20 – Concrete washout location near the southeastern portion of the project site. Photo facing east.

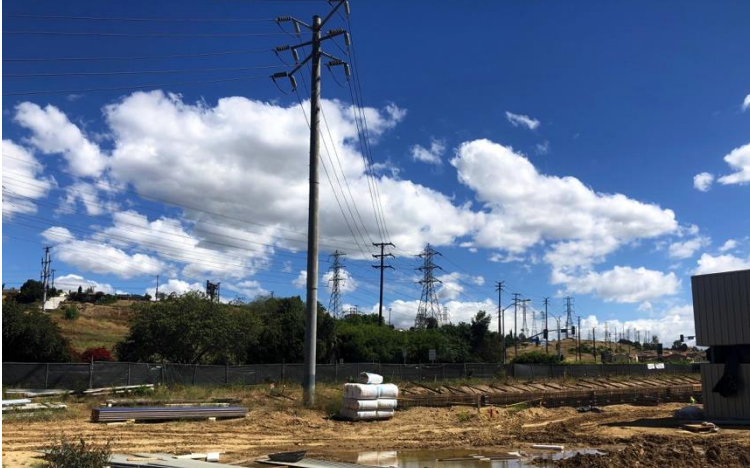
Photo 23 – TSP where a pair of Kestrels were nesting.

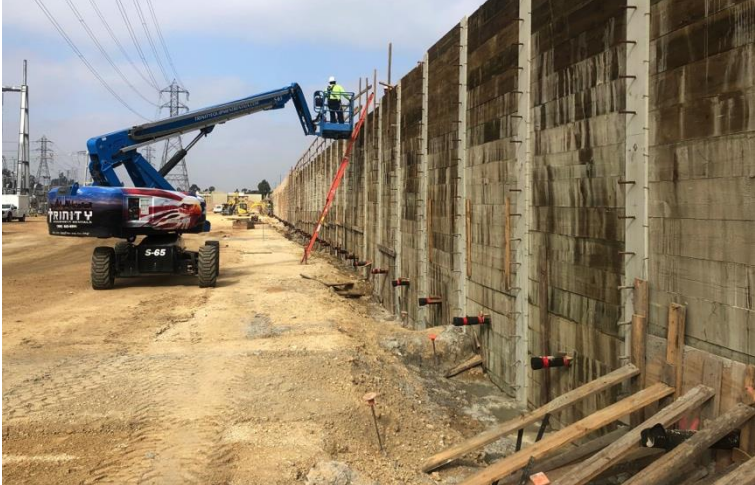
Construction work along the northern boundary wall continued at several different locations – Photo 3 – including additional “I” beam drilling toward the western end of the wall – Photo 4. The drilled holes were well sealed.

Photo 3 – Wall installation along the northern border. Photo facing west.

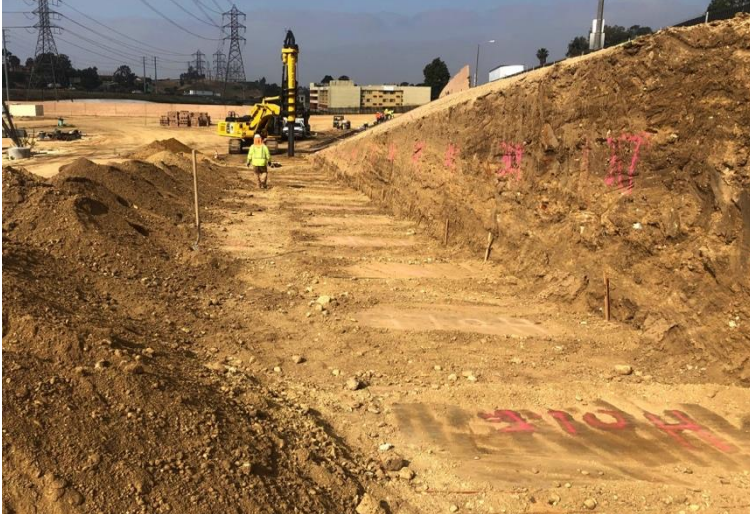
Photo 4 – Drilling operation for the northern wall. Photo facing west.
5/30/19	Mesa Substation

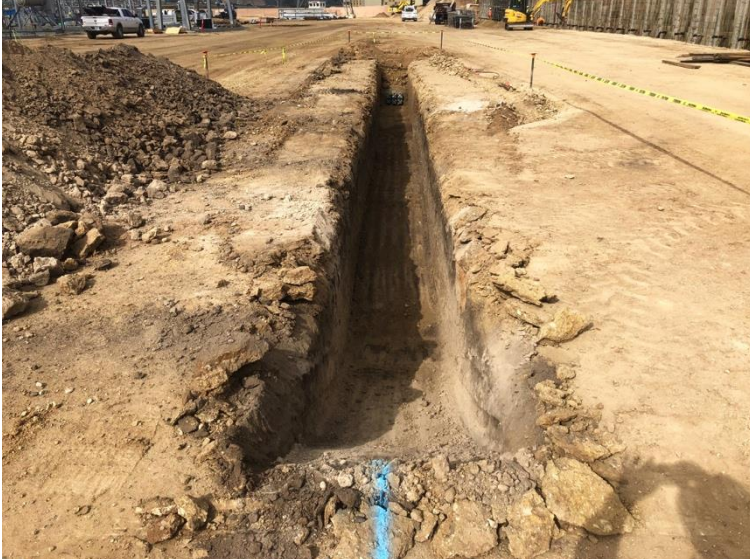
An open conduit trench was noted running east/west inside the northern wall – Photo 5. This trench had a sloped escape ramp at one end of the excavation.

Photo 5 – An open conduit trench with escape ramp. Photo facing west.
5/30/19	Mesa Substation

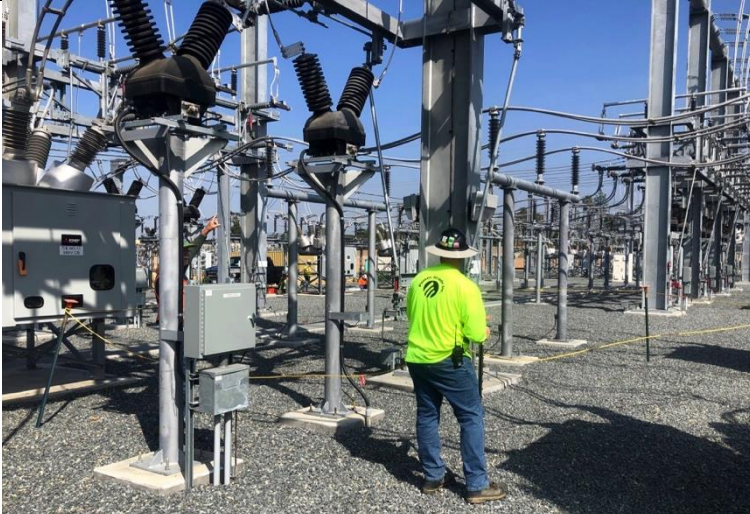
Biological monitors Karly Moore and Wayne Woodroof (Noreas) were at the 66-kilovolt (kV) switchrack area observing nesting bird activity. Wayne Woodroof said that the young in one nest had recently fledged; thus, they would remove the nest and the buffer stakes. Craig Pernot (Power Grade foreman) was on his way to the site with a man lift to remove the nesting material and buffer – Photo 6.

Photo 6 – Removal of a bird buffer w/in the 66-kV equipment. Photo facing north.

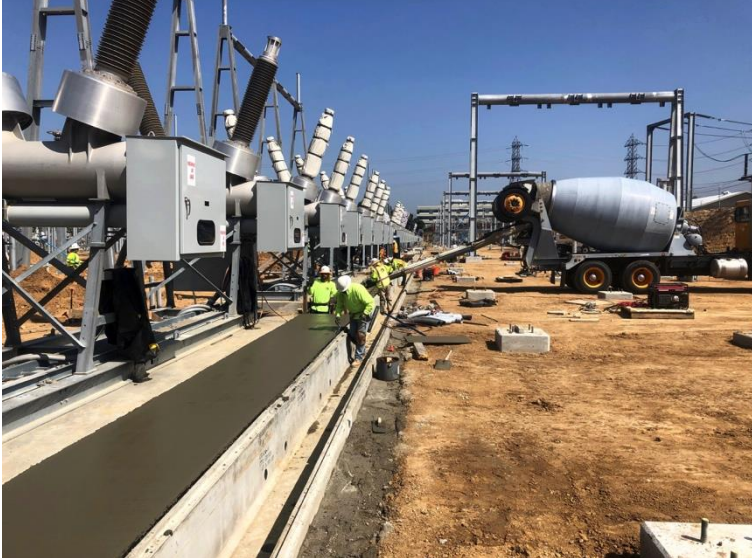
Photo 8 – 220-kV foundation work. Photo facing north.
5/30/19	Mesa Substation

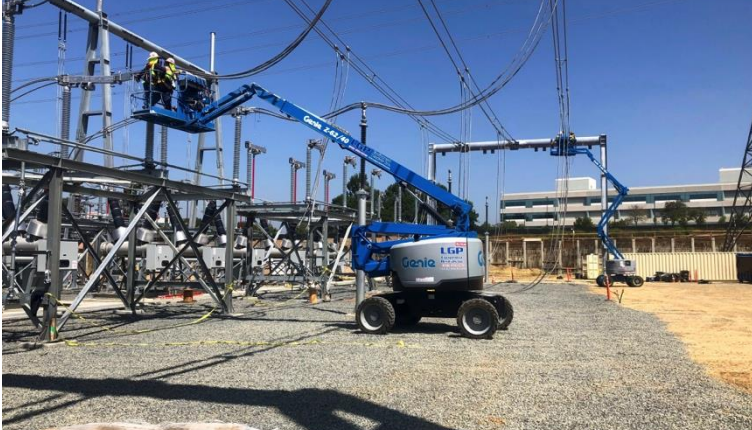
Photo 9 – 220-kV above ground installation work. Photo facing north.

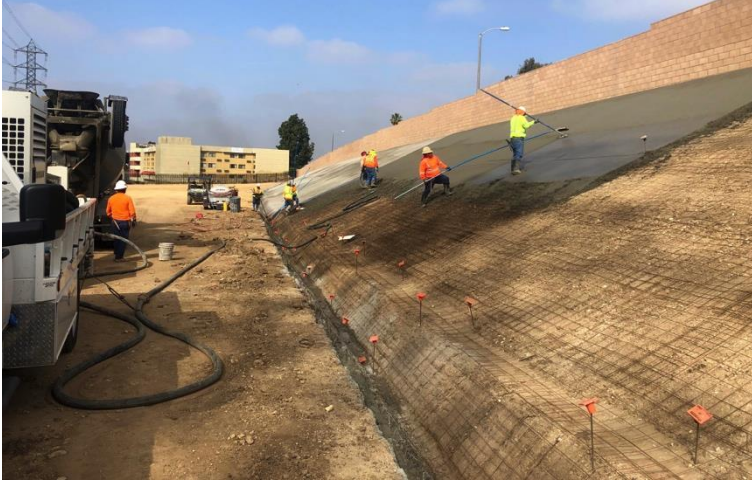
A large crew was spraying concrete over the earthen slope just inside the western portion of the northern boundary wall – Photo 10.

Photo 10 – Covering the north slope with concrete. Photo facing west.
5/30/19	Mesa Substation

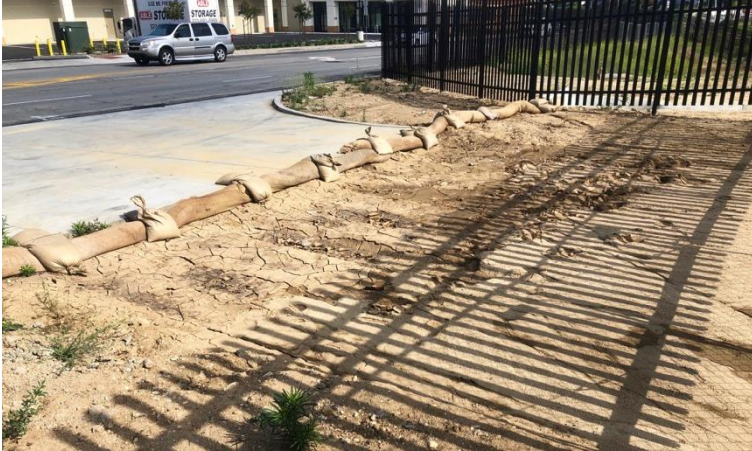
A row of wattle was added at the driveway that exits onto East Markland Avenue – Photo 12. No additional BMPs were added upslope from this location. Stormwater runoff coming down toward Markland Drive appears to be directed into the small “triangular” retention basin.

Photo 12 – East Markland driveway with newly installed straw wattle. Photo facing northwest.

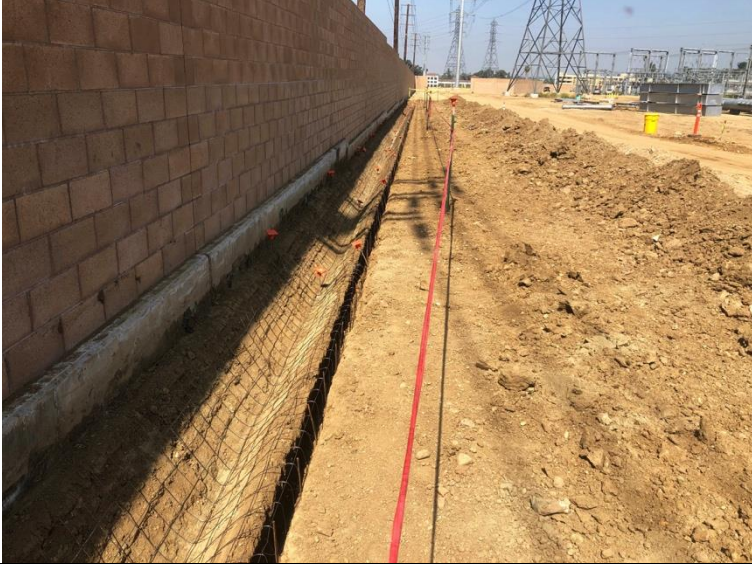
Construction work on a “V” ditch was occurring along the inside of the southern boundary wall – Photo 13.

<p>Photo 13 – “V” ditch installation along the inside of the southern boundary wall. Photo facing west.</p>
5/30/18	Mesa Substation

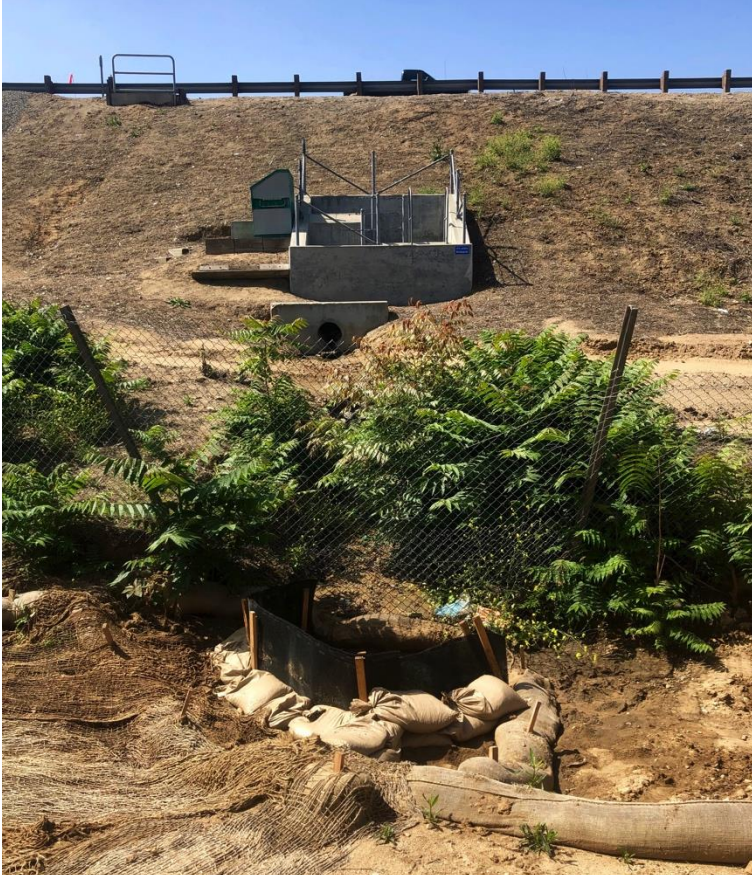
There were no substantial BMP upgrades along the southern boundary wall’s exterior, except for the addition of gravel bags around the drain inlet and the removal of the filter fabric over the inlet grate – Photo 14. It appeared that rainwater runoff from Highway 60 was entering the project’s detention basin via the drain inlet south of the boundary wall – Photo 15.

Photo 15 – Highway 60 drainage culvert – water coming from the highway drains into the project stormwater drainage system. Photo facing south.
5/30/19	Mesa Substation

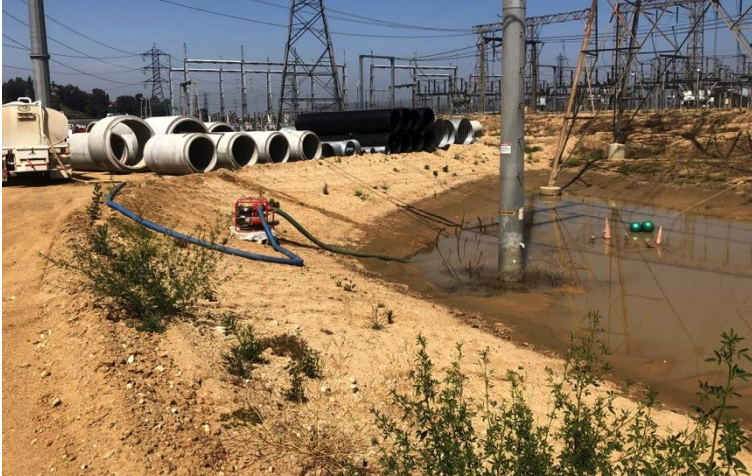
Water was being pumped out of a catch basin (located south of the existing substation) and into a water truck to be used for dust suppression throughout the project site – Photo 16.

Photo 16 – Pumping captured rainwater into a water truck to be used for dust control. Photo facing northwest.

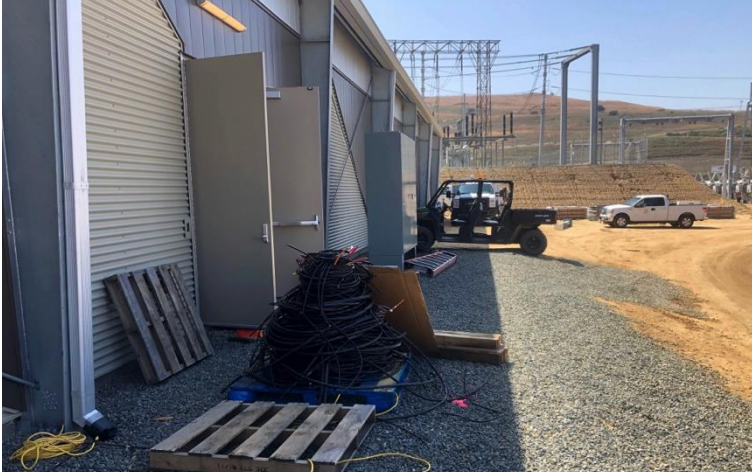
Lastly, construction work continued inside of the Senior Mechanical Electrical Equipment Room (MEER) building - Photo 17.

Photo 17 – Senior MEER. Photo facing south.
