**Re: Monthly Report Summary #9 for the Santa Barbara County Reliability Project**

CPUC Site Inspection Report

## Santa Barbara County Reliability Project CPUC Site Inspection Form

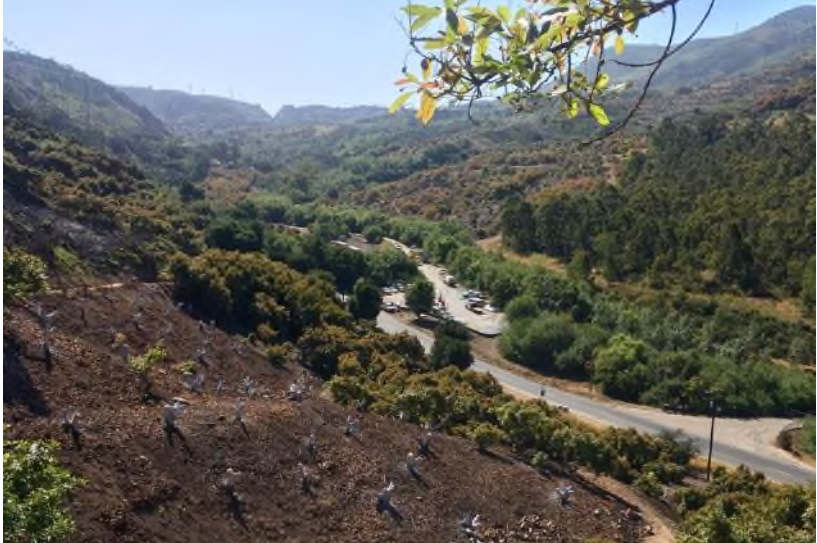
An aerial photograph showing a valley with a winding road. The foreground shows a dark, rocky slope. The road curves through a valley with green vegetation. In the background, there are hills and a clear blue sky.	Photo 7 – Looking back toward Highway 150 Yard from Construct 98. Photo facing east.
6/1/18	SBCRP – Construct 60

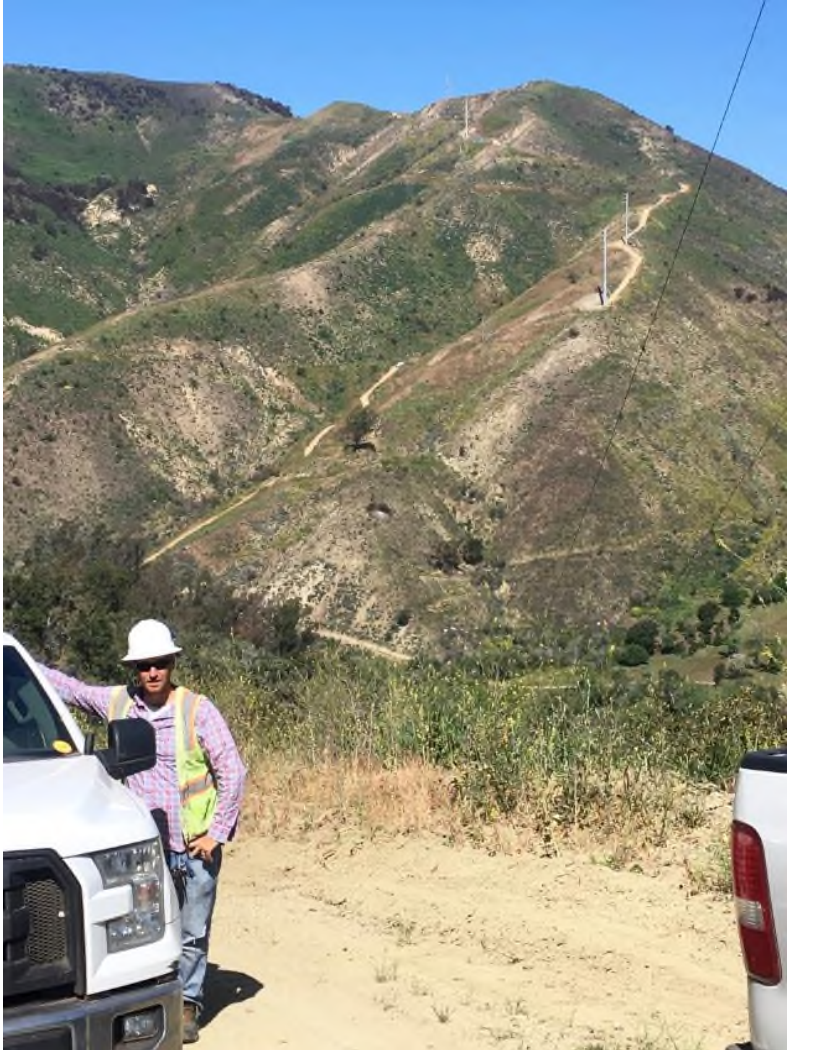
I rode with BRC biological monitor Matt Schaap to Construct 60 where the Henkels & McCoy (H&M) survey crew wanted to verify the accuracy of the 500-foot buffer around the red-tailed hawk nest in an existing tower. The red-tailed hawk chicks could be seen in the nest, but were assumed to be close to fledging. The survey results determined that the buffer stakes were farther than 500 feet from the nest, so we restaked the construction boundary. The H&M crew was anticipating they could pull wire a few days after my site visit. Looking west from Construct 60, I could see Constructs 62, 63, and 64 going up eastern side of Rincon Mountain (Photo 8).

A photograph of a person wearing a white hard hat, a plaid shirt, and a yellow safety vest. The person is standing next to a white pickup truck on a dirt road. In the background, there are hills with a dirt path and some vegetation.	Photo 8 – BRC lead biological monitor Matt Schaap. Photo looking west toward the eastern side of Rincon Mountain and Constructs 62, 63, and 64.
