Re: Monthly Report Summary #20 for the South Orange County Reliability Enhancement (SOCRE) Project

South Orange County Reliability Enhancement Project CPUC Site Inspection Form

Project:	South Orange County Reliability Enhancement (SOCRE) Project	Date:	June 7, 2019
Project Proponent:	San Diego Gas & Electric (SDG&E)	Report #:	VS036
Lead Agency:	California Public Utilities Commission (CPUC)	Monitor(s):	CPUC/Ecology and Environment (E & E) Compliance Monitor
CPUC PM:	Andrew Barnsdale, Energy Division	AM/PM Weather:	Overcast, cool, and calm
CPUC CM (E & E):	Joe Donaldson	Start/End time:	0645 to 0845
Project NTP(s):	Notice to Proceed (NTP) -1, NTP-2, NTP-2 Addendum 1, NTP-3, and NTP-4; Minor Project Refinement (MPR) -1, MPR-1 Addendum 1, and MPR-3.

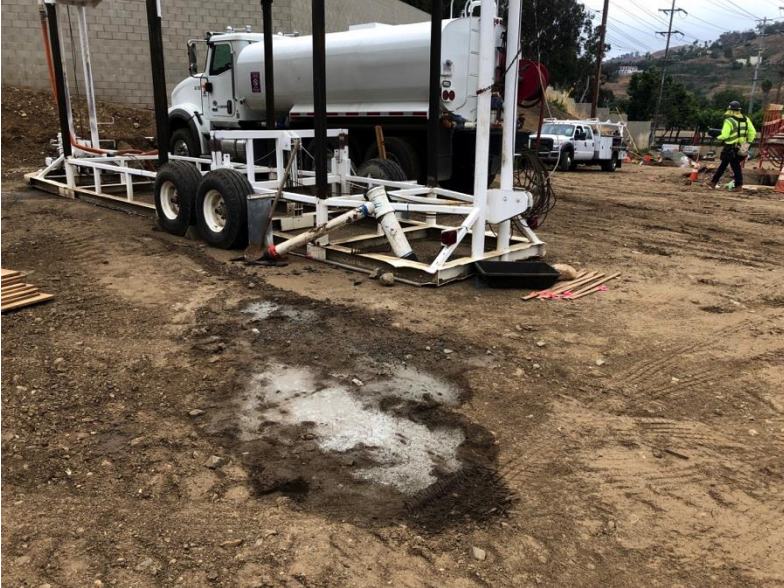
I spoke with SDG&E Lead Environmental Inspector about trash I had noted within the construction area. The SDG&E Lead Environmental Inspector said that the construction crews would complete a site-wide cleanup before the weekend. I also noted a small concrete washout area by the water tower (Photo 4) that needed cleanup. Later in the day, the SDG&E Lead Environmental Inspector sent a photo and description of the washout cleanup that had been conducted by the crews.

A white concrete mixer truck is parked on a dirt area. In the foreground, there is a concrete washout area with some water and debris. A worker in a yellow safety vest is visible in the background.	Photo 4 – Concrete washout area near the water tower. Photo facing southwest.
6/7/19	San Juan Capistrano Substation
