**Re: Monthly Report Summary #23 for the South Orange County Reliability Enhancement (SOCRE) Project**

CPUC Site Inspection Reports  
September 5, 13, 19, and 25, 2019

## South Orange County Reliability Enhancement Project CPUC Site Inspection Form

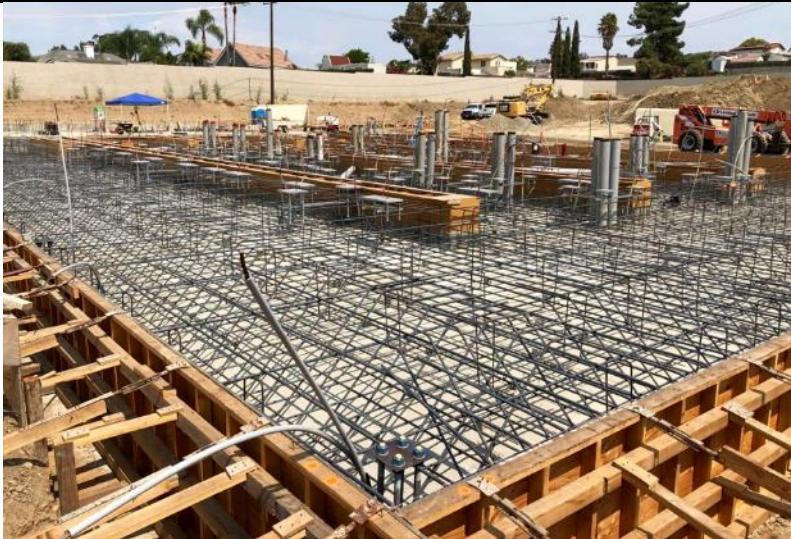
Photo 10 – 138-kV GIS building pad under construction. Photo facing northeast.
09/05/19	San Juan Capistrano Substation	 	Photo 11 – Soil stockpile area. Photo facing east.

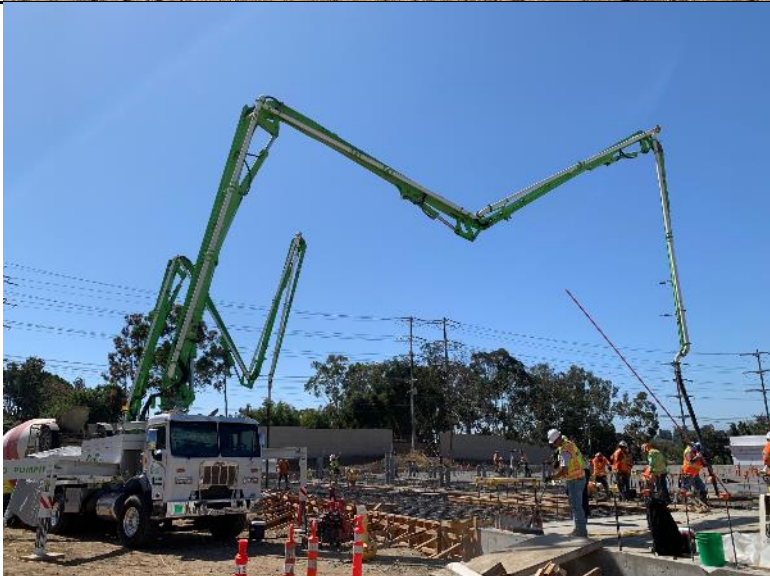
A large work area for conduit trenching/vaults inside of the San Juan Capistrano Substation site was closed off with cones and stringing. Conduit trenching and vaults in this closed area were partially covered (Photo 2). The LEI and I walked east of the San Juan Capistrano Substation site to observe the concrete pouring work. Two concrete pouring pumps were operating, and the concrete pouring activities were supervised (Photos 3, 4, and 5).

Photo 3 – Two concrete pour pumps operating. Photo facing south.

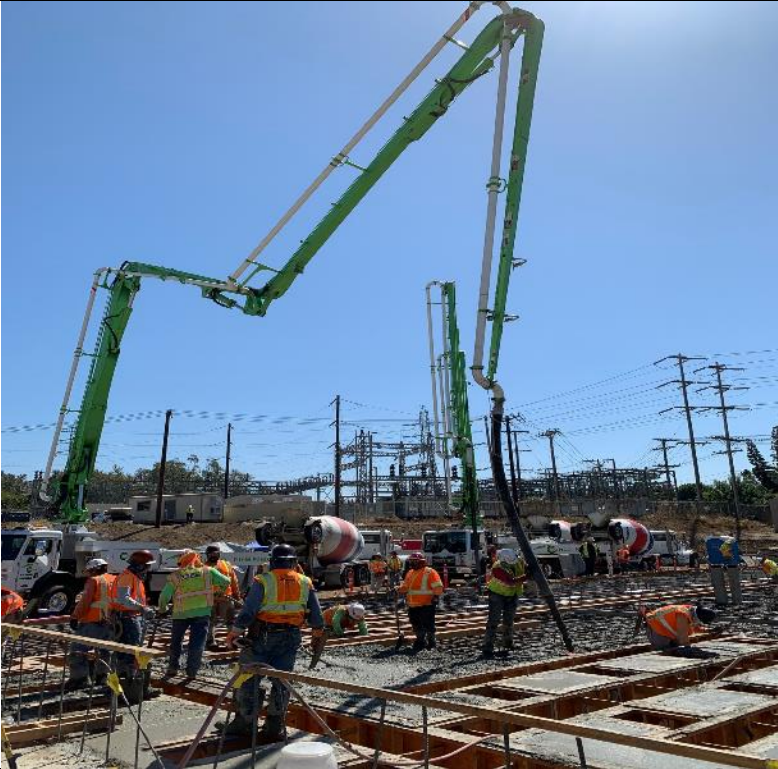
Photo 4 – Crews conducting concrete pour work. Photo facing east.
09/13/19	San Juan Capistrano Substation

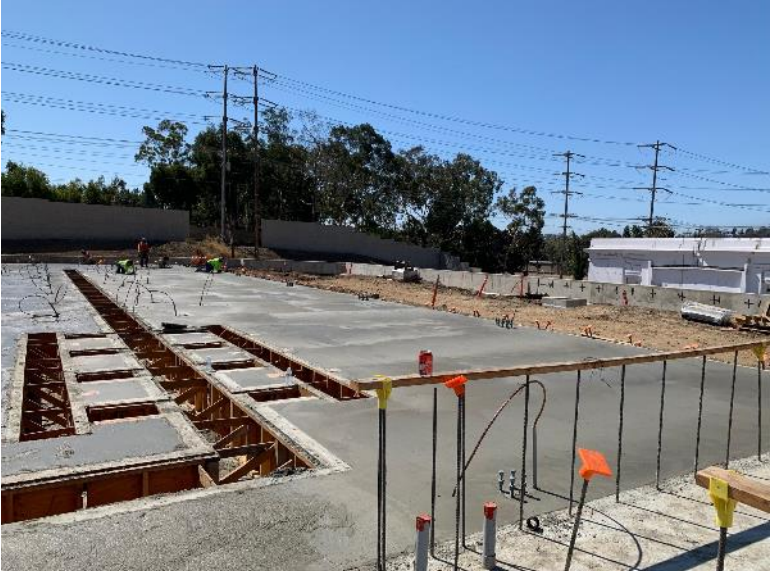
Photo 5 – Concrete pouring and smoothing. Photo facing south.

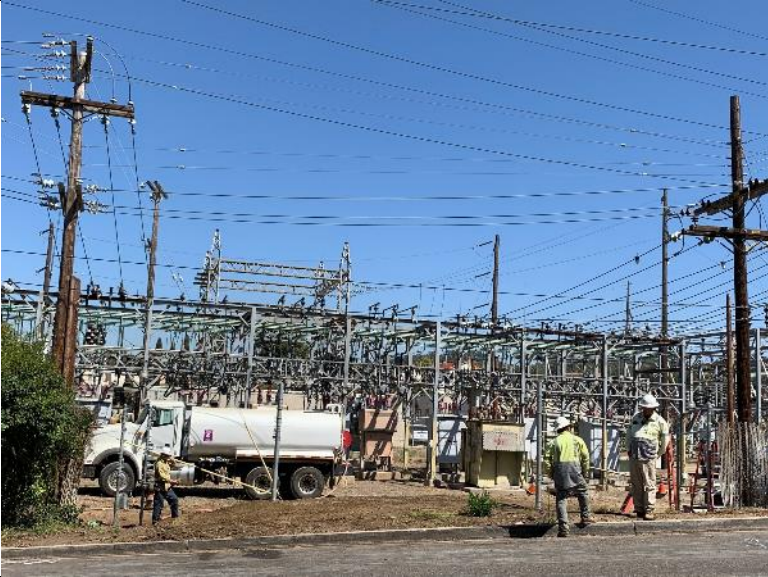
Photo 8 – Installation of new driveway. Crew spraying soil with water to minimize dust. Photo facing north.
09/13/19	San Juan Capistrano Substation

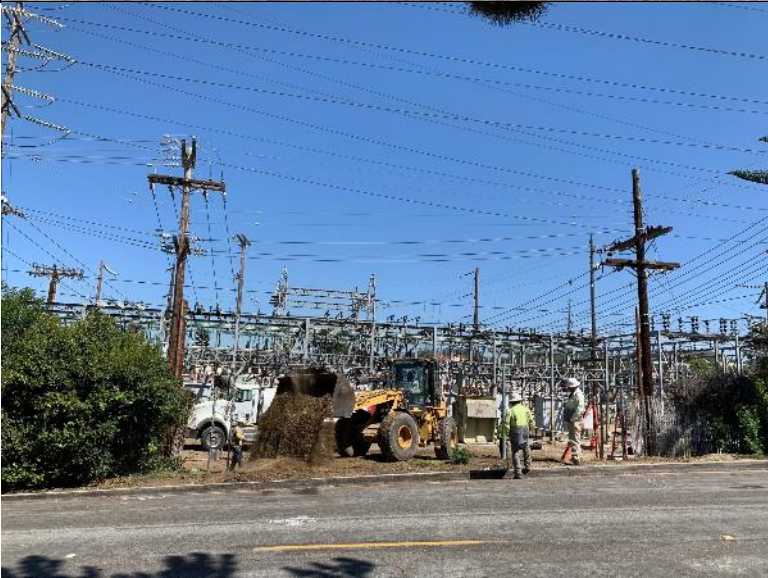
Photo 9 – Installation of new driveway. Crew backfilling soil. Photo facing north.
09/13/19	Serra Park, east of San Juan Capistrano Substation

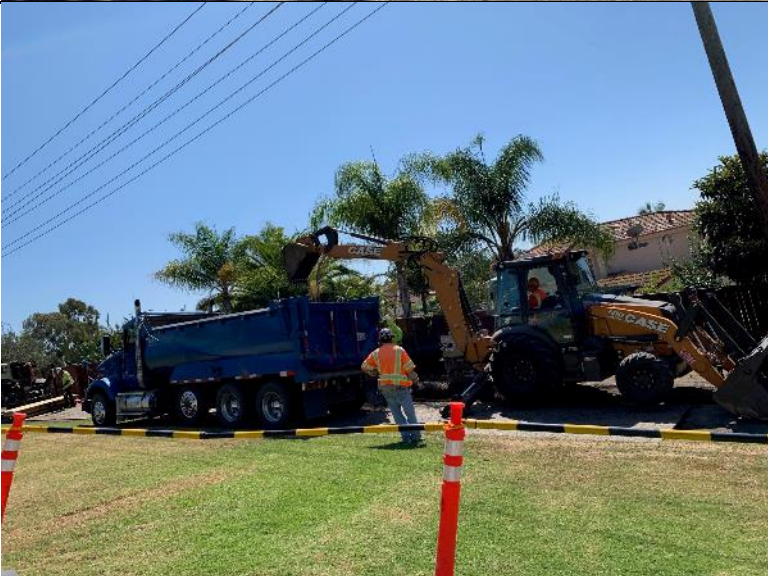
Photo 10 – Excavation activities near the south side of Serra Park. Photo facing southeast.

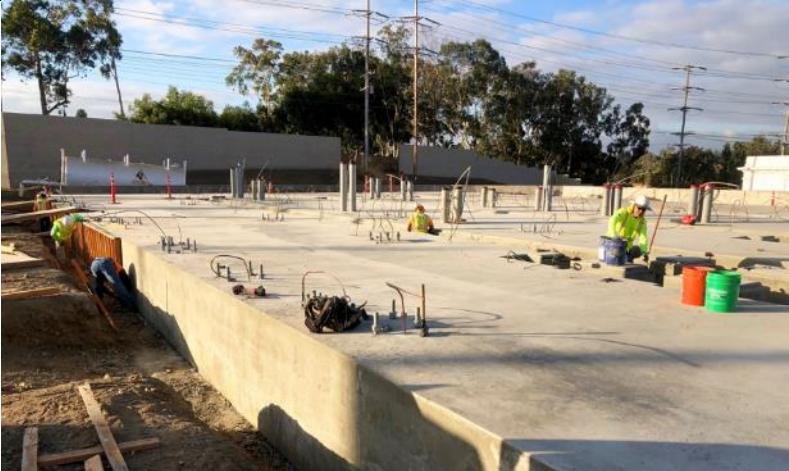
The pad for the 138-kilovolt (kV) gas-insulated substation (GIS) building had been poured, and crews were performing cleanup work on the new concrete and stripping forms (Photo 6). The SDG&E LEI said that 112 concrete trucks entered the site during the large concrete pour earlier in the week and no problems were reported. Some work was occurring on an excavated area at the northwest corner of the pad (Photo 7) and some backfilling had been completed around the pad (Photo 8). Photo 9 shows an overview of the pad.

Photo 6 – Newly poured 138-kV GIS building foundation. Photo facing south.
9/19/19	San Juan Capistrano Substation

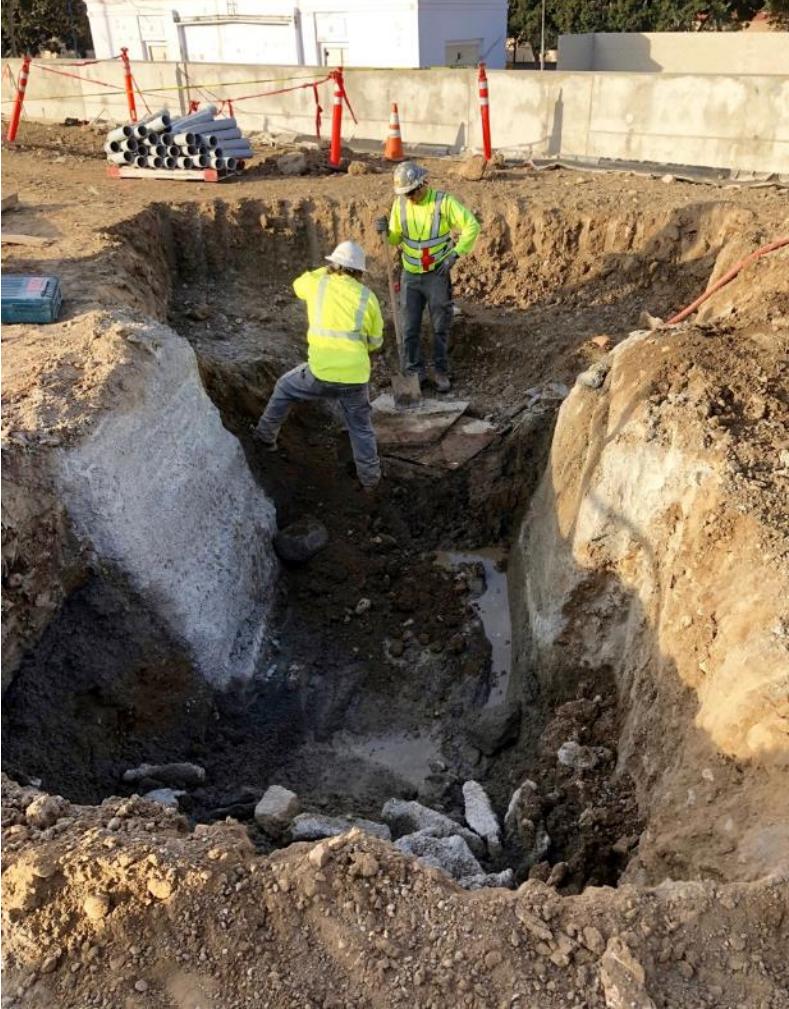
Photo 7 – Work within an excavation site at the northwest corner of the 138-kV GIS building pad. Photo facing west.

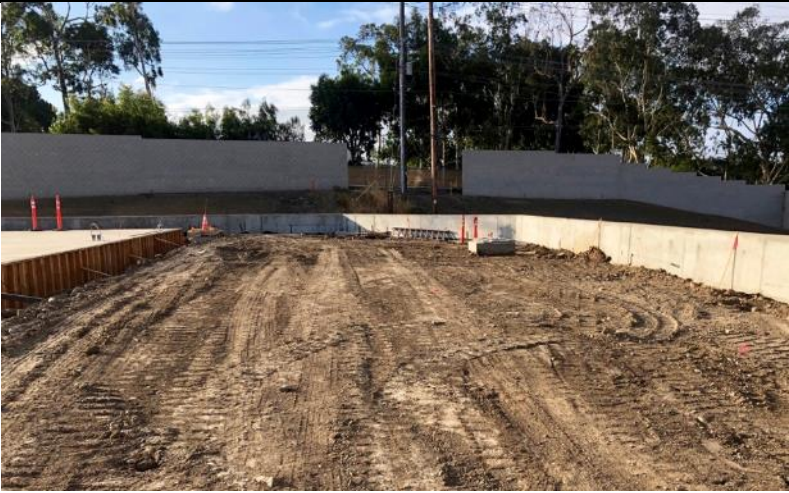
Photo 8 – Backfill work completed around the new 138-kV GIS building pad. Photo facing south.
9/19/19	San Juan Capistrano Substation

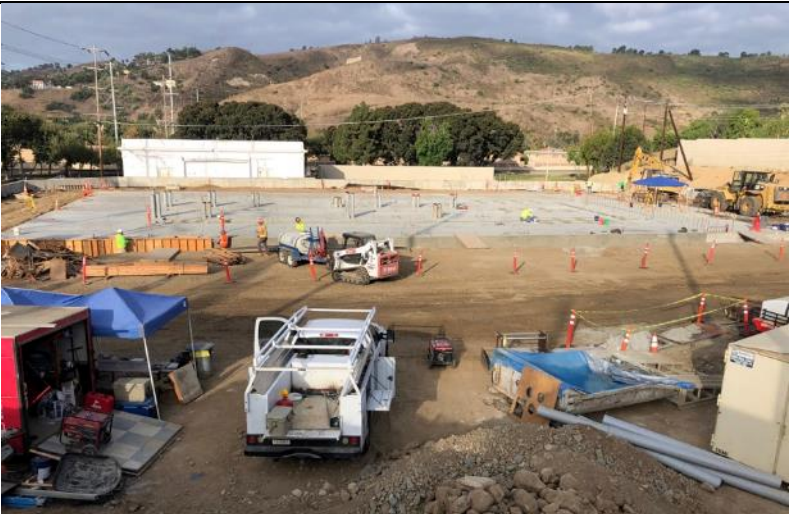
Photo 9 – Overview of the 138-kV GIS building pad. Photo facing west.
9/19/19	San Juan Capistrano Substation

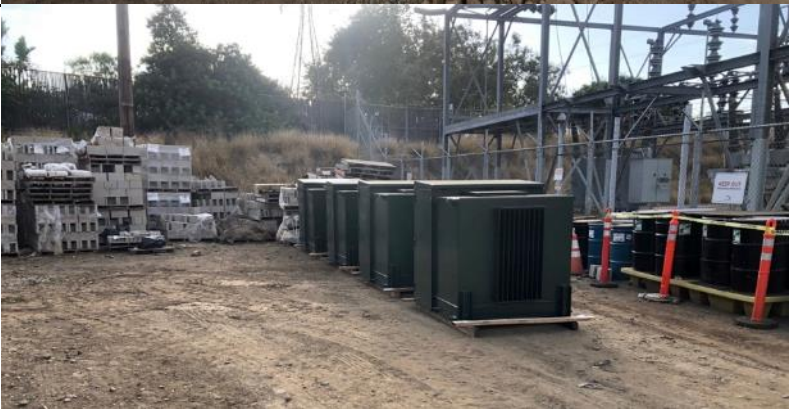
Some of the smaller transformers had been stockpiled onsite in the staging area near the existing 230-kV substation (Photo 10).

Photo 10 – Transformers stockpiled onsite. Photo facing east.

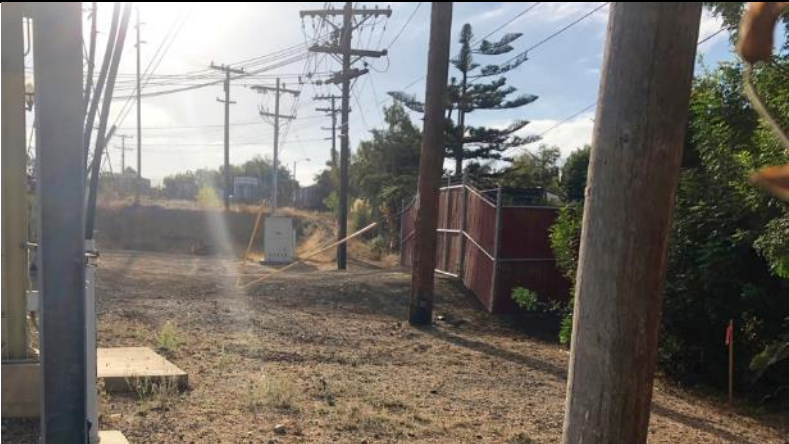
The new entry into the existing 230-kV substation was installed. A small berm was constructed inside the gate (Photo 11). The SDG&E LEI indicated that they need to place a small area of asphalt along the curb outside of the new gate (Photo 12).

Photo 11 – New access gate into the existing substation. Photo facing east.
9/19/19	San Juan Capistrano Substation

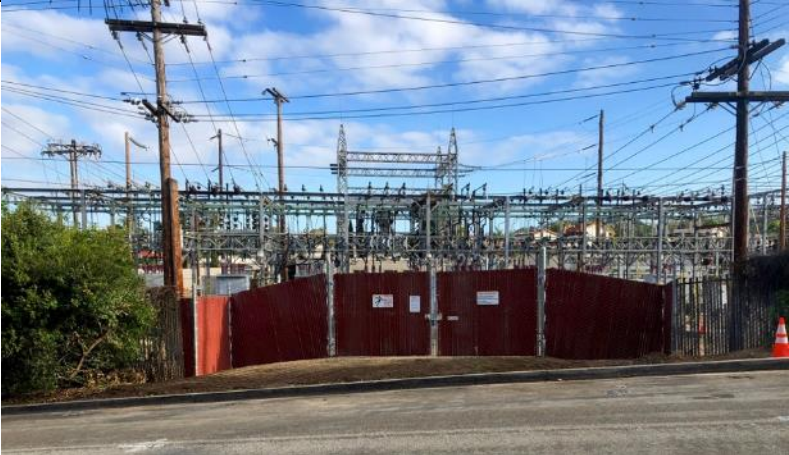
Photo 12 – New access gate into the existing substation. Photo facing north.
9/19/19	Serra Park, east of San Juan Capistrano Substation

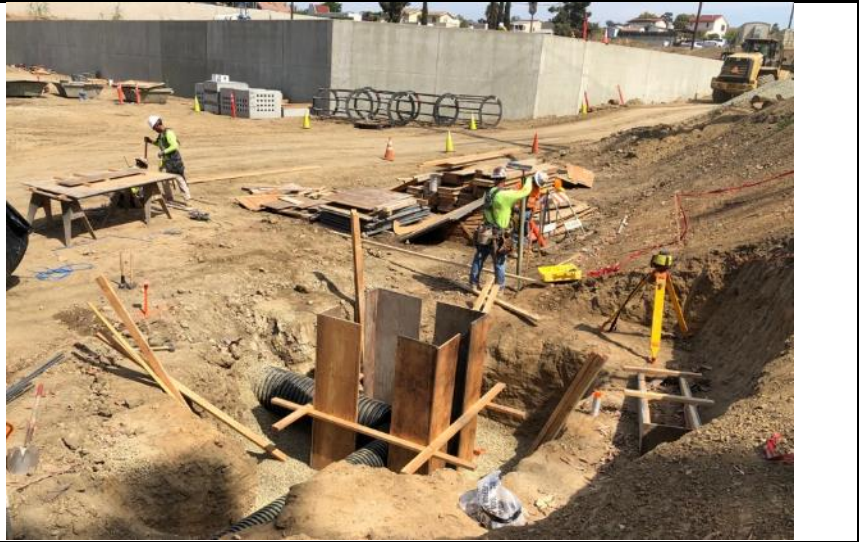
Inside the main gate to the San Juan Capistrano Substation, a crew was working on forms for a storm drain inlet (Photo 1).

Photo 1 – Stormwater drainpipe work continues. Photo facing east.
9/25/19	San Juan Capistrano Substation

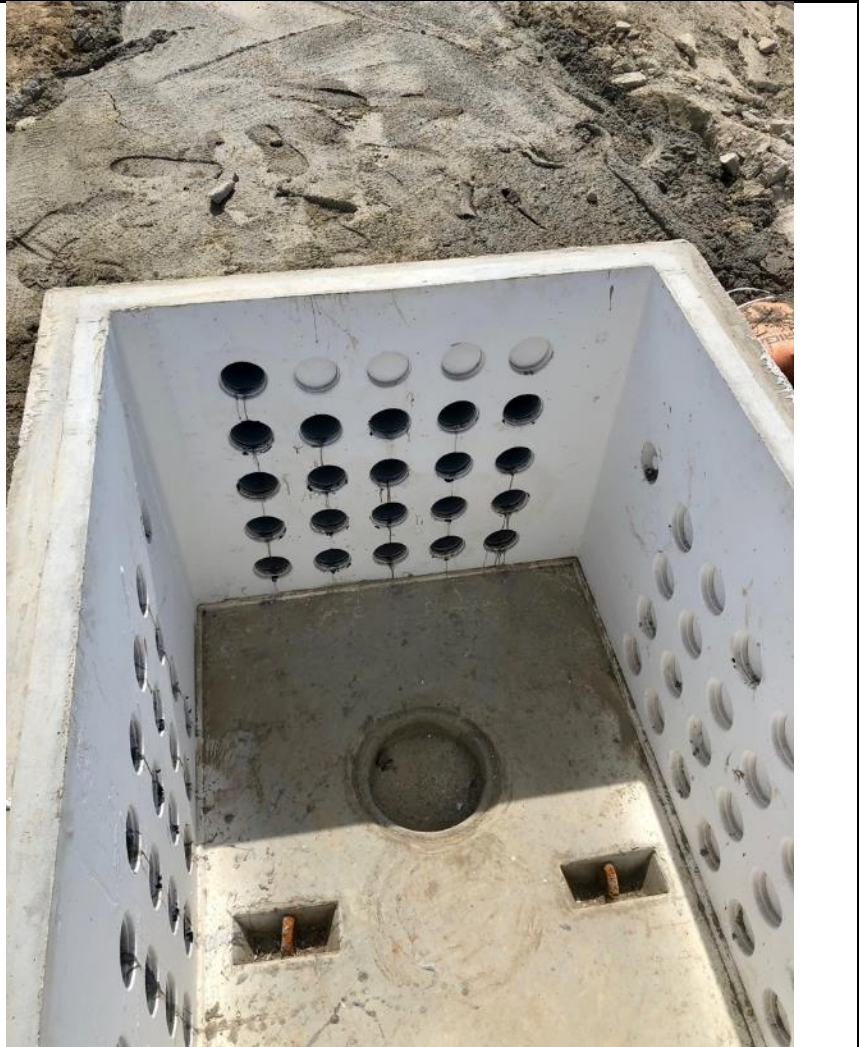
Most of the conduit trenches had been poured within the switch rack area. Some of the conduit vaults remain open (Photos 2 and 3). One of the conduit trenches had been partially covered (Photo 4). I requested that the LEI seal the openings, since a partially covered trench is difficult to check for animals and is more attractive to them. Later in the day, the LEI sent me a photo of the sealed conduit trench (Photo 5).

Photo 2 – Conduit vault within the switch rack area.

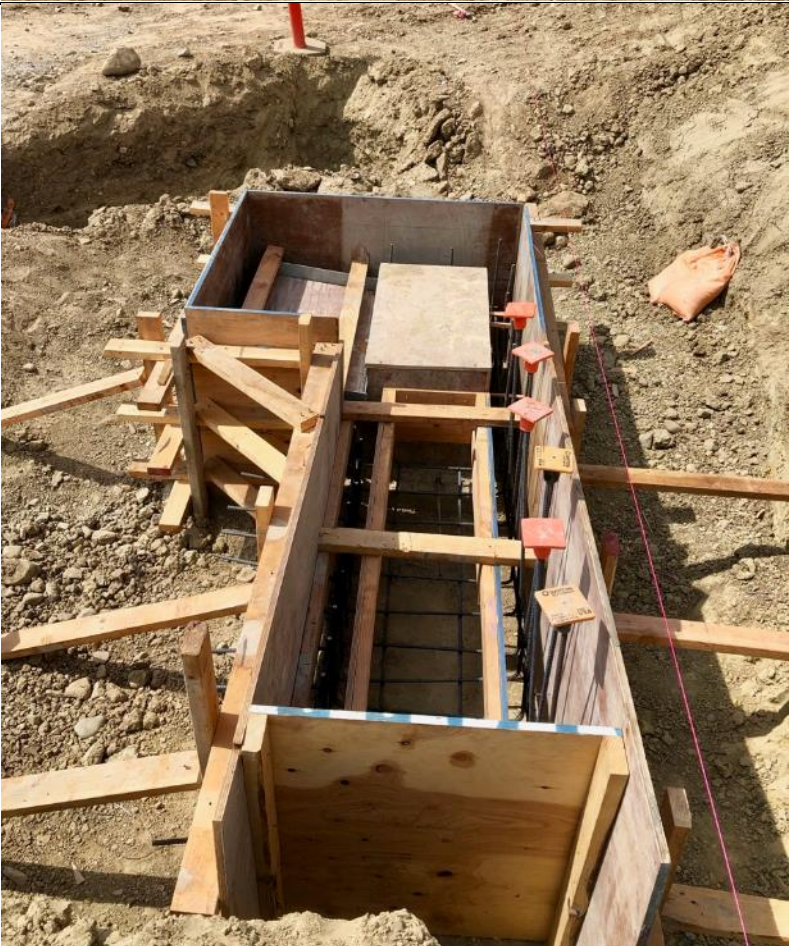
Forms had been placed over the storm drain system for another inlet in the northwest portion of the San Juan Capistrano Substation site (Photo 6).

Photo 6 – Stormwater drainpipe work continues in the northwest portion of the site.

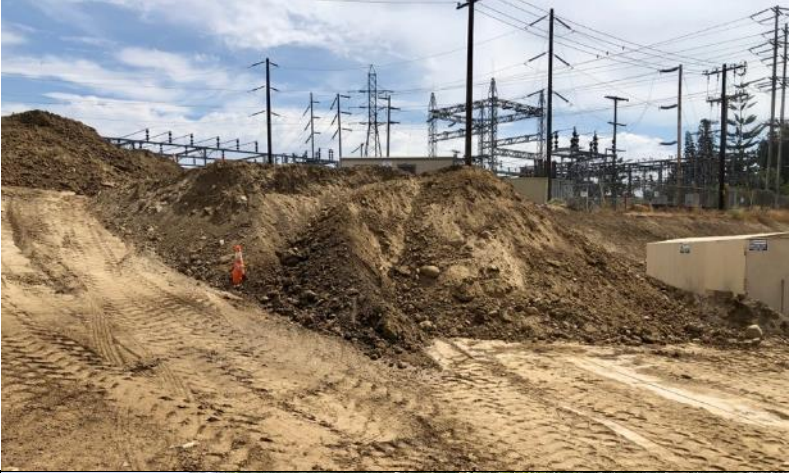
Slurry was being poured in a trench along the northern edge of the 138-kilovolt (kV) gas insulated substation (GIS) building (Photo 8). Final grading was being performed around the new 138-kV GIS building pad (Photo 9). Excess soil was being deposited in the soil stockpile area (Photo 10).

Photo 10 – Soil stockpile area. Photo facing southeast.
9/25/19	San Juan Capistrano Substation

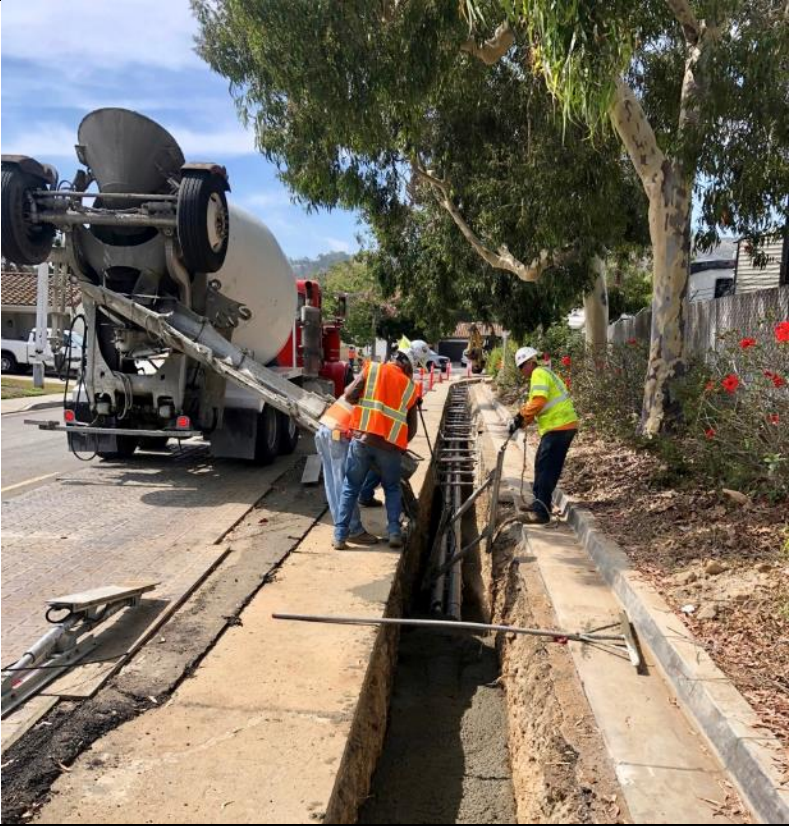
The underground conduit was being constructed along Calle Bonita near the San Juan Capistrano Substation. Crews were focused on pouring the portion of trench containing the conduit (Photo 11). Two additional environmental monitors were onsite. Because no excavation work was occurring, the paleontological and cultural resource monitors and Native American monitor were not onsite. The trench along the southern edge of Serra Park had been filled in with slurry (Photo 12) and was being used for access to the laydown yard. The laydown yard in the eastern portion of Serra Park appeared to be in good condition except for a parked forklift that lacked a drip pan (Photo 13). I placed a drip pan beneath the forklift and sent the LEI a message concerning the drip pan.

Photo 11 – Pouring the conduit trench along Calle Bonita. Photo facing west.
