Re: Monthly Report Summary #29 for the South Orange County Reliability Enhancement (SOCRE) Project

South Orange County Reliability Enhancement Project CPUC Site Inspection Form

| Project: | South Orange County Reliability Enhancement (SOCRE) Project | Date: | March 4, 2020 |
| Project Proponent: | San Diego Gas & Electric (SDG&E) | Report #: | VS071 |

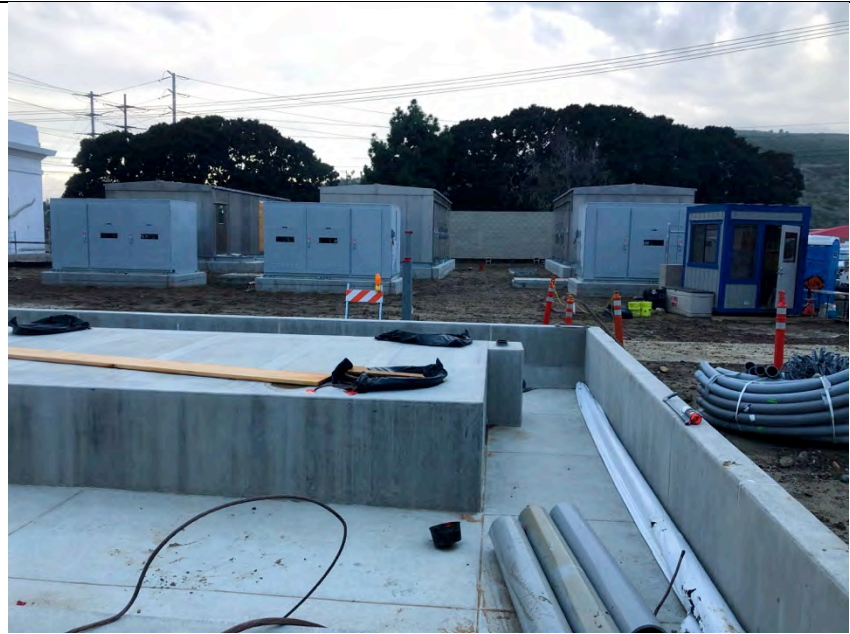
Crews continued to work surrounding the transformer locations (Photo 3), and electrical connection work was being performed in the switch rack area (Photo 4).

| Date | Location | Photo | Description |
|---|---|--|--|
| 03/12/20 | San Juan Capistrano Substation | A photograph showing several large, light-colored metal switch racks in an outdoor substation. In the foreground, there are concrete structures, possibly for cable management, with some pipes and cables lying on them. The background shows more racks and a blue utility building under a cloudy sky. | Photo 4 – Electrical connection work performed within the switch racks. Photo facing west. |

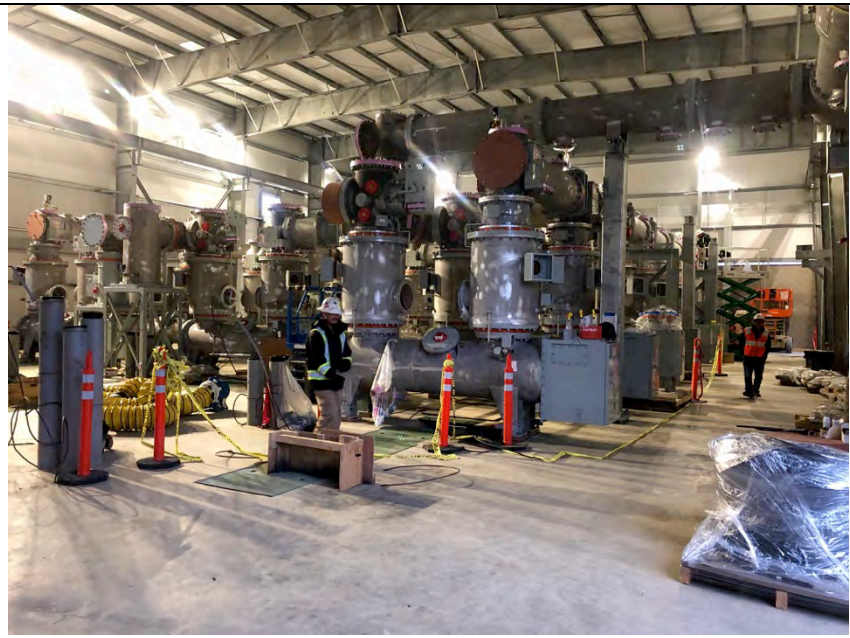
Equipment installation continues within the 138-kV GIS building (Photo 9).

| Date | Location | Photo | Description |
|---|---|---|--|
| 03/12/20 | San Juan Capistrano Substation | | Photo 9 – Inside the 138-kV GIS building. |

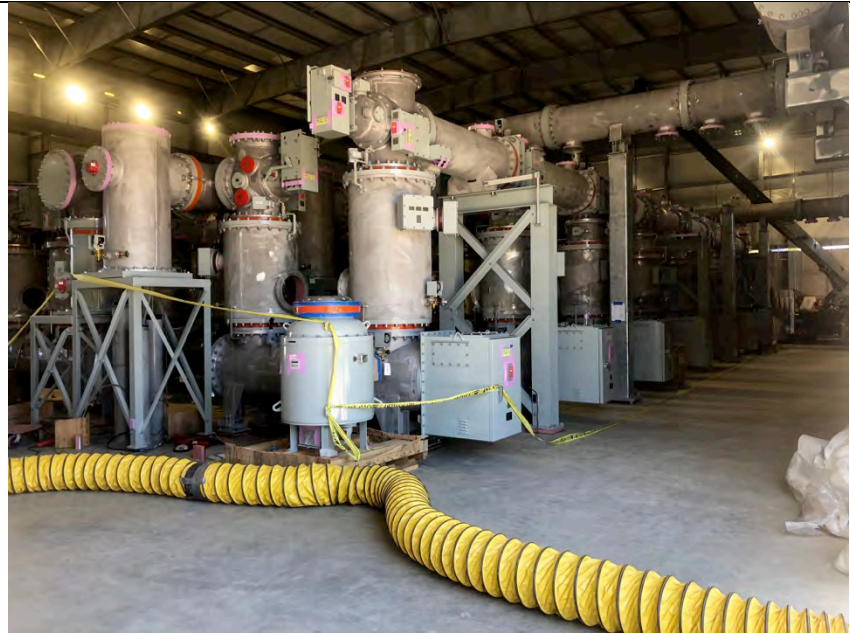
Equipment installation continues within the 138-kV GIS building (Photo 7). A generator powering equipment within the building was well-contained (Photo 8).

| Date | Location | Photo | Description |
|---|---|---|--|
| 03/26/20 | San Juan Capistrano Substation | A photograph showing the interior of a 138-kV GIS building. The room is filled with large, complex electrical equipment, including gas-insulated switchgear (GIS) units. A prominent feature is a long, thick, yellow braided cable that runs across the floor. The equipment is supported by metal structures, and the overall environment is industrial and well-lit. | Photo 7 – Inside the 138-kV GIS building. Photo facing north. |

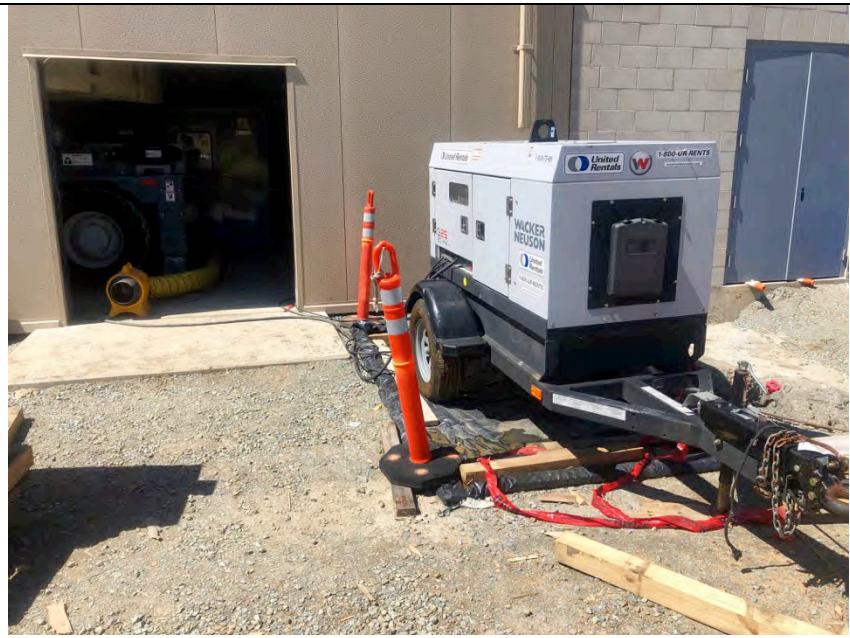
| Date | Location | Photo | Description |
|---|---|---|--|
| 03/26/20 | San Juan Capistrano Substation | A photograph of a well-contained generator on a trailer parked outside the 138-kV GIS building. The generator is white and black, with "WALKER NEUSON" and "United Rentals" logos visible. It is situated on a gravel area next to a concrete foundation. An orange traffic cone is placed near the generator. The building's exterior is light-colored with a blue door visible in the background. | Photo 8 – Well-contained generator outside the 138-kV GIS building. Photo facing west. |

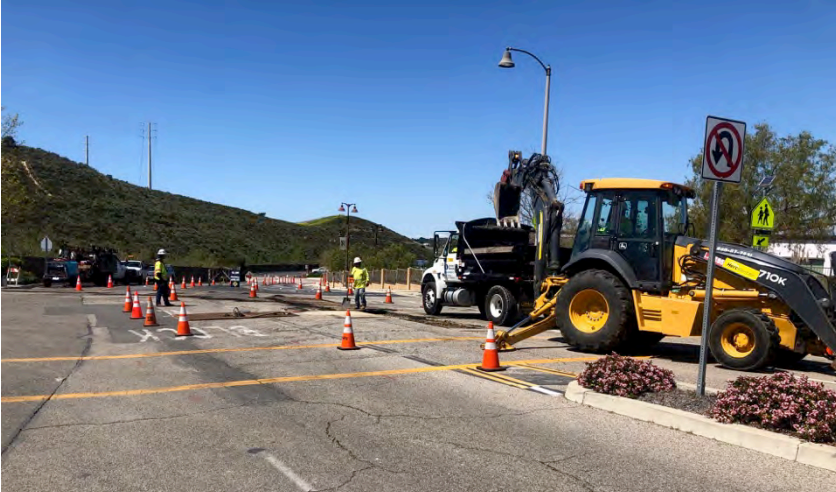
| REPRESENTATIVE SITE PHOTOGRAPHS | | | |
|---|--|---|---|
| 03/26/20 | Stallion Ridge Road | | Photo 9 – Potholing work performed within the Stallion Ridge Road. Photo facing west. |
