Re: Monthly Report Summary #31 for the South Orange County Reliability Enhancement (SOCRE) Project

This report provides a summary of the compliance monitoring activities that occurred during the period from **May 1 to 31, 2020**, for the South Orange County Reliability Enhancement (SOCRE) Project in Orange County, California. Compliance monitoring was performed four times between May 1 and 31, 2020, to ensure all project-related activities conducted by San Diego Gas and Electric (SDG&E) and its contractors were in compliance with the Final Environmental Impact Report (Final EIR) for the SOCRE Project, as adopted by the California Public Utilities Commission (CPUC) on December 15, 2016.

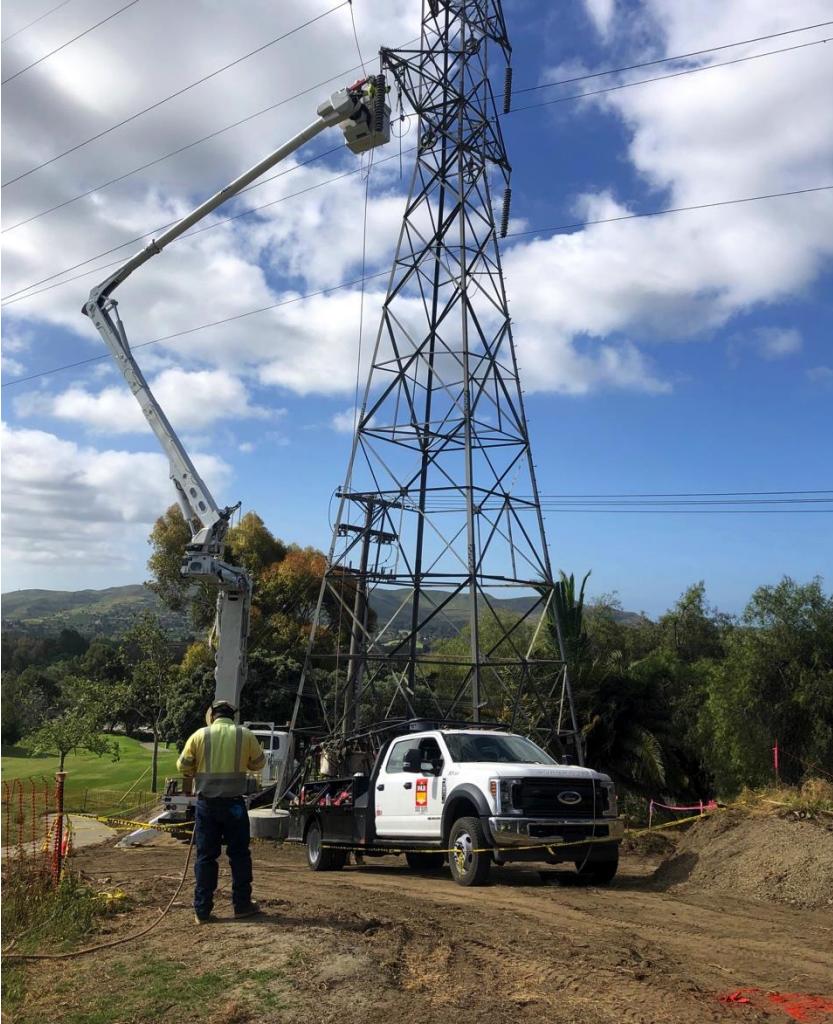
A tall, lattice-structured metal transmission tower stands on a dirt clearing. A white bucket truck is positioned to the left, with its boom extended towards the tower. A worker in a high-visibility vest is visible near the truck. The background shows a residential area with houses and trees under a blue sky with scattered clouds.	Photo 2 – A line crew working at tower location 5. Photo facing south.
05/15/20	SOCRE transmission corridor

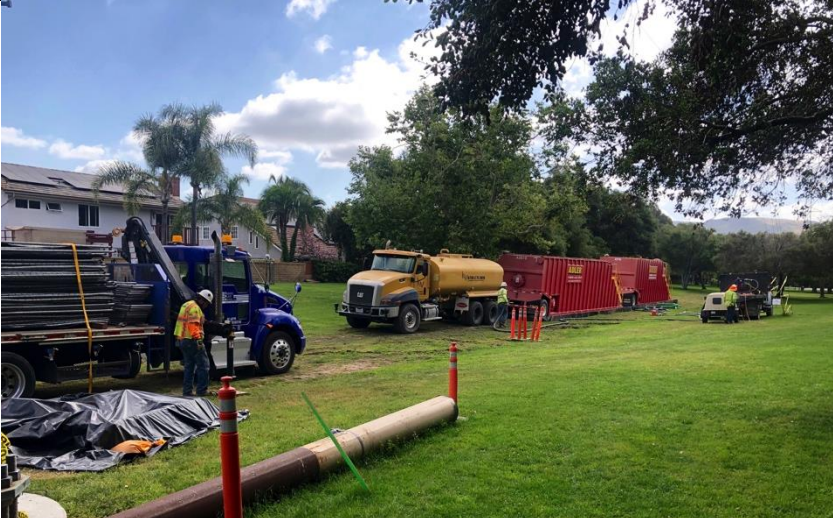
A grassy field is filled with construction equipment and materials. In the foreground, a large pipe lies on the grass. A blue truck is parked on the left, and a yellow truck is in the middle. A red container is visible in the background. The scene is surrounded by trees and a residential building.	Photo 3 – Equipment with materials being delivered and installed at tower location 8. Photo facing south.

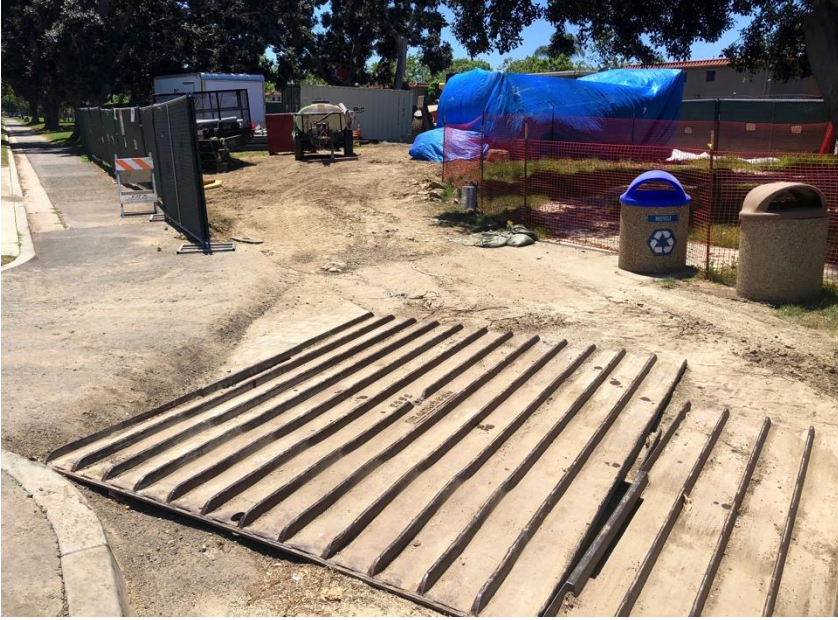
At the San Juan Capistrano Substation, the excavation of the bore pit began with laying down rumble plates at the work entrance (Photo 13). The excavated soil was transported offsite. The bore pit was almost at the necessary depth; the crew was waiting for additional shoring before completing the drilling (Photo 14).

A photograph showing a dirt area with several long, parallel metal rumble plates laid out on the ground. In the background, there is a blue tarp, a blue recycling bin, and a concrete trash can. A fence and some buildings are visible in the distance.	Photo 13 – Rumble plates installed at the entrance to the jack and bore site at Long Park. Photo facing south.
05/15/20	Long Park, west of the San Juan Capistrano Substation

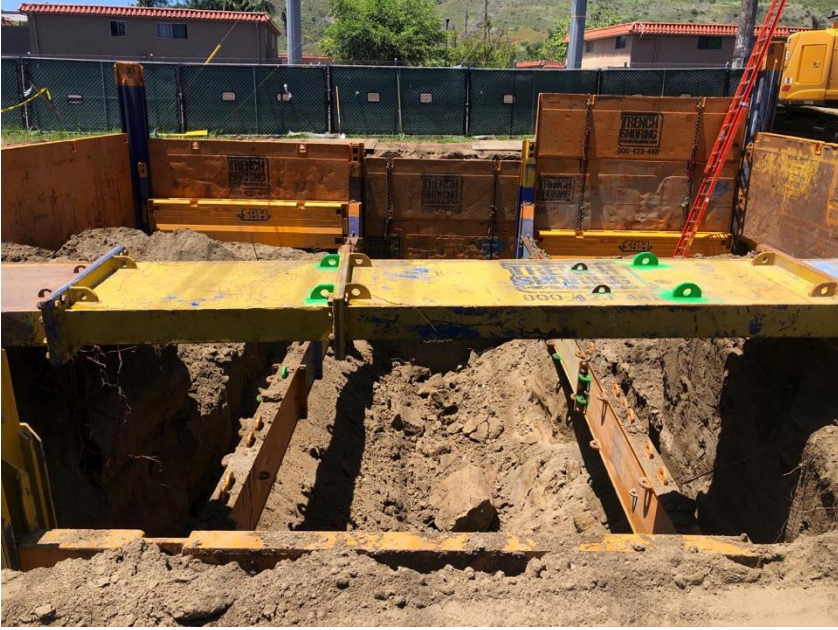
A photograph of a deep, rectangular bore pit. The pit is lined with yellow metal shoring. A yellow metal beam is positioned across the top of the pit. The ground around the pit is dirt and sand.	Photo 14 – The bore pit at the jack and bore site. Photo facing west.

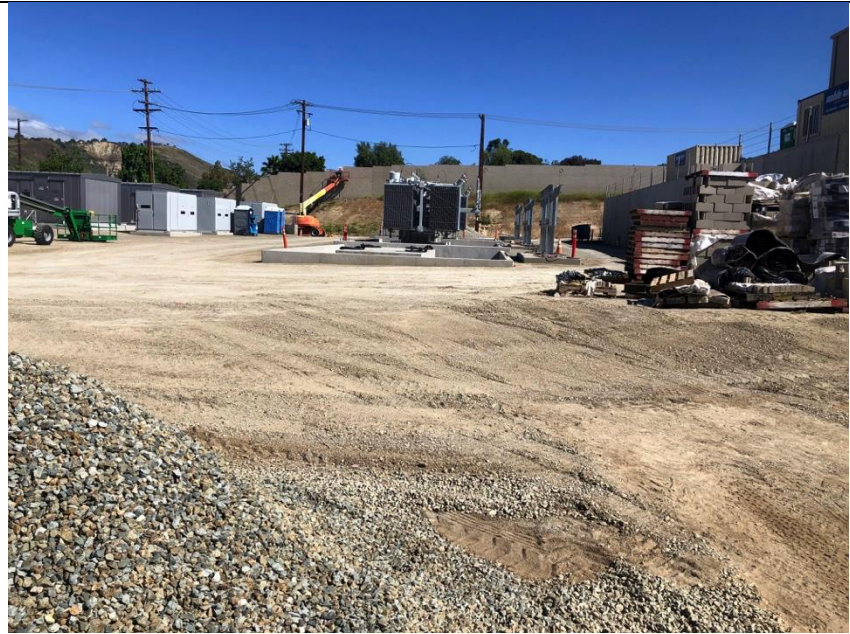
A wide-angle photograph of an outdoor construction site at a substation. The foreground is dominated by a large area of grey gravel. In the middle ground, there's a dirt and gravel area with some construction equipment, including a yellow excavator and a green tractor. In the background, several large, dark-colored transformers are visible, along with utility poles and power lines under a clear blue sky. The site appears to be in the process of road base installation.	Photo 2 – Road base installation around the transformers. Photo facing north.
05/20/20	San Juan Capistrano Substation

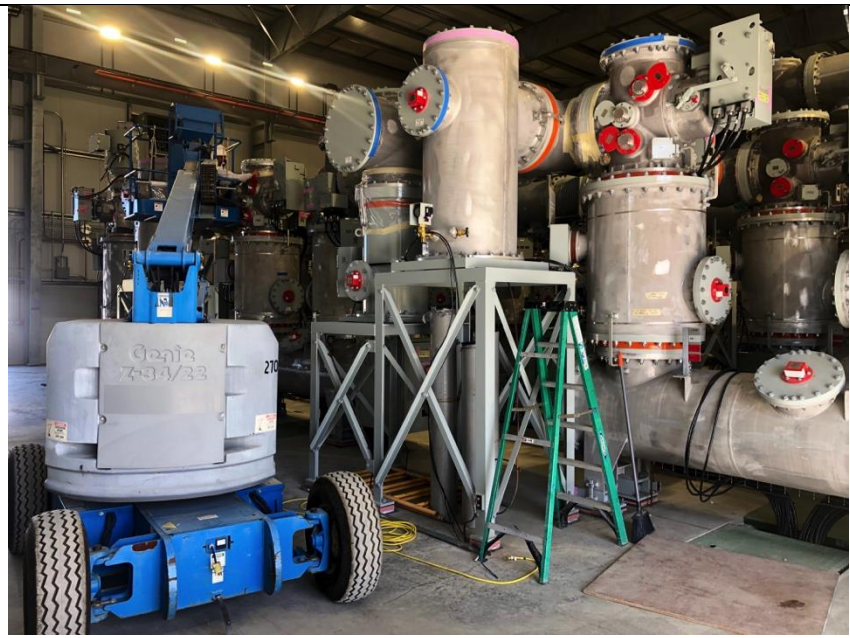
An interior photograph of a large industrial building, identified as the 138-kV GIS building. The room is filled with massive, cylindrical gas-insulated switchgear (GIS) units. These units are light-colored with various ports, valves, and electrical connections. A blue scissor lift is positioned in the foreground on the left, and a green step ladder is leaning against one of the GIS units. The floor is concrete, and the ceiling has industrial lighting fixtures.	Photo 3 – Inside the southeast corner of the 138-kV GIS building.
