Re: Monthly Report Summary #37 for the South Orange County Reliability Enhancement (SOCRE) Project

South Orange County Reliability Enhancement Project CPUC Site Inspection Form

Project:	South Orange County Reliability Enhancement (SOCRE) Project	Date:	November 5, 2020
Project Proponent:	San Diego Gas & Electric (SDG&E)	Report #:	VS102
Lead Agency:	California Public Utilities Commission (CPUC)	Monitor(s):	CPUC/WSP (formerly Ecology and Environment, Inc.) Compliance Monitor
CPUC PM:	Andrew Barnsdale, Energy Division	AM/PM Weather:	Partly cloudy, mild, and calm
CPUC CM (WSP):	Joe Donaldson	Start/End time:	0630 to 1130
Project NTP(s):	Notice to Proceed (NTP)-3 and NTP-6

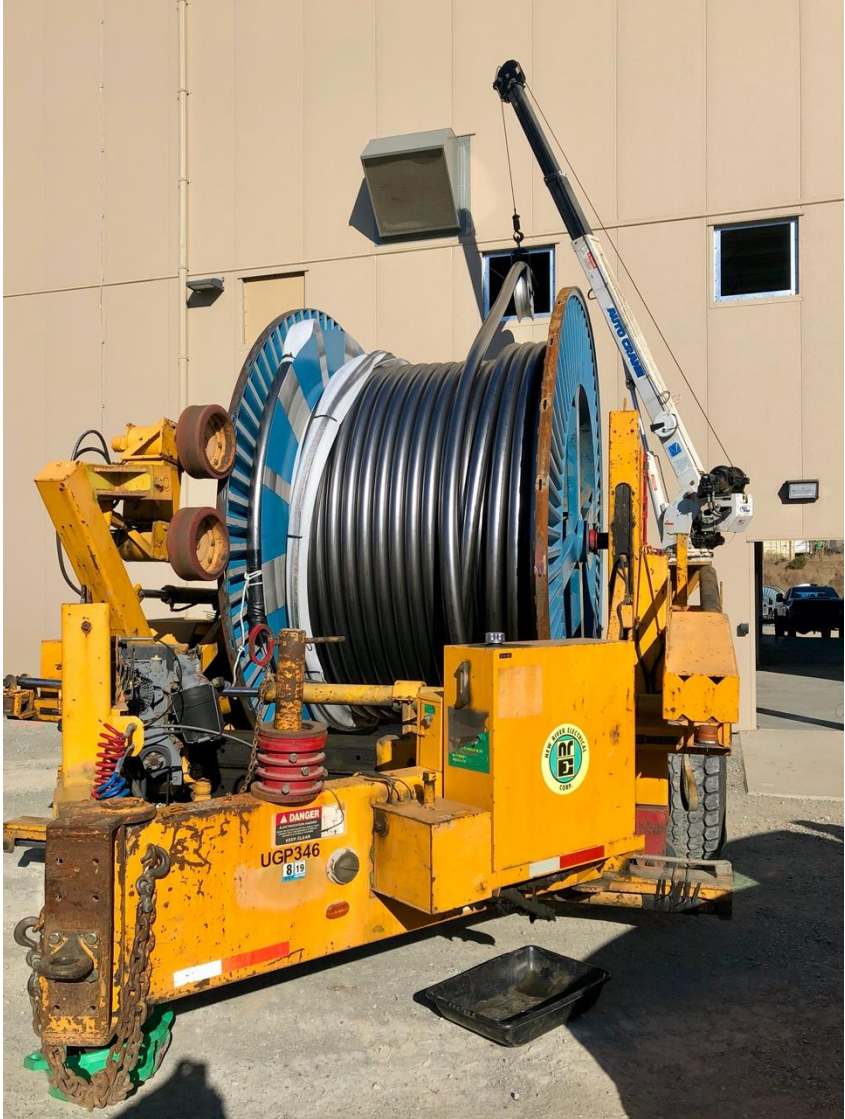
A yellow cable pulling machine, model UGP346, is the central focus. It features a large blue and white striped spool of cable. A crane arm is mounted on top, and a black tray sits on the ground in front. The machine is positioned on a paved area in front of a tan building with windows. A 'DANGER' sign and a 'MCE' logo are visible on the machine's body.	Photo 4 – Cable pulling into the 138-kV GIS building was underway. Photo facing northeast.
