January 28, 2021

Re: Monthly Report Summary #38 for the South Orange County Reliability Enhancement (SOCRE) Project

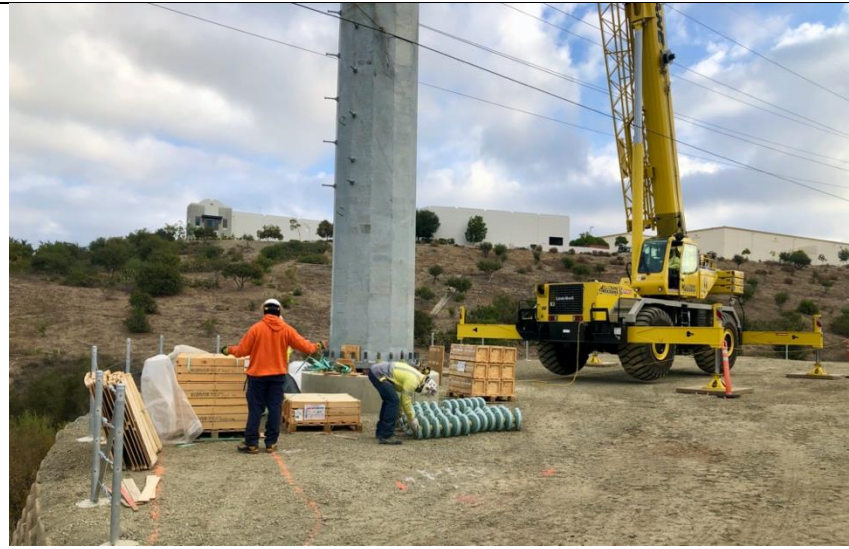
At tower location 39, a crane was onsite to install the last segment of the TSP (Photo 5). Crews were preparing equipment to be attached to the segment before it was installed (Photo 6). Some of the tower pad drainage ditches had not yet been installed (Photo 7). As we left the area, we observed the last segment of the TSP being offloaded from a truck (Photo 8).

<p>A yellow crane is positioned next to a large concrete segment of a transmission tower. The segment is staged on a dirt area. A worker in an orange shirt is standing near the base of the segment. There are stacks of materials and equipment in the background.</p>	Photo 6 – Equipment to be installed onto the top segment of the TSP staged at tower location 39. Photo facing north.

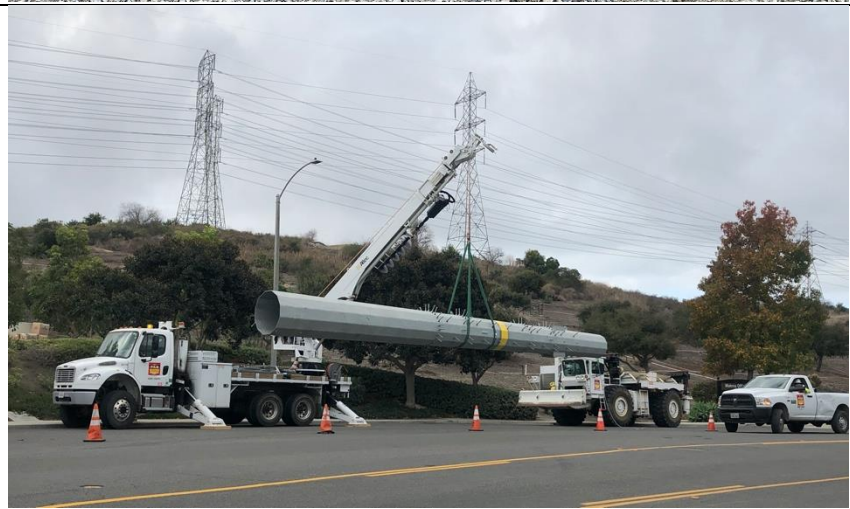
A white truck with a crane lifting a large pipe segment. The pipe is long and cylindrical, resting on the truck's bed. The crane is extended, holding the pipe. In the background, there are power lines and towers. The scene is outdoors on a paved area with orange traffic cones.	Photo 8 – Crews offloading the final segment of the TSP for tower location 39. Photo facing west.

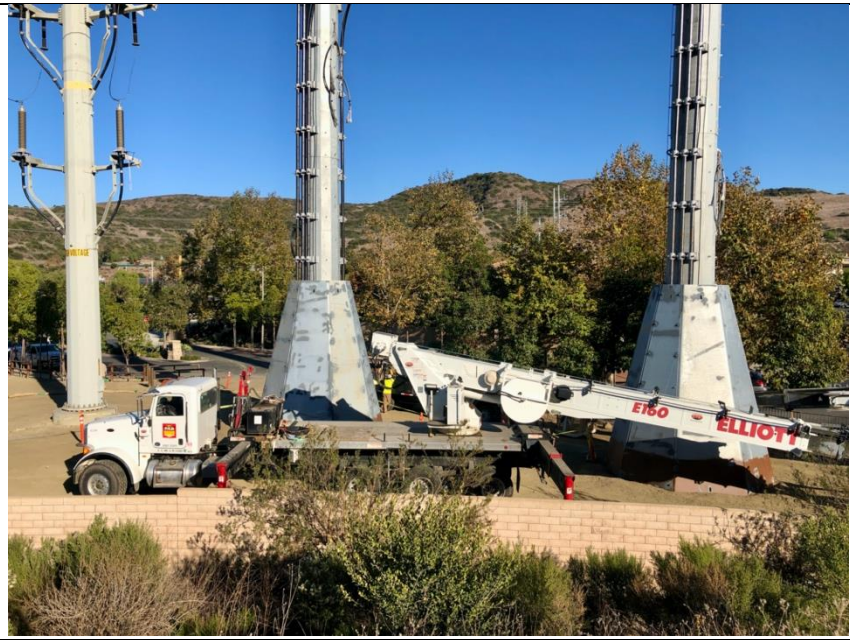
We drove to Stallion Ridge, noting a crew working on towers 16 and 17 (Photo 7).

A photograph showing two tall, grey metal transmission towers under construction. A white truck with a crane arm is positioned between the towers. The crane arm has "E160" and "ELLIOTT" written on it. The scene is outdoors with trees and hills in the background under a clear blue sky.	Photo 7 – Tower work at tower locations 16 and 17. Photo facing east.
12/21/20	SOCRE transmission corridor
