## MEMORANDUM

Re: SX-PQ Pre-Construction Road Condition Assessment for Staging Yards

On November 10, 17 and 22 2016, Icon Building Supplies conducted a pre-construction road condition assessment of all entrances and exits to the staging yards anticipated to be used during construction of the Sycamore to Penasquitos 230 kV Transmission Line Project to satisfy the pre-construction requirements of mitigation measure TRA-3.

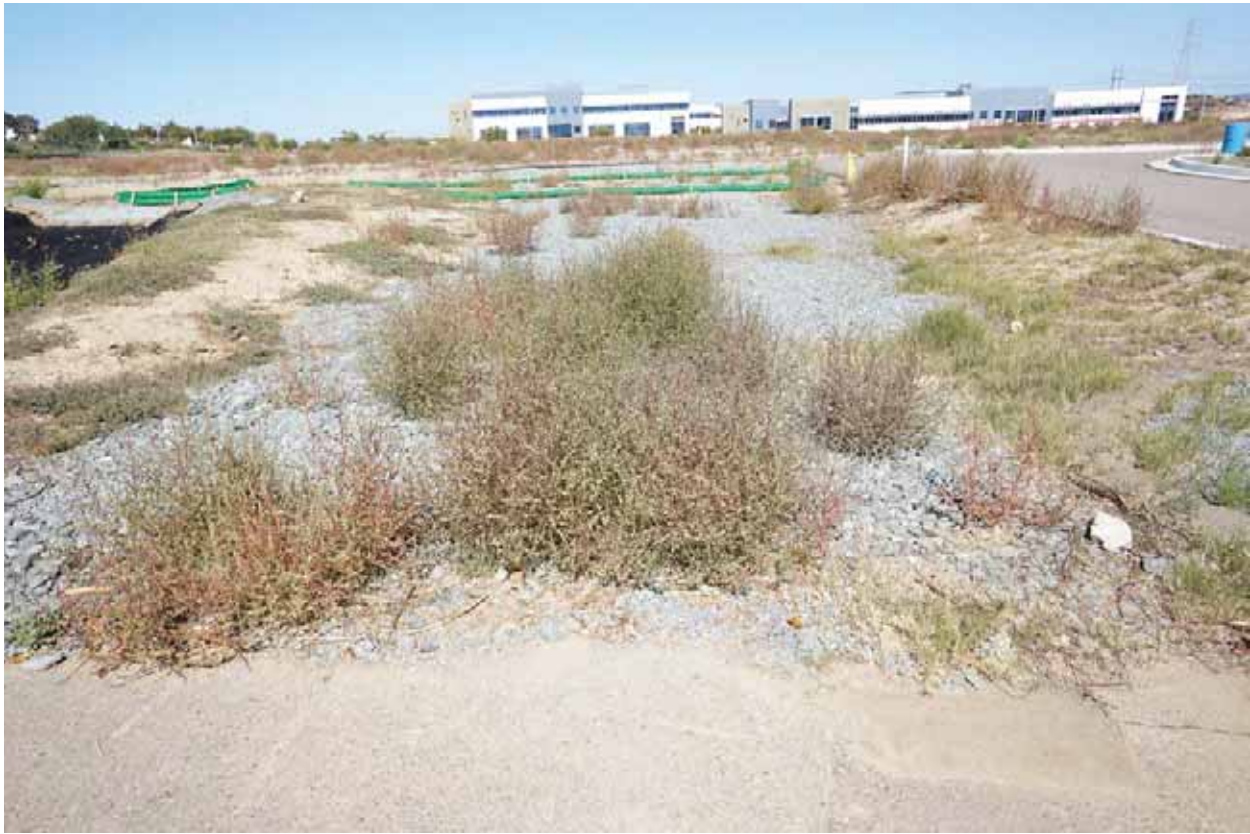
Photo taken 11/17/2016

Photo of interior conditions of Shire Yard.

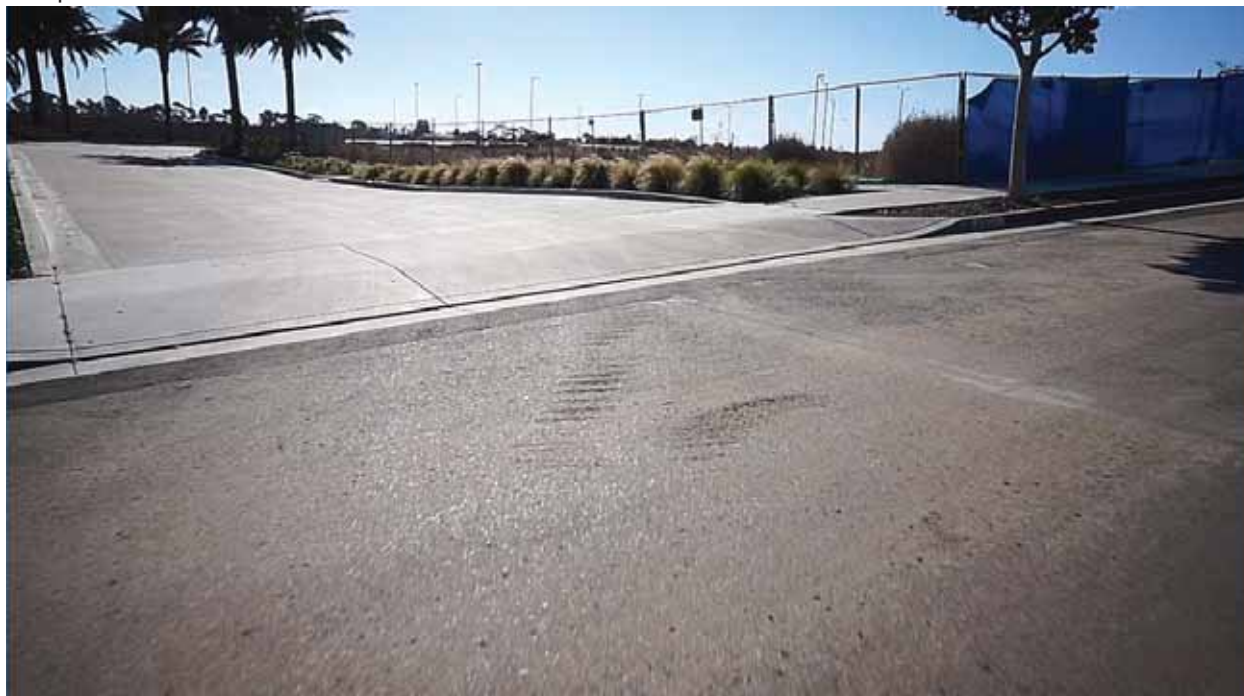
Alternative Shire Yard Photo taken 11/22/2016

A construction entrance would need to be developed for this yard or the yards could be accessed via the existing cul-du-sac that serves an adjacent facility.

The photo below shows the entrance to the cul-du-sac.

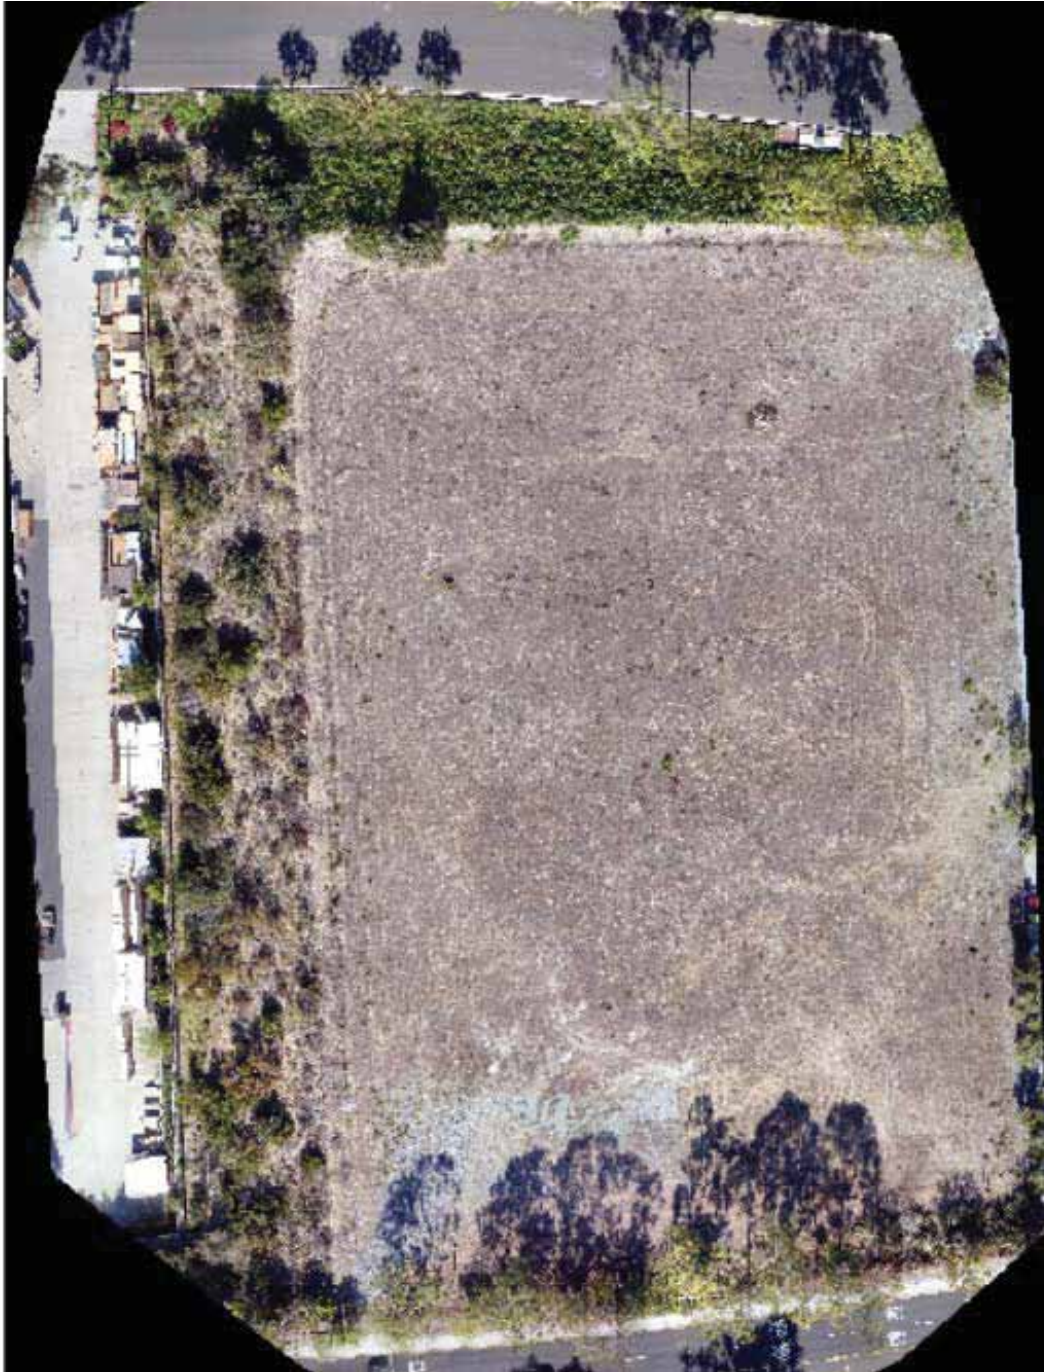
Stowe Staging Yard Aerial Photo taken 11/17/2016

The extent of the Stowe Staging Yard is captured in this aerial photo.

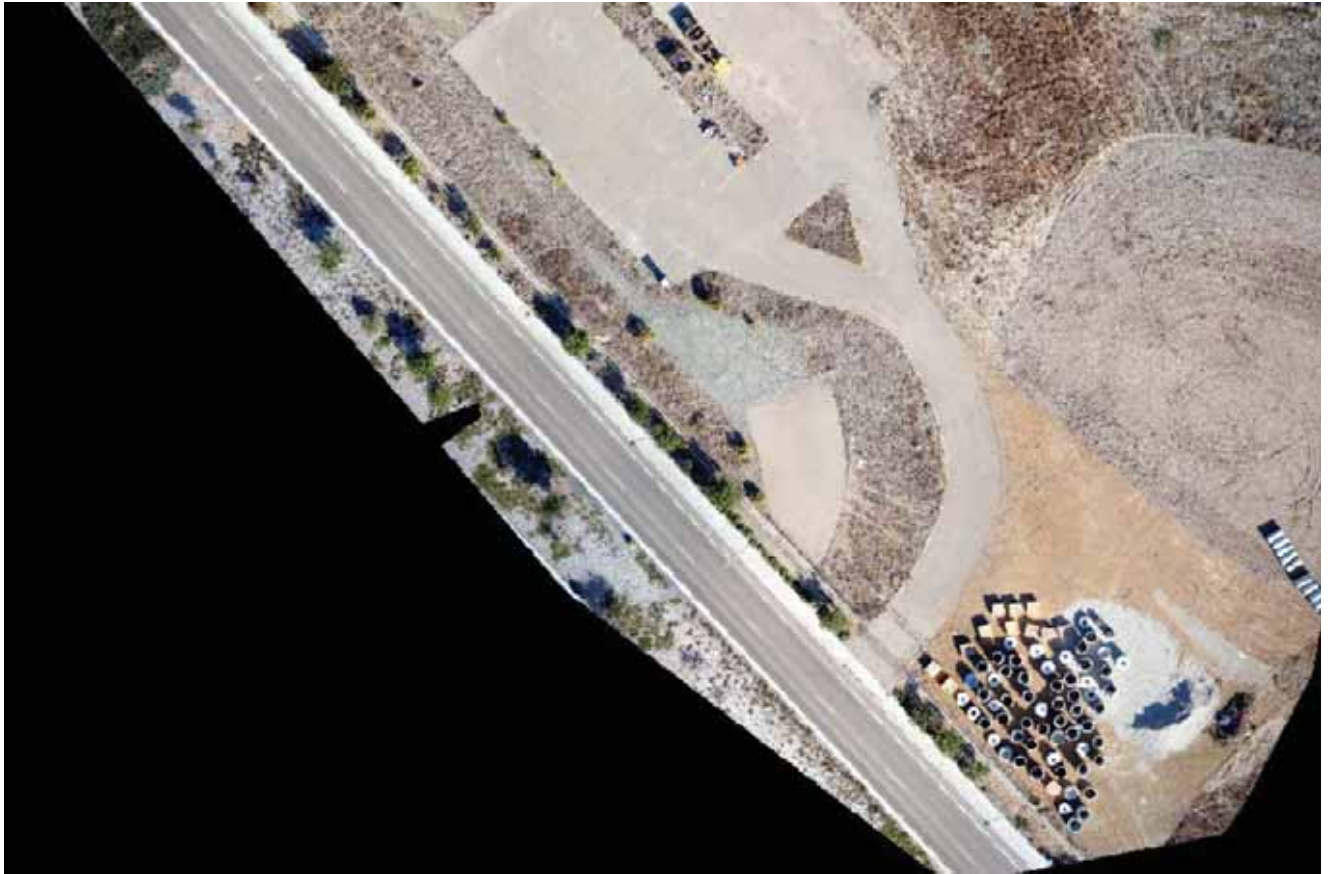
Carmel Valley Staging Yard Aerial Photo taken 11/22/2016

The entrance is located off of Camino Del Sur and most of the yard has been captured in this aerial photo:

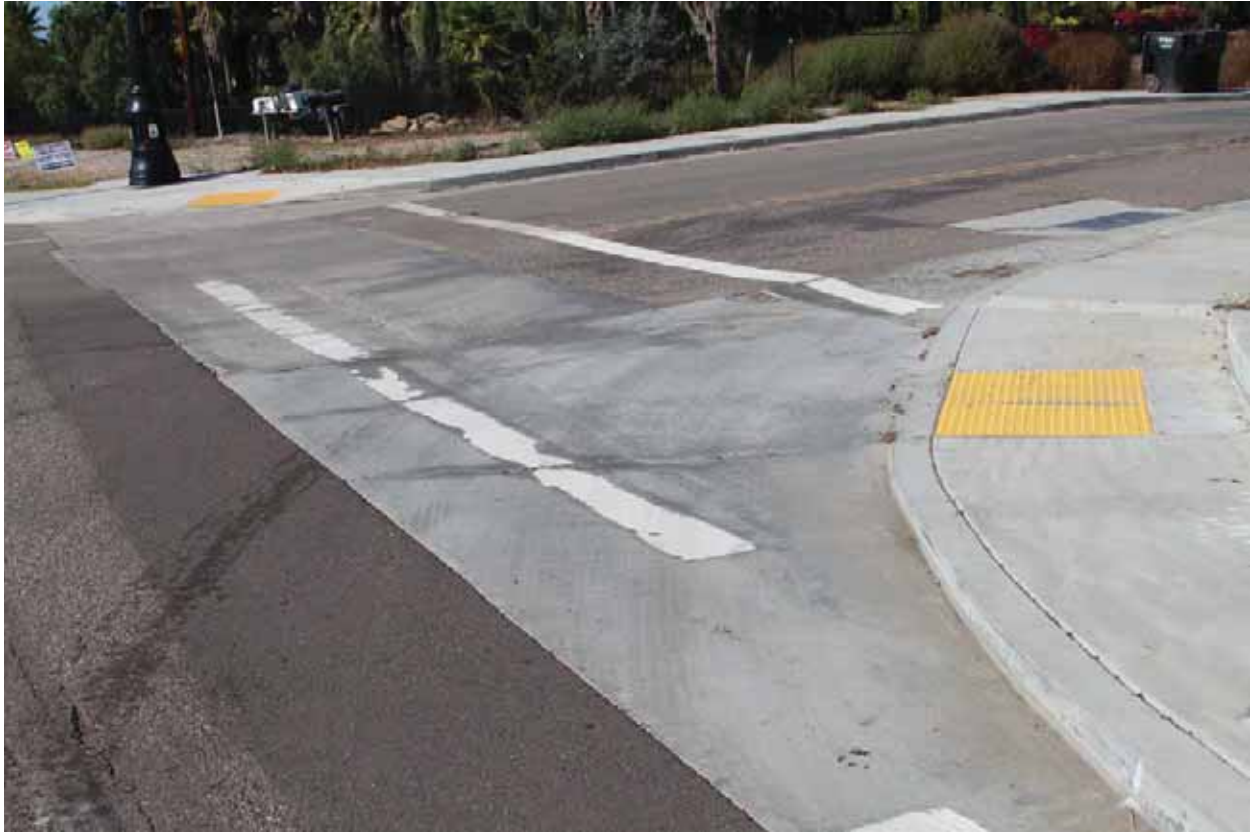
Evergreen Nursery Staging Yard Photo taken 11/22/2016

This photo shows the right turn onto Via Abertuna from Carmel Valley Road.

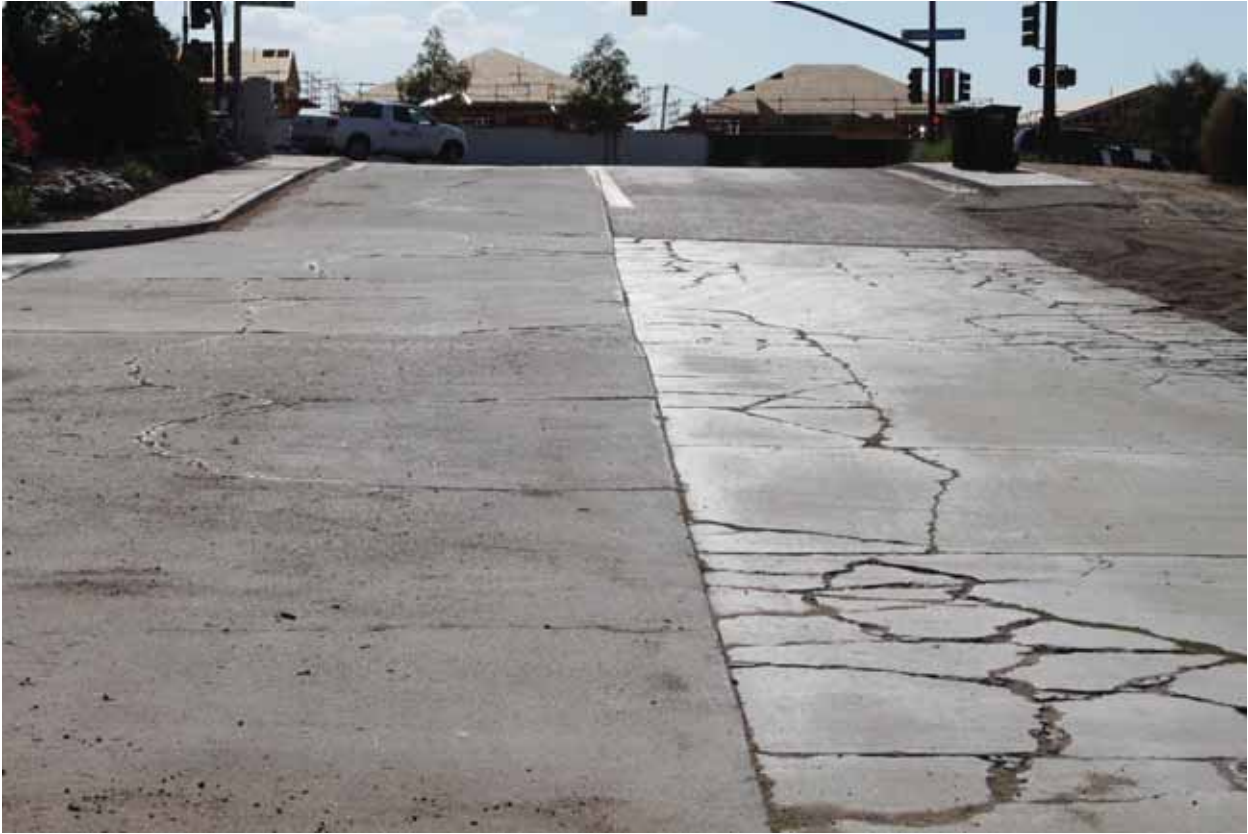
Evergreen Nursery Staging Yard Photo taken 11/22/2016

Via Abertuna is shown looking south towards Carmel Valley Road.

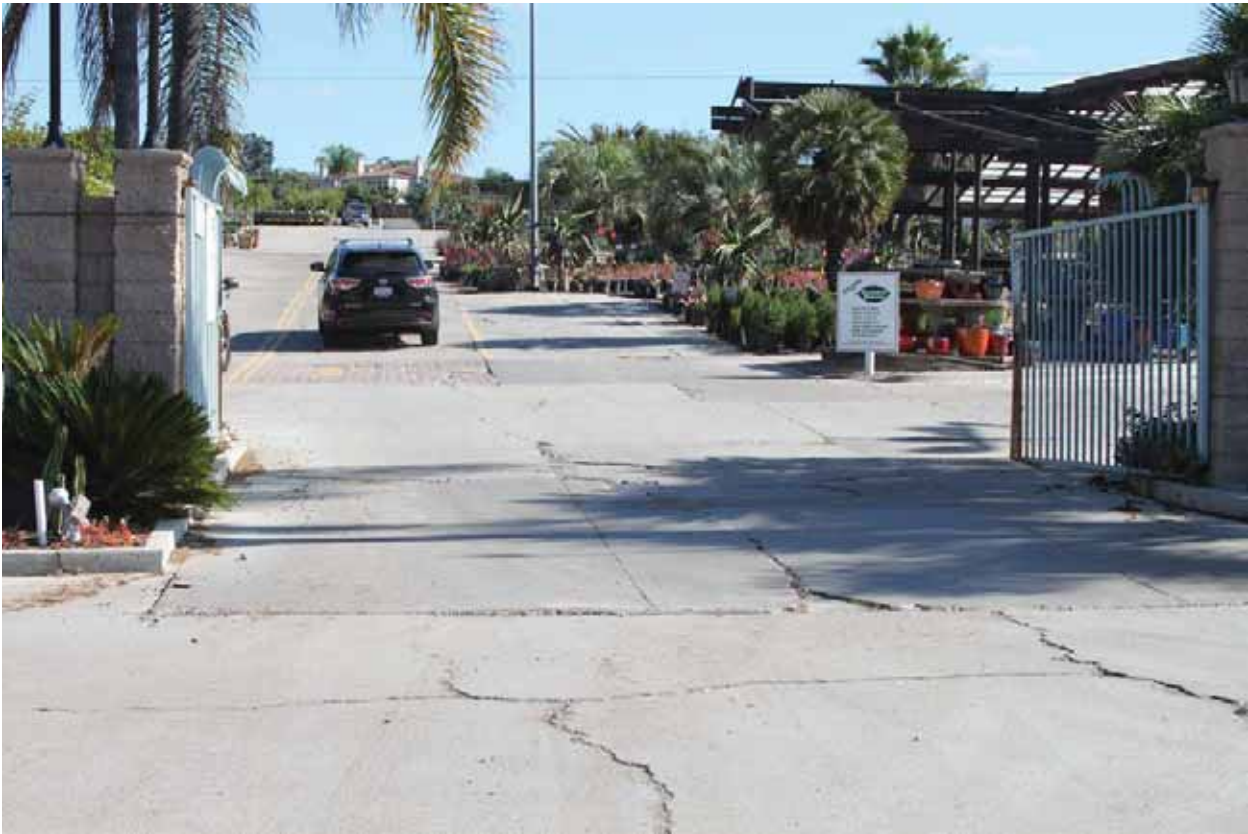
Evergreen Nursery Staging Yard Photo taken 11/22/2016

The entrance to the yard east off of Via Abertuna is shown here.

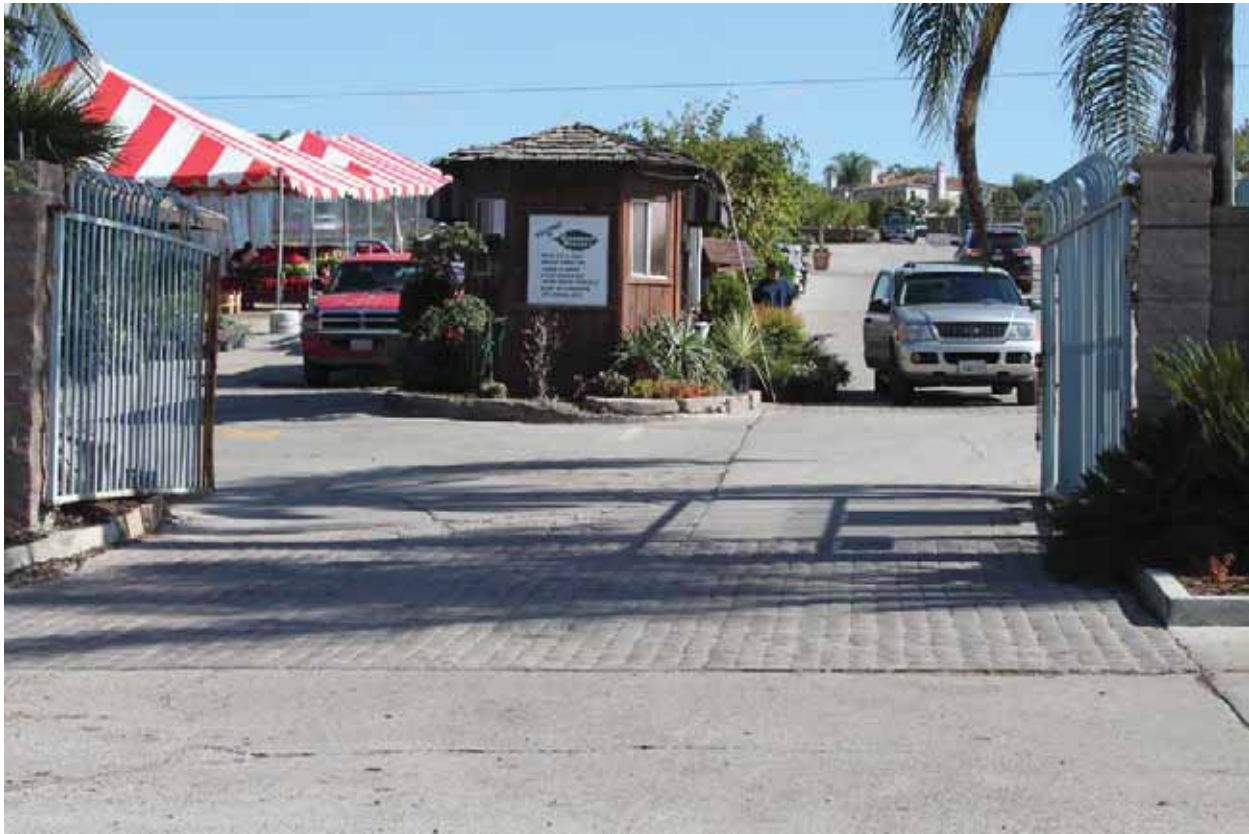
Evergreen Nursery Staging Yard Photo taken 11/22/2016

The exit from the Nursery east off of Via Abertuna is shown here.
