CALIFORNIA PUBLIC UTILITIES COMMISSION Safety and Enforcement Division Electric Safety and Reliability Branch

Incident Investigation Report

Incident Number: E20171009-02

Utility: Pacific Gas and Electric Company (PG&E)

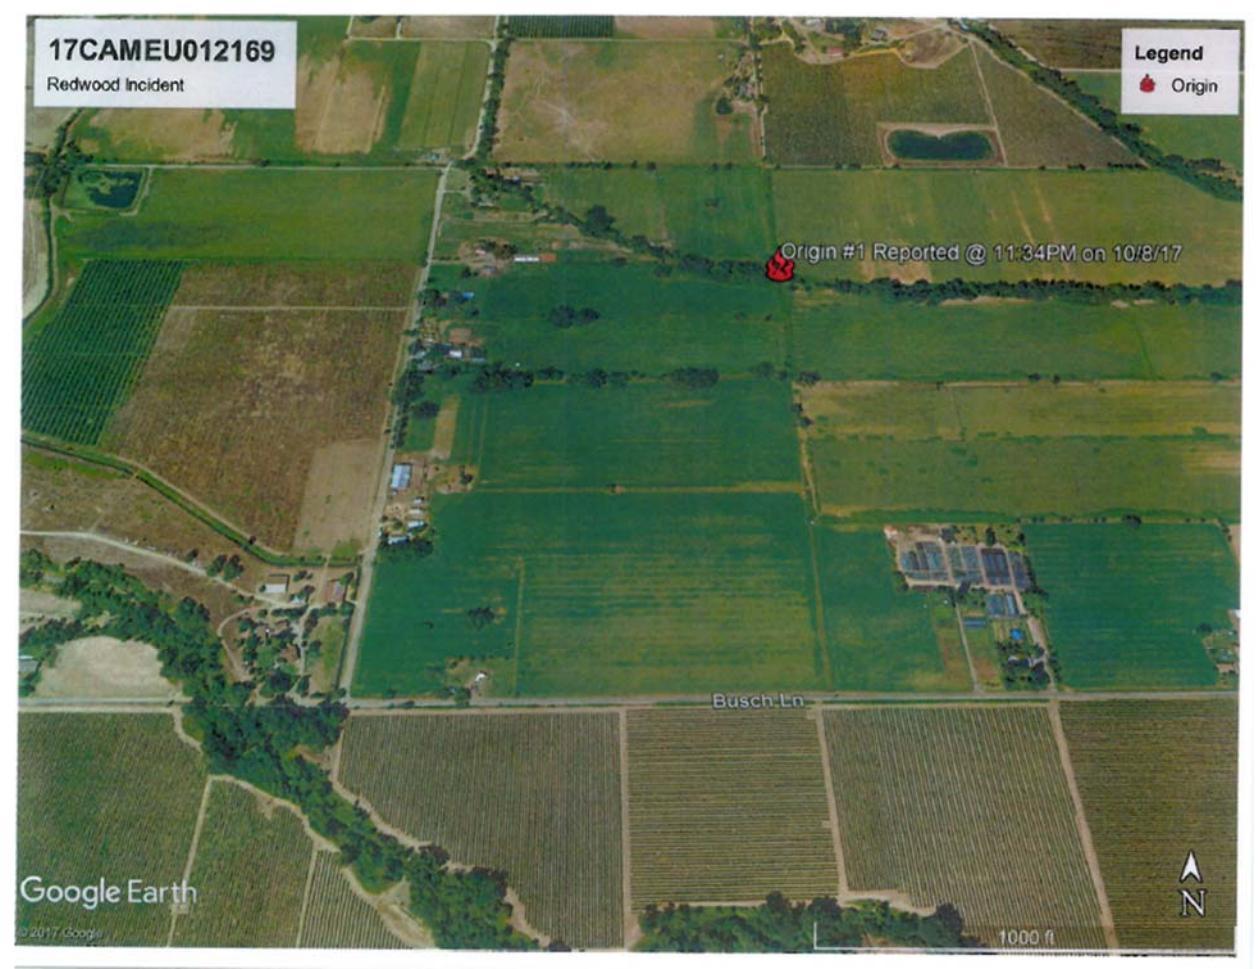
On October 8, 2017, at approximately 2334 hours, a 19-foot long branch from a 55-foot Valley Oak tree fell and contacted overhead conductors of PG&E's Potter Valley/Mendocino 60 kV transmission circuit located at 13801 N. Busch Road in Potter Valley. (Figure 1)

Figure 1. Red marker: approximate ignition point/location (N 39°20.953, W 123°07.882) near 13801 North Busch Road, Potter Valley (Origin #1) (Source: CAL FIRE)

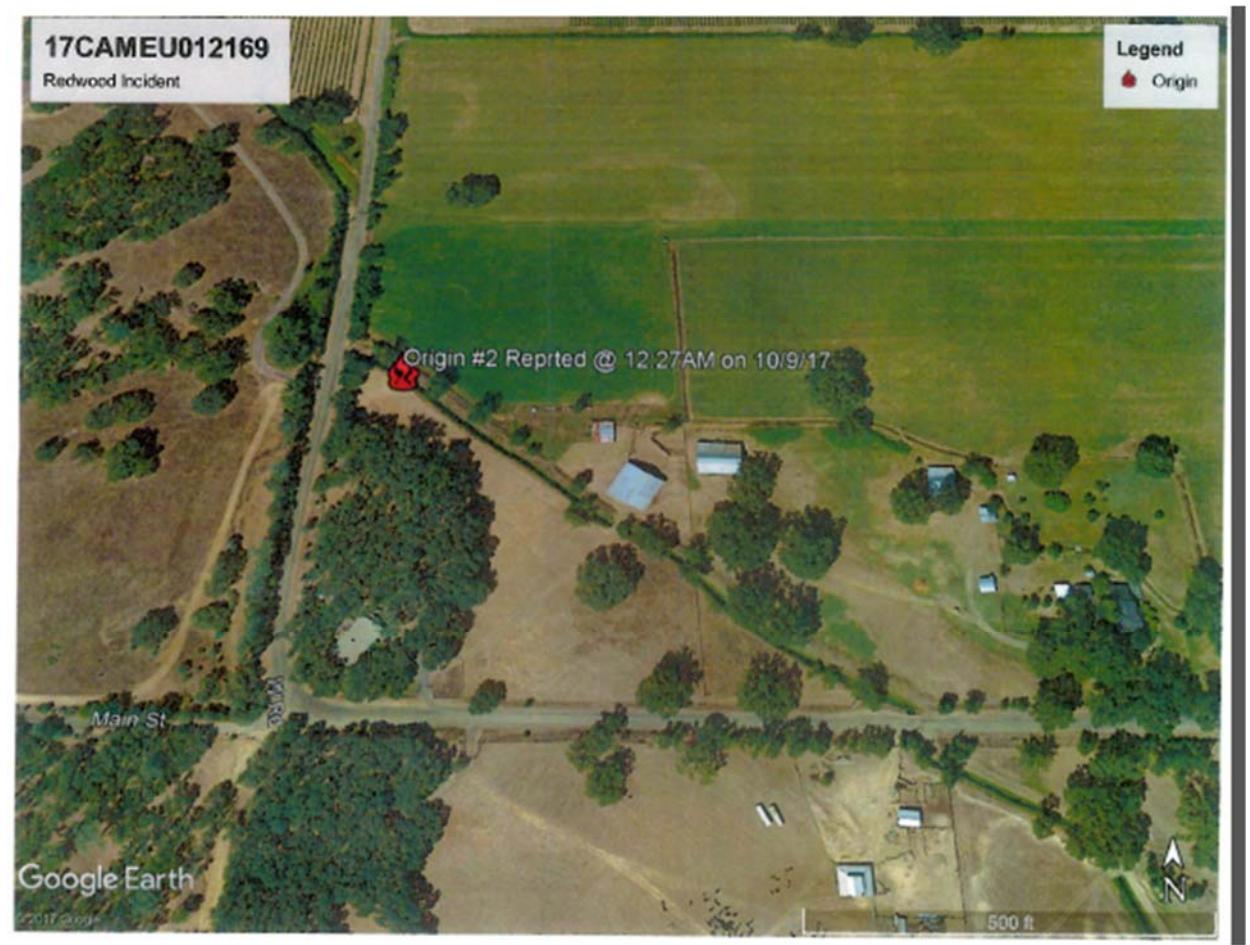
On October 9, 2017, at approximately 0027 hours, a 45-foot, 8-inch branch from a Valley Oak tree fell and contacted overhead conductors of PG&E's Potter Valley 1105 12 kV distribution circuit located at 9100 Main Street in Potter Valley. (Figure 2)

Figure 2. Red marker: approximate ignition point/location (N 39°19.397, W 123°07.877) near 9100 Main Street (Hawn Creek Road), Potter Valley (Origin #2) (Source: CAL FIRE)

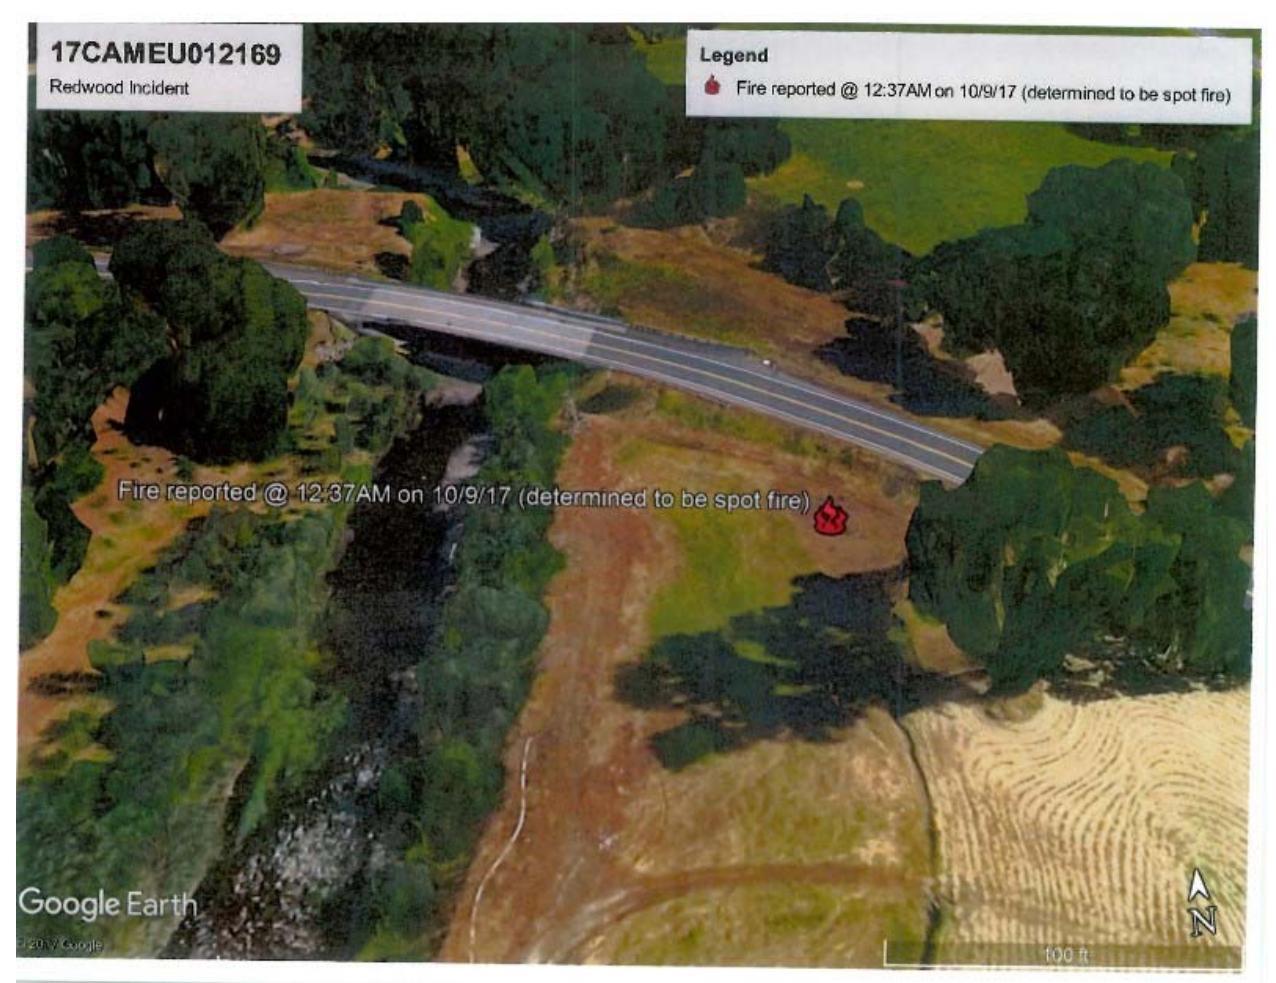
Another fire was also reported on October 9, 2017, at 0037 hours, in Redwood Valley, but CAL FIRE later determined it to only be a spot fire from embers blown from the high winds. (Figure 3) The three separate fires subsequently merged together and were named the Redwood Incident by CAL FIRE.

Figure 3. Red marker: approximate ignition point/location (39°18.742, -123°13.011) Spot Fire near East Side Road, Redwood Valley (Origin #3) (Source: CAL FIRE)

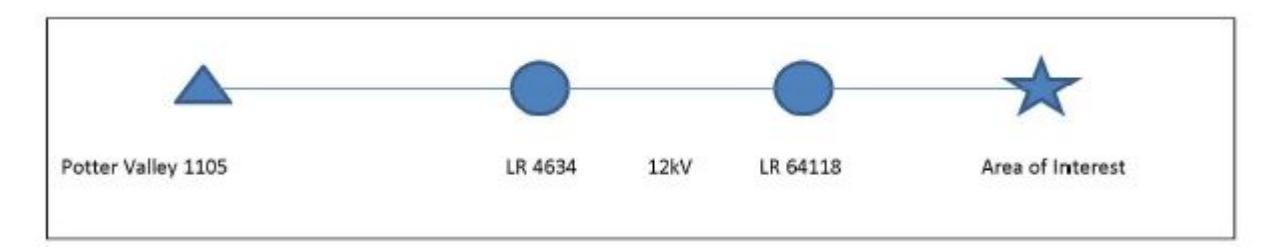
The distribution line at the incident location is the 12 kV Potter Valley 1105 Circuit. Line Recloser 64118 is the protective device upstream from the 9100 Main Street location. (Figure 8)

Figure 8. Diagram showing protection devices between incident span/Area of Interest (Source: PG&E)

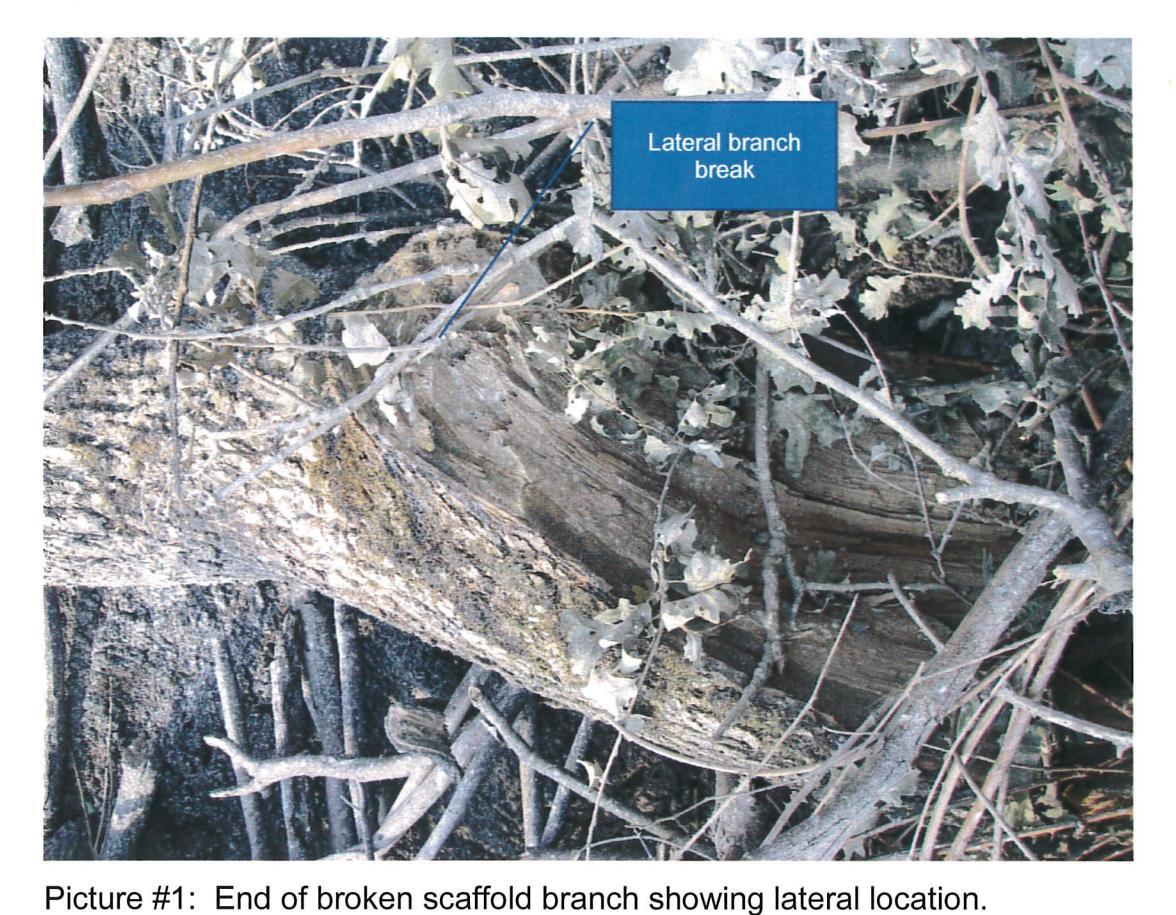
The upper break began at a branch union with a smaller lateral branch (Picture #1). This branch union appeared sound with no signs of structural defect, disease or other pest. An intact branchbark ridge indicates the branch attachment was normal and structurally sound.

I did not observe any indicators of structural problems at the branch break, or on the remainder of
the branch, or along the remainder of the main scaffold of the standing tree to the next branch union.
The general health of the tree appeared consistent with other white oaks in the area and is
consistent with a mature tree of this size.

5 Picture #2: Closeup of end of scaffold branch showing ash clinging to sapwood.
