CALIFORNIA PUBLIC UTILITIES COMMISSION
Safety and Enforcement Division
Electric Safety and Reliability Branch

Incident Investigation Report

Incident Number: E20171010-02

Utility: Pacific Gas and Electric Company (PG&E)

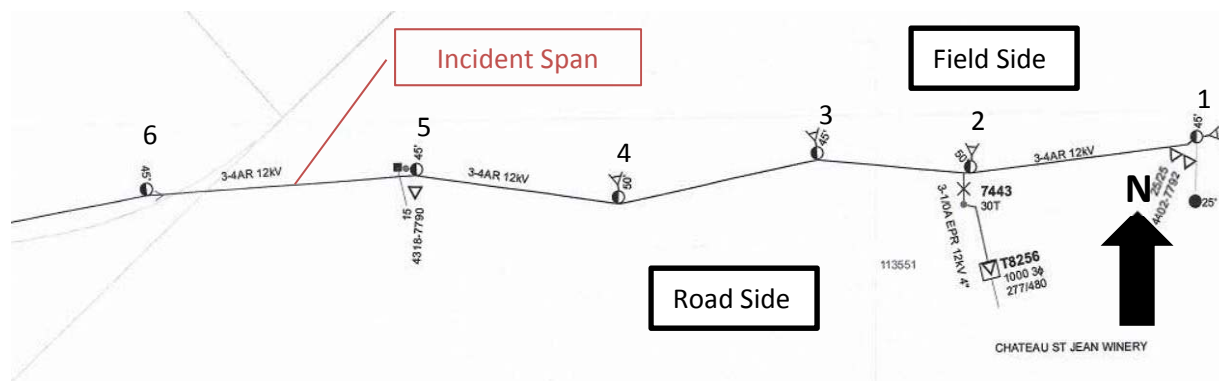
Figure 3. Schematic of pole locations (1-6) and incident span between Pole #5 and #6. Private road and subject conductors located south of the pole line. (Source: PG&E with added notes)

SED staff did not find any visual damage on Pole #1. Attached near the top of Pole #2 were fuses in the open position. Pole #3 did not exhibit any visual damage to facilities. On Pole #4, the field side conductor separated from the insulator and was hanging in a nearby tree. The incident span was still attached to Pole #5. At Pole #5, the road side phase was detached from the insulator and resting directly on the cross arm. The electric supply and communication conductors going west were on the ground. The subject Eucalyptus tree fell into the incident span between Poles #5 and #6. SED staff proceeded to Pole #6 and found it leaning in a tree and burnt through at ground level. The pole could no longer stand on its own without the steel reinforcement and nearby tree's support. All the conductors on the ground were marked as evidence by CAL FIRE and PG&E investigators. PG&E retained the base of the subject Eucalyptus tree as evidence. At Pole #7 (not included in Figure 6), the three primary level conductors were cut by PG&E and provided to CAL FIRE as evidence.

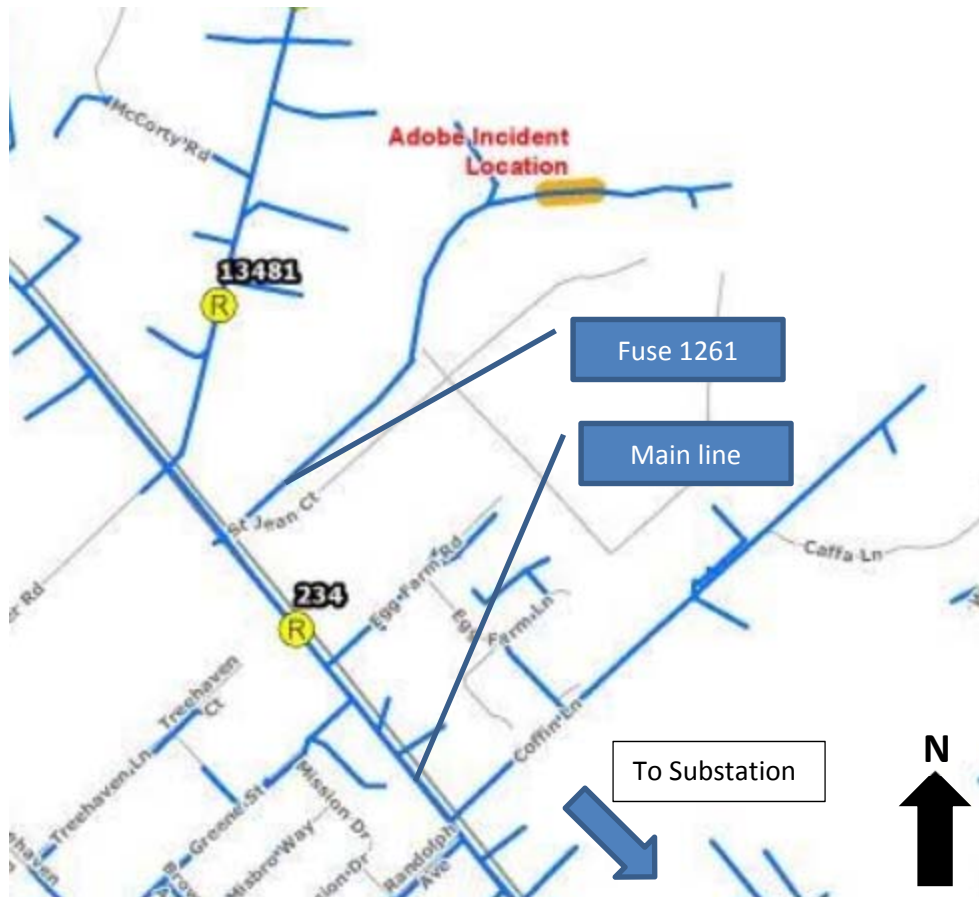
Figure 6. Map showing the approximate locations of protection devices upstream of incident span/Area of Interest. Not drawn to scale. (Source: PG&E)²⁹

The incident span was protected by upstream fuse 1261, Line Recloser 234 (LR-234, manufactured by Cooper Power Systems, type F4C), and finally the Dunbar-1101 Circuit Breaker (CB-1101). Fuse 1261, located at the branch from the main line near Highway 12, consists of three 65T fuses, in line with each of the conductors.

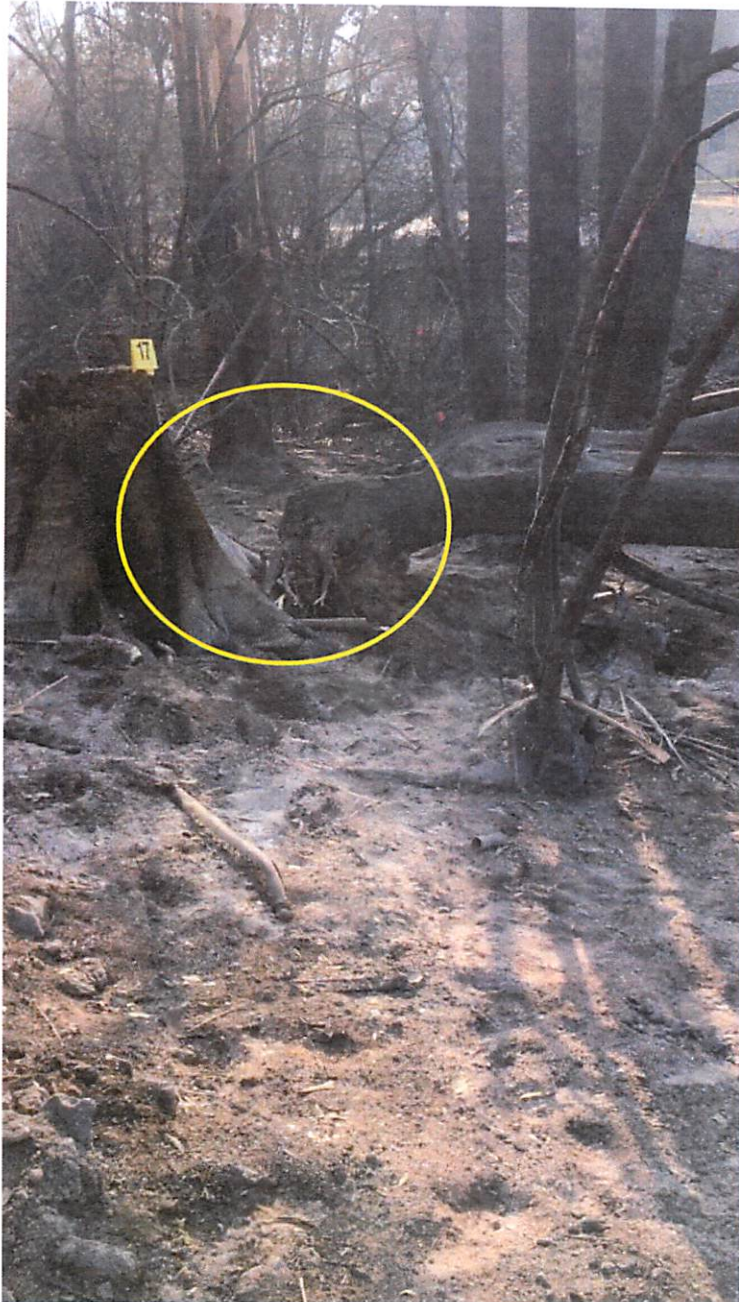
Appendix III Photo 3 Subject Tree

Weakly attached epicormic shoot failure. Technically a trunk failure.

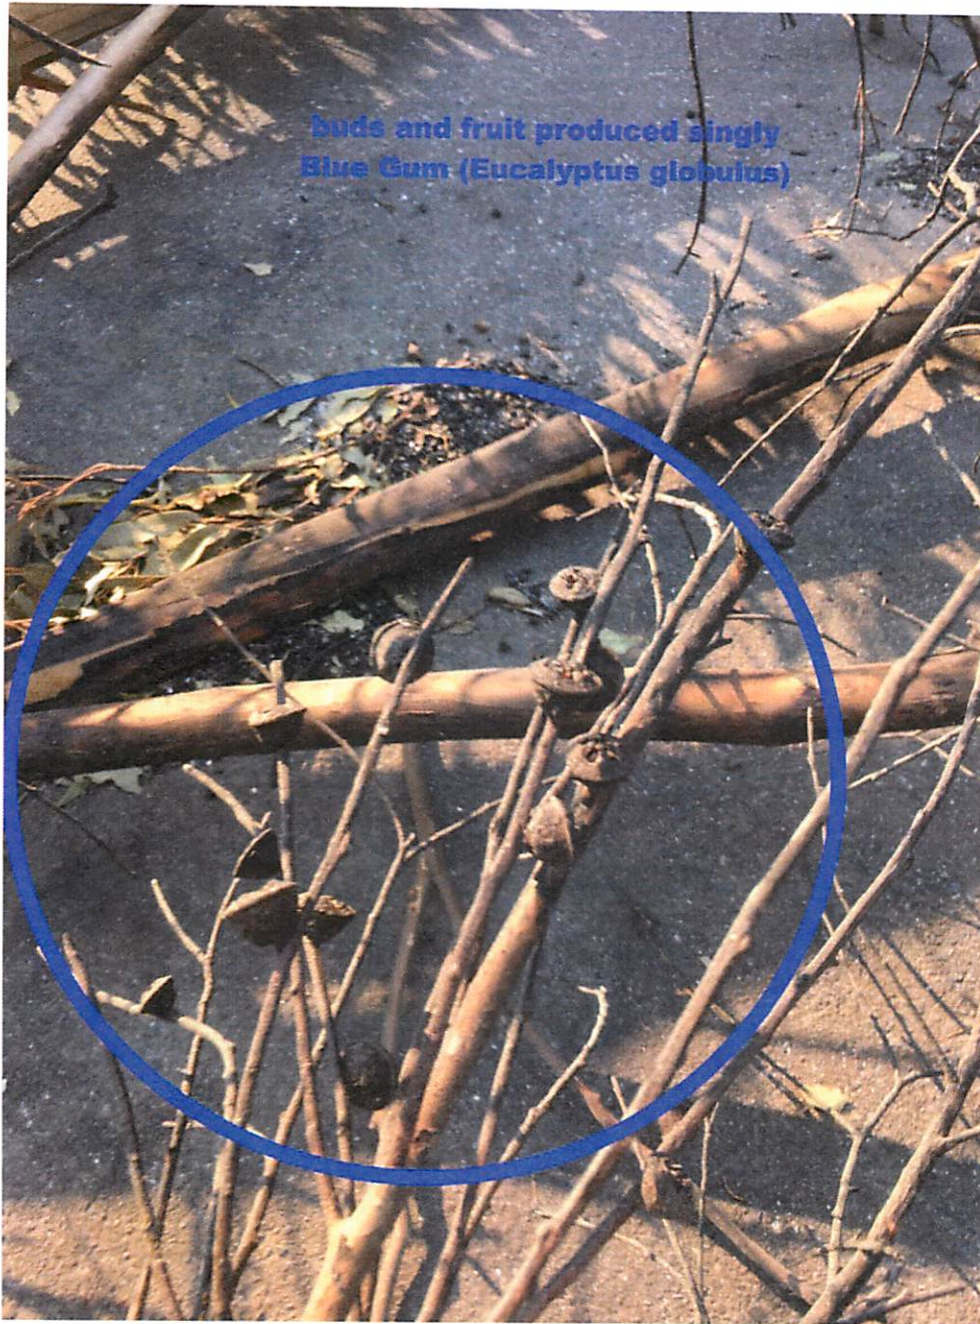
Appendix III Photo 4 Subject Tree

The subject tree a blue gum, "*Eucalyptus globulus*" (see Photo 4) is common to California. A page from a Californian's Guide to the Trees Among Us report Eucalyptus are the most widespread of all California cultivated trees. Eucalyptus was introduced to California from Australia in the 1850s. By the early 1900s blue gum (*Eucalyptus globulus*) was being extensively planted for lumber, pilings and post, fuel wood, medicinal products, tannin, oil, windbreaks, and as street and park trees (Dr. Matt Ritter). "*As California's forestry and fuel economy evolved, the inferior quality of young blue gum wood was discovered, most of the plantations remain uncut, and parts of the state are now burdened with the ecological legacy of this vast unharvested crop. Either prized as aesthetically pleasing heritage trees and monarch butterfly habitat or demonized as America's largest weed*".

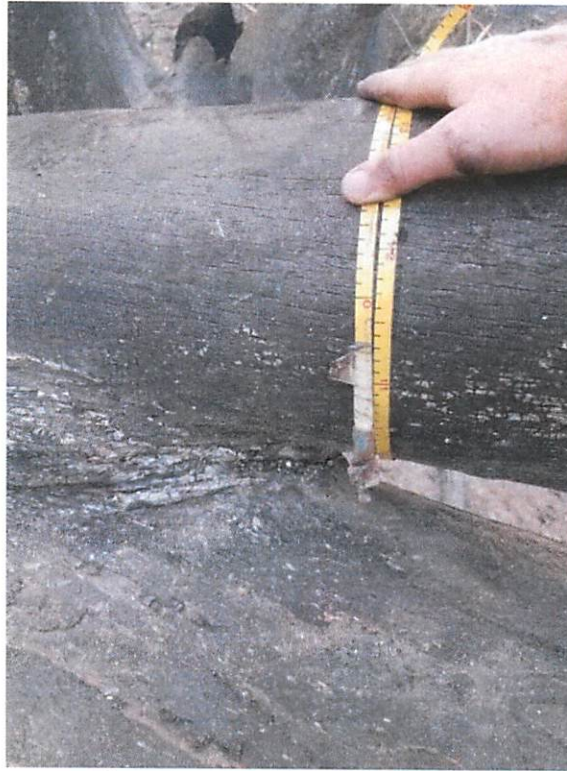
Figure 4: Diameter of the smaller fork.

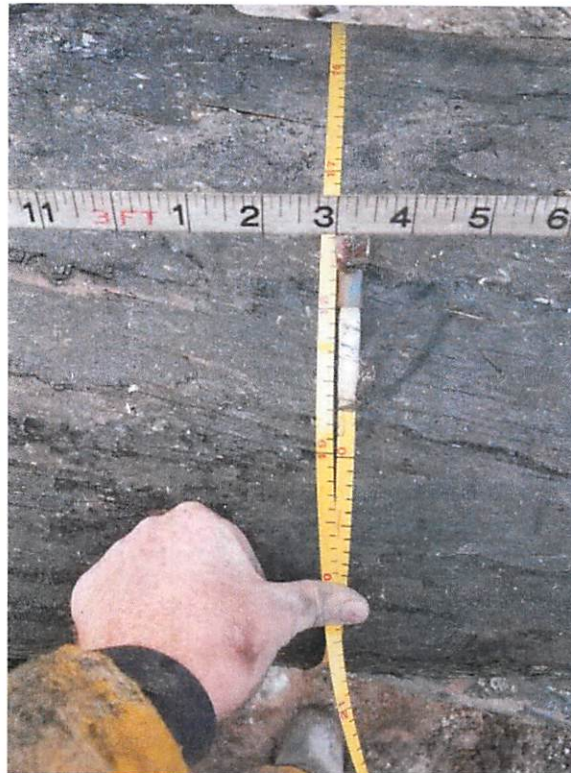
Figure 5: Diameter of the main fork.

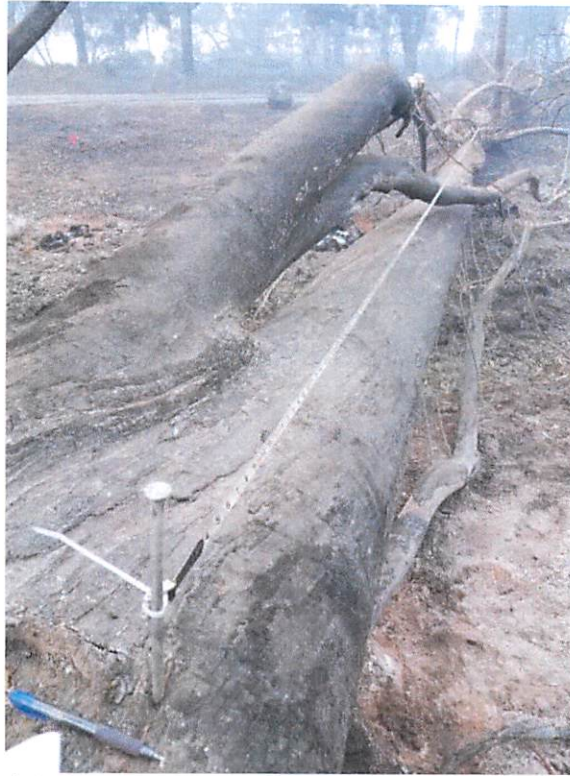
Figure 6: Nail inserted at point where sprout was growing over the top of the stump. Tree length was measured from the nail to the farthest tip of the branches, and then from the nail to the root collar. The sum of these two numbers is given as the total tree length.

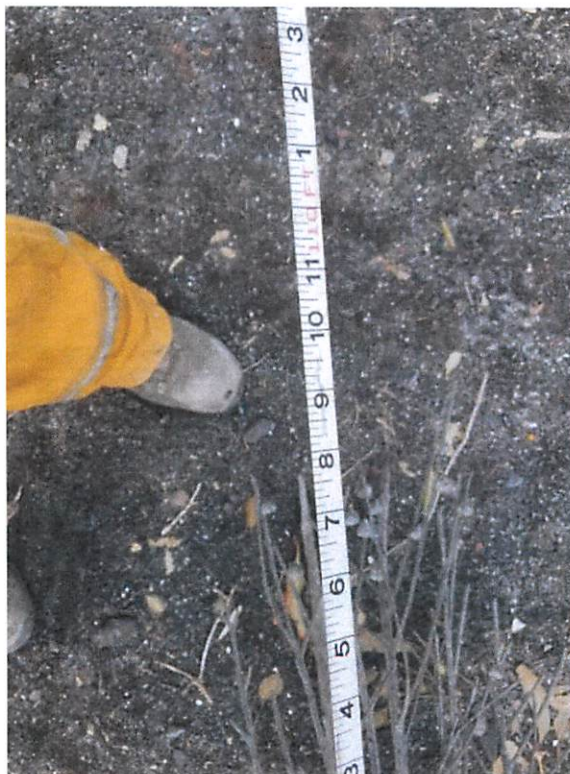
Figure 7: Measurement of the length of the fallen sprout from the nail to the farthest tip of the branches.

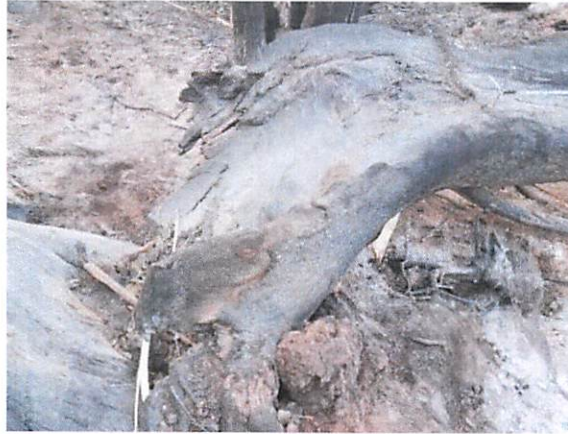
The tree in question is a sprout growing from the still living root system of a tree that was cut down many years previously. The sprout forks into two stems, a secondary and a main stem, 8.2' above the root collar. The sprout was growing up over the top of the stump it was sprouting from, but was only rooted at the base of the tree at the root collar (Figure 8 and Figure 9). The failure of the stump appeared to be due to a structural weakness as opposed to any insects, decay, or other pathogen. The branches on the sprout in question were all weighted to one side, consistent with how the tree fell (Figure 10).

Figure 8: View of the portion of the sprout that was growing over the top of the old stump.
