**CALIFORNIA PUBLIC UTILITIES COMMISSION**  
**Safety and Enforcement Division**  
**Electric Safety and Reliability Branch**

**Incident Investigation Report**

**Incident Number:** E20171011-02

**Utility Facilities Involved:** Redbud 1102, 12 kV Circuit

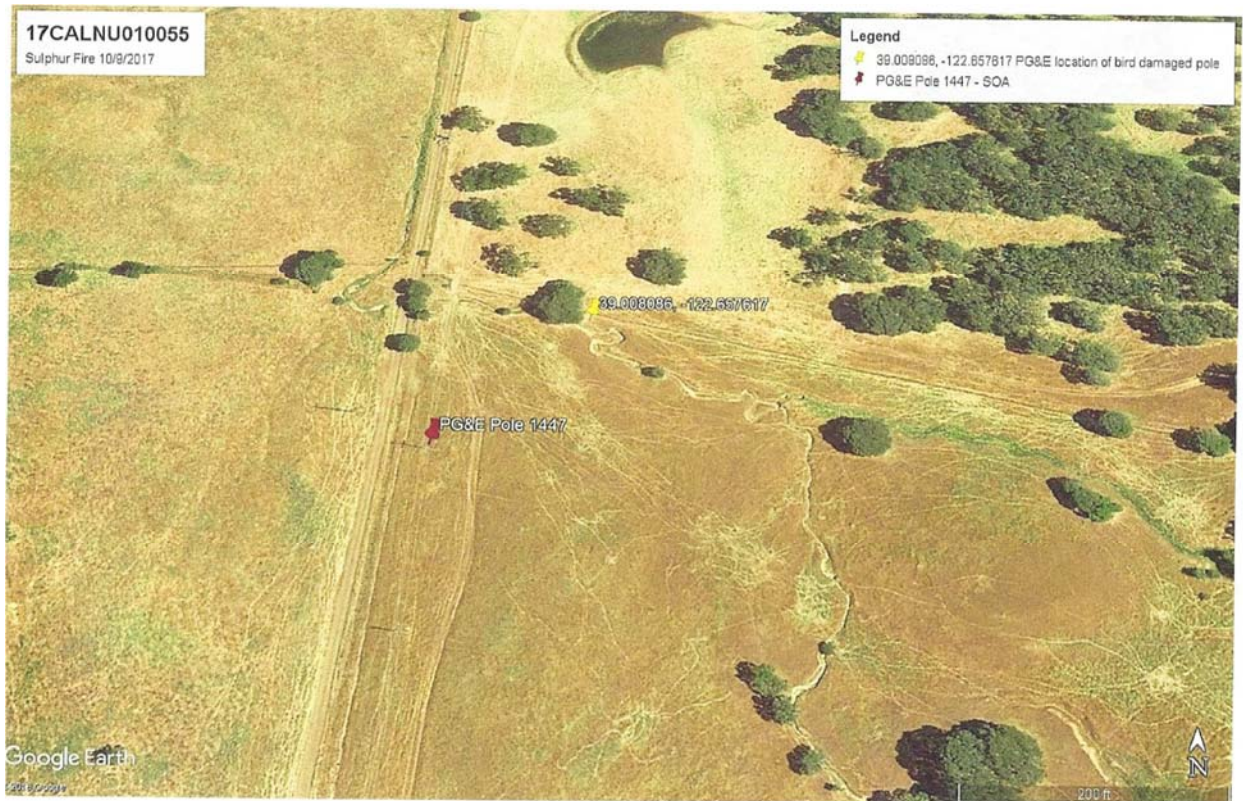
On October 8, 2017 at approximately 2359 hours, a top section of a PG&E pole (Fused Cutout Pole 1447) of PG&E's Redbud 1102 12 kV circuit located near Pomo Road and Sulphur Bank Road broke off near the communication level of the pole and fell to the ground. This section of the pole also contained three non-exempt fuses, of which two of them failed. The failure of the two fuses caused the dry grass at the base of the pole to ignite, which led to the Sulphur Fire.

**Figure 1.** Fire origin/incident location (39.127, -122.785) near 1350 Sulphur Bank Drive, Clearlake Oaks (Source: CAL FIRE)

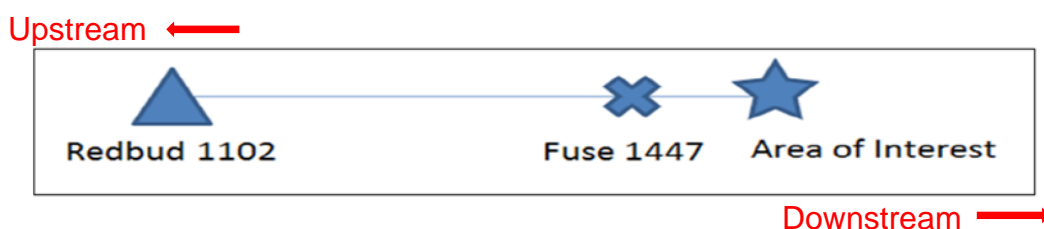
The Redbud 1102 Circuit Breaker (CB) is the source and protection device for the Redbud 1102 Circuit and is located at the Redbud Substation. Fuse 1447 is essentially at the same location as the area of interest since the fuses were located on the incident pole.

**Figure 4.** Single-line Diagram showing the fuse 1447 and CB 1102 upstream of the area of Interest/incident location. Not drawn to scale. (Source: PG&E)

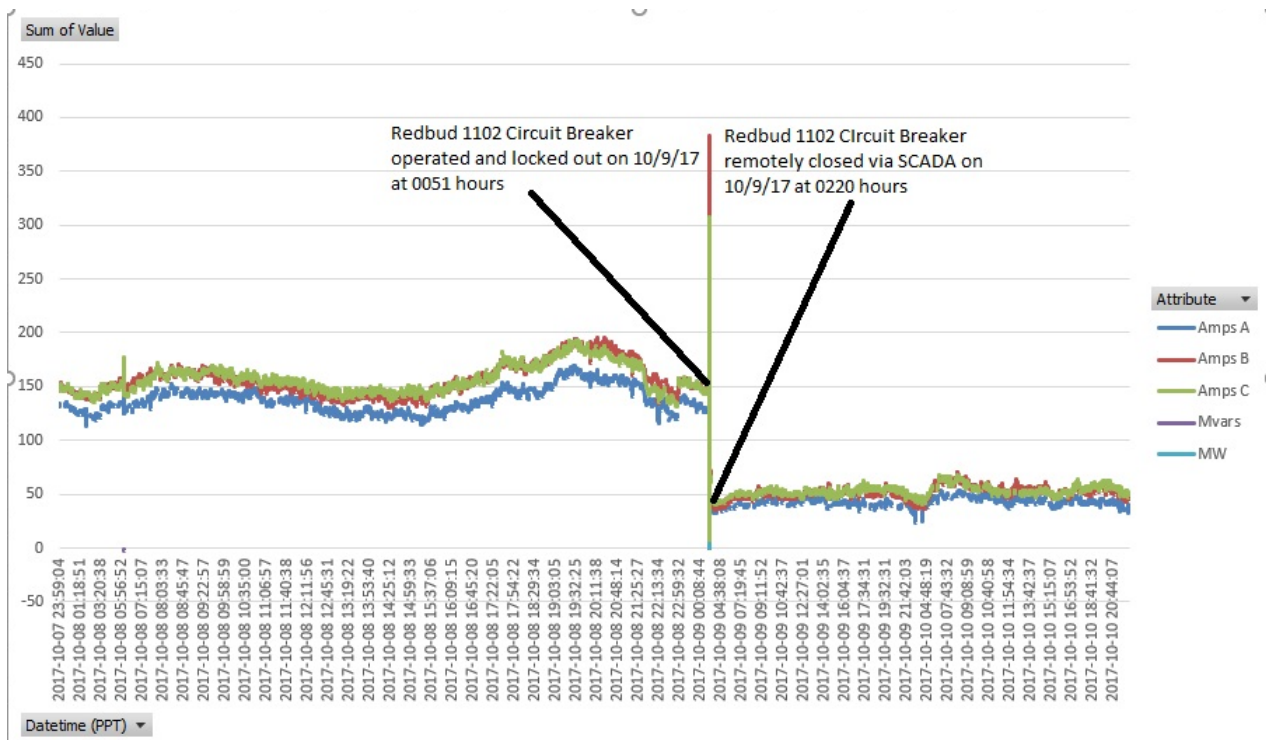
According to PG&E records, on October 9, 2017 at 0051 hours, the Redbud 1102 CB operated and locked out.<sup>13</sup> At 0241 hours, Switch 88137, a switch upstream of the incident location, was manually opened by PG&E and isolated the fire.<sup>14</sup> PG&E then remotely closed the Redbud 1102 Circuit Breaker at 0220 hours via SCADA.<sup>15</sup> These events can be seen on the SCADA load record of the Redbud 1102 Circuit Breaker (Figure 5).

**Figure 5.** Plot of the Redbud 1102 Circuit Breaker SCADA load from October 7, 2017 to October 10, 2017.

Based on PG&E's outage reports, smart meter data, and SCADA load data, SED did not identify a violation of GO 95, Rule 31.1.
