CALIFORNIA PUBLIC UTILITIES COMMISSION
Safety and Enforcement Division
Electric Safety and Reliability Branch

Incident Investigation Report

Incident Number: E20171020-06

Utility Facilities Involved: Bangor 1101, 12 kV Circuit

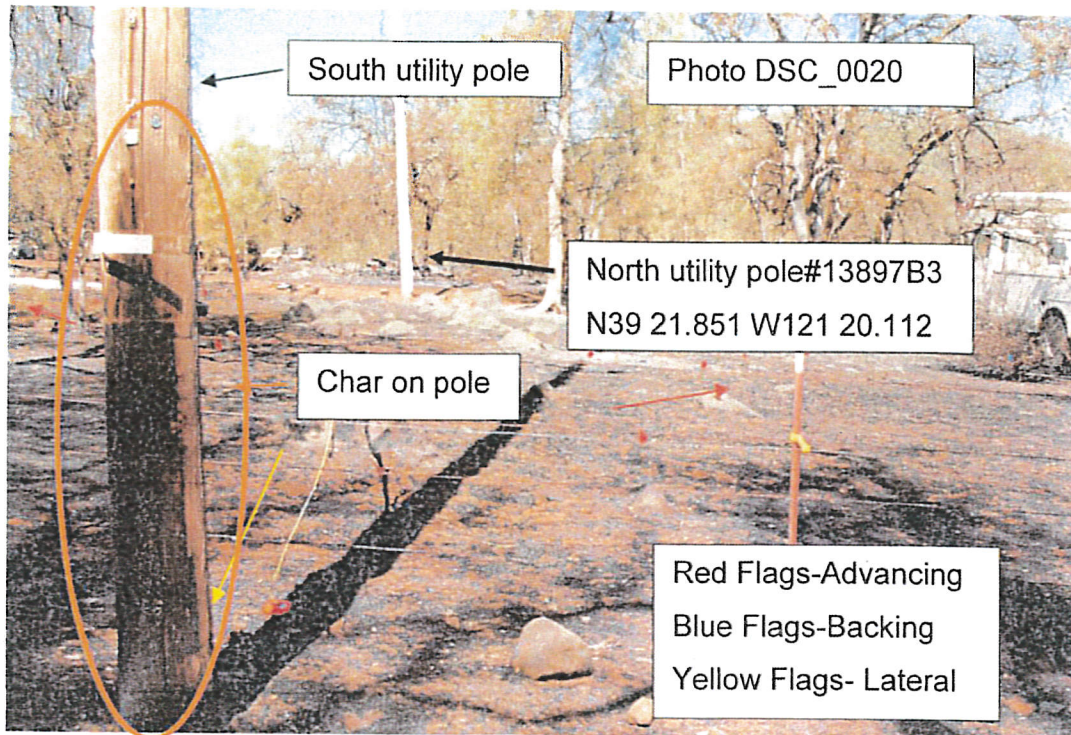
7
8 Examining the lines from the bucket truck I observed the AT&T communication lines
9 had sooting on them. I could not visually see any damage to the AT&T communication
10 lines attached between the two poles.

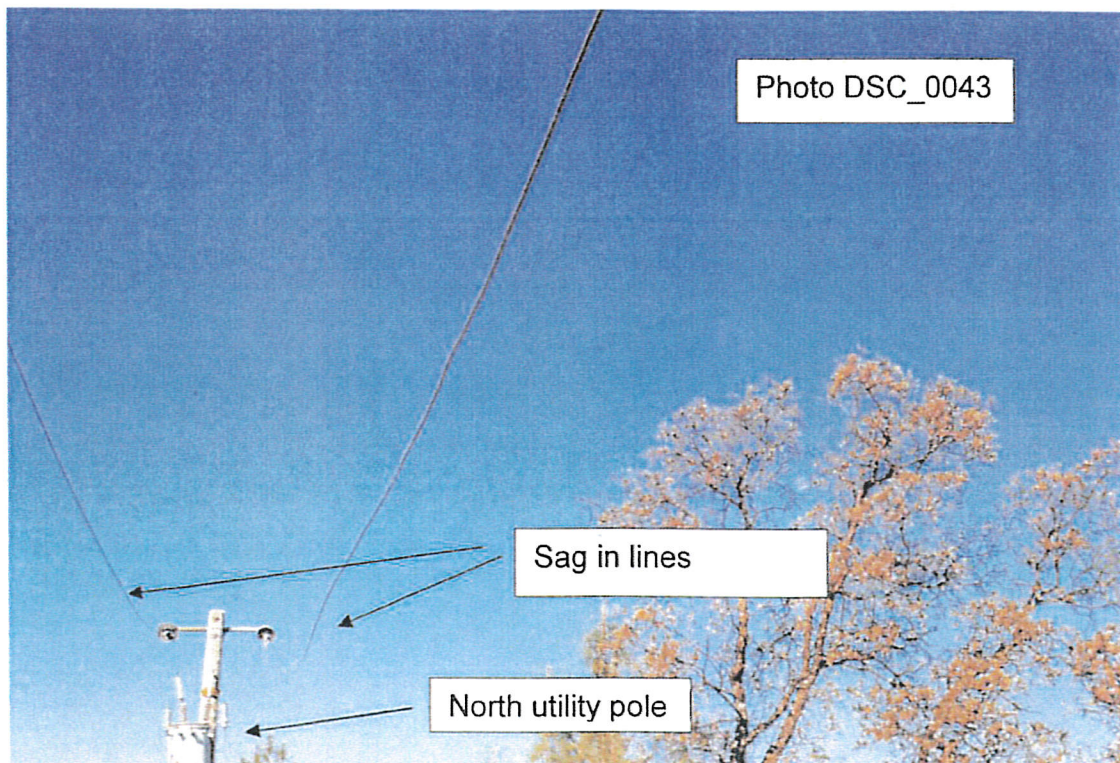
2 Examining the PG&E conductors from the bucket truck, I observed sag in the lines.

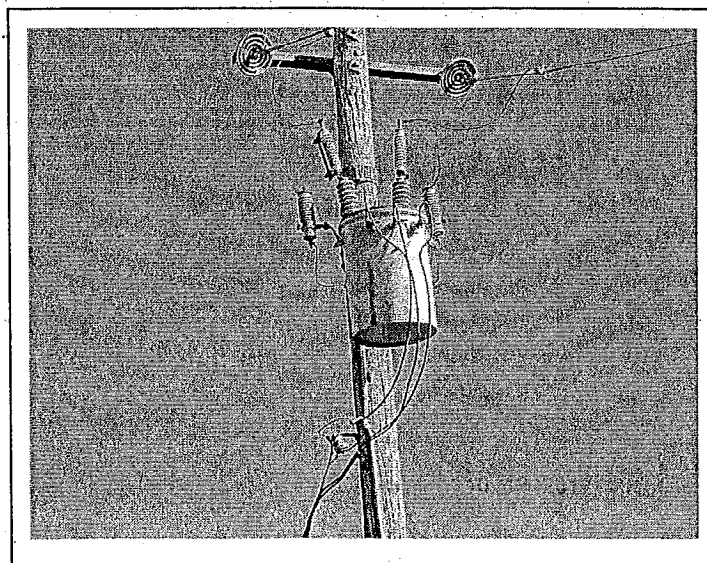
Photo 5

- 4.03 The electrical service drop conductors originating at the transformer in photos 4 and 5 had fallen to the ground. See photos 5 through 10 as typical. The main electrical service entrance and meter socket remains are exhibited in photo 10 as typical.

- 4.04 My attention was also directed at the utility conductors between two adjacent utility poles numbered 13897B3 and ?3?????2 as shown in Attachment 1. See photos 11 through 13 as typical. These conductors had severe droop problems and were not tensioned uniformly. See photos 5, 12 and 13 as typical.

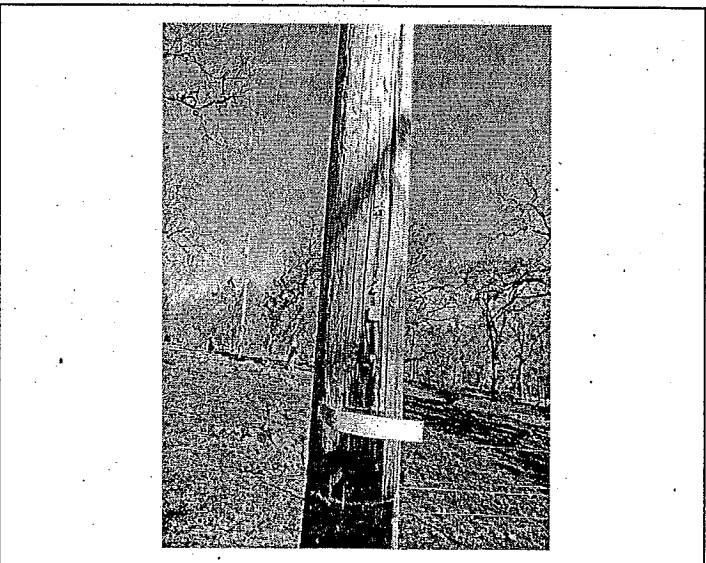
Photo 11

- 4.01 I was asked by BC Van Cor of CalFire to assist with the examination of the subject fire scene.
- 4.02 Upon arrival at the scene my attention was directed at the area indicated in Attachment 1 and photos 4 and 11 as typical.

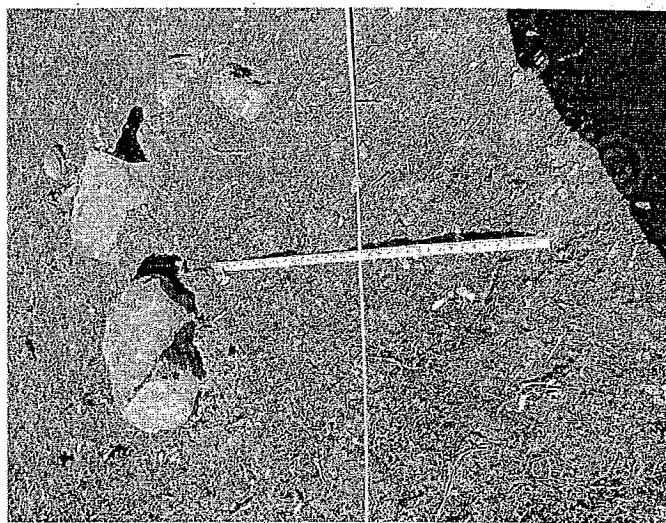
Photo 14

- 4.05 The approximate halfway point between the two utility poles is indicated on the ground in photo 14. Above that general area there was evidence of conductors slapping together so as to produce arcing damage on the conductors themselves. See photo 15 and 16 as typical.

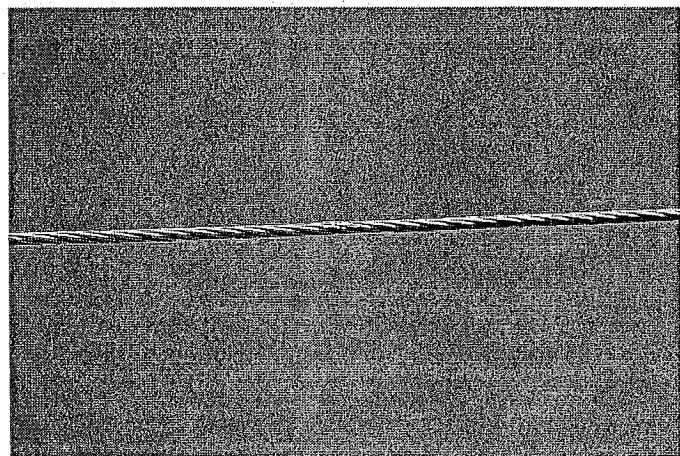
Photo 15 - CalFire photo # DSC_0045

3 Abstract: The most probable source of ignition was the electric arcing that was occurring on the conductors between the two utility poles indicated in Attachment 1. Both the concurrent wind event and the excessive slack in the high-voltage distribution conductors contribute to the probability above. The evidence of recent arcing on the two conductors confirms unauthorized contact between conductors. See photo 15 and 16 as typical.

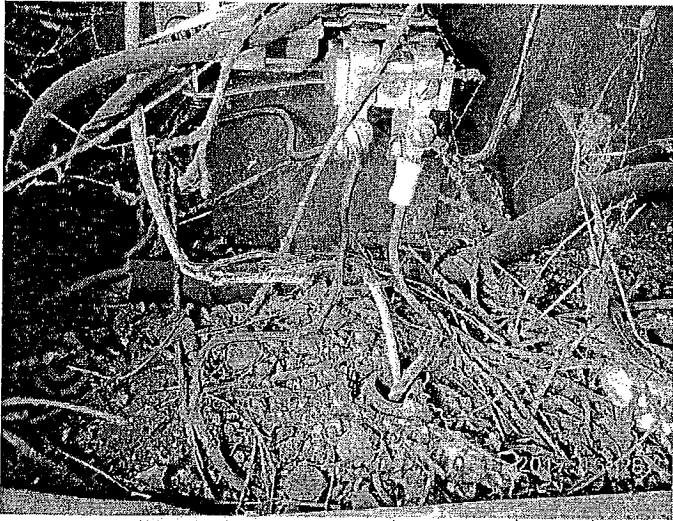
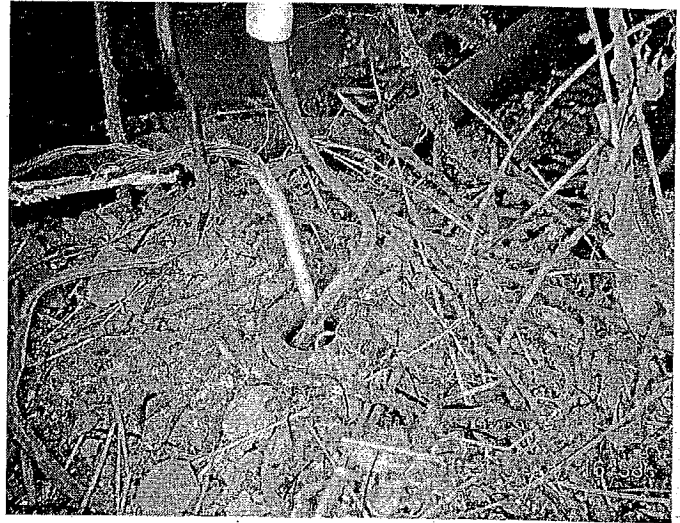
- 4.06 There was also a water well and well house providing water to the property. See photo 17 as typical.
- 4.07 Power was provided through PVC conduit to the well from the meter panel in photo 10. Water was returned to the same area via PVC piping. See photo 18 as typical. It was noted that rodents had taken up residence inside the well house pump control cabinet. See photos 19 and 20 as typical.

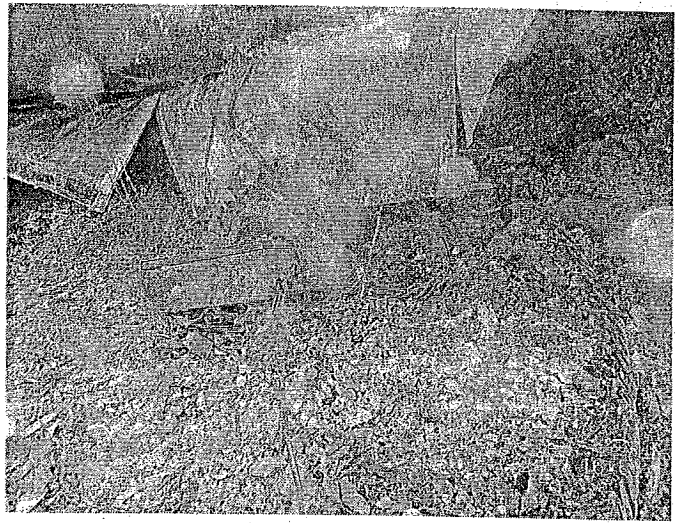
Photo 22

- 4.09 There was a trailer located a few feet from the electrical meter-service entrance. It was provided power by a flexible extension cord. Its circuit breaker panel and the large extension cord to it are seen in photo 22 as typical.
