**CALIFORNIA PUBLIC UTILITIES COMMISSION**  
**Safety and Enforcement Division**  
**Electric Safety and Reliability Branch**

**Incident Investigation Report**

**Incident Number:** E20171016-01

**Utility:** Pacific Gas and Electric Company (PG&E)

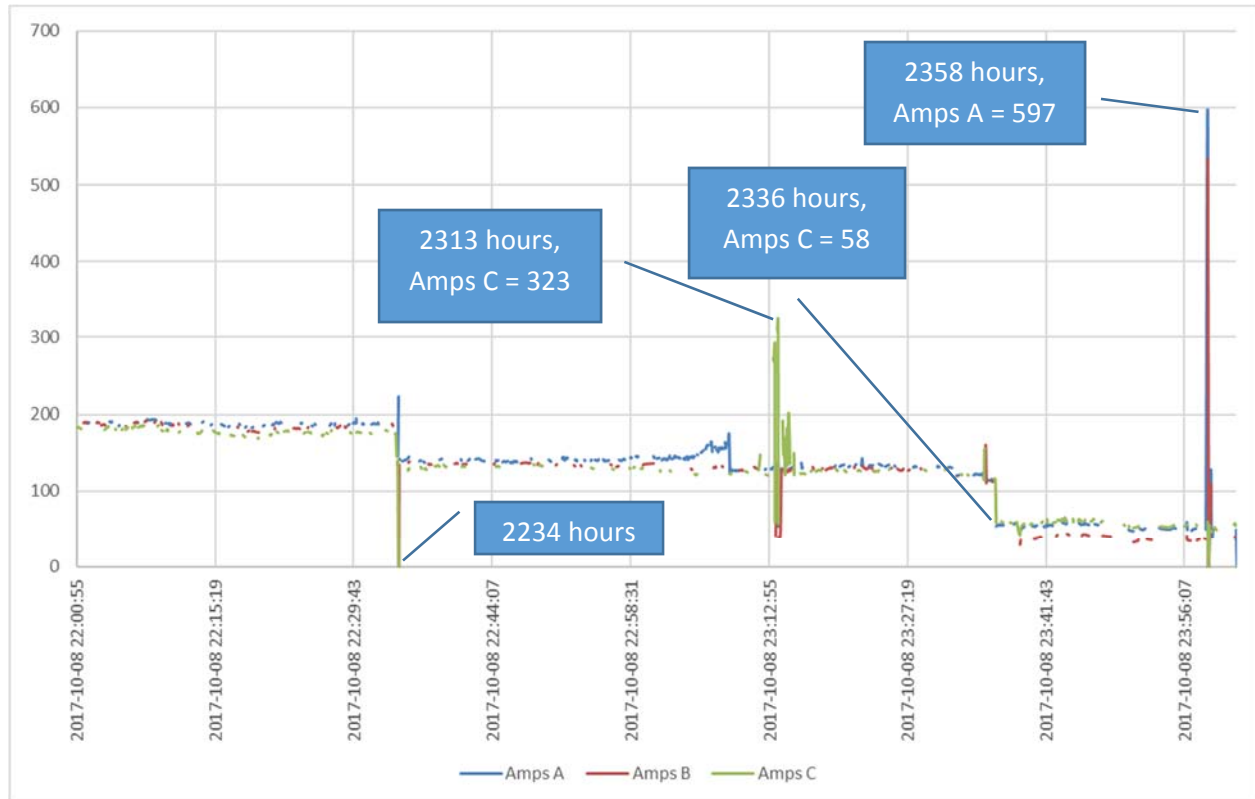
**Figure 7.** SCADA plot of load data recorded at Dunbar-1101 CB from October 8, 2017 at 2200 hours to October 9, 2017 at 0001 hours. The chart highlights times that signify either an operation of equipment (open/close) or a fault on the circuit.

On October 8, 2017 at 2251 hours, LR-47964 opened and reclosed once. The LR is set to operate 4 times before locking out<sup>34</sup> and did not seem to malfunction. PG&E last changed the settings for LR-47964 on February 23, 2016. Of the three phases, phases B and C recorded an overcurrent event ranging from 562 to 565 amps at around 2313 hours (adjusted time based on SCADA load data recorded at the Dunbar-1101 CB; originally 2311 hours). For comparison, the third phase (Phase A) registered about 4-5 amps.

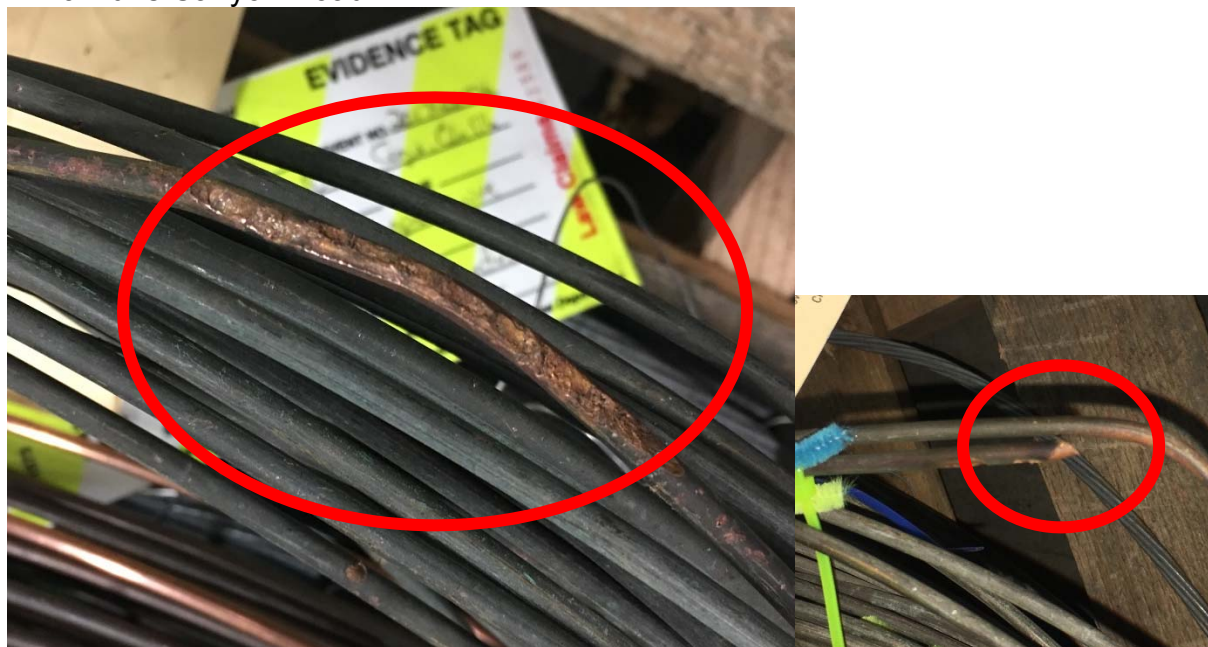
On June 11, 2018, SED staff visited PG&E's evidence storage location in Oakland, California. SED identified abrasion and separation for the solid copper conductors PG&E retained from Nuns 2. The conductors were labeled as part of the Nuns fire at 1210 Nuns Canyon Road.

**Figure 8.** PG&E evidence items from Nuns 2 location. **Left:** Abrasion on solid copper conductor. **Right:** End of separated copper conductor.

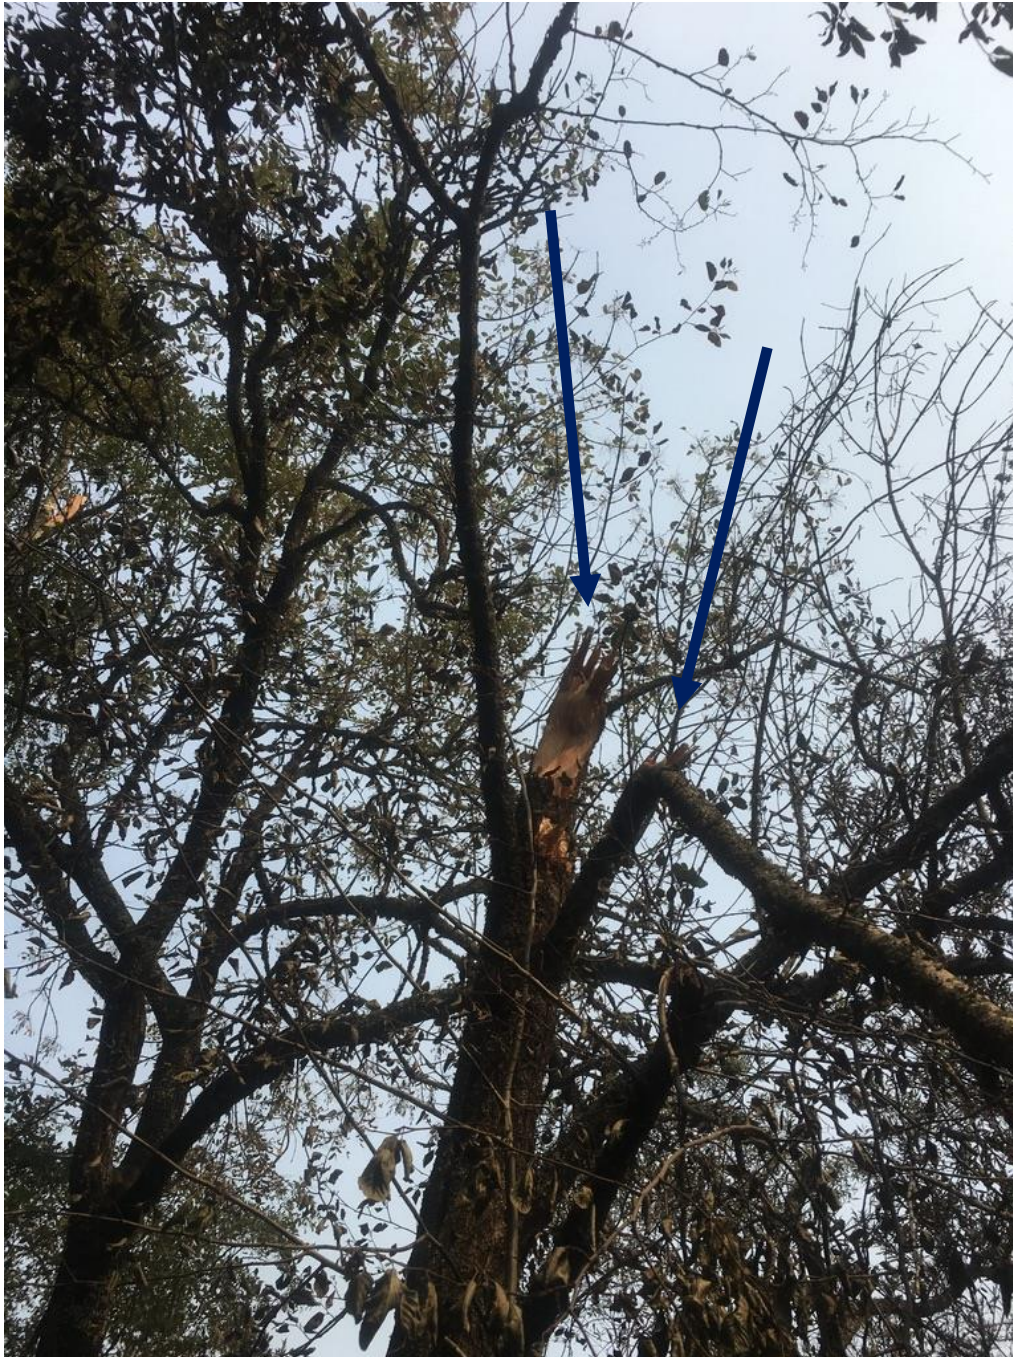
**Photo 2** - fractured branches from subject tree

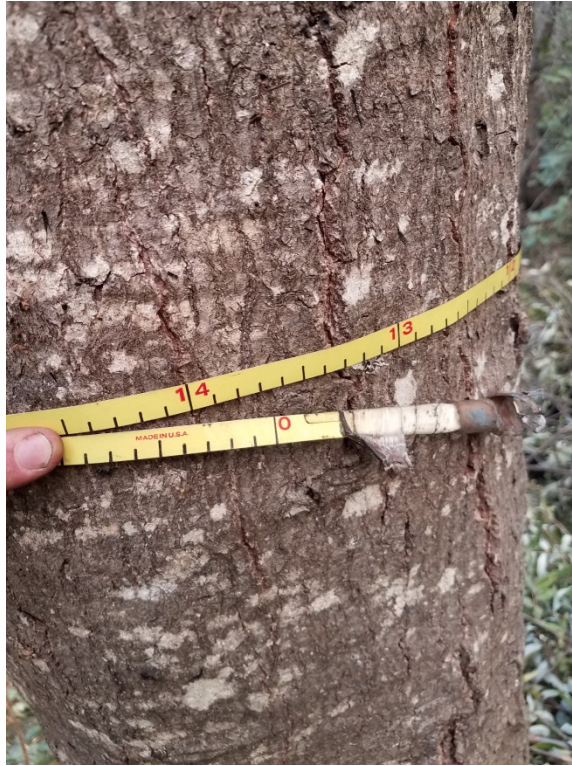
Diameter: 13.6" at breast height (4.5' from root collar) (Figure 1)

Figure 1: Diameter of tree taken at breast height (4.5' from root collar).

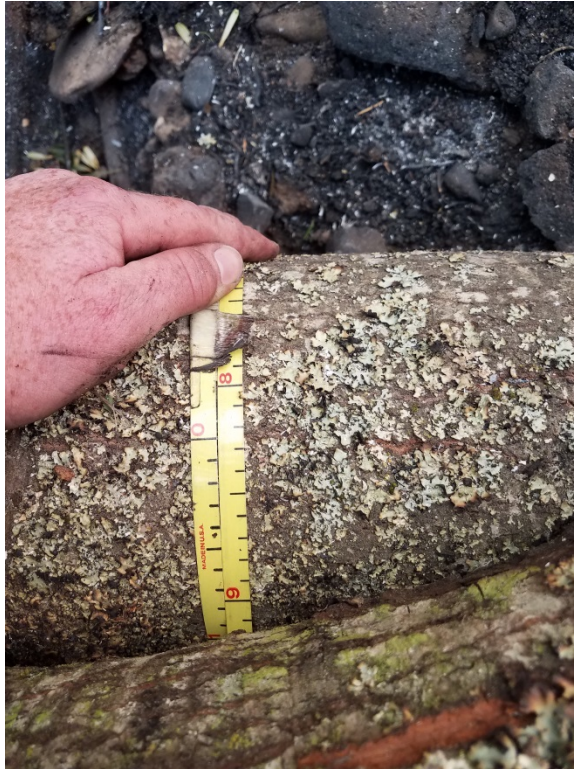
Diameter of broken top: 8.1" diameter (Figure 2)

**Figure 2: Diameter of broken top.**

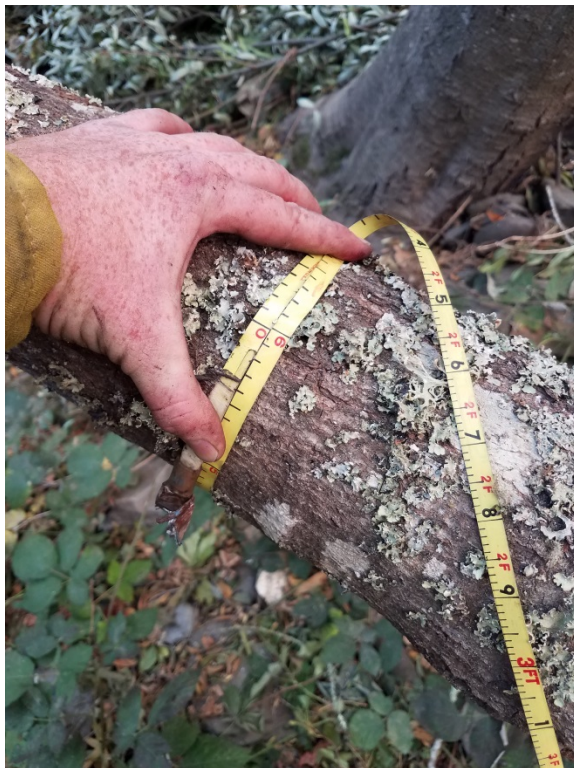
Diameter of broken branch: 6.0" diameter (Figure 3)

**Figure 3: Diameter of broken branch.**

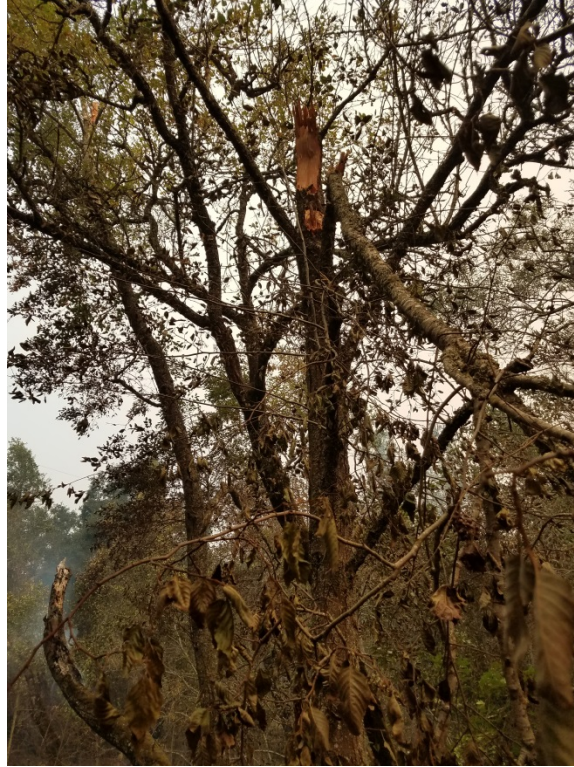
The top of this tree had broken off and fallen to the ground directly below the main stem of the tree (Figure 4).

**Figure 4: View of broken top of tree from below.**

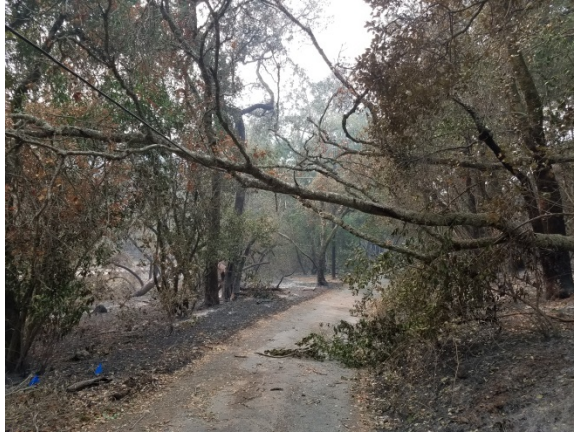
**Figure 6: View of the fallen Bay Laurel tree from Nuns Canyon Road.**

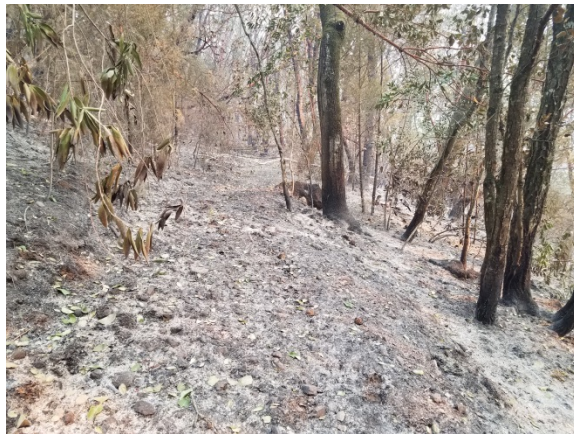
Evidence of past forest management activities are visible on the hillside above Nuns Canyon Road. Old skid trails are present, likely from past harvest entries, but do not appear as though they have been used by equipment in the last decade (Figure 7).

**Figure 7: Old skid trail on the hillside above Nuns Canyon Road.**

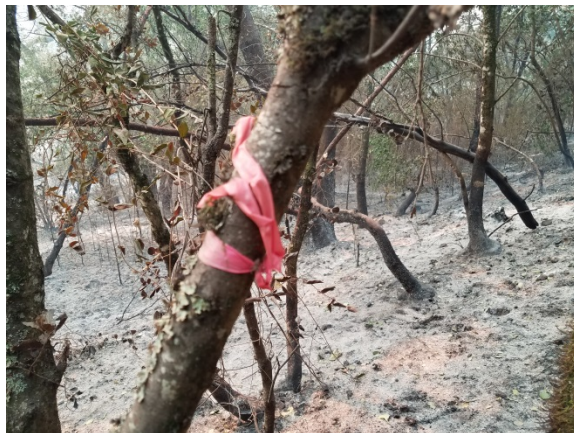
Pink flagging was seen hanging adjacent to the old skid trail, though the sun bleached and faded color suggests that it was not hung recently (Figure 8). The type and quality of flagging used, including degree of exposure to the sun can have a variable effect on aging, and so a reliable age for the flagging cannot be given. No stumps indicating a recent harvest entry were observed, though some decayed stumps and stump sprouting hardwoods were observed in the stand.

**Figure 8: Aged pink flagging along the old skid trail shown in Figure 7.**

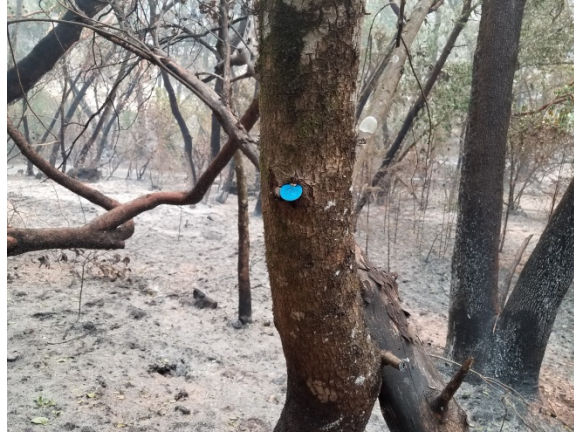
One young tree had a blue number tag hammered into the bole of the tree at breast height, though the tree has begun to grow around the tag, suggesting it is several years old (Figure 9). The degree to which the bark will grow over a number tag is dependent on how deeply the tag was nailed in, so a reliable age for the installation of this tag cannot be given. This practice is typical of forest inventory and measurement, and further suggests active management of this stand in the last few decades.

**Figure 9: Blue number tag hammered into the bole of a small tree in the stand. This is a practice typical of forest inventory.**

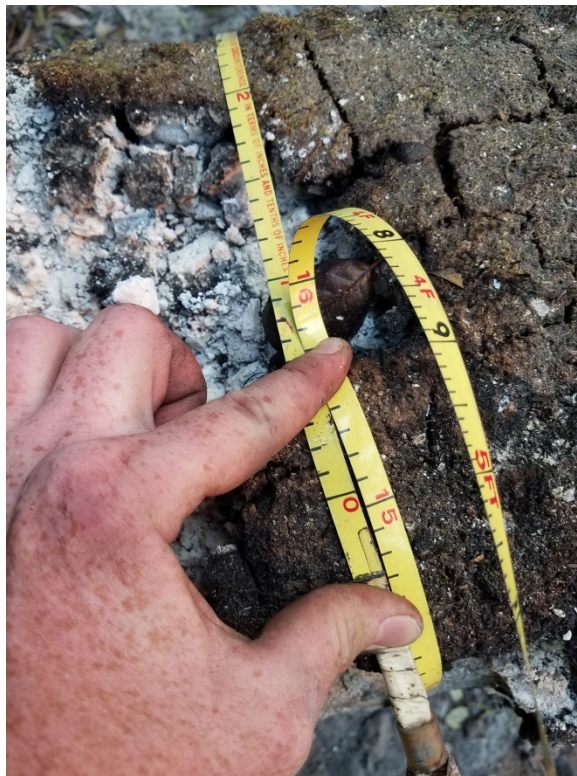
Diameter: 15" at breast height (4.5' from root collar) (Figure 10).

**Figure 10: Diameter of the tree at breast height (4.5' from root collar)**

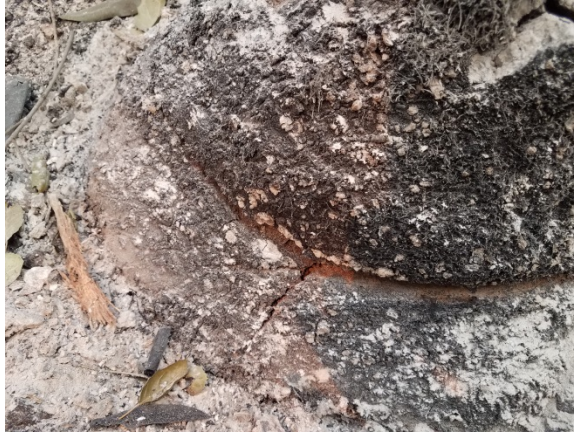
Tree has horizontal cracks at the base that extend into the sapwood (Figure 11). These could be possible chain saw marks, but the upward curve at the margins suggests that there may be some other cause as well.

**Figure 11: Horizontal cracks visible at base of tree. The width of the cracks and the depth they extend into the sapwood are possible indicators of saw marks, however the upward curve at the margin and diminishing width suggest that may not be the case.**
