CALIFORNIA PUBLIC UTILITIES COMMISSION
Safety and Enforcement Division
Electric Safety and Reliability Branch

Incident Investigation Report

Incident Number: Atlas 1: 171023-8596 & Atlas 2: 171020-8589

Utility Facilities Involved: Pueblo-1104, 12 kV Circuit

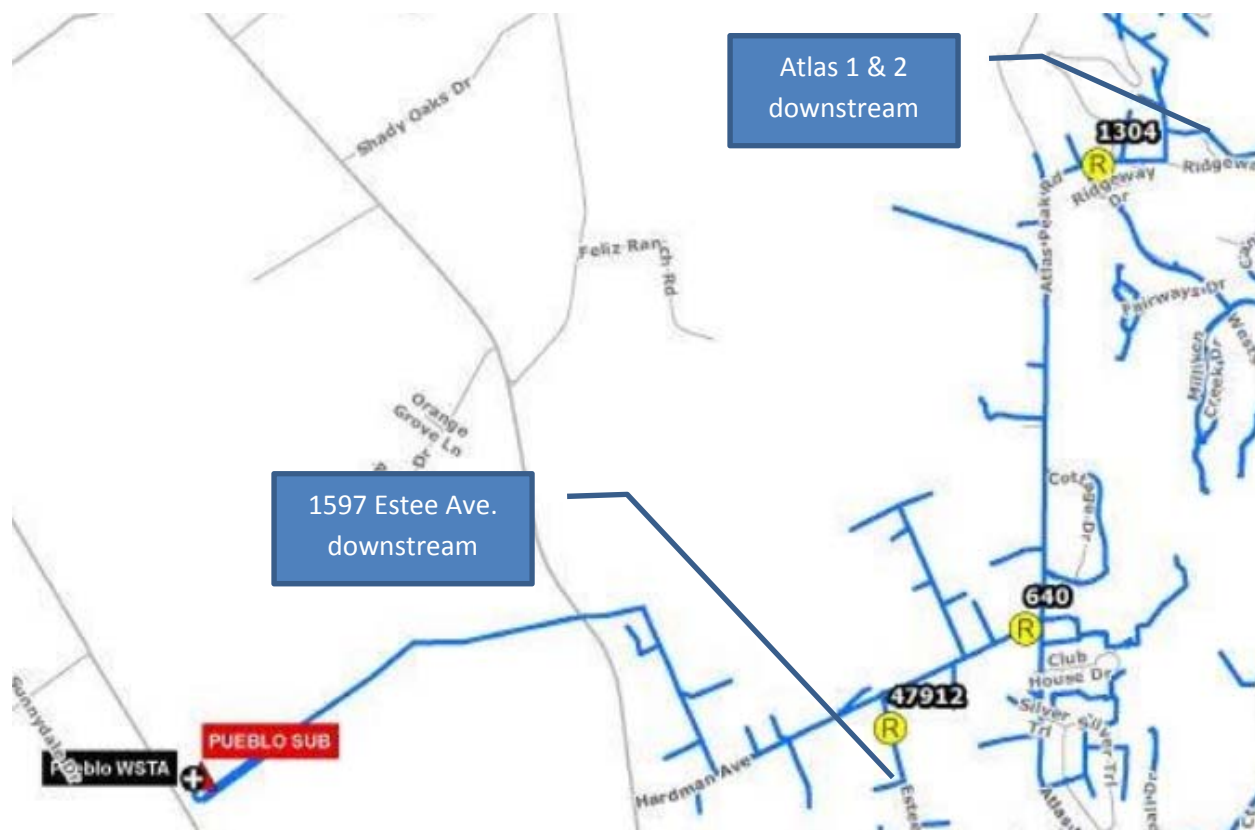
Figure 10. Partial view of Pueblo-1104 circuit with LR-640, LR-1304 and Sectionalizer 47912 shown. (Source: PG&E)⁴⁰

Of the PG&E outage reports reviewed, SED could not determine if Fuse 709 operated after the faults occurred at both locations. Also, LR-640 and LR-1304 each seemed to have operated once within 16 minutes of each other based on the “CONTROL ALARMS” recorded locally at each device. The LRs did not lock out, but rather LR-640 was manually opened by PG&E field personnel due to the Atlas fires.
