#### CALIFORNIA PUBLIC UTILITIES COMMISSION Safety and Enforcement Division Electric Safety and Reliability Branch

#### **Incident Investigation Report**

Incident Number: E20171026-01

**Utility:** Pacific Gas and Electric Company (PG&E)

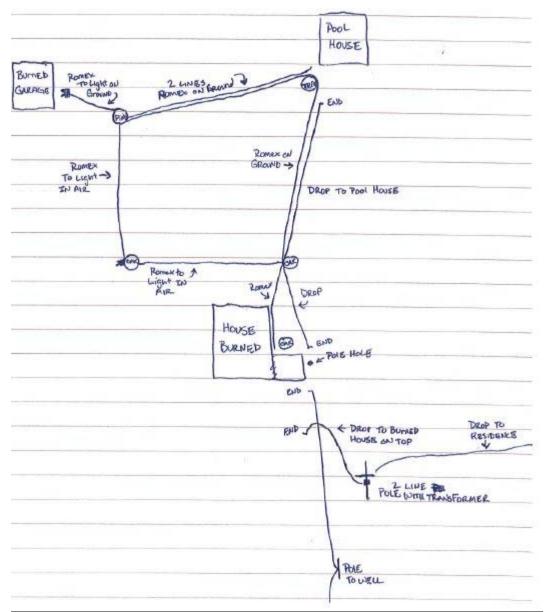
Figure 2: Graphical representation of the private electrical system at the incident location provided by CAL FIRE (not to scale)<sup>2</sup>.

The property located at 1128 Bennett Lane had an extensive private electrical system that fed power from the residence to a pool house and garage nearby as well as a pump station down the hillside. CAL FIRE provided a graphical representation of the private electrical system relative to PG&E's facilities in Figure 2.

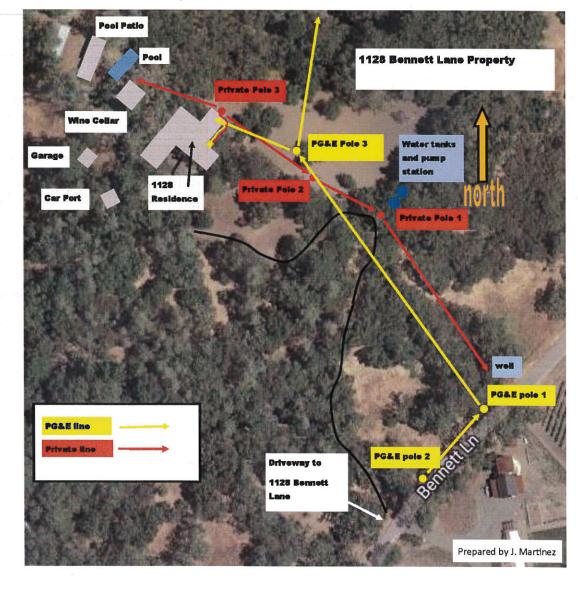
30	uphill to the reside	ence, by service drop	to a weather hea	ad on the roof. From there,
31	exterior conduit c LE80 (Rev. 7/2011)	onnects to the meter.	From the meter	, conduit carries conductor to a Officer Initials <u>M</u>

privately-owned power pole (private pole 3). From private pole 3, conductor extends north west towards the wine cellar and pool patio. Additionally, from private pole 3, conductor extends southeast towards private pole 2, then to private pole 1 where the water tanks and pump station are located. From private pole 1, conductor extends downhill where it ties into a well next to Bennett Lane. The graphic below includes a general representation of the developed property at 1128 Bennett Lane with a general schematic of the electrical system.

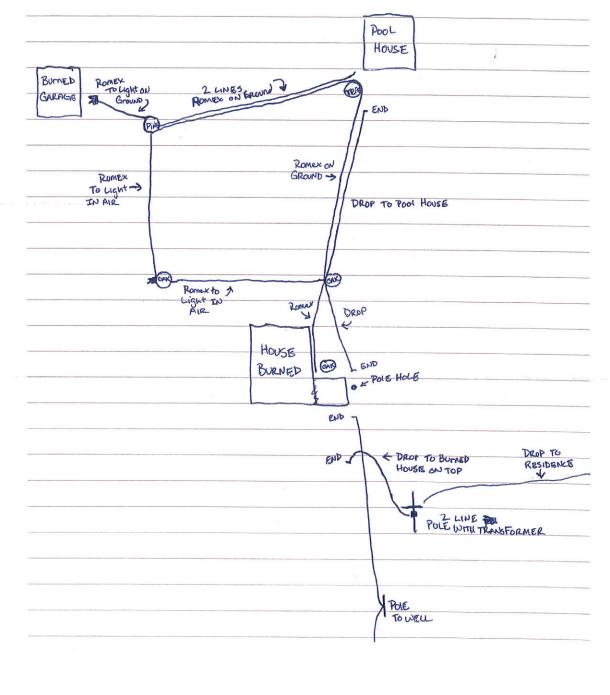
3 The graphic below includes a general representation of the private electrical system at

4 1128 Bennett Lane prepared by ROATH.

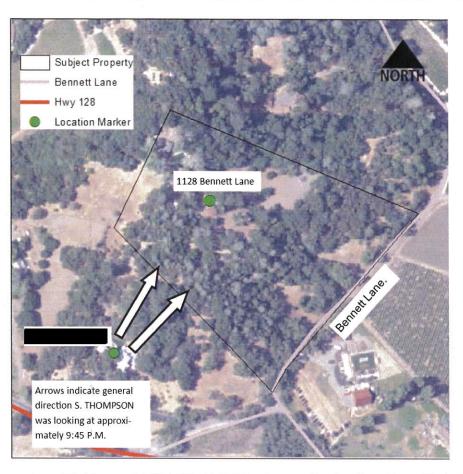
The 1128 Bennett Lane property is the next adjoining property to the northeast from the S. THOMPSON property. A fire spreading towards the S. THOMPSON residence from his description would likely have come from or passed through the 1128 Bennett Lane property. The graphic below, prepared by MARTINEZ, is a representation, based on the witness statement, showing where the witness was and what direction he was looking.
