# Root Cause Analysis of the Uncontrolled Hydrocarbon Release from Aliso Canyon SS-25

May 16, 2019

Root Cause Analysis Report

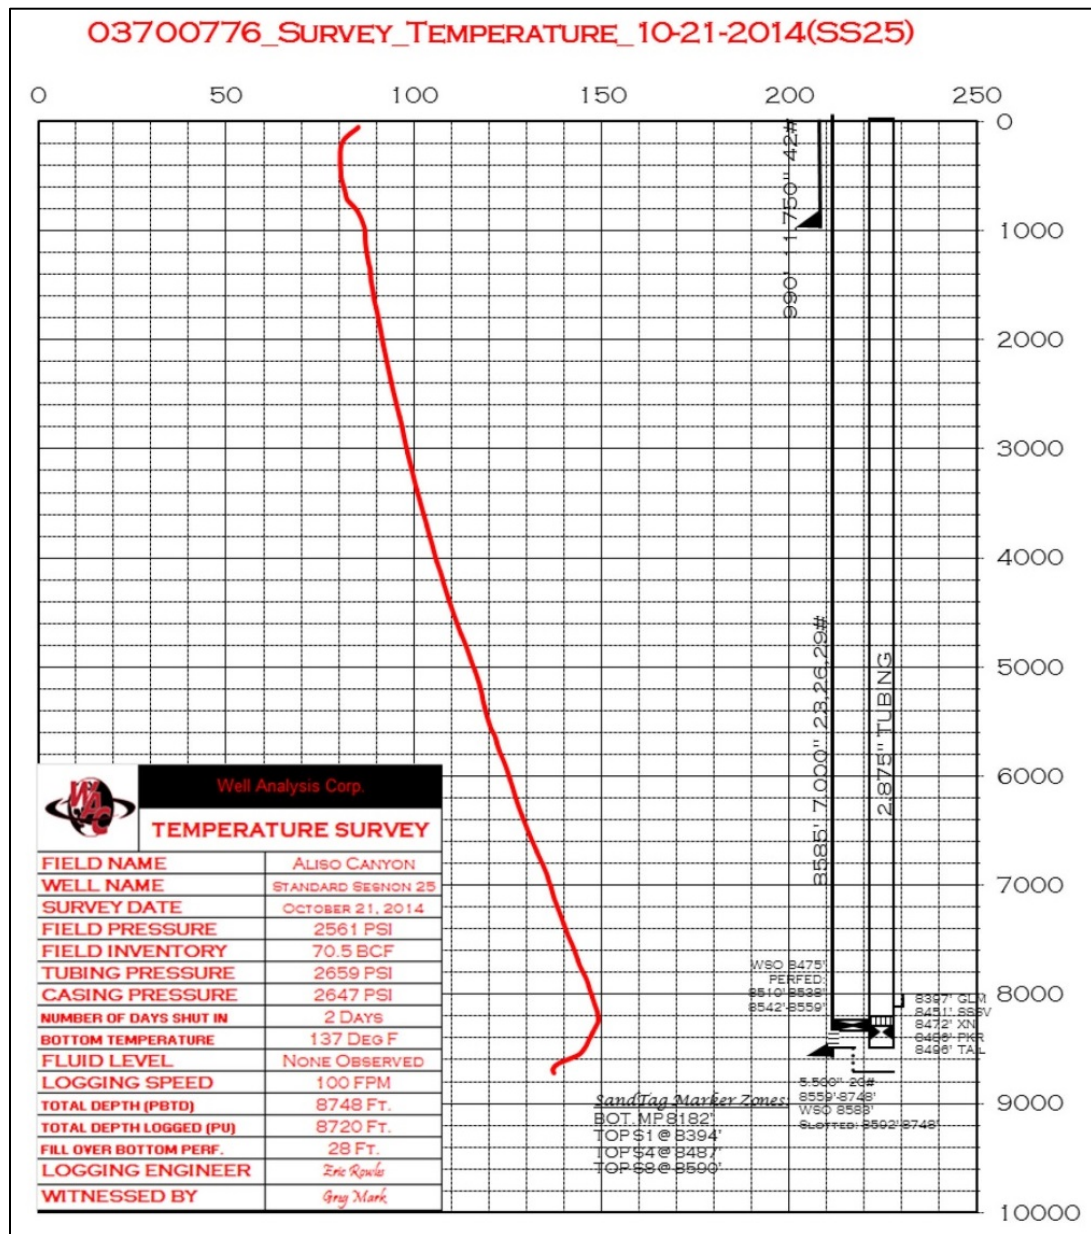
**Figure 14: Temperature Survey on October 21, 2014**

Figure 14 shows the temperature survey from October 21, 2014, the *last* survey before the incident of October 23, 2015, and shows no anomalies related to casing integrity. A cooling feature was found below approximately 8,200 ft related to gas injection and withdrawal, but it was not related to a casing integrity issue.

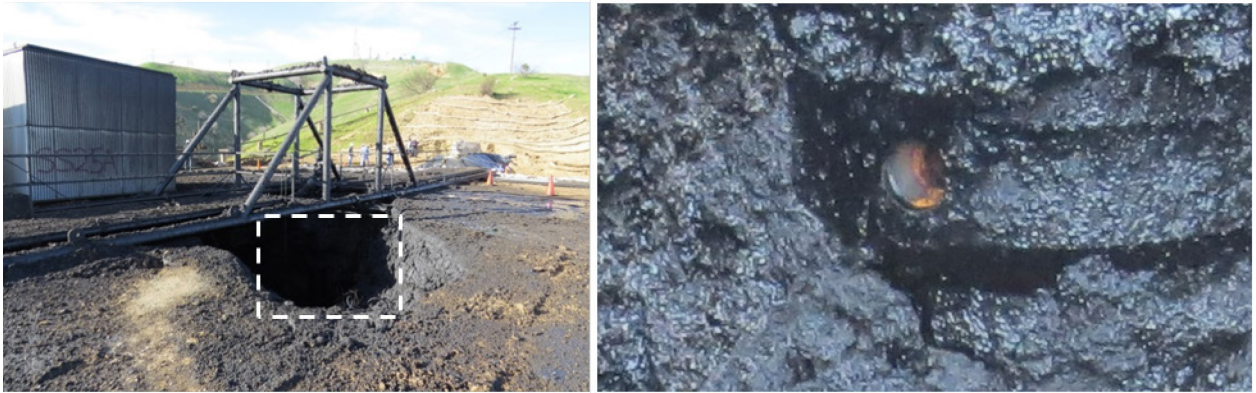
**Figure 18: Photos of Missing 11 3/4 in. Casing Valve Taken on February 25, 2016**

Figure 18 shows an image of the location of the missing 11 3/4 in. casing annulus valve. The valve backed off during the kill attempts and was not located during the Phase 1 evidence search. The valve most likely ended up at the bottom of the crater with the SS-25 cellar. The cellar collapsed to the bottom of the crater during its formation. A portion of the concrete pad that was attached to the cellar was hanging

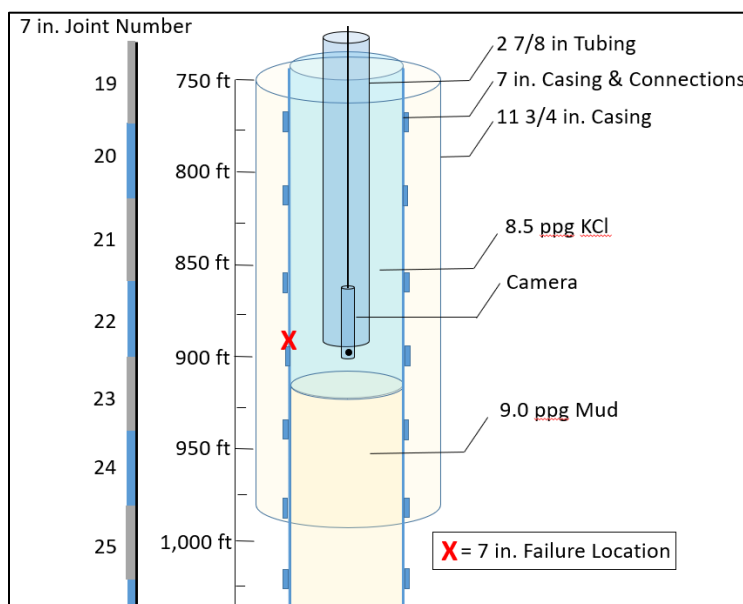
**Figure 23: Well Configuration for Through-Tubing Camera Run to View 7 in. Failure Area**

A Baker Hughes wireline was rigged up and used to run the EV downhole video camera through the tubing and into the 7 in. casing. Figure 23 shows a schematic of the well configuration for the video camera work. With the video camera positioned at the end of tubing, the tubing was slowly raised while simultaneously pumping clear 8.5 ppg KCl fluid. Pumping continued while the ID of the 7 in. casing was observed with the camera.

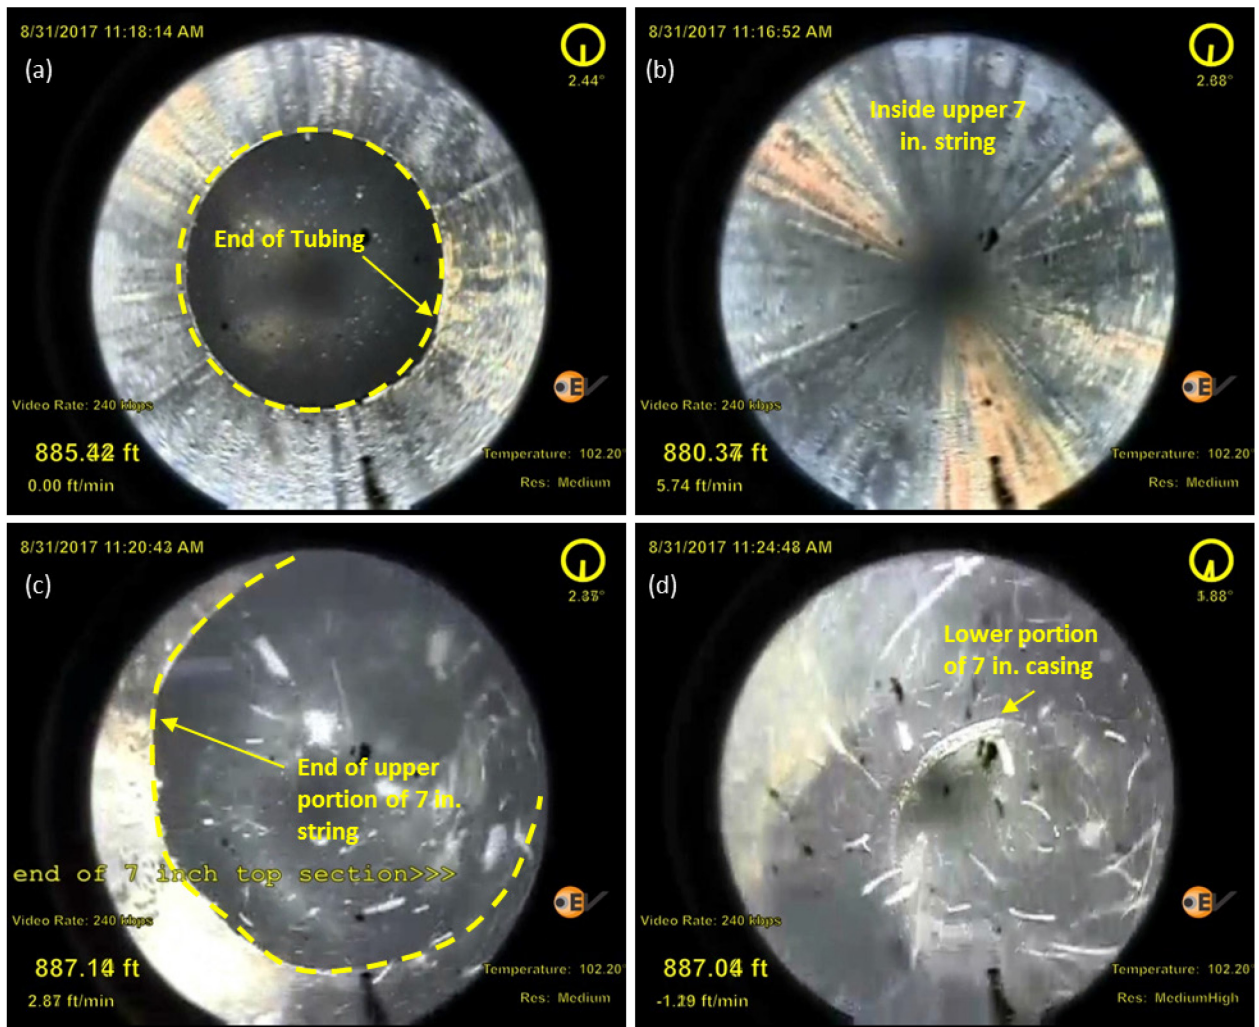
Figure 24: EV Lower Camera Snapshots from August 31, 2017 Showing the Parted 7 in. Casing

Figure 24 shows images extracted during the camera run. Figure 24 (a) shows the end of the tubing, which was set at approximately 885 ft. Figure 24 (b) shows the camera inside the upper 7 in. casing string after exiting the tubing. Figure 24 (c) shows the end of the upper 7 in. casing string. This was the location of the parted 7 in. casing. The camera exited the upper string and looked down at the lower string. Figure 24 (d) shows the lower 7 in. casing string offset from the camera. The lower string was sitting approximately 5 in. below the upper string. The camera runs confirmed that the 7 in. casing was parted and that the lower fish was offset from the upper string.

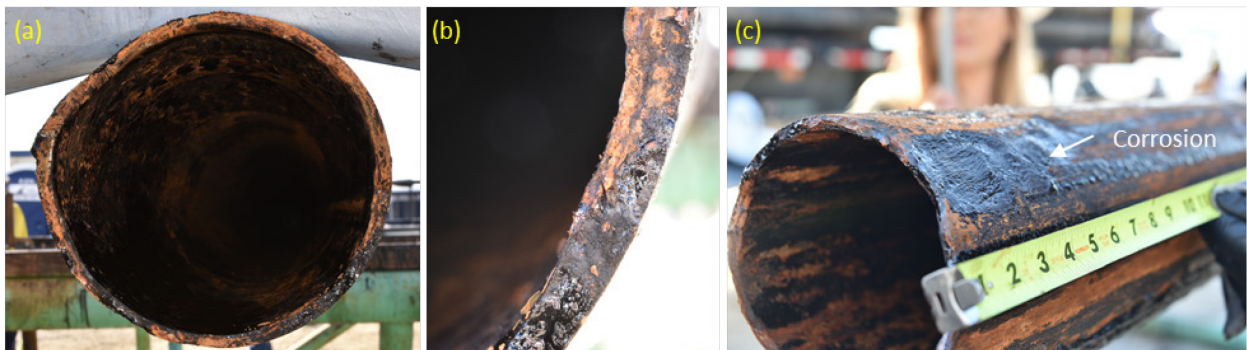
**Figure 27: Parted Casing (C022) on the SS-25 Pipe Rack**

The upper circumferential fracture surface was examined on the SS-25 pipe rack. Figure 27 shows an (a) overall and (b) close-up image of the fracture surface. The images show that the fracture surface was obscured by the presence of oil and scale. The circumferential fracture surface appeared mostly flat with a pointed section that faced the south side of the rig floor. Figure 27 (c) shows corrosion features adjacent to the fracture surface.

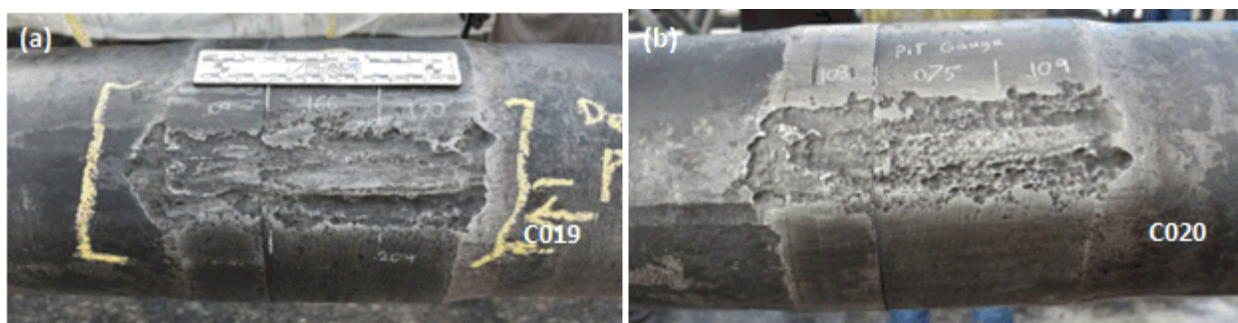
**Figure 29: Connection Corrosion on (a) C019 and (b) C020**

Shallow metal loss was first identified on the C014 connection and was present on the remainder of the extracted casing pipe bodies and connections. Corrosion was identified on many of the connections below C014 with increasing severity. Figure 28 shows the shallow corrosion on the C014 connection. Figure 29 shows corrosion on the connections for (a) C019 and (b) C020. The corrosion is similar to C014's but more severe.

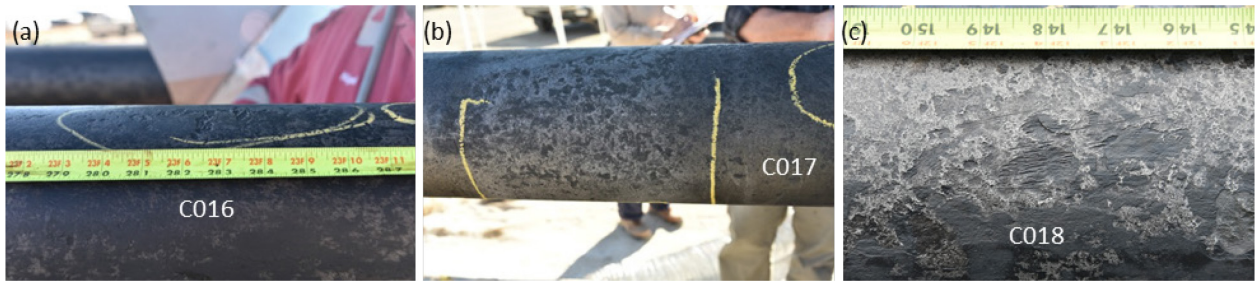
**Figure 30: Pipe Body Corrosion on (a) C016, (b) C017, and (c) C018**

Corrosion was also identified on the pipe bodies, beginning with C014. Figure 30 shows examples of pipe body corrosion from (a) C016, (b) C017, and (c) C018. Figure 30 (c) shows corrosion with striated grooves slightly angled from the longitudinal axis of the pipe. This type of feature was identified at many locations along the casing below C014. Figure 31 shows examples of corrosion with striated grooves from (a) C018 and (b) C022. Figure 32 shows the largest corrosion feature identified during the PS-20 inspection. The shape and morphology appeared to be consistent with the features found on the connections (Figure 29).

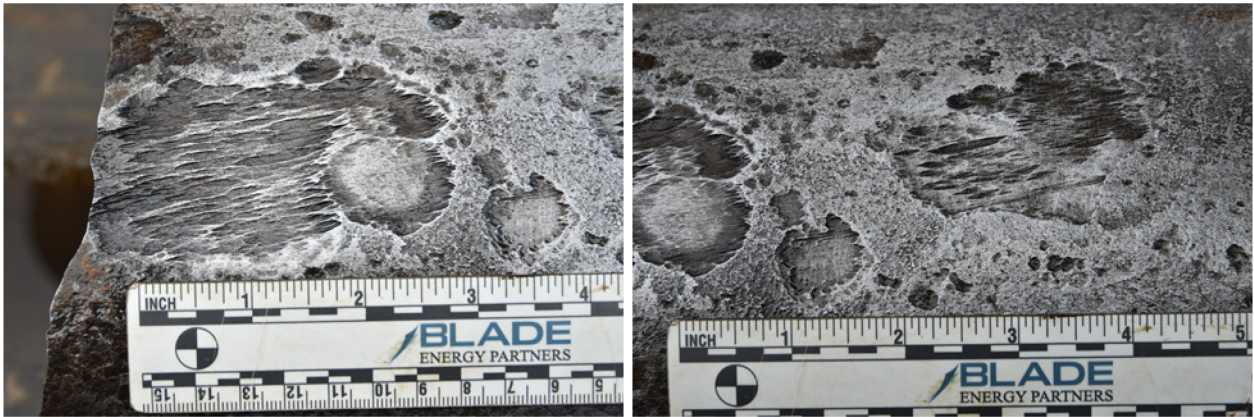
**Figure 35: Corrosion with Striated Grooves Adjacent to Fracture Surface**

The fracture surface was removed from C022 prior to cleaning and inspection. A cut location approximately 1 ft from the fracture surface was selected, cleaned, and inspected with MPI and UT. An additional cut was made on C022 to remove the connection. Figure 33 shows a diagram of the C022 cut locations. The diagram shows that the section containing the fracture surface was designated C022B after the cuts were executed. Cuts were made using the cold cutter as it had been done on the rig floor. Figure 34 (a) shows cutting joint C022. Figure 34 (b) shows the cutoff piece after cleaning with Sentinel 909. Figure 35 shows the C022B corrosion features adjacent to the fracture surface.

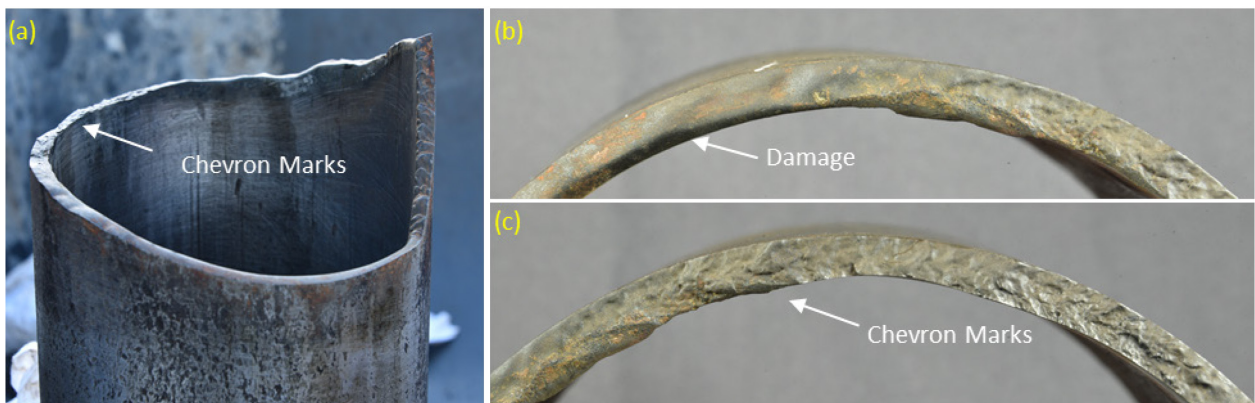
**Figure 36: (a) Circumferential Fracture Surface after Cleaning Showing (b) Erosion and (c) Chevron Marks**

The fracture surface was examined after being cleaned with Sentinel 909. Most of the fracture surface had been eroded, but chevron marks were visible in some areas. Figure 36 (a) shows the circumferential fracture surface after cleaning with Sentinel 909. Figure 36 (b) and (c) shows close-up images of the fracture surface taken in the field lab after undergoing ultrasonic cleaning.

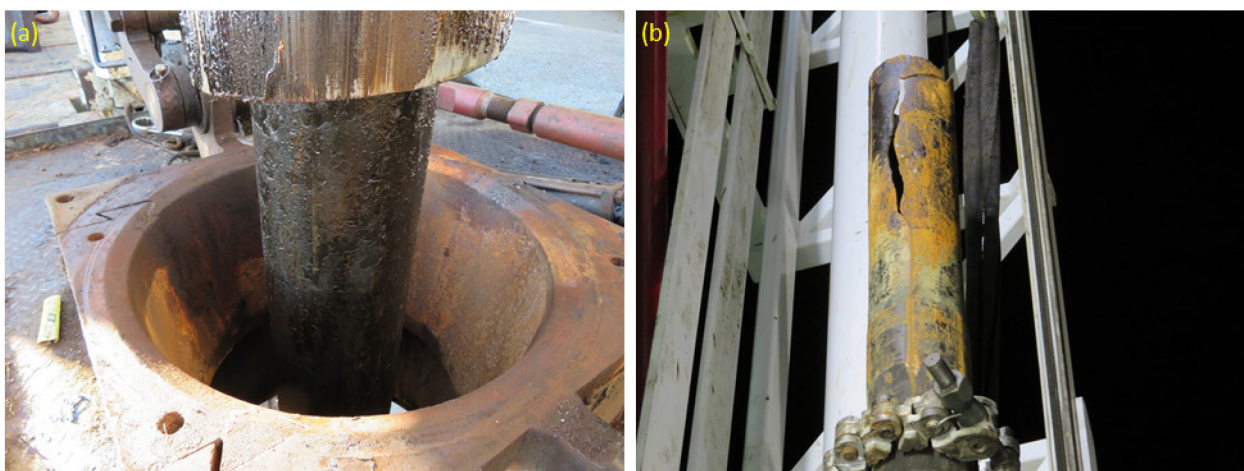
**Figure 39: Lower Section of the Parted 7 in. Casing (a) In and (b) Out of the Pawl Tool**

Figure 39 shows the fish on the rig floor with the tool (a) engaged and (b) removed. This was the first opportunity to visually examine the fish. The first major observation was that there was an axial rupture below the circumferential parting. C023 was moved from the rig floor to the pipe racks using the crane and a nylon sling. The pipe handler was not used to eliminate damage due to handling. The fracture surfaces were wrapped with VCI and covered for the night. C024 was extracted on November 15, 2017. A 13 ft section (C023A) of C023 was cut on the SS-25 pipe rack using the cold cutter to remove the axial rupture and circumferential parting. The pipe sections (C023A, C023B, and C024) were transported to PS-20 for further inspection. These pipe sections were inspected at PS-20 and preserved in the as-recovered condition for further analysis in Houston, TX. No onsite cleaning was done for these samples.

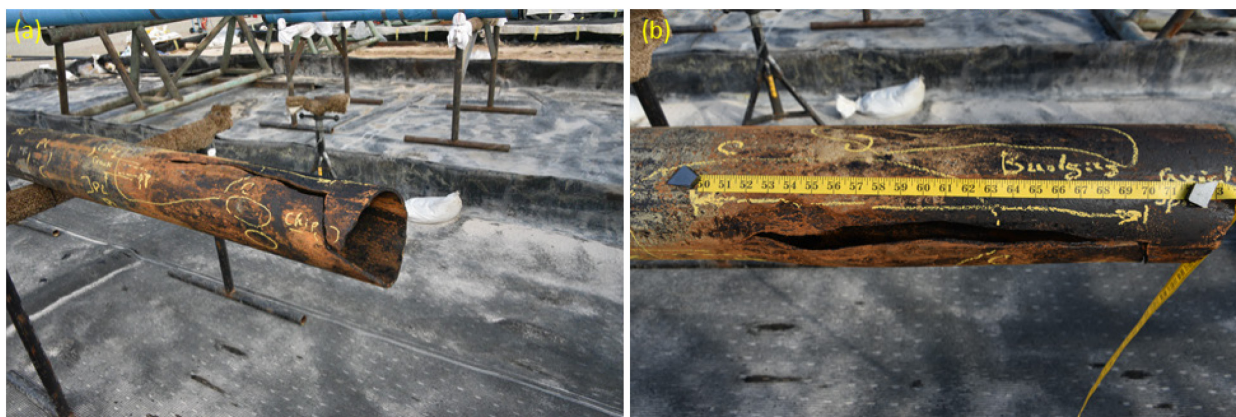
**Figure 40: Axial Rupture and Circumferential Parting (C023A)**

Figure 40 (a) and (b) show the axial rupture and circumferential parting on the 7 in. casing. The axial rupture was surrounded by a corrosion feature and was located below the circumferential parting. Wall thinning, along with bulging was observed near the middle of the axial rupture. The axial rupture had one lower arrest point away from the circumferential fracture, adjacent to the connection. The upper portion of the axial rupture turns similar to the lower arrest point, but was connected to the circumferential parting by an inclined fracture surface.

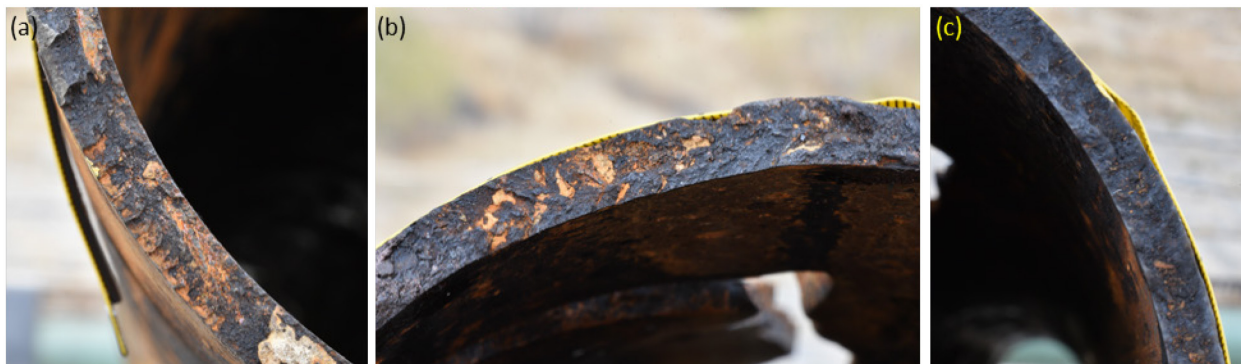
Figure 41: Circumferential Parting Fracture Surface (a) Features, (b) Chevron Marks, and (c) Surface Erosion

The fracture surface was covered with oil deposits and scale products but features were identifiable. Figure 41 (a), (b), and (c) show surface features, chevron marks, and other features, respectively.

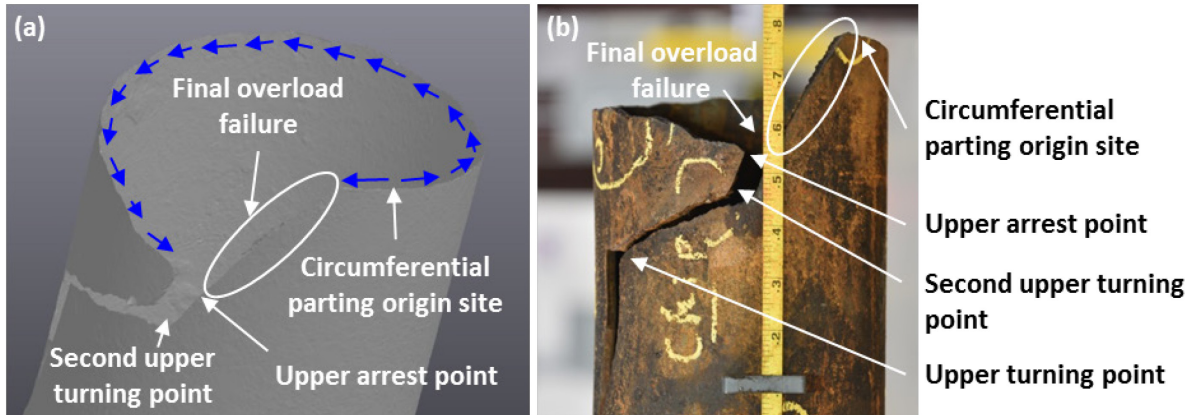
Figure 47: (a) Laser Scan and (b) Photo Indicating Circumferential Parting Initiation Site and Final Failure

Visual and stereoscopic examination of the circumferential parting showed that the failure was not a continuation of the axial rupture, but rather re-initiated near the corner on one side of the parted casing. The origin site was determined based on chevron marks identified on the fracture surface. Figure 47 is a (a) laser scan and (b) image which identifies the upper arrest point, circumferential parting initiation site, and the final overload failure. Figure 48 is stitched stereo images showing the chevron marks and propagation direction of the circumferential parting. These observations indicate that the axial rupture and circumferential parting were two separate events despite their close proximity, and that they are most likely related to each other. This is discussed in more detail later within this section.

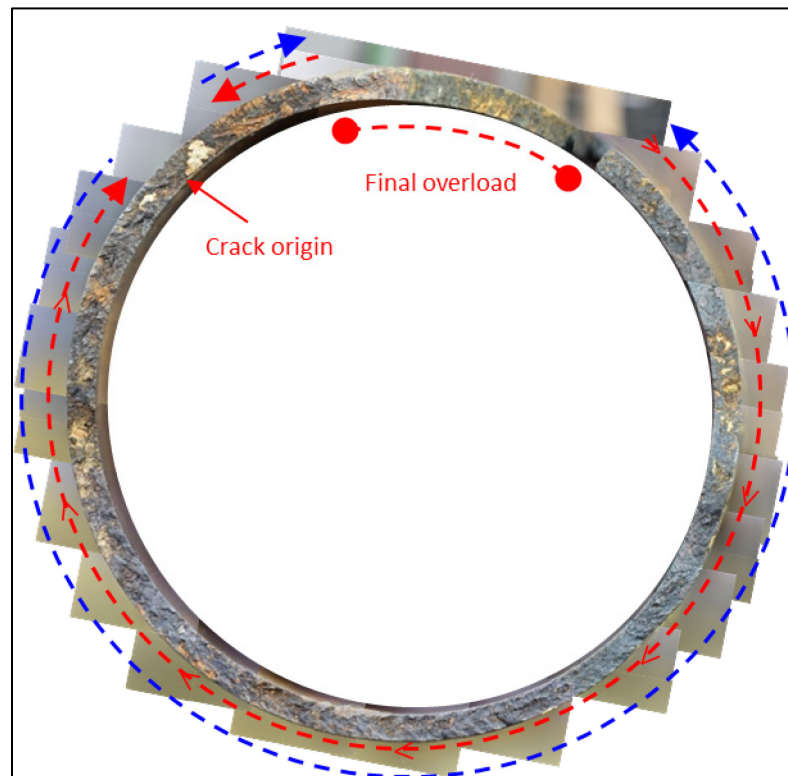
Figure 48: Stitched Images of the Lower Circumferential Parting Fracture Surface

The circumferential parting was brittle, which was different from the axial rupture. No evidence of local plastic deformation or overload necking was observed near the fracture surfaces on either side of the circumferential parting.

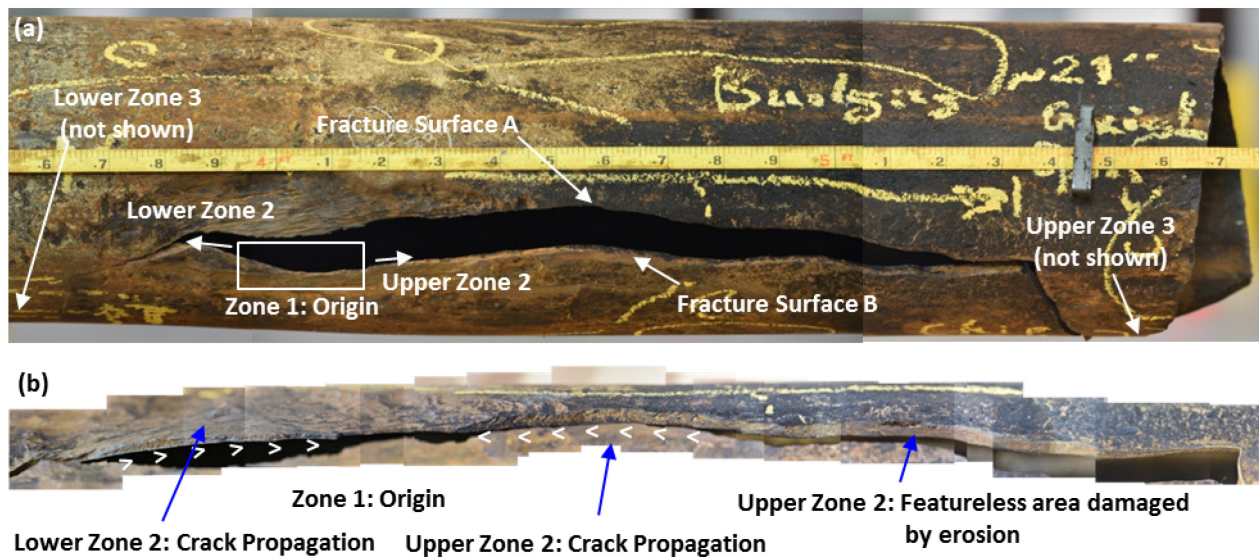
**Figure 50: (a) Front and (b) Top Views of Fracture Surface B Identifying the Three Zones**

Figure 50 illustrates the three zones of the axial rupture. Zone 1 is a short section of the axial rupture, which was identified by severe wall thinning due to corrosion. Zone 2 extends from the lower and upper boundaries of Zone 1 to the boundary of the lower and upper arrest region. Lower and upper Zone 2 contained chevron marks. However, upper Zone 2 contained a featureless segment created by erosion. Zone 3 contained the lower and upper arrest region. The arrest points in Zone 3 cannot be seen in Figure 50 (a) or (b).

Zone 1 was determined based on the chevron marks in Zone 2. The apexes of the chevron marks generally point towards the origin of a failure. The chevron marks in Zone 2 pointed towards the area with the maximum metal loss. Both observations suggested that this area was the origin of the axial rupture, and it was denoted as Zone 1.

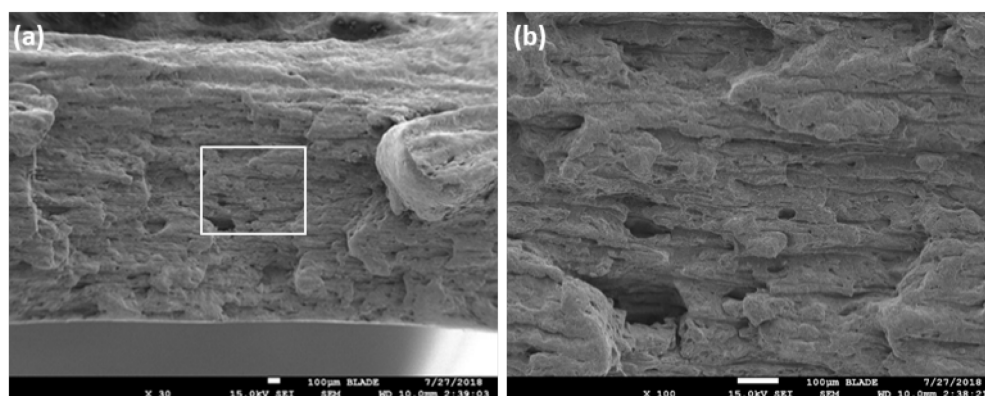
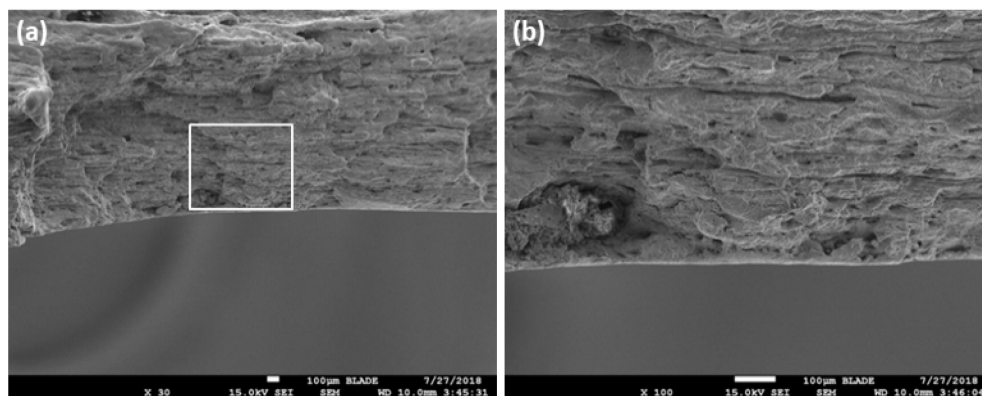
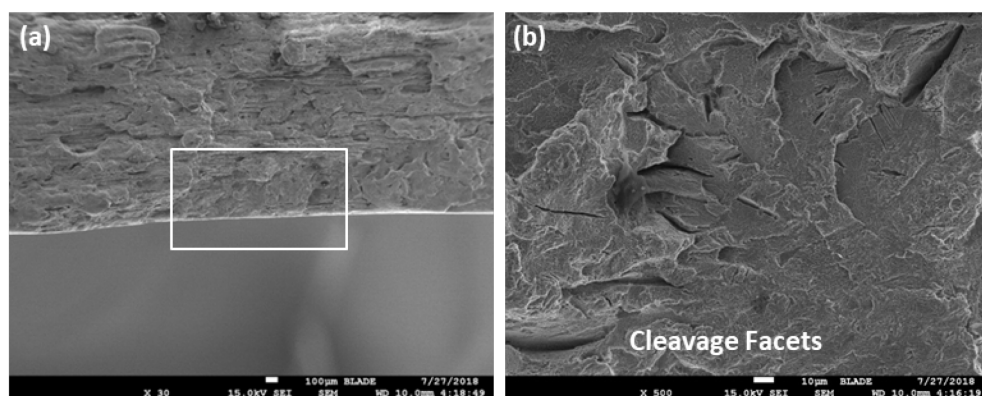
C023A1B2C and C023A1B2D were examined with the SEM at several locations and magnifications to identify the fracture mode of the origin (Zone 1). Figure 53 shows the areas of interest (AOI) chosen during the SEM examination. C023A1B2C contained most of the origin and was selected for detailed examination. Figure 54 and Figure 55 are SEM images of two AOIs (A8 and A17) that represent the typical features identified in the origin during the examination. The images show woody-type morphology, deformation markings, possible dimples, and pearlite-like features. Cleavage and grain boundary facets were not observed in any of the AOIs in the origin.

A transition from ductile to a ductile–brittle mix was observed beginning at A19 (Figure 53). The transition showed a shift from a woody-type morphology to a mix of woody-type morphology and cleavage. The amount of cleavage facets appeared to increase from location A19 to A27. The observations implied that the speed of the axial rupture was increasing through the transition zone until the crack became fully unstable. Figure 56 is a SEM image from A19 showing the ductile–brittle mixed fracture mode. The images show areas of cleavage facets and deformation markings.

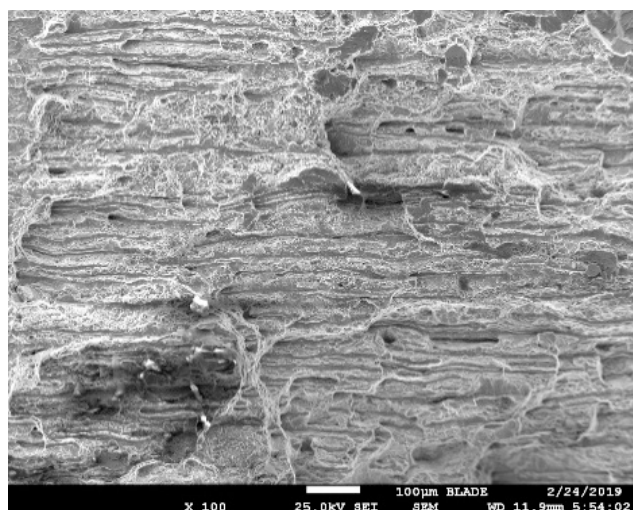
Figure 57: SEM Images of J-R Specimen L4-000 Taken at 100×

The initial examination of the axial rupture suggested that the origin experienced ductile tearing based on the woody-type morphology and deformation markings. The fracture surface produced by J-R ductile tearing tests were used to confirm the ductile tearing observed in the origin. Specimen L4-000 was tested at room temperature, which was comparable to the downhole temperature at the time of the axial rupture. Figure 57 shows SEM images taken at 100× showing the woody-type morphology. Higher magnification images showed the dimpled nature of the surface.

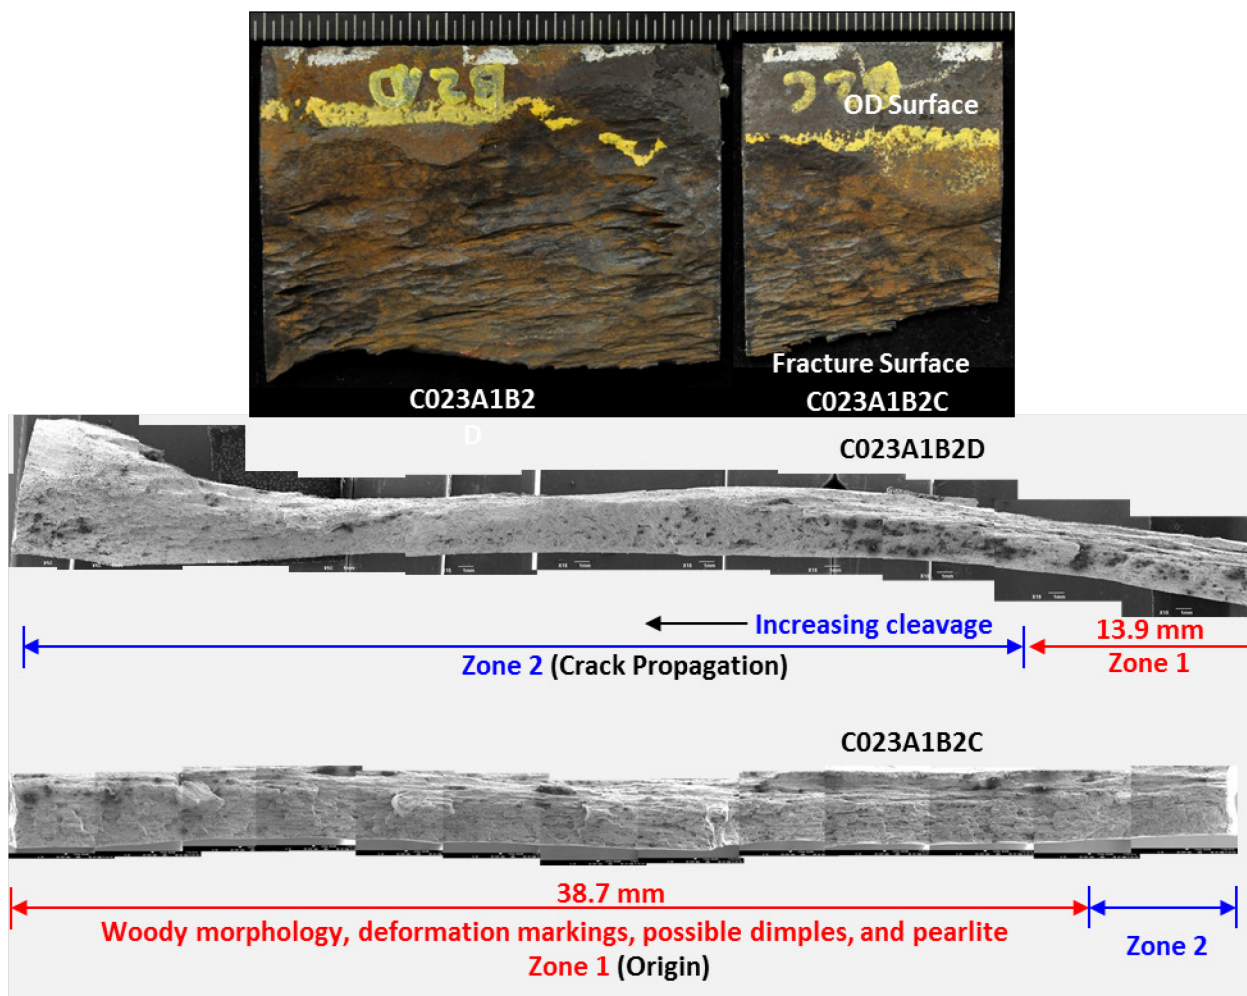
Figure 58: Origin Measurements Based on Micro Definition for C023A1B2C and C023A1B2D

The origin was originally defined based on metal loss measurements and chevron marks identified on the fracture surface. The origin length based on this criterion was measured at 4.8 in. (123 mm). The origin was redefined based on micro-scale features identified on the fracture surface. The micro-scale-based measurement was defined as the length of fracture surface that exhibits fully ductile tearing with no cleavage facets. The origin length based on the new micro-scale definition was 2.13 in. (54 mm). Figure 58 shows the Zone 1 measurements for C023A1B2C and C023A1B2D based on the new origin definition. The origin was measured as 0.55 in. (13.9 mm) and 1.52 in. (38.7 mm) for C023A1B2C and C023A1B2D, respectively. The kerf from the saw cut was approximately 0.06 in. (1.4 mm). The measurements result in a total Zone 1 length of 2.13 in. (54.0 mm). The initial origin length was reduced by more than a factor of two.

The length difference of the origin based on the micro (SEM) and macro (visual) definitions reflects the difference in the role they played for the axial rupture. The micro definition measurement of 2.13 in. represents the initial size of the crack origin. The macro definition measurement of 4.8 in. represents the rapid propagation of the crack as indicated by chevron marks.

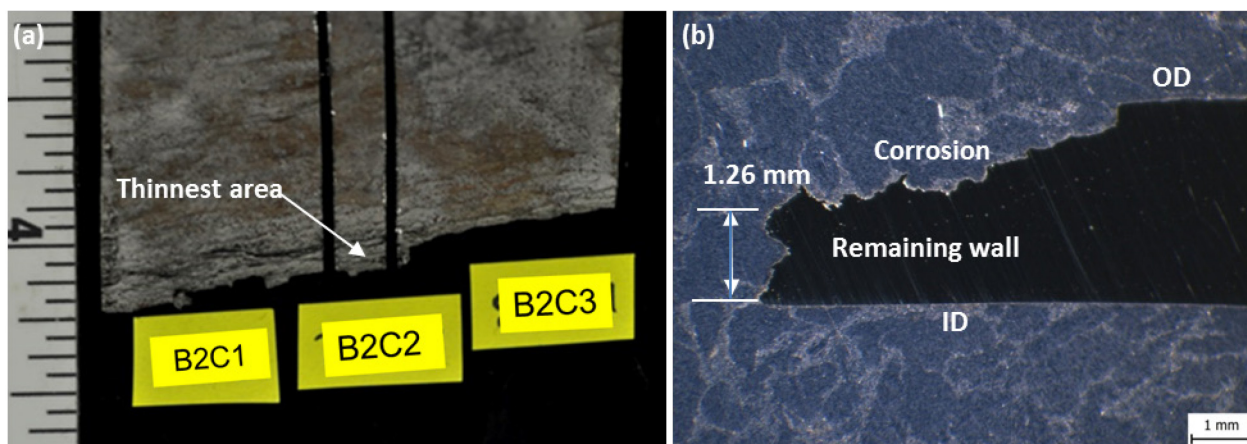
**Figure 59: (a) Macro and (b) Metallographic Image of C023A1B2C2 Showing the Remaining Wall**

A metallographic cross section was made to accurately measure the minimum remaining wall. The origin specimens (C023A1B2C and C023A1B2D) were visually examined to identify the thinnest area. The selected area was cross-sectioned, mounted, and polished for examination with a microscope. Figure 59 shows the location of the (a) metallographic section of C023A1B2C and the (b) measured remaining wall thickness on the polished specimen. The measured remaining wall was 0.0496 in. (1.26 mm), and the measured wall thickness of the unaffected area was 0.321 in. (8.15 mm). The calculated maximum metal loss, or maximum corrosion depth, was 85% actual wall thickness. The refined measurement of 0.0496 in. was accurate and was used as an input parameter for failure pressure calculations.

Ductile tearing and bulging could have contributed to the remaining wall measurement by ductile deformation. The measured remaining wall would then have been a combination of the original metal loss due to corrosion and thinning caused by the axial rupture. Cross-sections adjacent to the fracture surface were examined to determine if bulging and ductile tearing contributed to the remaining wall thickness measurement. Detailed metallographic examination confirmed that the grains appeared equiaxed and not elongated. Therefore, the remaining wall loss of 85% was caused by metal loss due to corrosion.

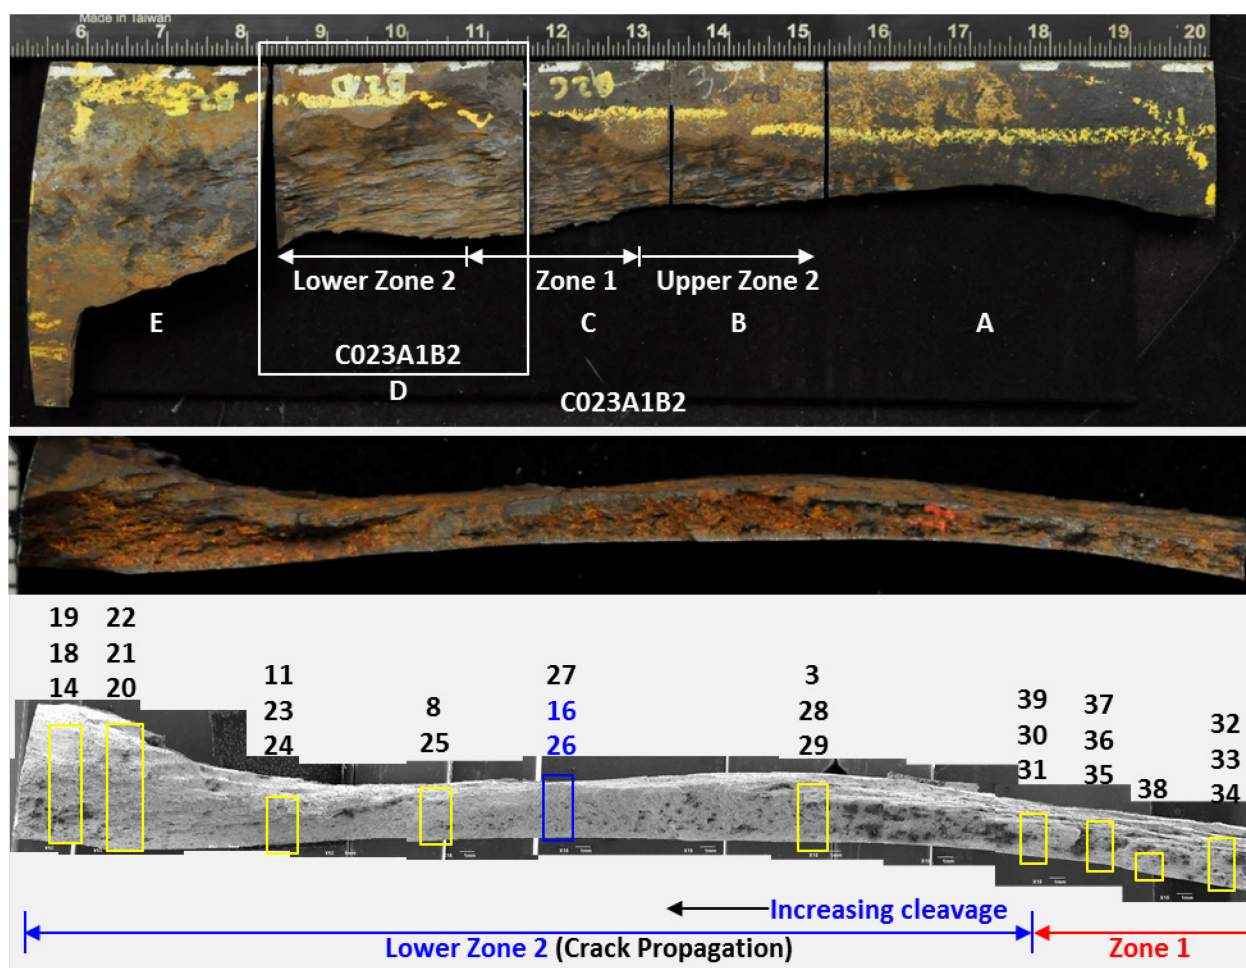
Figure 60: Images Showing Division Between Zone 1 and Lower and Upper Zone 2

Zone 2 was separated into two sections by Zone 1. The two sections are referred to as Upper and Lower Zone 2 in reference to the zones' relative position in the SS-25 well (Figure 60). Lower Zone 2 was examined first with a detailed SEM examination of specimen C023A1B2D. Figure 60 also shows the C023A1B2D fracture surface before (middle) and after (lower) cleaning.

The SEM examination showed a mixed fracture mode that consisted of cleavage (brittle) and micro-void-coalescence and dimples (ductile). The amount of cleavage increased with distance from the origin, but decreased as the crack approached the lower turning point. Figure 61 shows typical SEM images taken from locations in Zone 2.

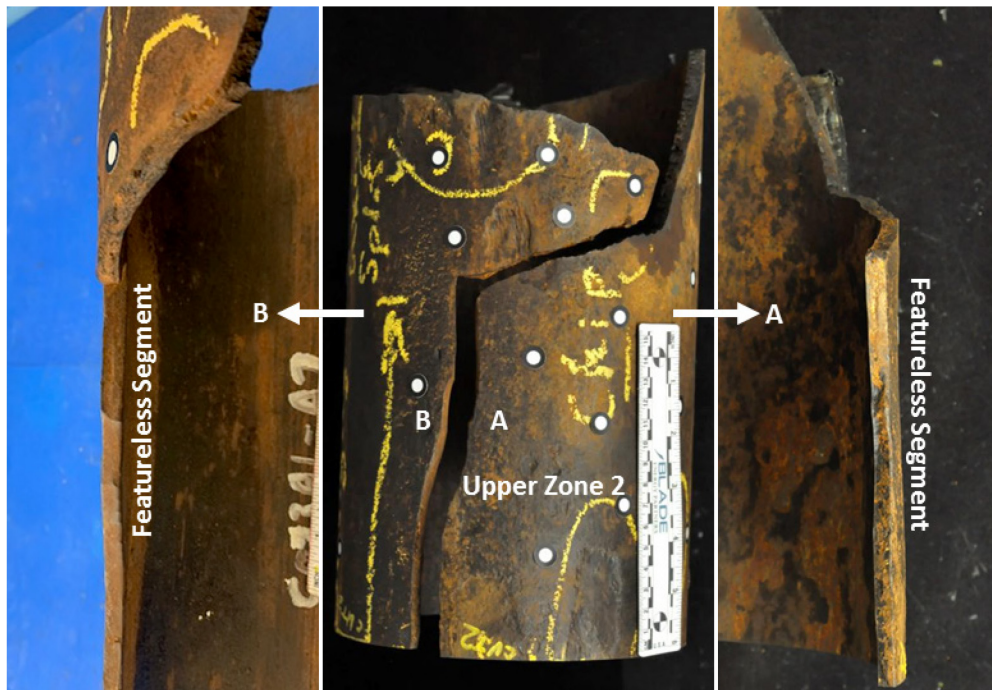
**Figure 62: Overview of Upper Featureless Zone**

Upper Zone 2 contained a 9 in. long featureless region in addition to a region with chevron marks. The 9 in. featureless region appeared relatively smooth with no visible chevron marks. Visual examination of the featureless region suggested that the fracture surface had been eroded due to escaping gas caused by the axial rupture. Figure 62 shows an overview of Upper Zone 2. Fracture surfaces A and B are mating surfaces of the rupture, which show the Upper Zone 2 featureless segment. Fracture surface A was used to characterize the fracture surface, while B was preserved for future investigations.

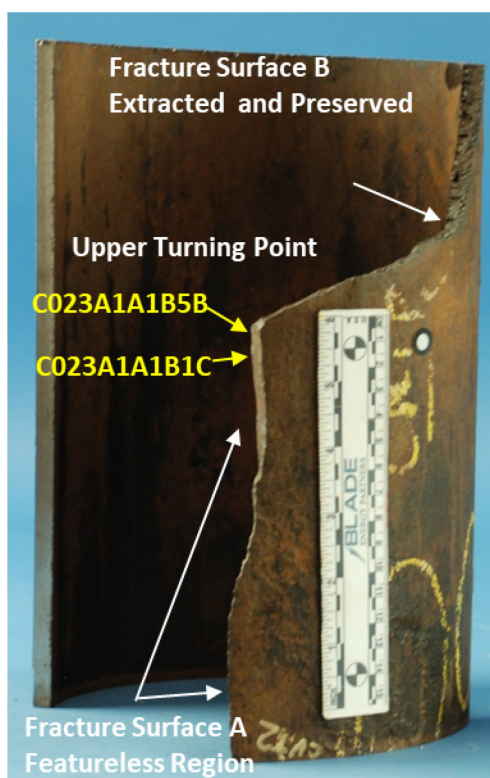
**Figure 63: Fracture Surface A Featureless Region of Upper Zone 2**

Two specimens were investigated to characterize the Upper Zone 2 featureless region. Figure 63 is a macro photograph of the featureless region. Specimen C023A1A1B5B contained a small section of the featureless zone and the upper turning point. Specimen C023A1A1B1C contained a portion of the featureless zone directly below specimen C023A1A1B5B. Both specimens were examined in detail with the SEM.

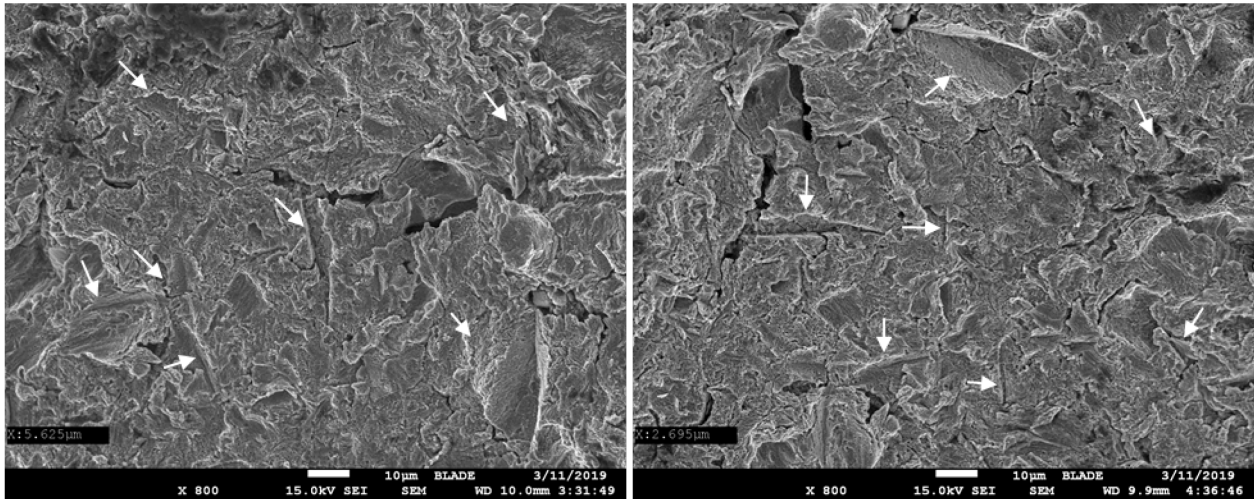
Figure 64: Representative SEM Images of Erosion Marks (White Arrows) Taken at 800×

Specimen C023A1A1B5B was examined first. The specimen was extracted and cleaned ultrasonically in a 1% Citranox solution for six minutes at room temperature. SEM observations revealed an eroded fracture surface with fine erosion marks. Figure 64 shows the representative SEM images of the eroded fracture surface. Erosion marks left on the fracture surface were readily identified at magnifications above 500 $\times$ . Figure 65 shows the measured width distribution of 30 randomly selected erosion marks, which were used to estimate the particle size of the solids in the released gas flow. The results showed that the erosion marks had a maximum measured width of 8  $\mu\text{m}$ , and more than 60% of the erosion marks had measured widths within the range of 4–6  $\mu\text{m}$ . Multiple factors contribute to the width of erosion marks, including solid particle size, hardness, brittleness, speed, and angle of impingement. The particles were assumed to be three times the size of the erosion marks. Based on this assumption, the maximum particle size was 24  $\mu\text{m}$ , and more than 60% of the particle sizes were in the range of 12–18  $\mu\text{m}$ . These observations confirm that the Upper Zone 2 featureless segment was produced by erosion. The observations of specimen C023A1A1B1C were consistent with C023A1A1B5B. Featureless regions were the result of erosion from high-pressure gas with sand particles.

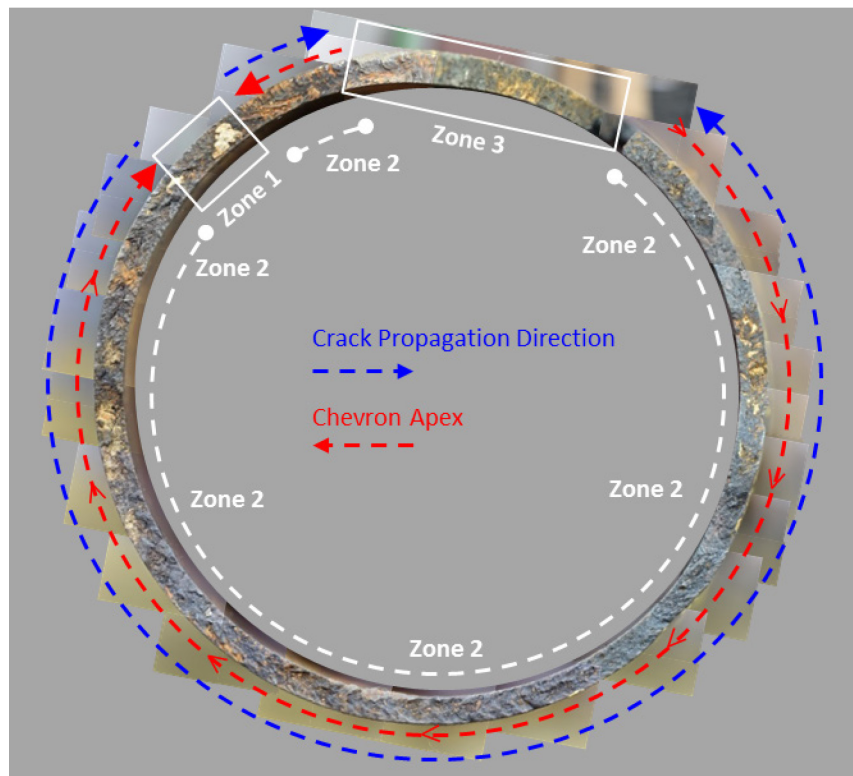
Figure 69: Zone 2 Chevron Marks and Crack Propagation Direction

Zone 2 was characterized by chevron marks with their apexes oriented towards Zone 1 (origin). Figure 69 shows the fracture surface in the non-cleaned condition. The chevron marks are clearly visible on a majority of the fracture surface in Zone 2. Zone 2 is identified by the dashed white circle in Figure 69. The dashed red and blue circles represent the chevron apexes and crack propagation, respectively. Zone 2 began at Zone 1 and arrested at the upper arrest point for the axial rupture. The beginning and end points for Zone 2 are indicated by the white dots at the end of the white circle.

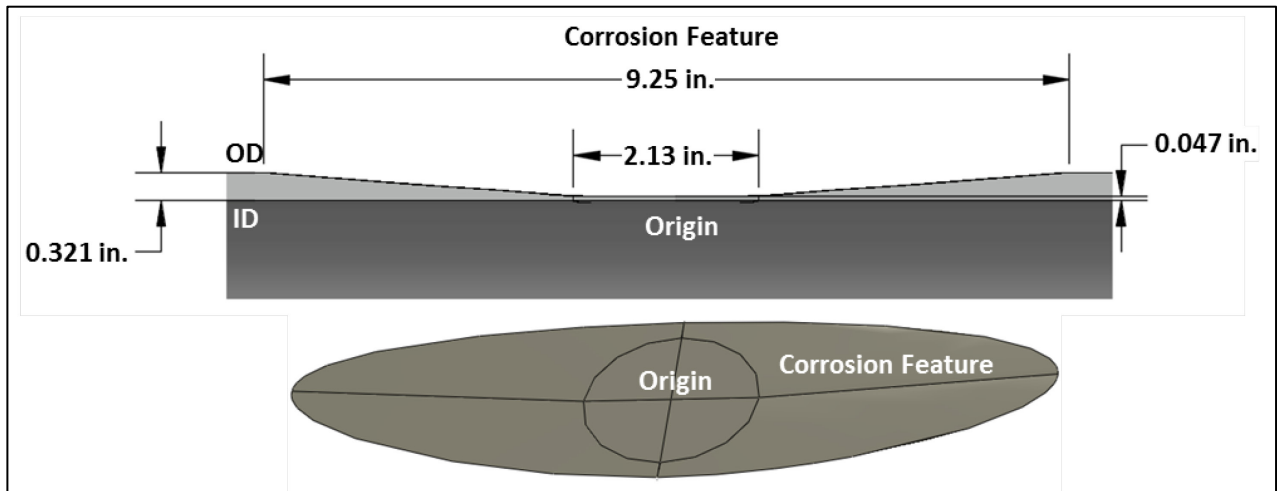
**Figure 71: Corrosion Feature Geometry Model 1**

Model 1 was a simplified model that focused only on the wall thinning effect (Figure 71). The wall loss of 85% (remaining wall of 0.047 in.) is depicted in the origin that was 2.13 in. The overall corrosion feature was 9.25 in. long.

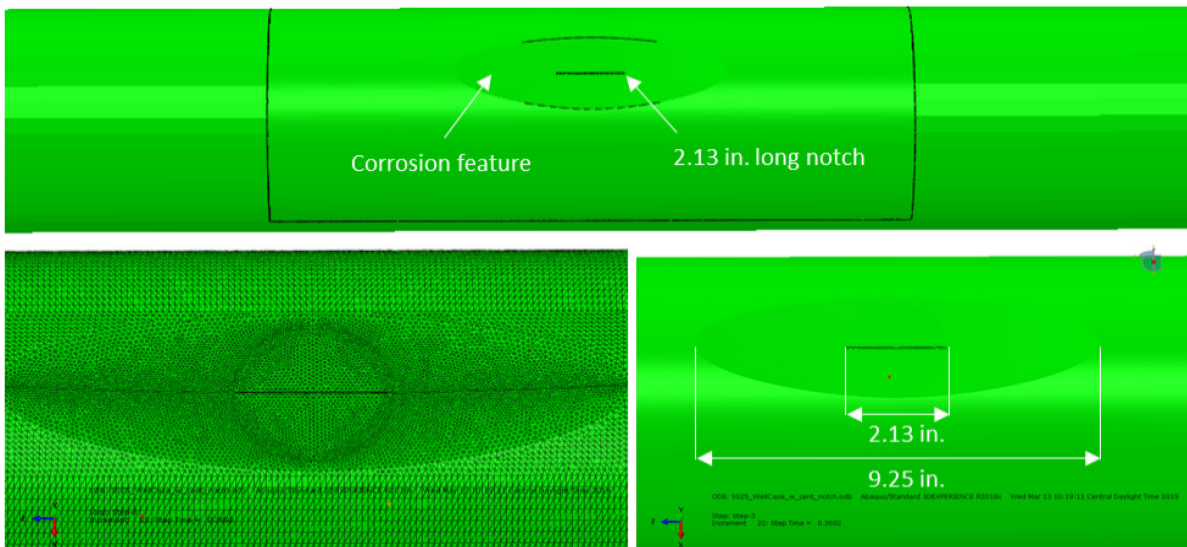
**Figure 72: Model 2 Schematic and Mesh for Corrosion Feature and 2.13 in. Notch**

Model 2 included a notch that depicted the striated grooves that were observed at the failure locations. The grooves' dimensions were measured, and the diameter of the notch was noted to be 0.2 mm. However, the small dimensions were beyond the capability of the FE modeling tools; a notch radius of 1.0 mm was used to capture the notch effect of the corrosion grooves. The bottom of the notch was placed at a depth such that the remaining wall was equal to 1.26 mm, which is the same remaining wall as Model 1.
