# Root Cause Analysis of the Uncontrolled Hydrocarbon Release from Aliso Canyon SS-25

May 16, 2019

Root Cause Analysis Report

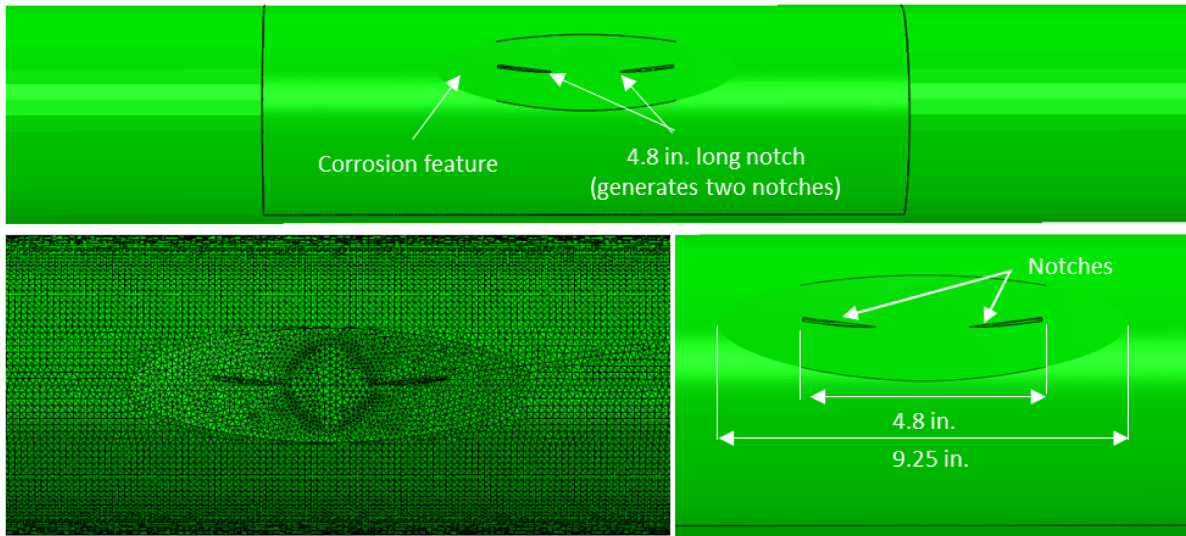
**Figure 73: Model 3 Schematic and Mesh for Corrosion Feature and 4.8 in. Notch**

Model 3 was designed to introduce the notch effect while maintaining the wall thinning within the ductile tearing region (2.13 in. circular region). The semi-elliptical bowl was modeled in the same way as Model 1. Unlike Model 2, the minimum wall thickness of 1.26 mm was maintained within the ductile tearing zone. A notch was introduced with a length increased to the macro definition of the origin (4.8 in.).

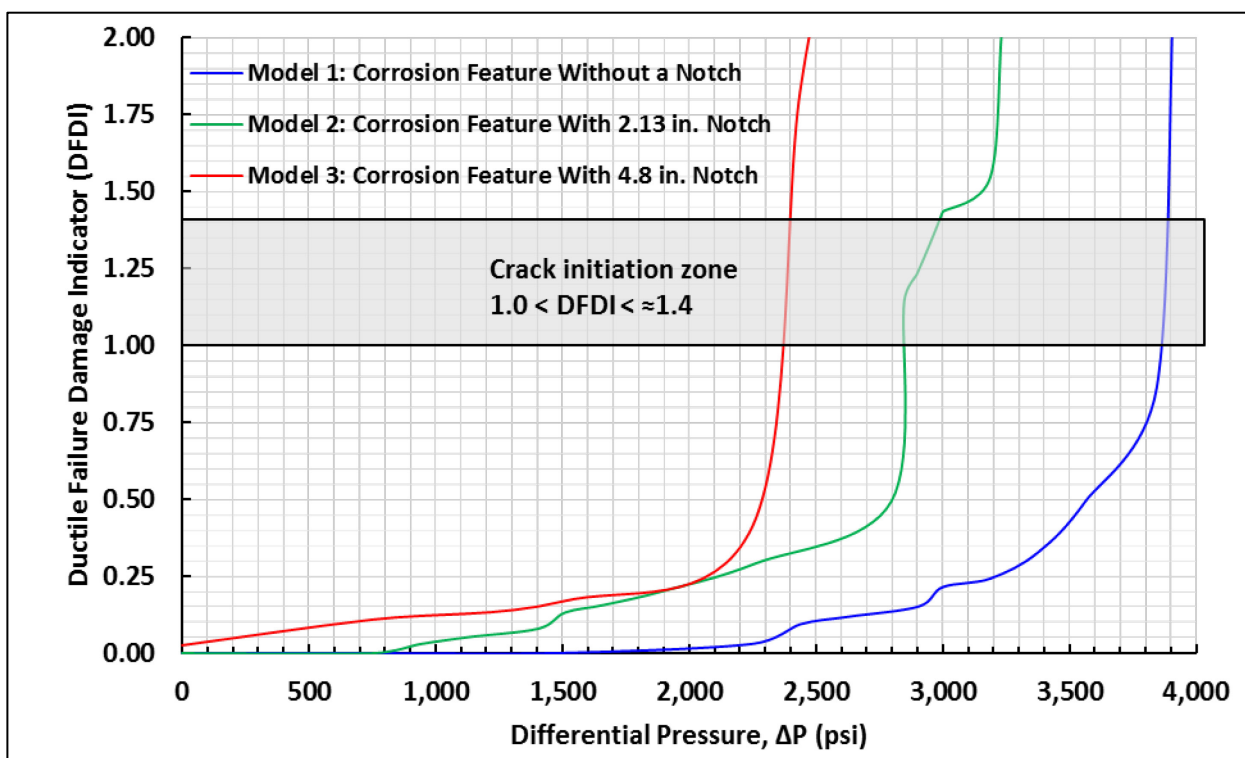
**Figure 74: DFDI Evolution with Differential Pressure for Models 1, 2, and 3**

A DFDI value of 1.0 was used to determine the differential pressure at which a crack would initiate within the corrosion feature. The DFDI is predicted for the three models as a function of pressure, and Figure 74 shows the results. The DFDI evolution is exponential, which implies the DFDI increases from 1.0 to 1.4 with a small increase in pressure. This implies that the crack initiates and grows by ductile tearing.

Table 5 shows the point of crack initiation in the plastic region when DFDI equals 1. The pure corrosion wall loss model predicts a pressure of 3,850 psi for a crack to initiate in this region. As shown previously in Table 4, the internal pressure on October 23, 2015, reached around 2,700 psi on surface and 2,791 psi at 892 ft. Model 1 schematic of the corrosion is not reflective of the failure scenario. Models 2 and 3 have differential pressures ranging from 2,327 to 2,836 psi, which is in the range of the pressures that existed at 892 ft. Since neither model completely captures the complexity of the failure region due to limitations of the FE modeling, the predicted range of failure pressures is from 2,327 to 2,836 psi. The key finding from the modeling is that the presence of the grooves was an essential element of the failure occurring at 2,791 psi internal pressure.

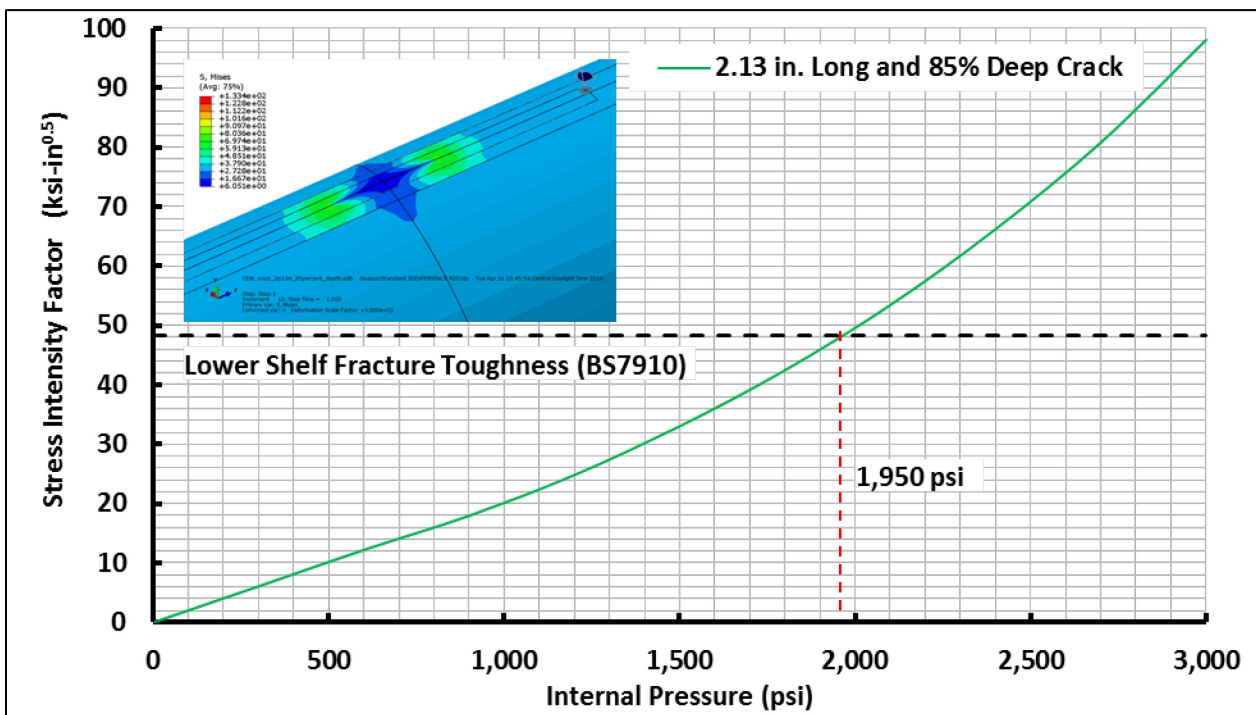
Figure 75: Stress Intensity Factor Evolution with Applied Internal Pressure

Charpy data were used to establish the fracture toughness of this material. The 7 in. casing J55 material exhibited lower shelf toughness properties at temperatures of 75°F (24°C). At room temperature, the average full size Charpy is around 14 J. This Charpy was converted to lower shelf fracture toughness ( $K_{IC}$ ) based on equations from BS7910 and equals 48.3 ksi-in<sup>1/2</sup> shown with a dashed line in Figure 75.

In the FE model of the crack, the crack tip stress intensity factor reaches a value of 48.3 ksi-in<sup>1/2</sup> equaling the fracture toughness when the internal pressure was approximately 1,950 psi. Figure 75 shows the results of the fracture mechanics analysis. The crack is unstable beyond 1,950 psi at room temperature. The results show that a 2.13 in. long and 85% deep crack would propagate at differential pressures  $\geq$  1,950 psi. The estimated strain-based failure pressure (2,327—2,836 psi) is above the fracture toughness-based instability pressure (1,950 psi). This shows that once the 2.13 in. crack formed by ductile tearing was unstable.

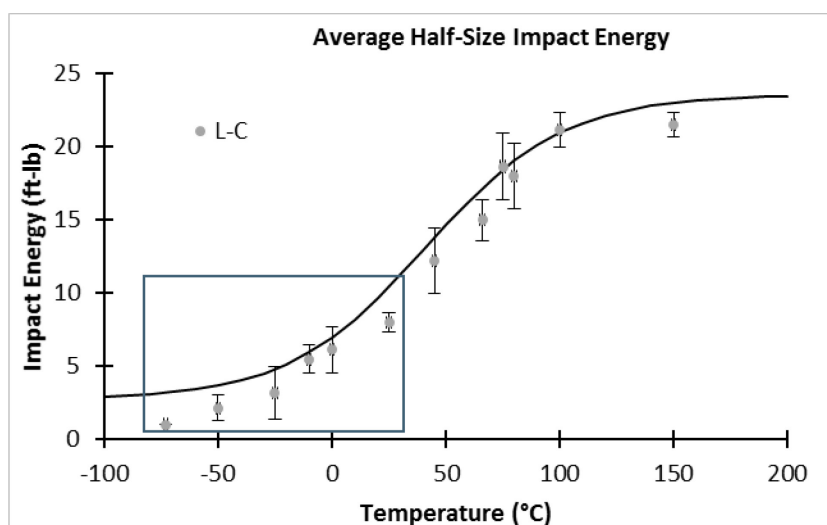
**Figure 76: Average Half-Size Charpy Impact Energy vs Temperature for L-C Orientation**

The region of interest is the lower shelf that is marked by the box in Figure 76. Fracture toughness has been correlated to Charpy data for the lower shelf based on BS7910, which is shown by the equation below.

The fracture toughness that is estimated for the circumferential parting (Table 6) is correlated to Charpy. Then, from the Charpy data, the temperature is estimated and shown in the last column. The circumferential parting occurred at a temperature that would have ranged from –76°F to –38°F (–60°C to –39°C); the range is defined by the defect dimensions and the fracture mechanics model that is used.

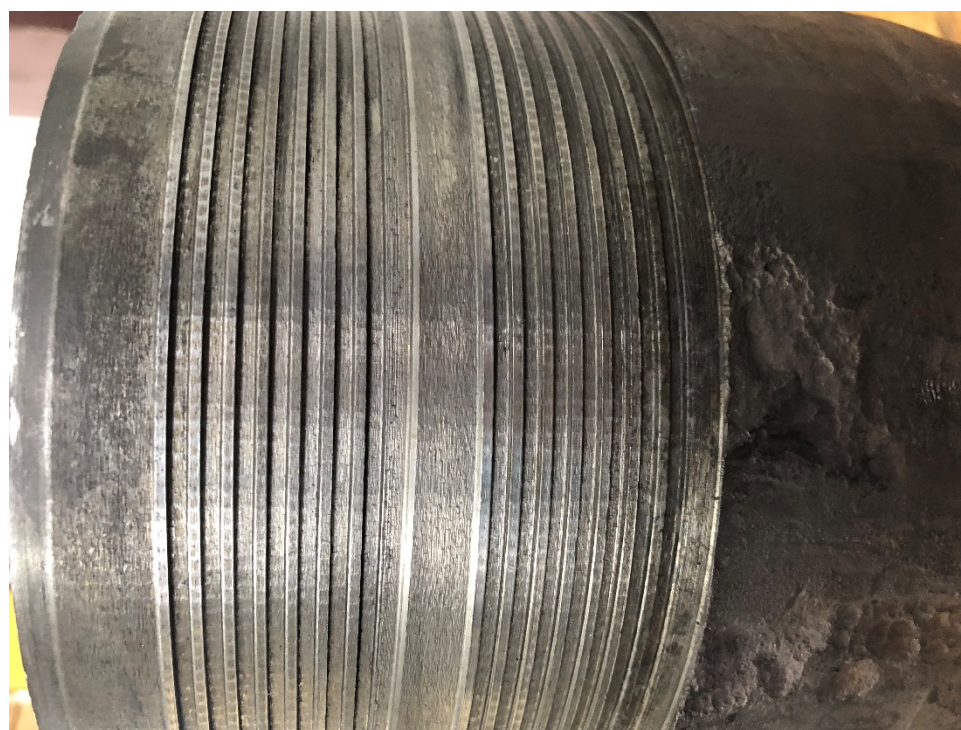
Figure 78: Pin and Box from Leaking Connection C023A1C

The highest leak rates came from C016B and C023A1C, which leaked at 1,120 SCCM (57 scf/D) and 196 SLM (9,967 scf/D) respectively. Connection C023A1C was located in the well 2.3 ft below where the 7 in. casing parted. The remaining seven leaking connections had very low flow rates.

None of the rates were high: there were no indications of any thread erosion as shown in Figure 78. The threads appeared to be in as-machined condition; however, the testing showed that for C021B at 1,000 psi the connection was leaking at more than 4 SCCM, whereas at 3,300 psi the leak rate was 128 SCCM. The leak rates were low and it could be stated that the gas seeped through the connections. The connection testing results were reproducible, implying that the nine connections leaked, albeit at low flow rates. Consequently, the conclusion based on the examination of the threads and the connection testing results was that hydrocarbon gas seeped through some of the connections at low flow rates.

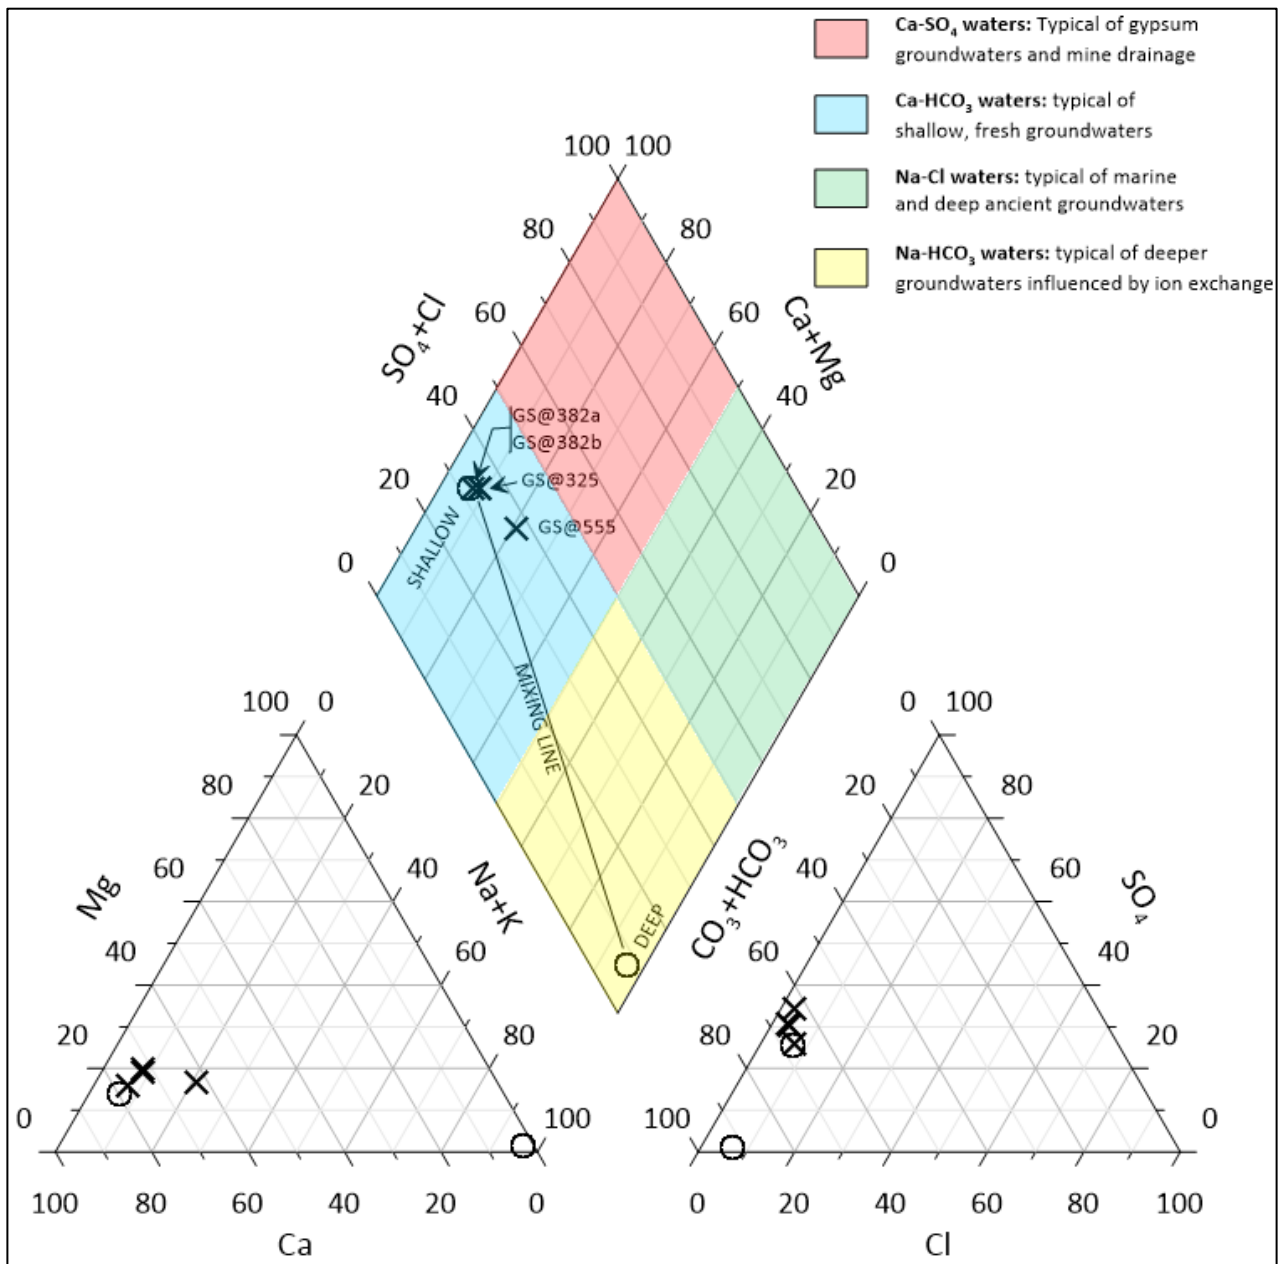
**Figure 80: Piper Plots Showing all the Water Analyses**

To interpret the water samples, the grab samples that were collected while drilling and the samples collected from the two monitoring wells are depicted on a Piper Plot in Figure 80 [27]. The grab samples compared to the monitoring well samples from shallow depth were identical, which was expected. These waters had calcium cations with bicarbonate. However, the deeper sample was richer in sodium with bicarbonate anions. The cations were different for the shallow versus the deeper water samples.

The difference in the water samples may be due to a mechanism that is discussed in hydrochemical literature known as ion-exchange [28]. The interaction of the water with the clay minerals has been known to result in an exchange of the ion from the water with that adsorbed on a solid. Clays are known to have high ion-exchange capacities when compared to other minerals. As the water permeated deeper into the formation, it would have encountered other clay formations, and the calcium ion would have been replaced by the sodium ion. This mechanism explains the difference in water chemistry between the shallow and deeper samples.

There were distinct shallow (340 to 440 ft) and deeper (900 to 1,000 ft) groundwater with slight differences in water chemistry. This water likely represented the environment in the production casing annulus and outside of the surface casing.

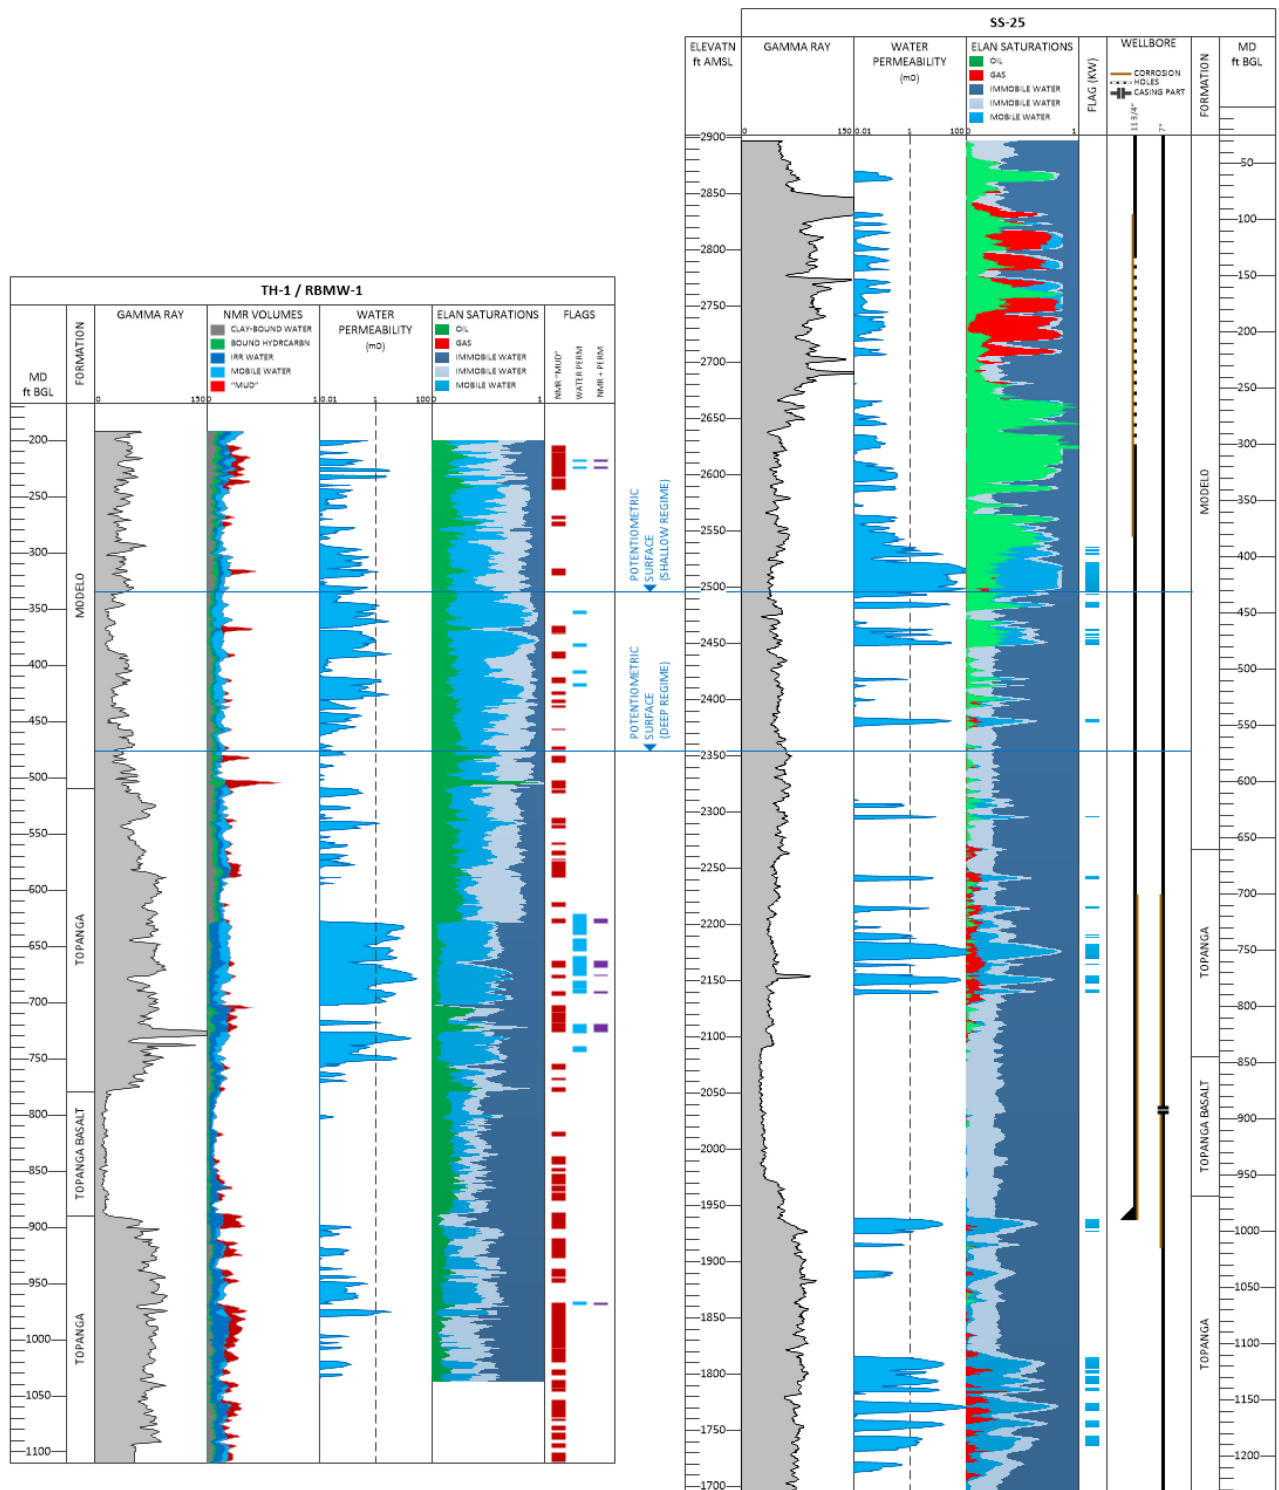
Figure 81: Correlated Geophysical Logs for RBMW-1 and SS-25 Wells

In summary, Figure 81 suggests that the mobile water is encountered in distinct higher-permeability layers in both Modelo and Topanga formations, but not in the basalt layer. From both logs, the basalt contains no water in SS-25 and RBMW-1. Below the basalt, there is a distinct water zone ranging from 990 to 1,010 ft in SS-25 right at and below the 11 3/4 in. shoe. There is a water permeability streak and mobile water between 990 and 1,010 ft in SS-25. This was likely the source of water that entered the production casing annulus. Further, several shallow high-permeability water layers are observed in both

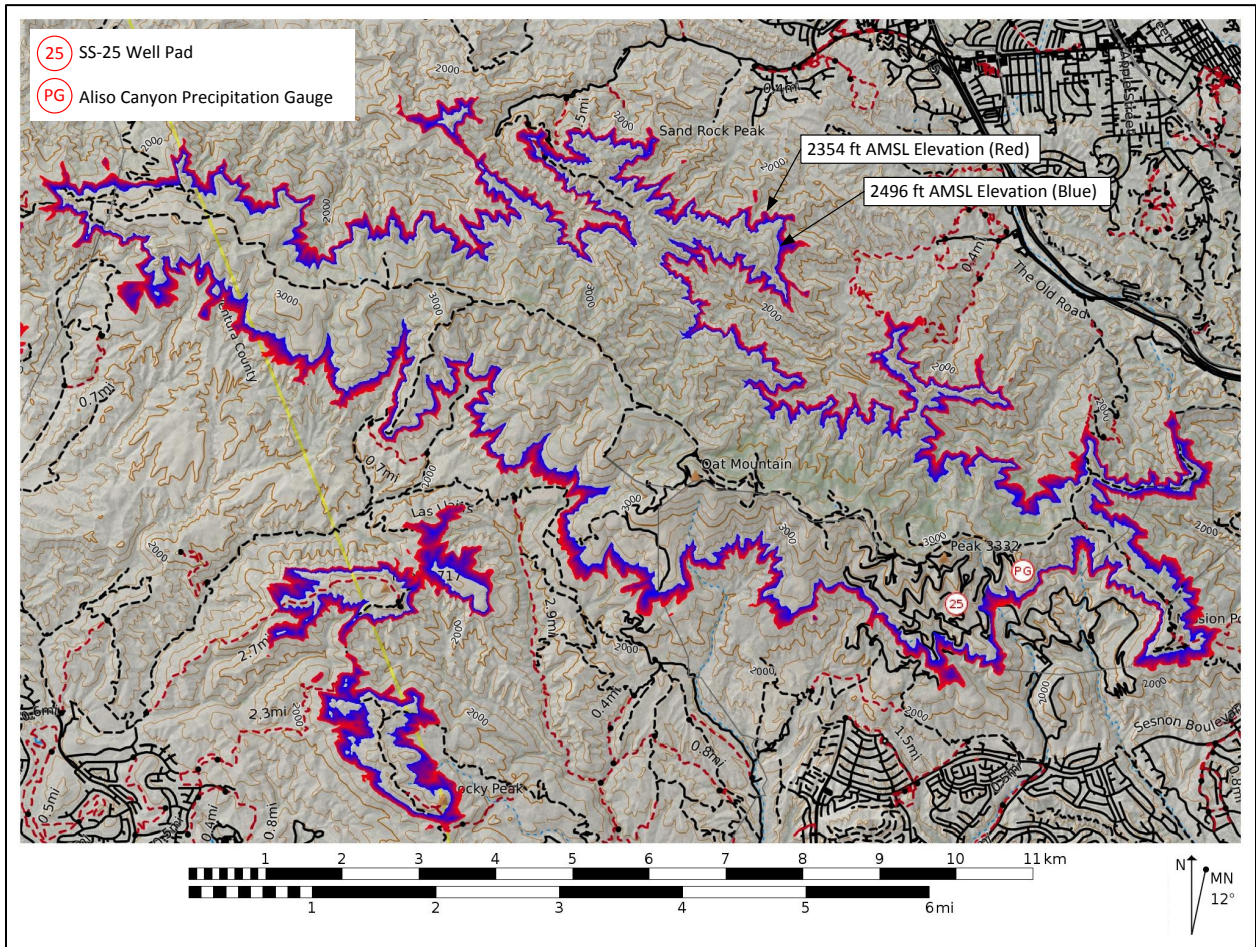
Figure 82: Regional Elevation Contour Map [29]

The standing water level in RMBW-1 was 2,354 ft above mean sea level (AMSL) (483 ft) and in RMBW-2 was 2,496 AMSL (341 ft). Therefore, the source of groundwater must lie above these elevations. Figure 82 shows the elevation map around Aliso Canyon field. The 2,354 ft AMSL and 2,496 ft AMSL levels are marked. In Figure 82, the red-blue shaded (filled) region is the elevations between 2,354 ft AMSL and 2,496 ft AMSL. The red edge of the shaded area is the lower (2,354 ft AMSL) elevation; the blue edge of the shaded area is the higher (2,496 ft AMSL) contour. The source of groundwater must lie within these contours; however, there are no surface bodies of water (such as lakes and rivers) within these contours. Since there is no existing body of water that is a source of groundwater, precipitation that falls within these contours can be the only source of this water.

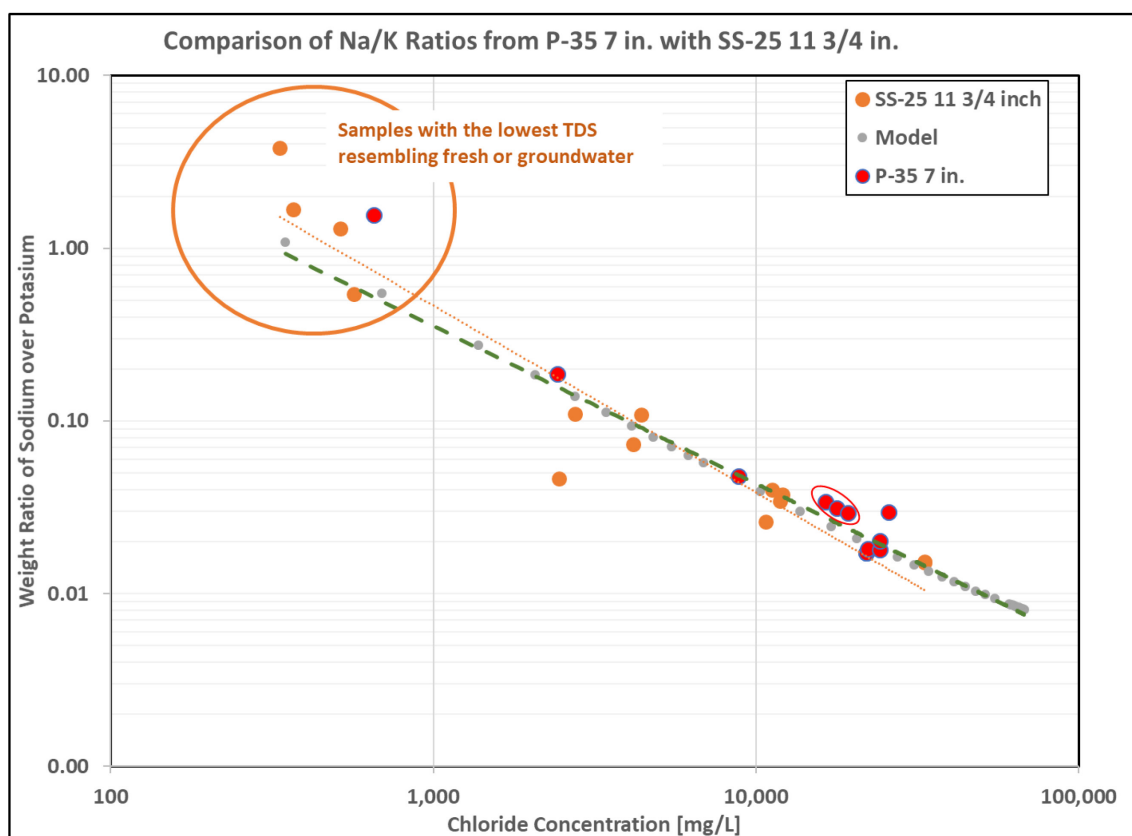
Figure 84: CHDT Results-Ratio of Sodium over Potassium versus Chloride

Through interpretation of the chemical analyses of these samples, it was established that their mineral content varied in wide limits, from about 400 mg/L to over 60,000 mg/L. More importantly, it was also found that the sodium to potassium weight ratio in the many samples that were collected from both wells increased exponentially with a decrease in the chloride concentration, as shown in Figure 84.

These results are interpreted by recognizing that during the drilling and completion of these wells, workover fluids, largely consisting of potassium chloride, got sequestered in areas of high permeability and porosity of the formations through which the wells were drilled. In certain locations around 900–1,000 ft (SS-25) and 400–500 ft (P-35), however, high Na/K ratios were found with very low chloride concentrations. This could only have occurred if low salinity groundwater rich in Na and low in K caused the residual, sequestered, workover fluid to be diluted. This dilution process was modeled and the model was found to result in identical relationships for both wells. These results conclusively establish the presence of low salinity groundwater at certain depths. Only if such low salinity groundwater were in fact flowing at these locations would the extreme dilution to less than 500 mg/L chloride in certain samples have been possible.

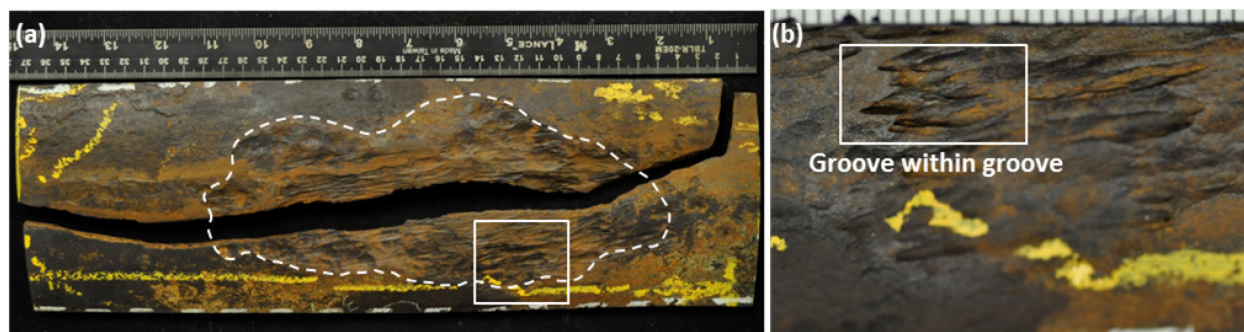
**Figure 89: (a) Joint 22 Axial Rupture and (b) Type I Feature Showing V-shaped Tips**

Type I was typical of the failure location and was characterized by striations as shown in Figure 89. These striation features have a groove with a sharp 'V' on each end of the groove. Type I corrosion could be visually identified, and the size of these features varied by location. The striated grooves were noted in all the joints starting from joint 18 onwards; however, none of the connections exhibited this type of corrosion.

Type I corrosion at the failure location, as shown in Figure 89, is distinct in nature. The possible cause for such corrosion was assessed and investigated by using morphology, scale, and microbial data.

The axial rupture occurred at the location where the Type I corrosion feature was present (Figure 89). Type I features can be described as a patch of metal loss with striated grooves that are oriented 10 to 15 degrees off longitudinal axes. The grooves contained pointed tips as seen in Figure 89. Some groove tips were present within another groove. The Type I metal loss features were observed as isolated patches along the length of the SS-25 7 in. casing. The maximum wall loss within the patch was 85% of wall. Adjacent to the feature was unaffected metal surface (no metal loss).

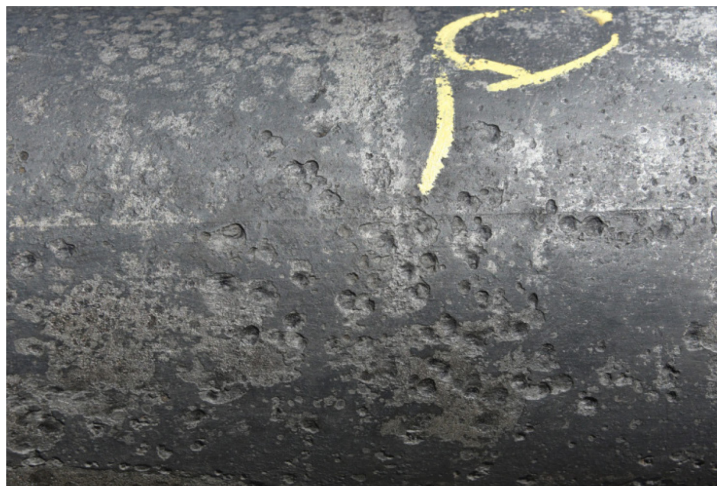
**Figure 90: Type II Corrosion—Isolated Small Pits**

Another type of corrosion that was observed in the joints is classified as a Type II feature as shown in Figure 90. These features were isolated smaller pits, and quite often shallow. These were observed across all of the joints and some connections.

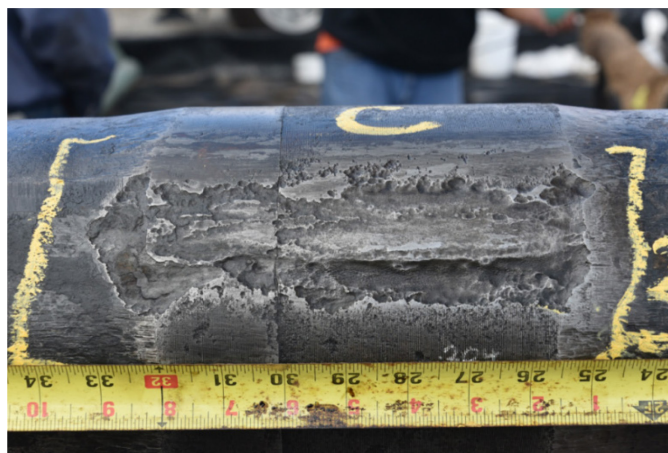
**Figure 91: Type III Corrosion feature**

Finally, Type III features appeared as very unusual elongated shapes. Several small scoop-shaped features adjacent to each other are seen within the elongated region as shown in Figure 91. The middle region of Type III feature is not severely attacked by corrosion. Nearly, every connection from connection 16 onwards exhibited Type III, and it was not noted on any of the joints, with one exception (joint 20).

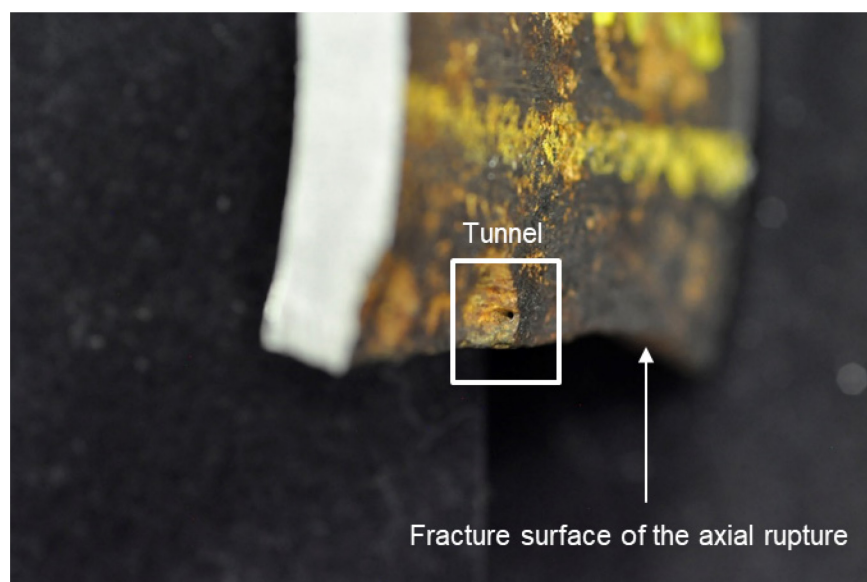
**Figure 92: C023A1-B2A5 Groove Tunnel Adjacent to Axial Rupture Fracture Surface**

The axial rupture specimen C023A1-B2 from joint 22 had a corrosion patch with striated grooves (Type I corrosion feature). The corrosion patch had a length of 9.5 in. along the longitudinal axis. The specimen was divided into smaller sections to facilitate the SEM investigation of the fracture surface and corrosion features. Specimen C023A1-B2A5 from the axial rupture had a visible tunnel in the groove that was visually identified (Figure 92). The tunnel orientation was parallel to the axial rupture fracture surface. The tunnel penetrated the base metal. Figure 93 shows the magnified image of the tunnel using the SEM image of the same tunnel in Figure 92. Within the tunnel there are scale deposits. Despite the samples being exposed to kill and other fluids since the leak event, the scales and other deposits within these tunnels should have been relatively unaffected.

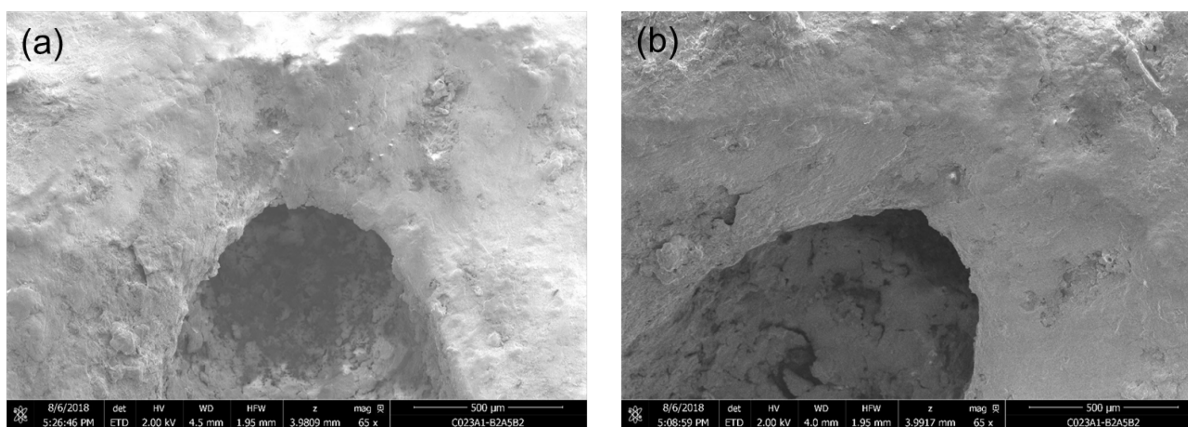
**Figure 93: Specimen C023A1-B2A5B2 Tunnel Seen at Different Angles**

Specimen C023A1-B2A5B2 was subjected to several focused ion beam (FIB) and metallographic cross sections. FIB is a tool that uses a gallium (Ga) ion source to cut the specimen at an angle while inside the SEM chamber and was used to assess the specimen or deposits to minimize any damage during sectioning. The intent of FIB sectioning was to avoid smearing and other modifications of the scale that might have occurred during traditional sectioning. The nature of the base metal and scale was investigated using the SEM after the FIB cross sectioning. The schematic of FIB sectioning and the corresponding SEM views are shown in Figure 94. FIB was used to remove a few microns following the local sectioning; the sectioned regions were pristine and revealed the nature of the deposit layers.

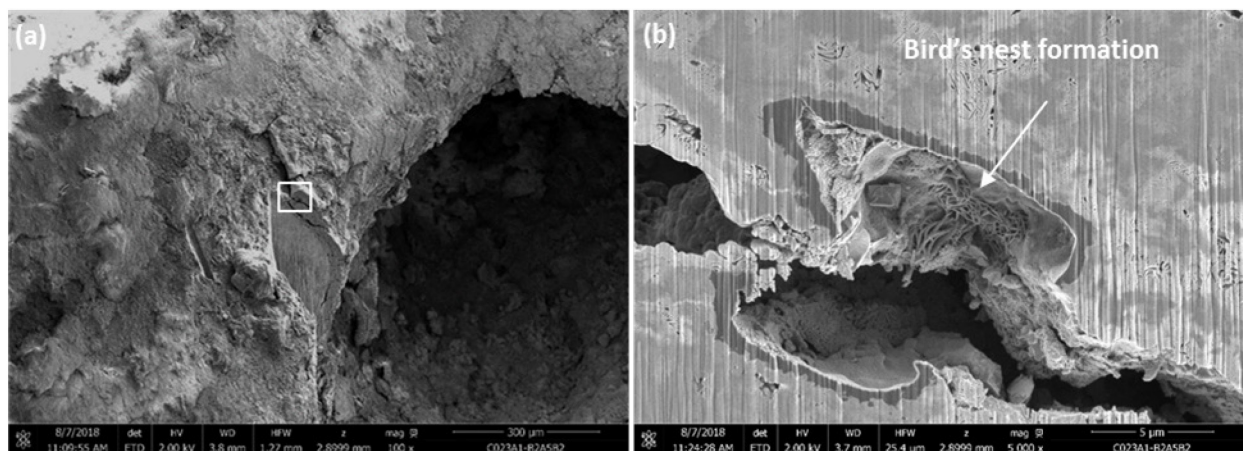
**Figure 95: FIB Cross Section of the Tunnel Wall in C023A1-B2A5B2 at (a) 100 $\times$  and (b) 5,000 $\times$**

FIB cross-sectioning was done on the wall of the tunnel to look at the deposit morphology on sample C023A1-B2A5B2. Figure 95 shows the corrosion deposit morphology, which looks like the bird's nest formation. This has been described by various authors who have studied atmospheric corrosion [30] [31] [32]. An EDS analysis revealed that the corrosion deposit contained  $\approx 40$  atomic percent (at%) Iron (Fe), 18 at% Carbon (C), 18 at% Oxygen (O), 9 at% Calcium (Ca), 0.2 at% Sulfur (S), and small amounts ( $<1$  at%) of other elements. Another FIB cross section at the tip of the tunnel (Figure 96) reveals the corrosion products that form inside the tunnel. The main elements found with EDS were C ( $\approx 60$  at%), Fe ( $\approx 19$  at%), O ( $\approx 19$  at%), and small amounts of S, K, Mn, Cl, Si, and Al. The corrosion product did not appear to be dense. Several layers of deposits were seen inside the tunnel.

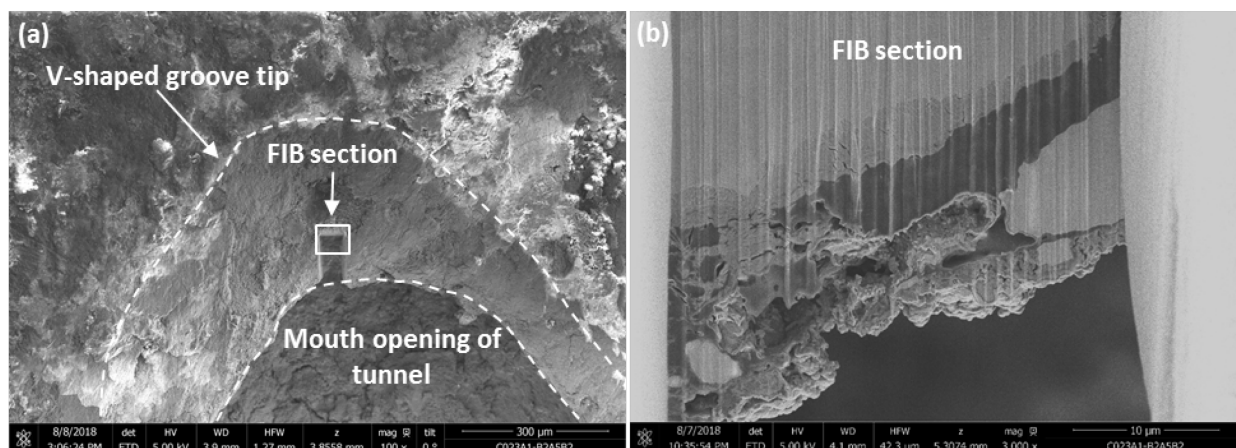
**Figure 96: FIB Cross Section of the Tunnel Tip in C023A1-B2A5B2 Viewed at (a) 100× and (b) 3,000×**

Further investigation of the area adjacent to the major tunnel identified a smaller tunnel at the initial formation stage. A closer look at the low magnification image in Figure 96 (a) shows a small, darker circular feature (white arrow) that appears to be another tunnel directly above the FIB cross section. Figure 97 shows a high magnification image of the circular feature. Material that appears to be extra-cellular was within the smaller tunnel. EDS analysis showed that the material surrounding the forming tunnel had a high amount of C ( $\approx 77$  at%), with 10 at% Fe, 9 at% O, and 0.6 at% S. The high carbon on the extra-cellular looking material may indicate biological activity related to the formation of the tunnel.

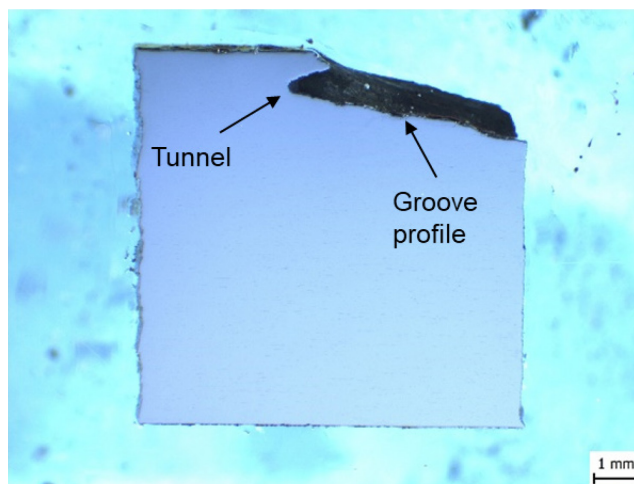
Figure 98: Stereo Microscope Image of C023A1-B2A5B2A

C023A1-B2A5B2A was subjected to a progressive-step wise metallographic sectioning across the major tunnel after the FIB investigation. The sample was mounted in epoxy. Figure 98 shows the groove profile of the depth of the tunnel along the longitudinal axis of the pipe after the second polish. The tunnel has a mouth opening of 0.0197 in. (0.5 mm) and extends 0.0393 in. (1 mm) into the metal. Figure 99 shows that the corrosion deposit at the tip of the tunnel is denser. Lamellar (plate-like) features are visible from SEM high magnification image in Figure 99. The presence of the lamellar cementite provides an anchor to the corrosion products [33]. EDS analysis showed that the corrosion product inside the tunnel was rich in O and C. The analysis also revealed that manganese sulfide (MnS) inclusion was present and surrounded by the corrosion product.

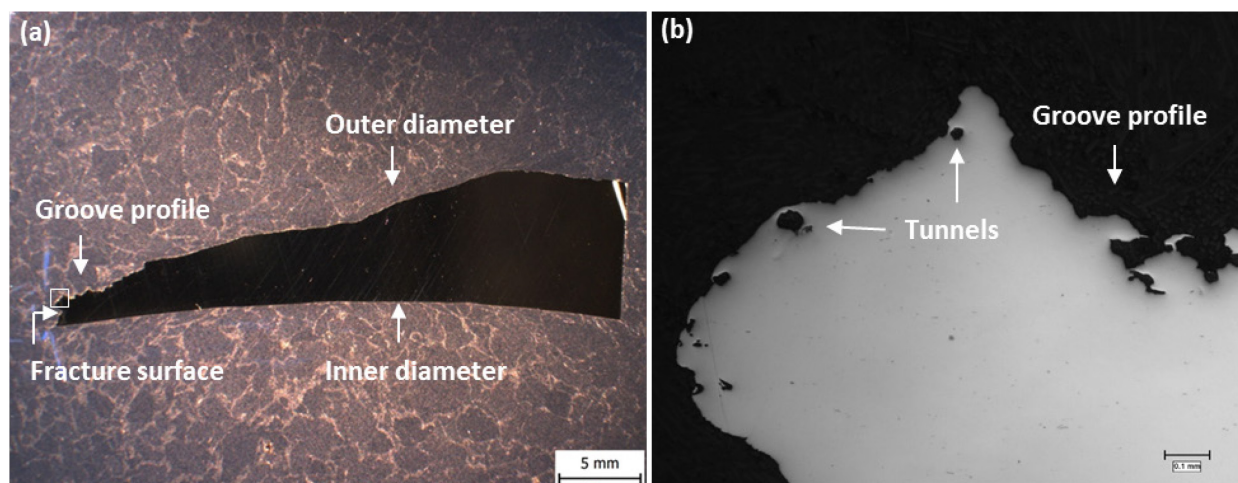
Figure 100: (a) C023A1-B2C2 Mounted and Polished and a (b) High Magnification Image Near Fracture Surface

C023A1-B2C2 was extracted from the initiation site of the axial rupture fracture surface. The specimen was mounted in epoxy and polished. Figure 100 shows a cross section of C023A1-B2C2 indicating the presence of tunnels directly below the groove inside of the Type I corrosion feature. The cross section also shows that MnS inclusions are present in the tunnel along with the acicular corrosion deposit. Figure 101 shows the SEM image of the cross section and the sulfur and manganese mapping obtained with EDS. The corrosion products inside the tunnel were not very dense. They were identified as hematite, modified hematite, magnetite, and organic matter using Raman spectroscopy.

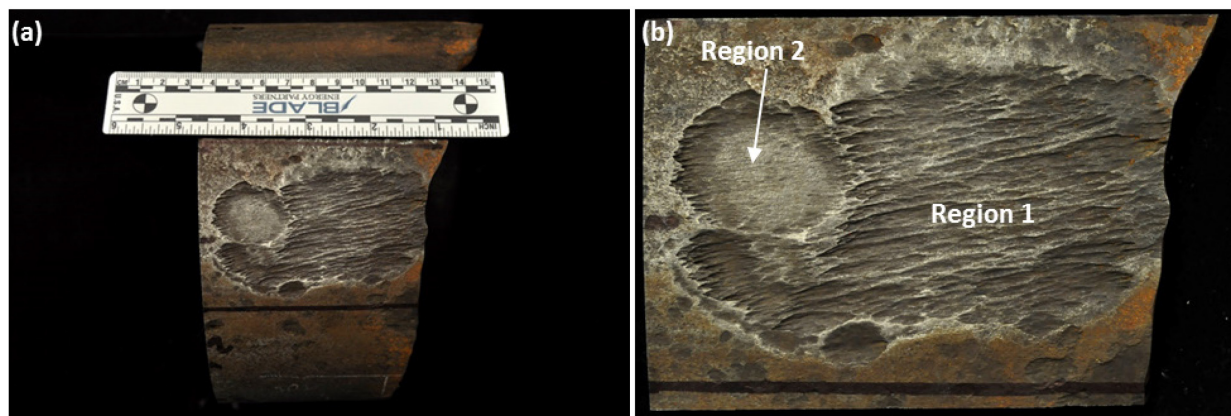
**Figure 102: (a) C022B1 Specimen Extracted from the 7 in. Casing Adjacent to the Circumferential Fracture; (b) Macroscopic View of C022B1 Specimen After Cutting**

Specimen C022B1 was extracted from the failed joint (joint 22). The specimen was located adjacent to the circumferential parting. The corrosion patch is approximately 3.5 in. long in the longitudinal direction and contained two regions. Region 1 of the corrosion patch has striated grooves that are visible within the entire region. Region 2 of the corrosion patch contains groove tips that are visible on the edge; however, striated grooves are not very visible on the mid region (Figure 102). The crystalline deposits were also observed on the striated grooves. Raman spectroscopy analysis of specimen C022B1 showed presence of carbonate, iron oxide combination, and organic matter. The number of grooves and groove density was quantified in a patch of corrosion, which was then compared to MnS density. There was no relationship between the two; the MnS density was much higher than the groove density. The

conclusion of this study was that there was no apparent correlation between MnS inclusions and the grooves.

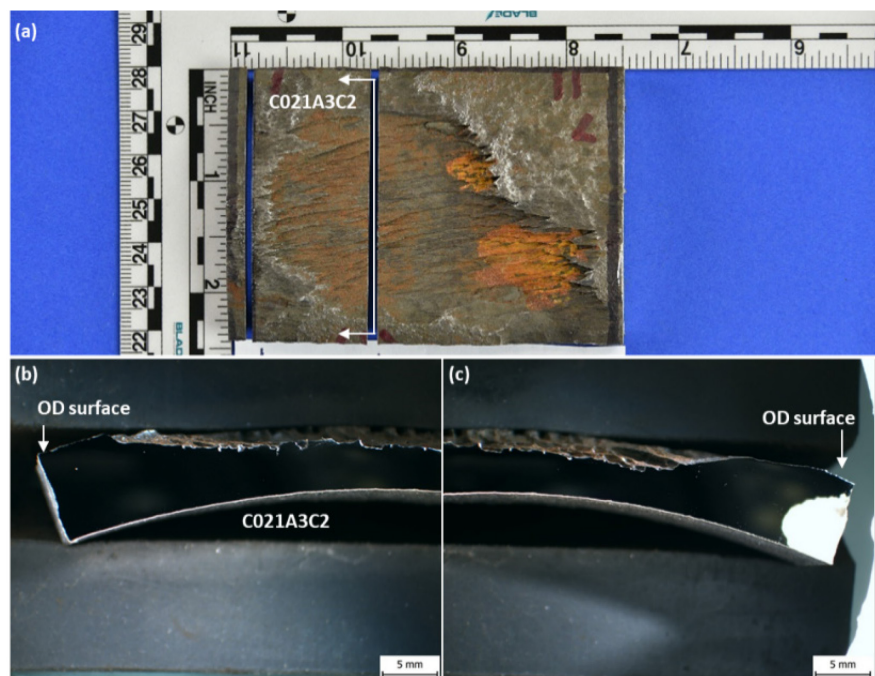
**Figure 103: (a) C021A3C Pipe Section from 7 in. Casing; (b) and (c) Cross section near center**

Specimen C021A3C was extracted from joint 21 of the SS-25 7 in. casing. This specimen exhibited a corrosion patch with striated grooves (Figure 103 [b]) approximately 3 in. long along the longitudinal axis. Groove tips were seen within larger groove tips and the striated grooves were visible over the entire corrosion patch. Raman analysis showed the presence of hematite ( $\text{Fe}_2\text{O}_3$ ) and an iron oxide combination of hematite ( $\text{Fe}_2\text{O}_3$ ), goethite ( $\alpha\text{-FeO(OH)}$ ), and ferrihydrite ( $\text{Fe(OH)}_3$ ).

Specimen C021A3C was sectioned across the striated grooves to investigate the groove profile and tips. Figure 103 (b) and (c) shows the profile of the grooves within the corrosion patch and unaffected OD

surface indicated by arrows. This image shows severe metal loss towards the center of the corrosion patch. Each individual groove contributed to the metal loss profile.

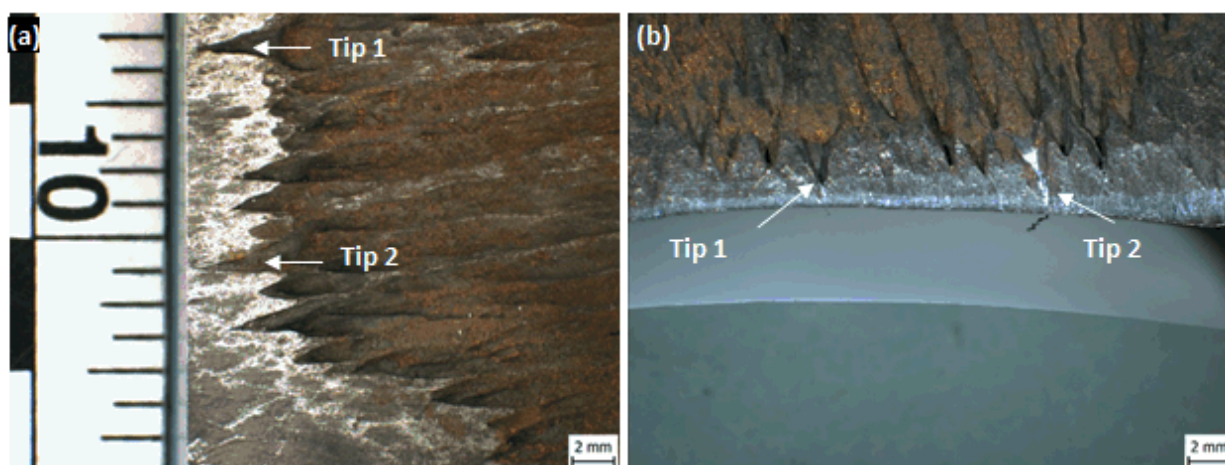
Figure 104: (a) Top View of Specimen C021A3C2; (b) Tilted View of Specimen C21A3C2 Sectioned Near the Groove Tips

The cross section of specimen C021A3C2 near the groove tips revealed several tunnels underneath the groove tip. C021A3C2 groove tips were cross sectioned 1 mm ahead of the V-shaped groove tips. The dark circles in Figure 105 reveal the presence of several tunnels underneath Tips 1 and 2. Figure 106 are metallographs taken after the polished surfaces were etched of tunnels under Tips 1 and 2. Figure 106 (a) shows that even small tunnels can occur at 850  $\mu\text{m}$  below the OD surface, and in Figure 106 (b) under Tip 2, the tunnels appeared to coalesce into a larger tunnel. A closer look at the tunnel under Tip 1 in Figure 106 (a) shows tunnels of various diameters that are isolated within the ferrite-pearlite microstructure. None of these tunnels appeared to be connected. In contrast to these, under Tip 2, the tunnels appeared to have coalesced into a large tunnel, as shown in Figure 106 (b).

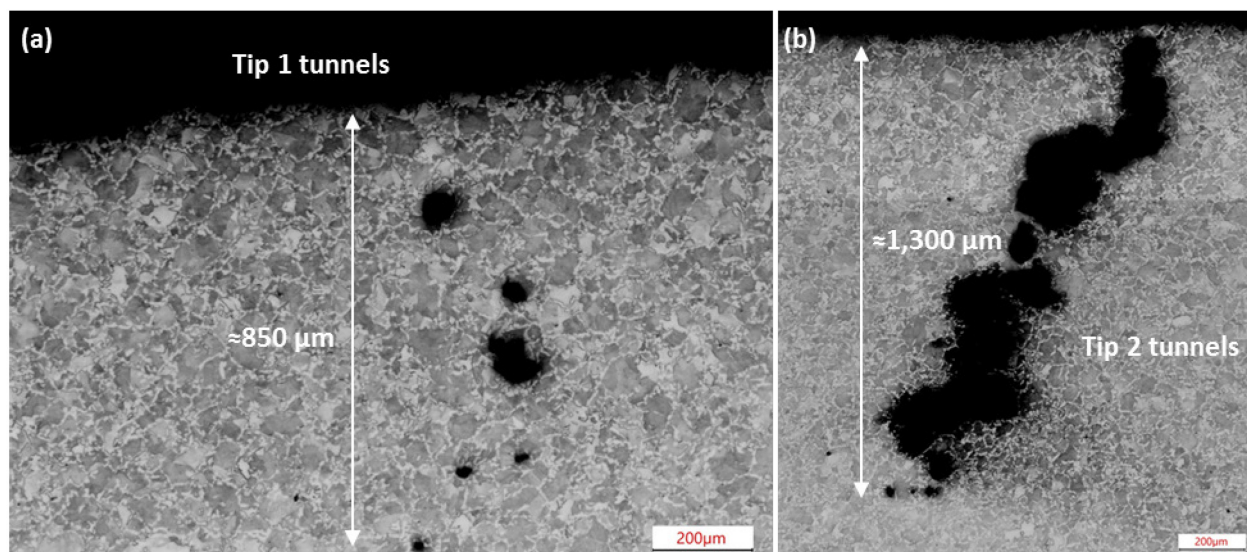
**Figure 106: Microstructure Adjacent to Tip 1 and Tip 2 Tunnels**

All the tunnels were filled with corrosion product. SEM images taken at higher magnification show the presence of the lamellar feature and MnS inclusion in the corrosion products. EDS confirmed the presence of MnS and showed that the corrosion product was rich in O. The lamella structure was seen both on the etched pearlite (alternating layers of ferrite and cementite) and on the corrosion products). There seemed to be a preferential anodic dissolution of ferrite, leaving the cementite behind.

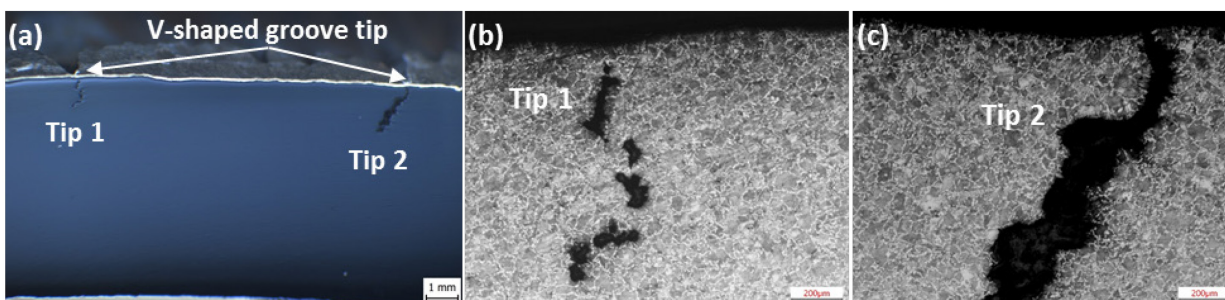
**Figure 107: Specimen C021A3-C2 after Second Polish**

Specimen C021A3-C2 was re-polished, which removed approximately 1 mm of material from the previously-polished surface (Figure 107). Tips 1 and 2 in Figure 107 clearly indicate that the tunnels under Tip 1 grew in size and the tunnels under Tip 2 merged into a larger tunnel. Raman spectroscopy identified organic matter, modified hematite, and magnetite in the corrosion products present in the tunnel.

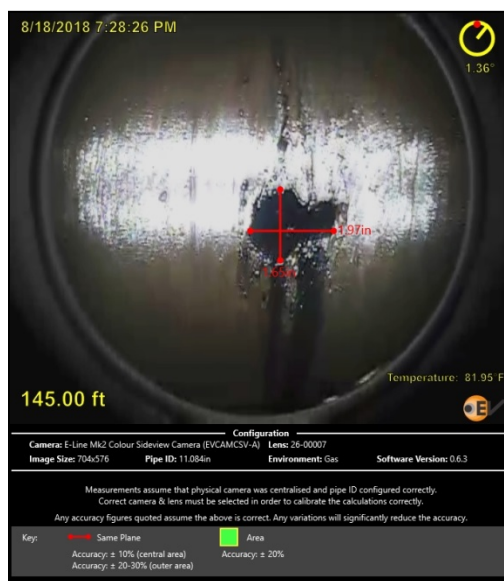
- At shallow depths in the casing, ranging from 90 to 385 ft, there were holes or metal loss indications. The various technologies, including caliper, UCI and HRVRT identified these through wall metal losses. The camera data were consistent with the logging data, and a typical photograph of the hole is shown in Figure 108. A total of 58 holes were identified, with 50 of them in joint 5 at depths ranging from 152.1 to 195.4 ft.

- Some of these approximately 58 holes could have existed prior to the 7 in. casing axial rupture. Many of the holes exhibited sharp corners that may have been more typical of a burst failure, implying that they occurred due to a pressure surge in the surface casing. These holes provided a pathway for the gas to the surface that further complicated the well-control operations. These holes provided a less resistant pathway to the surface, resulting in a higher gas leak rate.

**Figure 108: Picture of Hole in 11 3/4 in. Casing with Dimensions from Video Imaging at 145 ft**
