# Root Cause Analysis of the Uncontrolled Hydrocarbon Release from Aliso Canyon SS-25

May 16, 2019

Root Cause Analysis Report

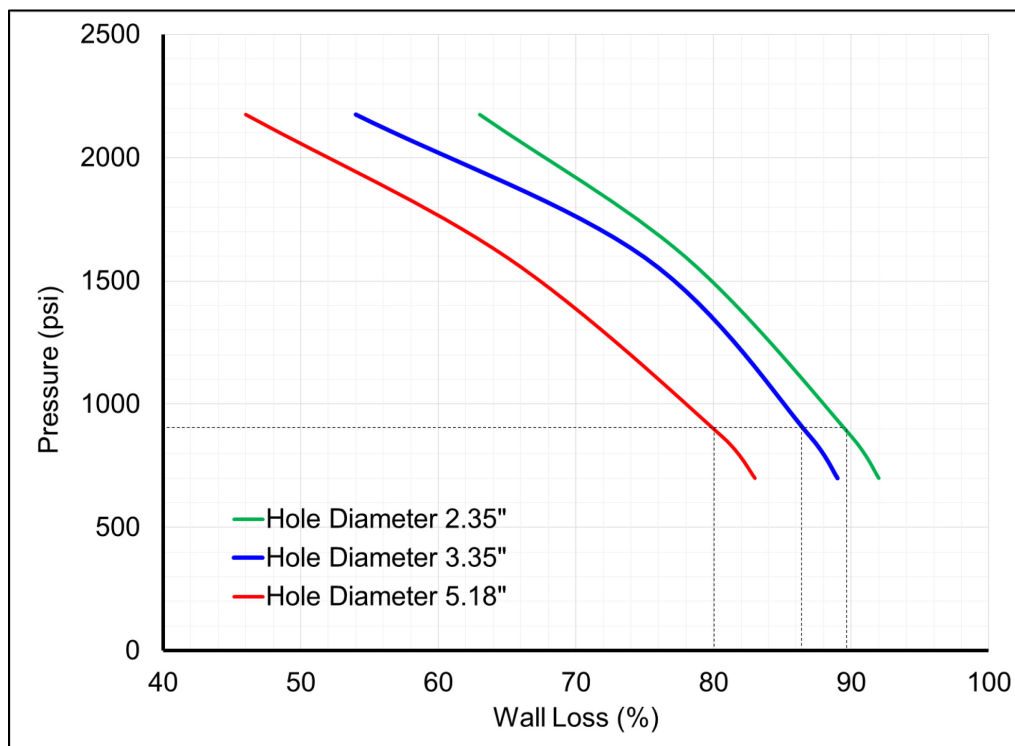
Figure 109: RSTRENG Safe Pressure Limit as a Function of Wall Loss

- Failure pressure was estimated using RSTRENG, assuming three different hole diameters and variable wall loss. The results are summarized in Figure 109, which shows that the external corrosion would have resulted in a hole at penetrations ranging from 80 to 90% of wall loss. The holes may have been a consequence of an internal pressure of 800 psi or higher. The pressure in the surface casing annulus surged to 800 psi at one point right after the axial rupture. The holes are likely a consequence of the axial rupture.

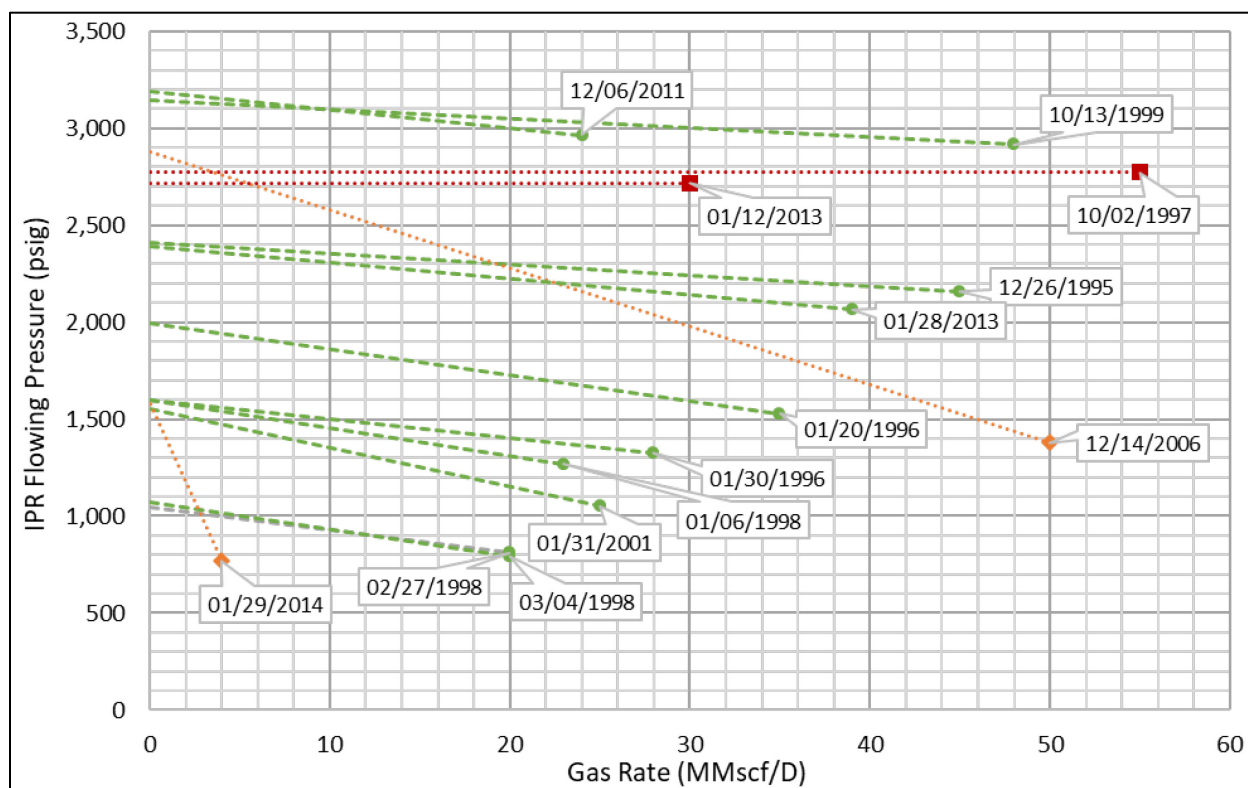
**Figure 111: SS-25 Validation of Well Tests 1995–2015**

Figure 111 shows the well tests for the previous 20 years on a performance chart. Wellhead pressures (WHP) were converted to bottomhole pressures by using the well model. In the figure, the well test itself is marked as a circle with a line connecting back to the reservoir pressure that was estimated from the provided static shut-in pressure. (As expected, the reservoir pressure varied by month of test according to the yearly cycle of demand.) The colors and symbols are as follows:

The questionable test of January 12, 2013 (in red), was re-run on January 28, 2013. The questionable test of January 29, 2014 (in orange), was not re-run; it was the test that was the most recent prior to the leak. Any adjustments based on the January 29 test that were made to any model would have under-predicted deliverability. This most recent test was inconsistent with the tests of the last 20 years.

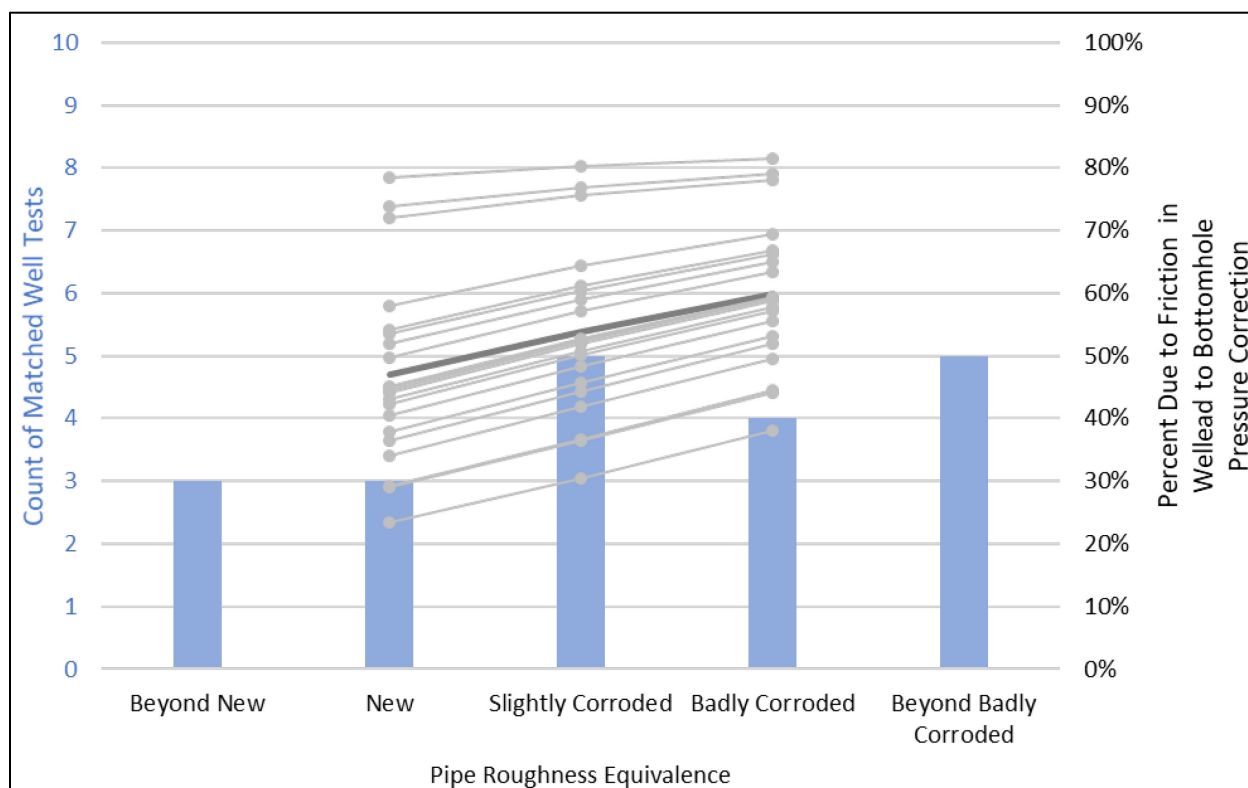
**Figure 112: SS-25 Pipe Roughness Study for Well Tests 1980–2015**

Figure 112 shows the best-estimate pipe roughness for well tests from the last 37 years. The roughness differed from test to test, and friction was significant (it averaged 45 to 60% of pressure loss in the outflow model).

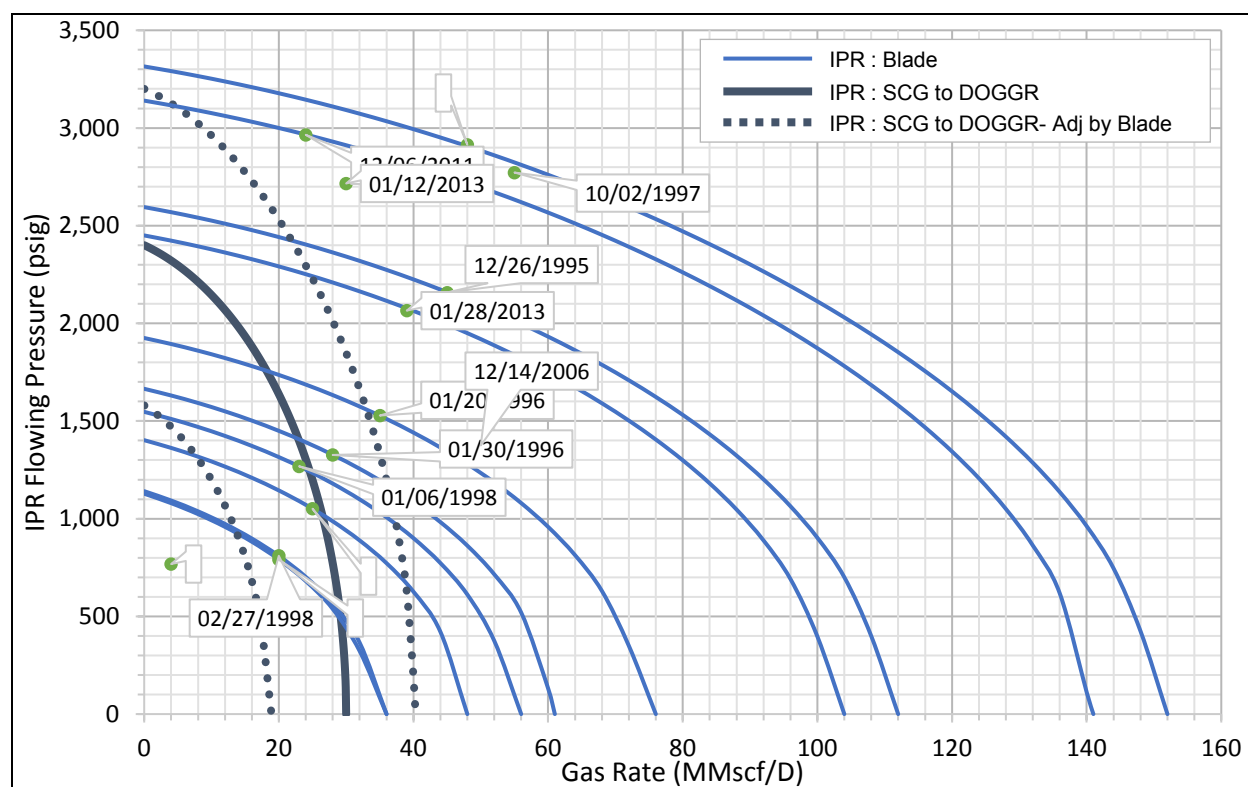
Figure 113: SS-25 Match of Well Tests 1995–2015

Figure 113 shows the best estimated match of the analyzable flow tests for the last 20 years using the best-estimate properties shown in Table 16. Blade’s inflow performance relationship (IPR) estimates for each well test are plotted as solid, thin blue lines. The model’s drainage area reservoir pressure varied, at the most, 100 psi from the static measured pressure at the time of the test.

Blade identified an IPR curve that first appeared in a SoCalGas response to a DOGGR request [40]. This request implied that a national laboratory was modeling the kill attempts on behalf of DOGGR, and DOGGR wanted the laboratory to use the same data that the well-control company was using. This SoCalGas-provided IPR curve is plotted in Figure 113 as a solid, thick navy line.

The SoCalGas IPR did not match Blade's best-estimate IPR, which was derived from valid well tests. The Blade model could be used to match the SoCalGas IPR by changing the permeability from 80 to 30 md and increasing the gas turbulence to  $0.5 \text{ (MMscf/D)}^{-1}$ . Blade adjusted the reservoir pressure of the SoCalGas IPR, and this was still not representative of any well test. A more representative IPR obtained from proper modeling of the production well tests would have been a better basis for designing kill attempts.

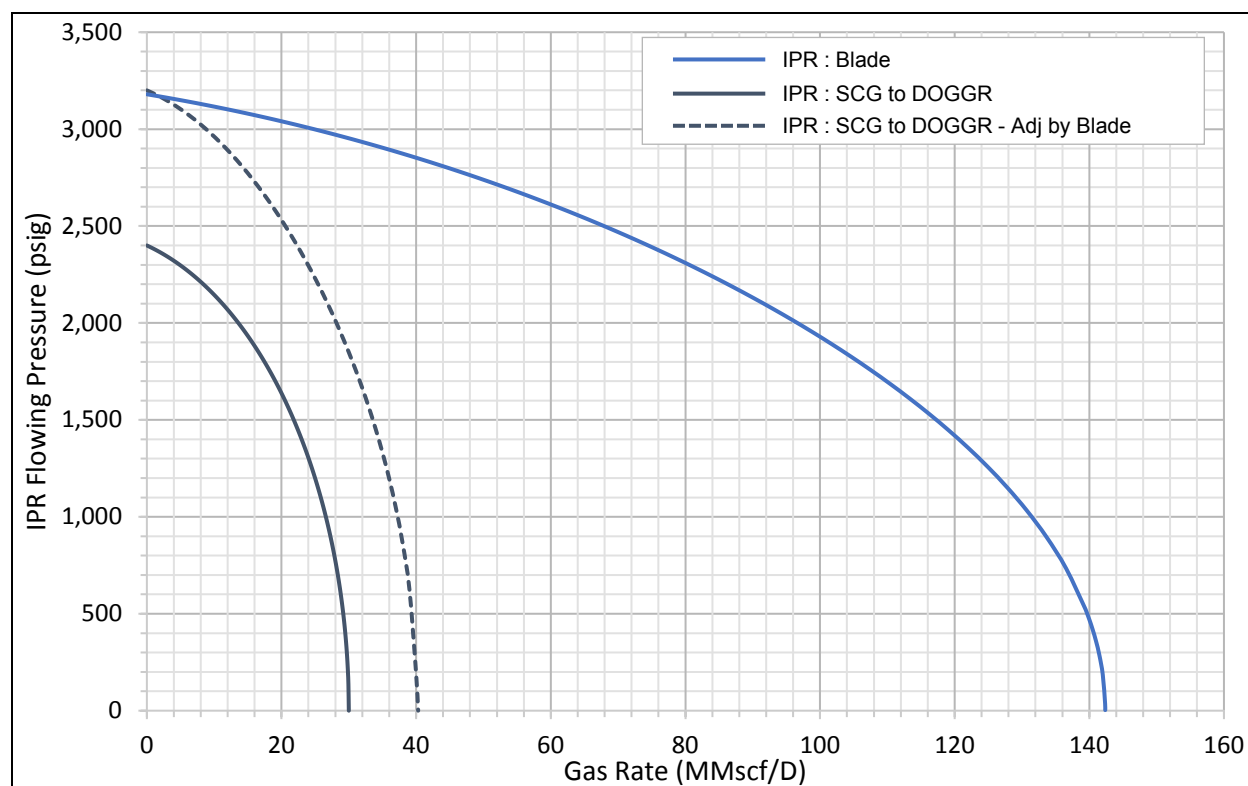
**Figure 114: SS-25 IPR Model for October 23, 2015**

Figure 114 shows Blade's IPR model as of October 23, 2015, after injection was shut down. It also shows the SoCalGas IPR adjusted to the initial reservoir pressure. That IPR model was not representative of the actual flow; it underestimated the actual leak rate by a factor of 3.4–3.6.

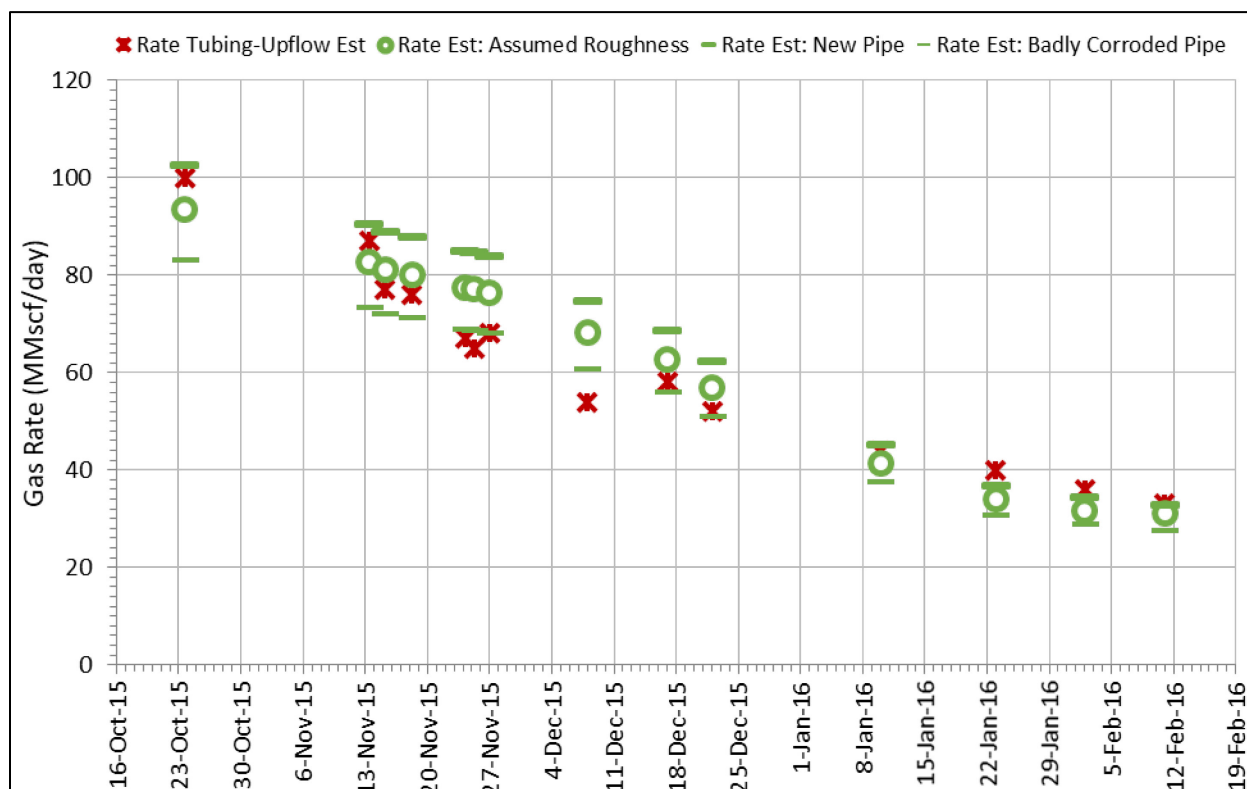
**Figure 115: SS-25 Key Rate Estimates using Upflow-Only and Upflow-Inflow Models**

Blade performed such *tubing-upflow only* calculations. Figure 115 compares the results of these calculations (in red) with the more accurate *upflow-inflow* (or IPR) models (in green). The tubing-upflow estimates prior to and after the kill attempts matched the upflow-inflow model for new pipe. This further validated Blade's IPR model, which was used in reviewing the kill attempt designs. During the kill

attempts, the well flow was more unstable, and the estimates were more scattered. Both methodologies for rate estimates suggested that the first kill should have been designed for at least 93 MMscf/D.

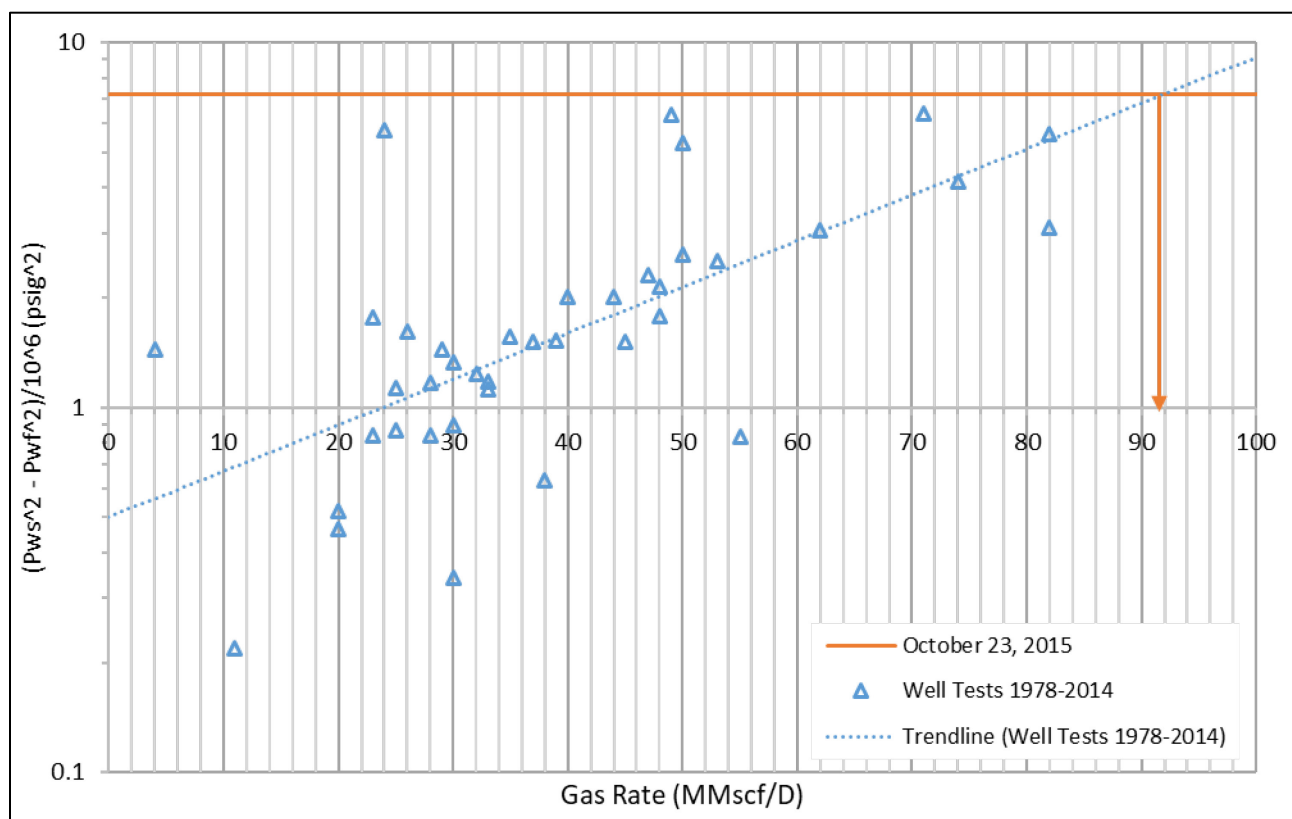
Figure 116: P-Squared Rate Estimate for October 23, 2015

There was a third method available to estimate the leak rate. This is shown in Figure 116, where  $P_{ws}$  is the static WHP (i.e., well shut-in or not flowing) and  $P_{wf}$  is the flowing WHP upstream of the choke. This process allows the calibration of the well deliverability and the estimation of the well flow rates at various pressure differences. The results are shown in Figure 114; the initial leak rate on October 23 matched the 91 MMscf/D estimated through the more accurate model. SoCalGas did use this method to estimate the leak rate; however, the leak rates were estimated to be ranging from 56 MMscf/D to 62 MMscf/D because the downstream choke pressure was used instead of upstream choke pressure.

The key observation from the PROSPER analysis discussed above is that the gas rates were significantly higher than those estimated during the incident. The higher gas rate could have been correctly estimated using industry-standard flow simulations or other methods using data available at the time of the incident. Additional details regarding the well deliverability modeling and analyses please refer to the supplementary report on SS-25 Nodal Analysis with Uncontrolled Leak Estimation [41].

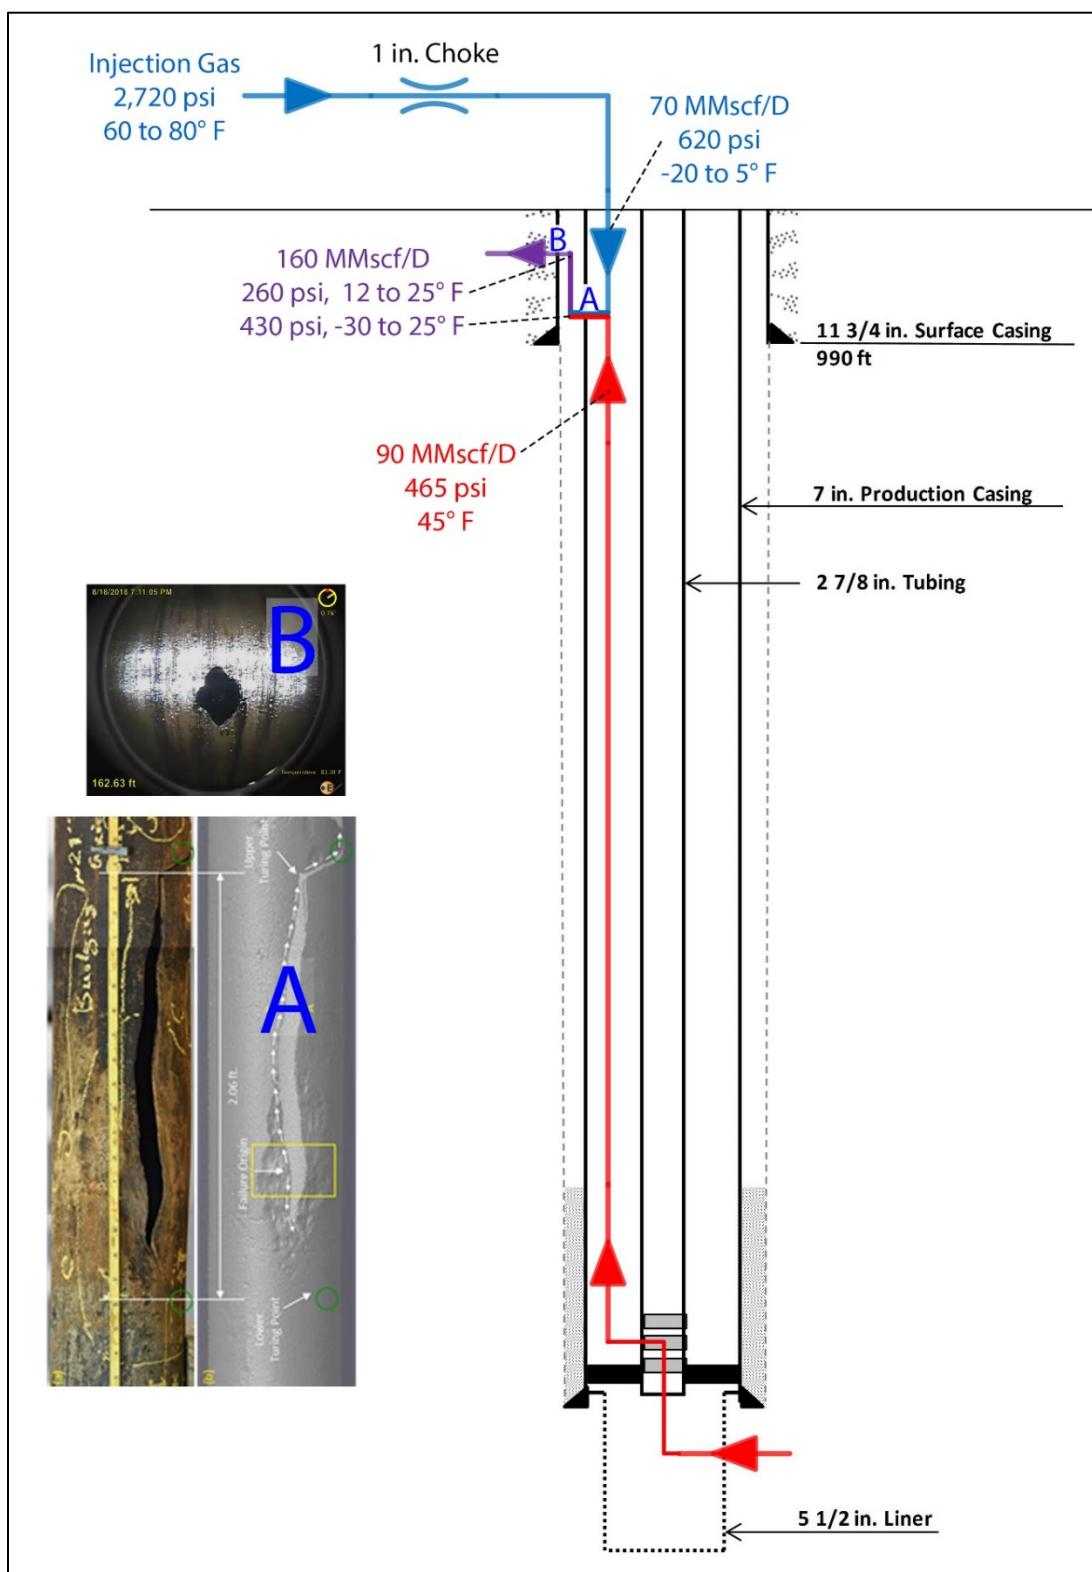
Figure 117: Summary of the PROSPER Results Prior to Shut-In of SS-25,  
A-Ruptured 7 in. Casing and B-Hole in the 11 3/4 in. Casing

To determine when the 7 in. casing failure occurred, Blade first modeled the flow in SS-25 prior to the shut-in. The problem was solved by using PROSPER. Figure 117 shows the SS-25 well flow problem posed to PROSPER and the pressure, rates, and temperatures that PROSPER calculated. First, focusing on the flow from the wellhead down the 7 in. × 2 7/8 in. production casing annulus to the leak point at 892 ft, the WHP required to drive 70 MMscf/D to 892 ft was 620 psi, and the arrival pressure at this depth was 465 psi. The WHP of 620 psi was too high to cause the SSV to close. In fact, even if the pressure at 892 ft were 260 psi (and it could not have been this low because 260 psi was the pressure at the holes in the surface casing as shown in Figure 117-B), the WHP would still have been about 500 psi. This means that when SS-25 was on injection, even if the 7 in. casing had already failed, the SSV would not have closed. The only time the SSV would have closed would have been when the well was shut in and the 7 in. casing had already failed. This is confirmed by the fact that the SSV closed immediately when SS-25 was shut in on the afternoon of October 23, 2015.

Figure 117 shows that prior to the shut-in of SS-25, the total estimated leak rate at 892 ft. through the production casing was 160 MMscf/D, of which 70 MMscf/D was from the injection system and 90 MMscf/D from the reservoir. This period, however, lasted less than half a day before the leak was detected and the well was shut in.

Metallurgical analysis showed that the 7 in. casing failed in two steps. The first was the instantaneous 2 ft long axial rupture that occurred at ambient temperature. The axial rupture (Figure 117-A) was followed by a low temperature brittle circumferential parting of the 7 in. casing. The parting was brittle and required extremely low temperature ( $-78^{\circ}\text{F}$  to  $-38^{\circ}\text{F}$ ).

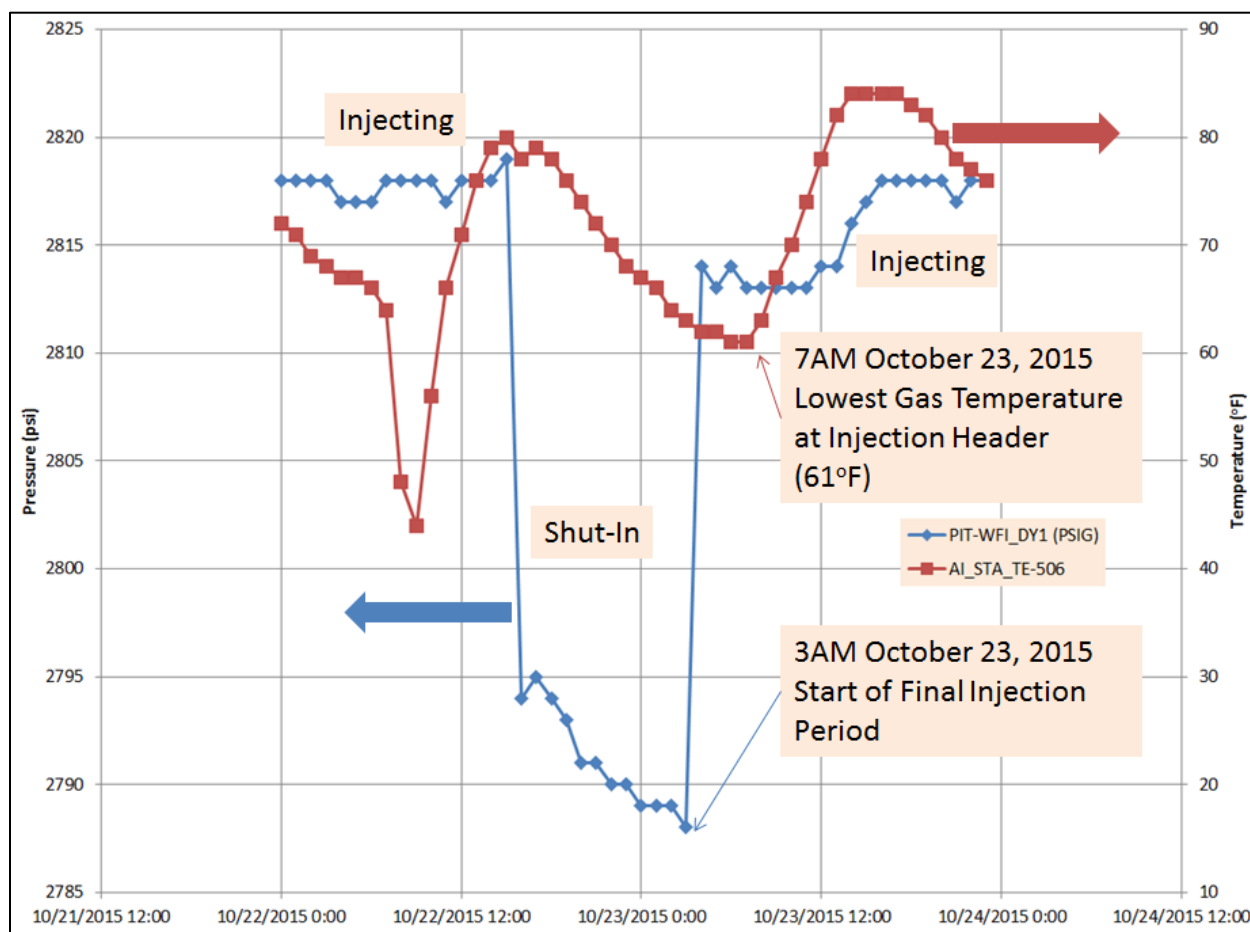
**Figure 118: PIT-WFI\_DY1 Hourly Pressure and AI\_STA\_TE-506 Hourly Temperature Measurements**

Figure 118 shows the hourly pressure and temperature reading at the compressor station. The pressure gauge, PIT-WFI\_DY1, measured the pressure in the trunk line to the western area of Aliso Canyon, which included SS-25. The pressure varied between about 2,815 psi and 2,790 psi. When the pressure was 2,815 psi, SS-25 was injecting. The system was shut in around 3 PM on October 22, 2015; injection was restarted between 3 and 4 AM on October 23, 2015.

Had the 7 in. casing failed during the shut-in period, the pressure reading of PIT-WFI\_DY1 would have fallen to as low as 300 psi, the low pressure set point of the SSV. This is because the leak at SS-25 would have drained the gas in the trunk line leading to SS-25 until the SSV closed. Figure 118 shows that PIT-WFI\_DY1 during the shut-in period prior to the final shut-in. No anomalously low-pressure reading was observed. The 7 in. casing did not fail during this shut-in period. The 7 in. casing, therefore, must have failed during the final injection period, which started after 3 AM on October 23, 2015.

Such low temperatures however could have occurred prior to final shut-in of SS-25. Figure 118 shows that the temperature at the compressor station was between  $60^{\circ}\text{F}$  and  $85^{\circ}\text{F}$ . SS-25 is about 1,000 ft higher in elevation relative to the compressor station. Therefore, the inlet gas temperatures to the SS-25 1 in. choke were likely several degrees lower. The pressure drop across the 1 in. choke was estimated to be 2,100 psi. Using the  $0.56^{\circ}\text{F}/14.7$  psi J-T coefficient, this pressure drop corresponded to a decrease in temperature of about  $80^{\circ}\text{F}$ . The outlet temperature of this 1 in. choke therefore ranged from  $-20$  to  $5^{\circ}\text{F}$ . PROSPER estimated that the flow down the 7 in.  $\times$  2 7/8 in. annulus led to an additional  $8^{\circ}\text{F}$  temperature

Figure 118 shows that during the final injection period, the lowest temperature measured at the compressor station occurred between 7 and 8 AM on October 23, 2015. Consequently, the gas temperature at the failure location would have been the coldest during this period. This suggests that the circumferential parting likely occurred between 7 and 8 AM. Therefore, the initial axial rupture must have happened sometime prior to the parting but after the start of injection on October 23, 2015.

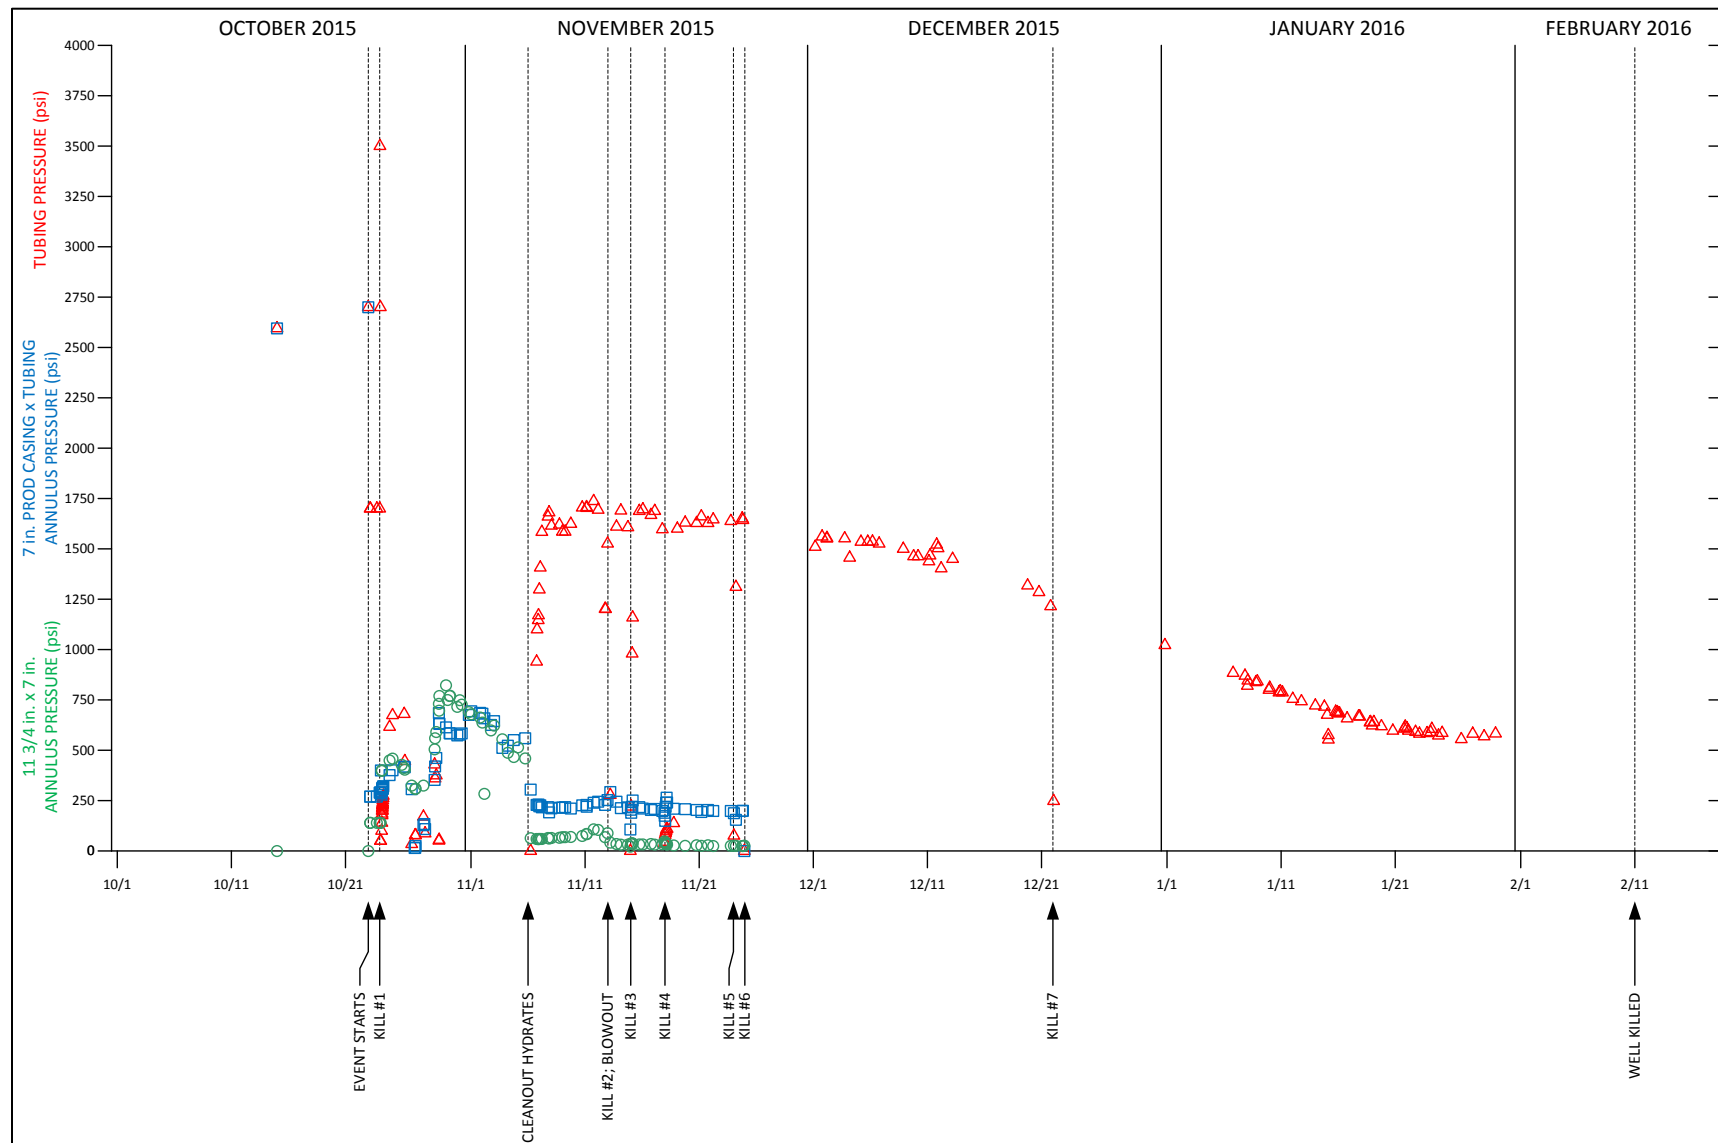
Figure 119: SS-25 Wellhead Pressure Measurements During the Incident

This redirection was important because the surface casing annulus pressure was as high as 800 psi between October 25 and November 6, 2015 (Figure 119). PROSPER estimated that, at these pressures, the temperature of the leaking gas could have reached  $60^{\circ}\text{F}$ . If the bulk of this warm gas had flowed up the 11 3/4 in.  $\times$  7 in. annulus, the upper section inside the well would have thawed out significantly, increasing the gas flow to the surface. However, because this did not occur, the upper section stayed cold.

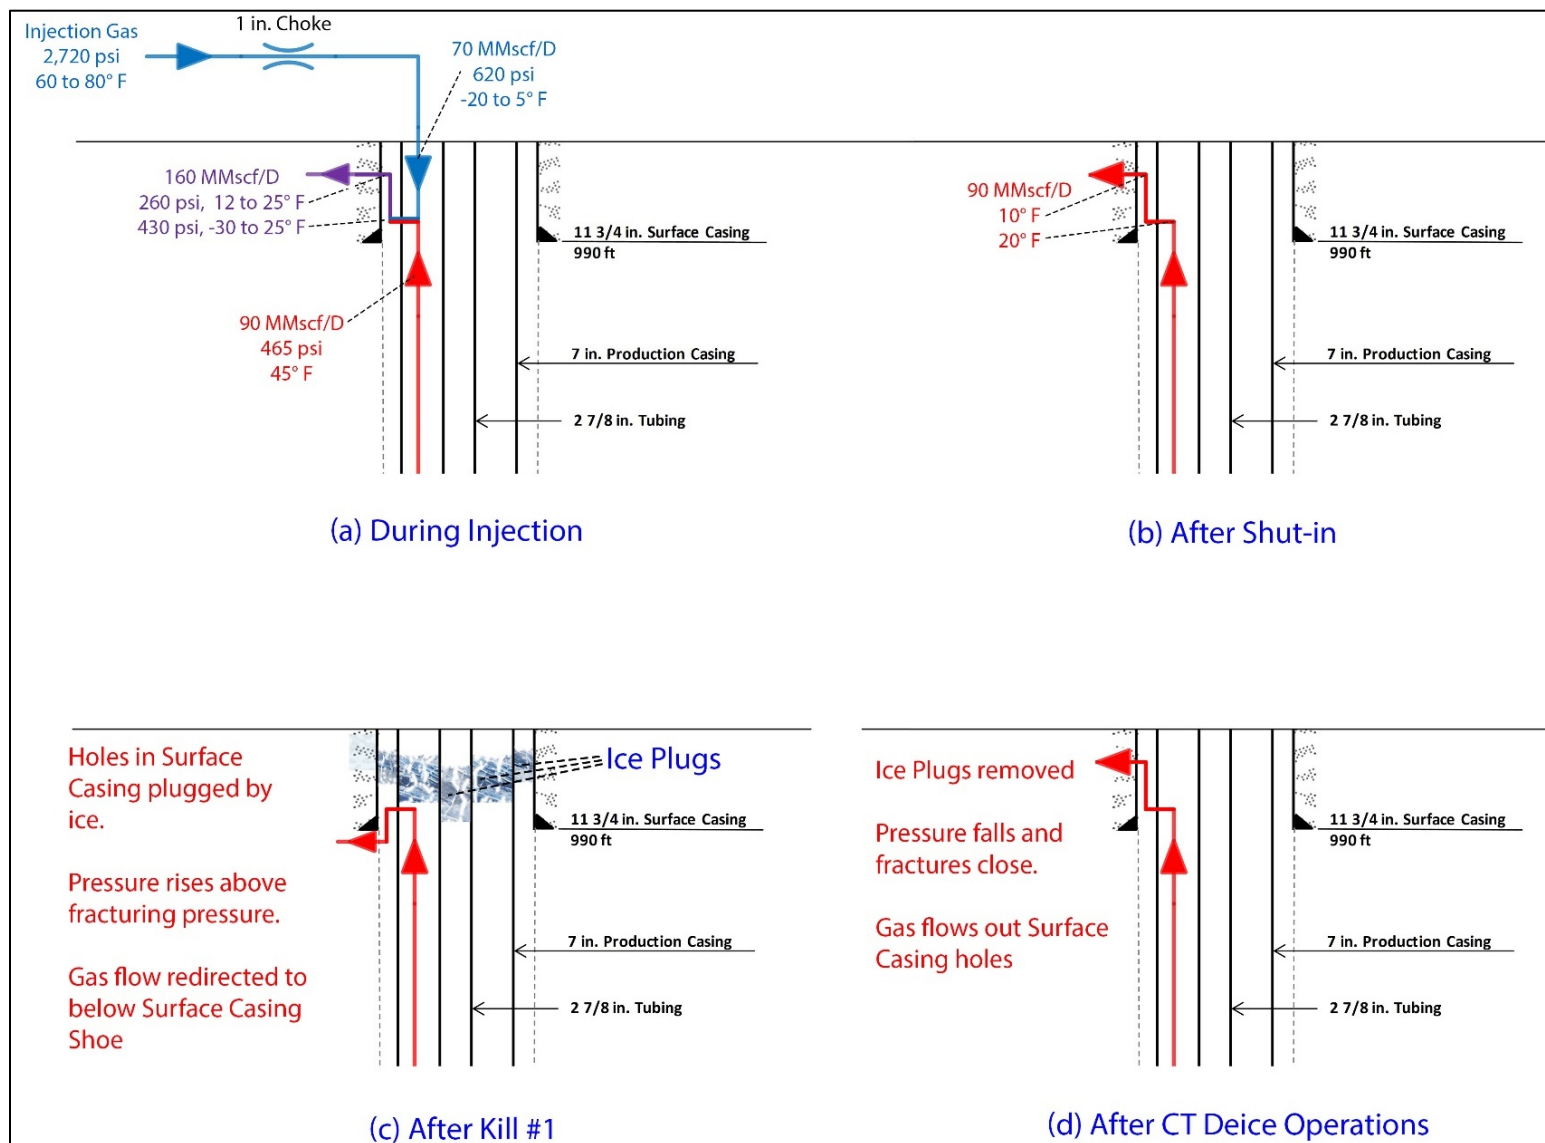
Figure 120: Summary of the Leak Paths Prior to SS-25 Shut-In to after Deicing Operation on November 6, 2015

On November 6, 2015, a solution of glycol and 10.8 ppg  $\text{CaCl}_2$  was pumped down the tubing and unblocked the pathways, allowing the gas to flow out of the 11 3/4 in. holes again. The pressure in the 11 3/4 in.  $\times$  7 in. annulus fell to 60 psi, which was lower than the initial 140 psi pressure. The kill attempt #1 might have opened up additional pathways for the gas, and the deicing operation might have unplugged them. The DOGGR representative reported that after the deicing operation, the gas leak rate increased substantially [6]. Figure 120 summarizes how the flow paths changed from prior to the shut-in to after the deicing operation.

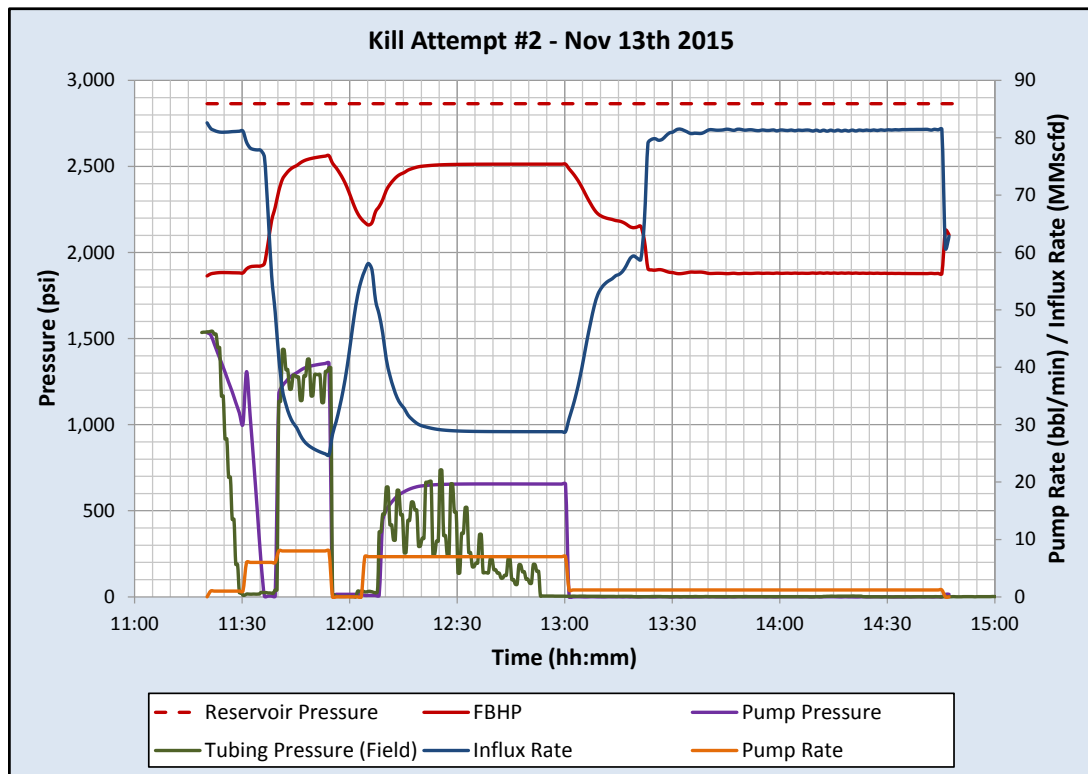
**Figure 122: Simulation of Kill Attempt #2**

Blade simulated kill attempt #2 in detail (Figure 122). When the FBHP<sup>ii</sup> (flowing bottomhole pressure) (solid red line) is less than the reservoir pressure (dashed red line), the gas will flow from the reservoir into the wellbore as shown by the influx rate (solid navy line). The well is killed if the FBHP is higher than the reservoir pressure so that the influx rate is zero.

Figure 122 shows the results of the kill attempt as it was executed. As kill fluid was pumped into the well, the FBHP (solid red line) increased, and the influx rate (navy line) decreased (between 11:30 AM and 11:55 AM and between 12:05 PM and 1 PM). However, the FBHP did not rise above the reservoir pressure (dashed red line), and the influx rate did not go to zero; therefore, the well was not killed. When the pump was turned off (between 11:55 AM and 12:05 PM) or pump rate (orange line) was reduced (after 1 PM), the FBHP decreased, and the influx rate increased. In fact, between 12:05 PM and 1 PM, both the FBHP and the influx rate stabilized at 2,500 psi and 28–29 MMscf/D; this indicates that the kill attempt was not sufficient to kill the well even if the pumping had continued indefinitely.

At the time of kill attempt #2, the estimated leak rate was 83 MMscf/D. Blade's analysis indicates that the 9.4 ppg fluid was not dense enough to kill the well at a realistic pumping rate. The well could have been killed by pumping a 12 ppg fluid at 9 bpm or a 15 ppg fluid at 6 bpm (Table 20). (Blade's analyses assume that kill fluids would have been pumped down the tubing; it would have been impossible to kill SS-25 by pumping down the 7 in. casing.)

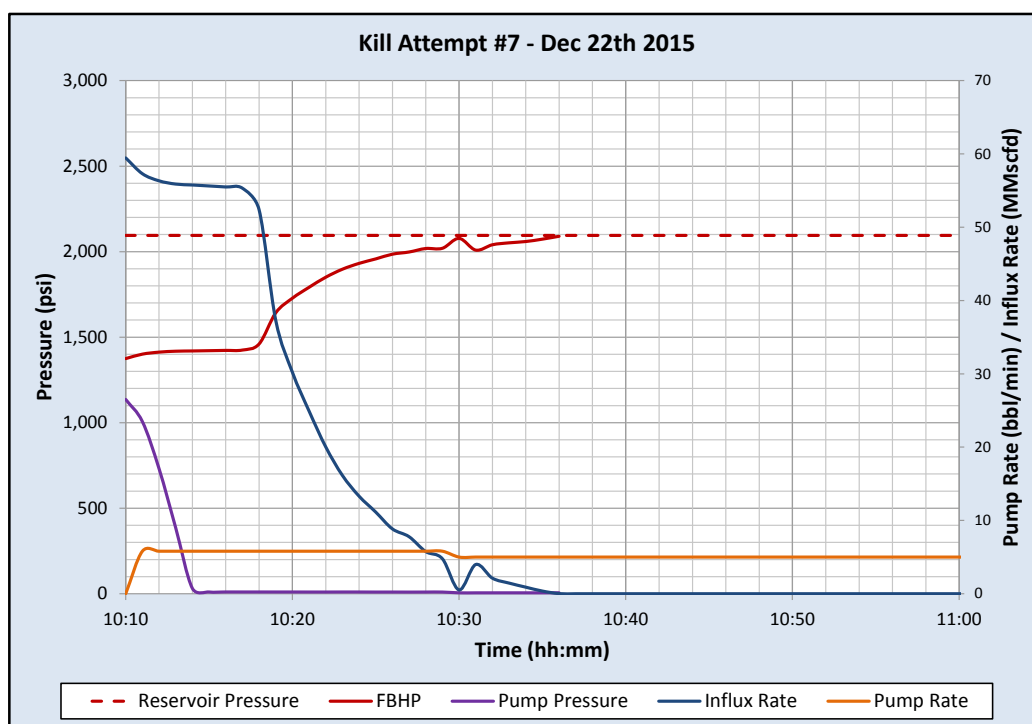
Figure 123: Simulation of Kill Attempt #7

The estimated leak rate was 60 MMscf/D. Results of Blade's simulations are shown in Figure 123. As pumping continued, the FBHP (solid red line) approached the reservoir pressure (dashed red line), and both influx rate (solid navy line) and pump pressure (solid purple line, also WHP) went to zero. This behavior was consistent with what was observed in the field during the kill attempt. At 10:30 AM, the well was just about to be killed, although premature shutdown of the pumps resulted in the FBHP decreasing and the influx rate increasing. Pumping needed to continue for some time after the well had seemed to have been killed to ensure that the well had been effectively killed. This did not happen in the field because the pumps were shut down early. Blade's analysis (Table 25) confirms that the well should have been killed with either 12 ppg fluid pumped at 6 bpm or 15 ppg fluid pumped at 5 bpm.

In conclusion, kill attempt #7 was a "near kill" that failed because the pumping was terminated early due to concern for potential wellhead damage. A contributing factor was the cumulative damage done by previous, unsuccessful kill attempts to the well site and wellhead, which caused this kill attempt to be terminated early.

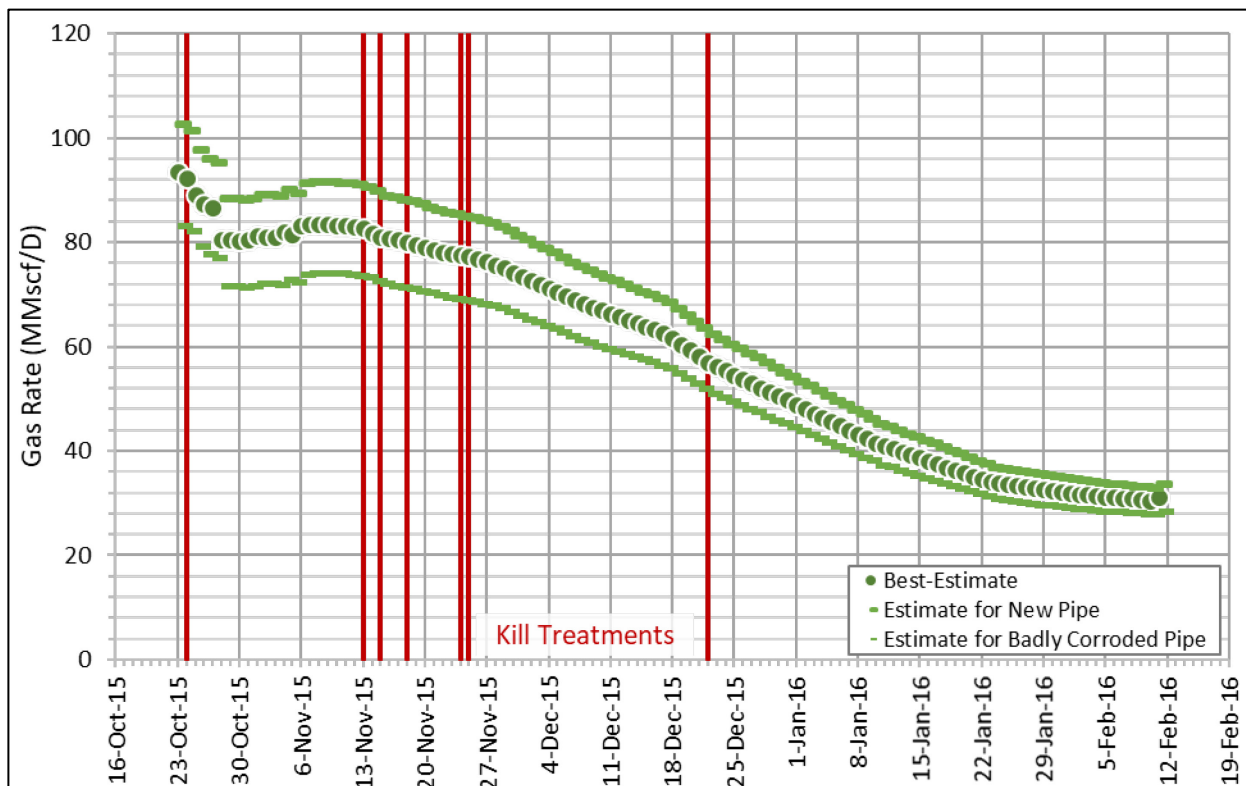
Figure 124: SS-25 Leak Rate Estimate (October 23, 2015–February 11, 2016)

The cumulative gas release volume was estimated using the modeling results. Figure 124 presents Blade's SS-25 withdrawal rate estimate for the duration of the uncontrolled leak using the PROSPER model described in Section 3.2.1. The kill attempts are shown to highlight the rates that the kill attempts should have been designed to kill. Kill attempt #1 had a discharge rate of 93 MMscf/D, kill attempts #2 to #6 had discharge rates from 83 to 78 MMscf/d, and kill attempt #7 had a discharge rate of 60 MMscf/D. Blade derived the best-estimate rate from data available after the well was killed.

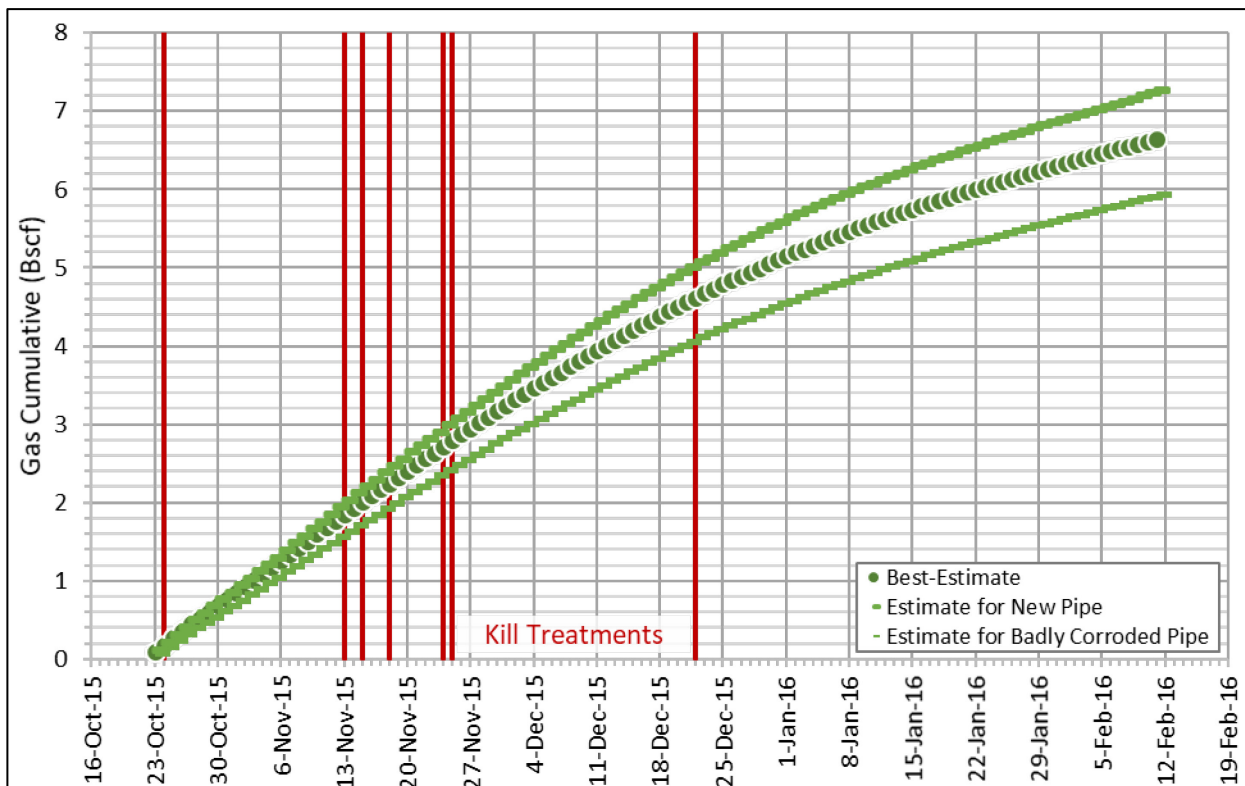
Figure 125: SS-25 Leak Cumulative Estimate (October 23 to February 11)

Figure 125 presents Blade's SS-25 cumulative leak estimate for the duration of the incident. If the uncontrolled leak had ended by kill attempt #2, the methane discharge would have been less than one-third of the final amount.

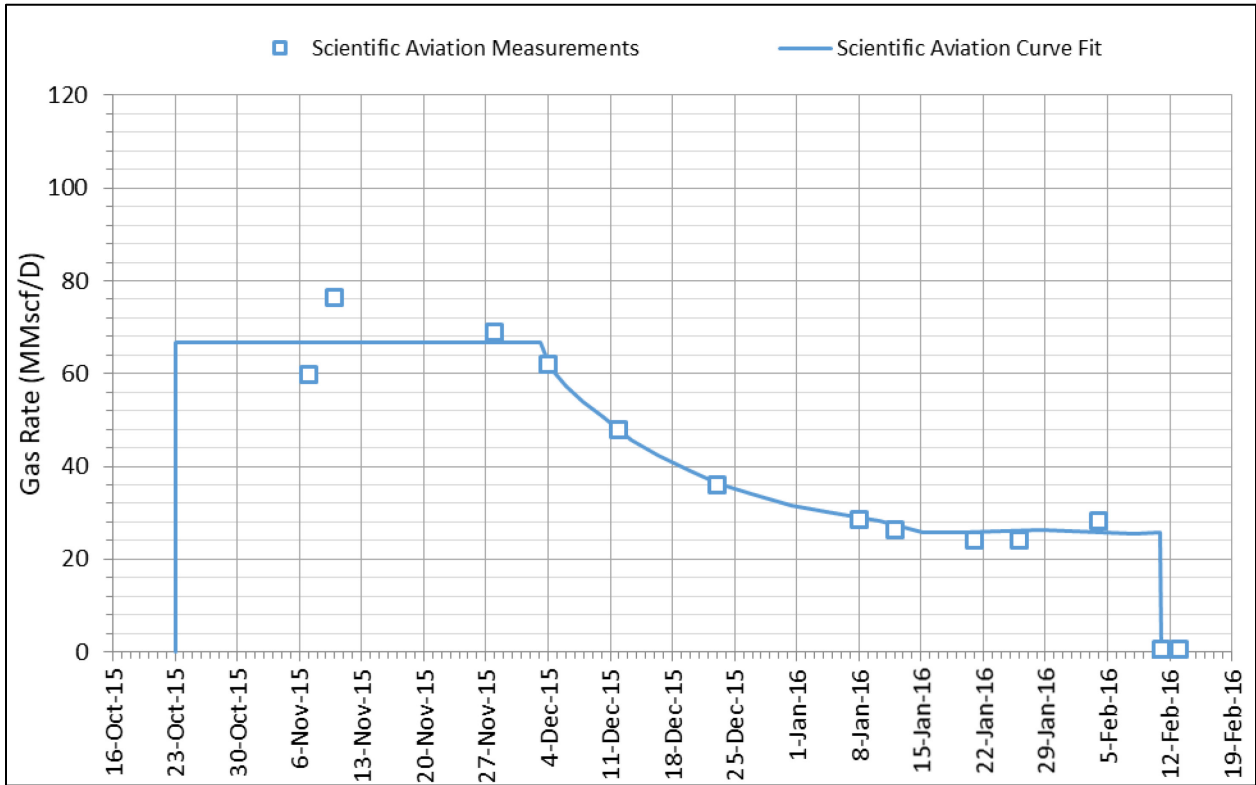
**Figure 126: SS-25 Measured Leak-Rate History–Scientific Aviation**

CARB derived their estimate following a review of the Scientific Aviation estimate. Scientific Aviation estimated the airborne emissions of the leak by analyzing data gathered by flying a specially equipped aircraft over the leak site [48]. Figure 126 shows the estimated airborne rates (converted from metric tons of methane to standard gas rates using the equation of state model from Blade's SS-25 PROSPER well model).

Although Scientific Aviation's plane was nearby for other measurements when the SS-25 leak occurred and mobilized quickly to measure the leak, the initial leak rates were not measured. Also, only airborne hydrocarbons were measured, and this did not necessarily represent the total leak. Hydrocarbons could have dispersed through the fracture matrix and taken an unknown path that delayed emissions to the air. This dispersion and delay were likely to affect the Scientific Aviation measurements.
