# Root Cause Analysis of the Uncontrolled Hydrocarbon Release from Aliso Canyon SS-25

May 16, 2019

Root Cause Analysis Report

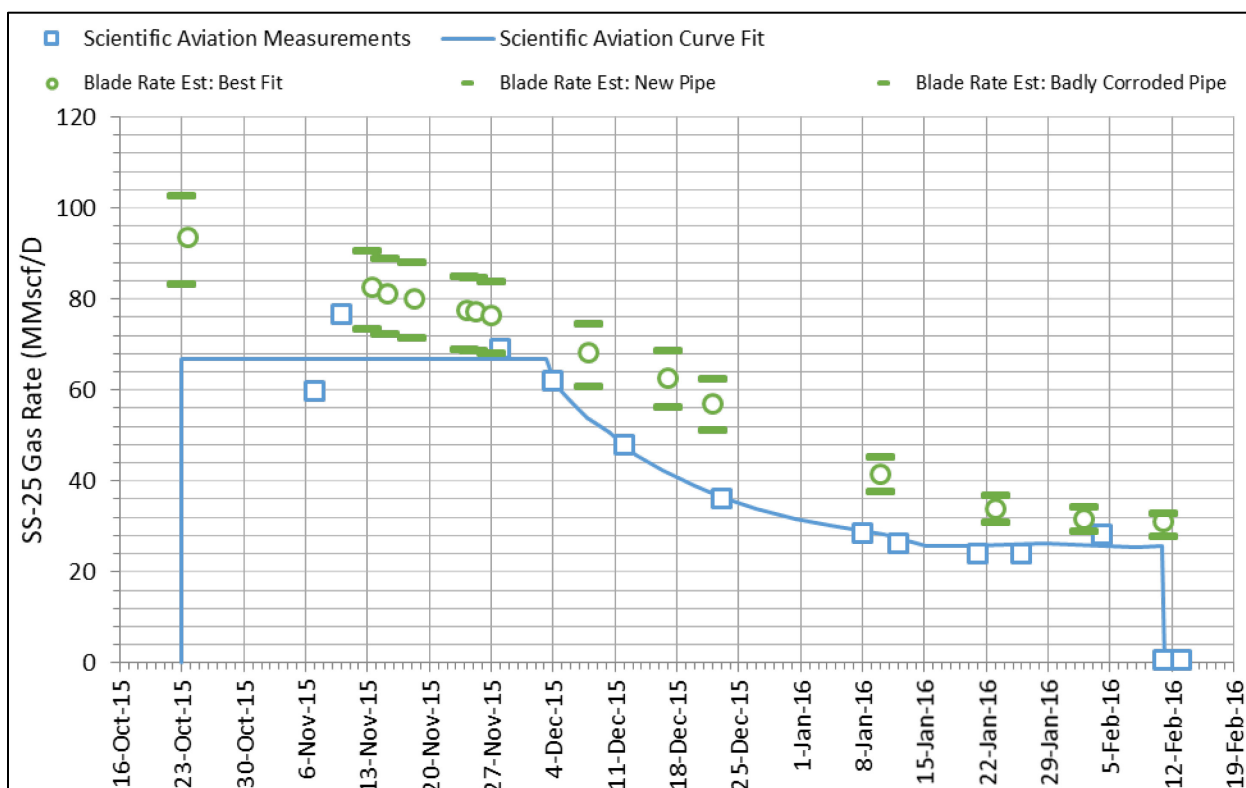
**Figure 127: SS-25 Leak-Rate History Comparison—Blade and Scientific Aviation**

Figure 127 compares the rates of Scientific Aviation with those of this report. The lower estimated rates, which assumed badly corroded tubing and casing, were the lower limit, and the higher estimated rates, which assumed new tubing, were the upper limit. Pulled production casing and logging after the leak showed evidence of metal loss, corrosion, and scaling. The best rates were from the assumed pipe roughness based on corrosion and scaling and were always just at or above the Scientific Aviation rates. Note that the plateau rate assumed by Scientific Aviation for the six weeks was a result of limited measurements.

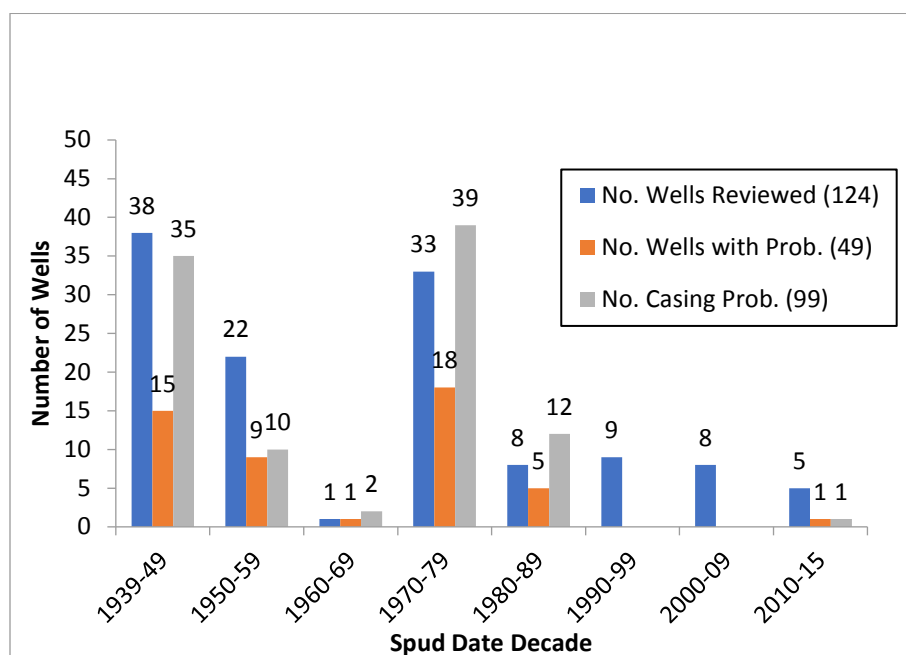
**Figure 129: Number of Wells Reviewed, Wells with Failures, and Casing Failures**

Figure 129 shows a breakdown of the number of wells reviewed, wells with casing problems, and casing failures by spud date (the start date of the well drilling process) at ten-year intervals. As the plot shows, most of the drilling activity happened in two groups: from 1939 to 1959, when the field was developed for oil and gas production, and from 1970 to 1979, when many of the gas storage wells were drilled.

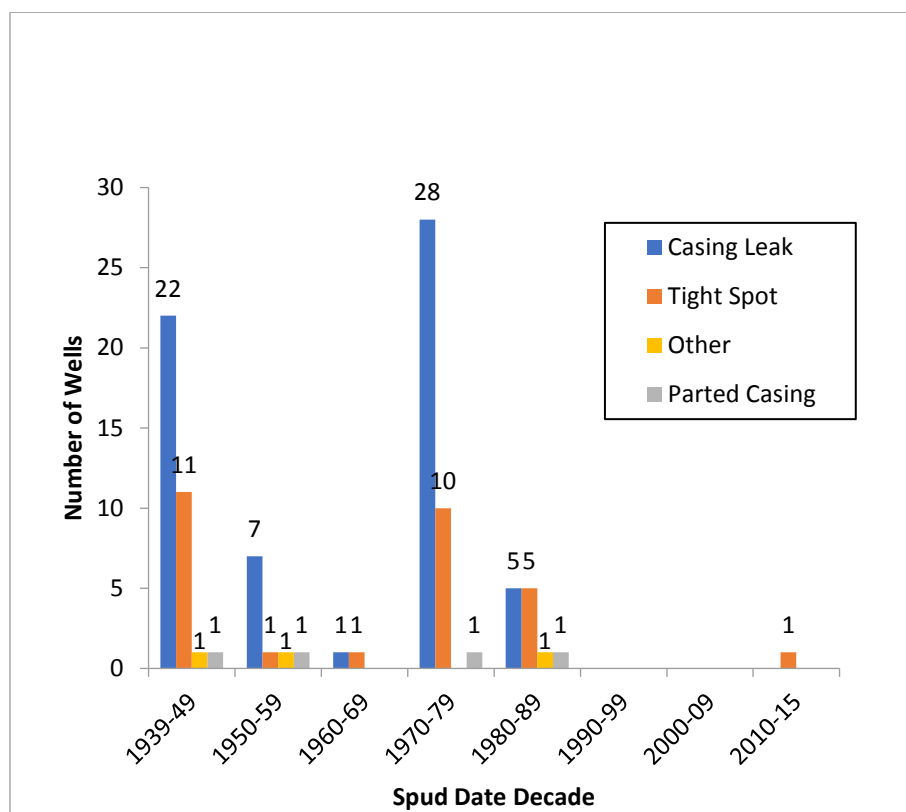
**Figure 130: Number and Types of Casing Failures by Spud Date**

Figure 130 shows that casing leaks represent the majority of the casing failures.

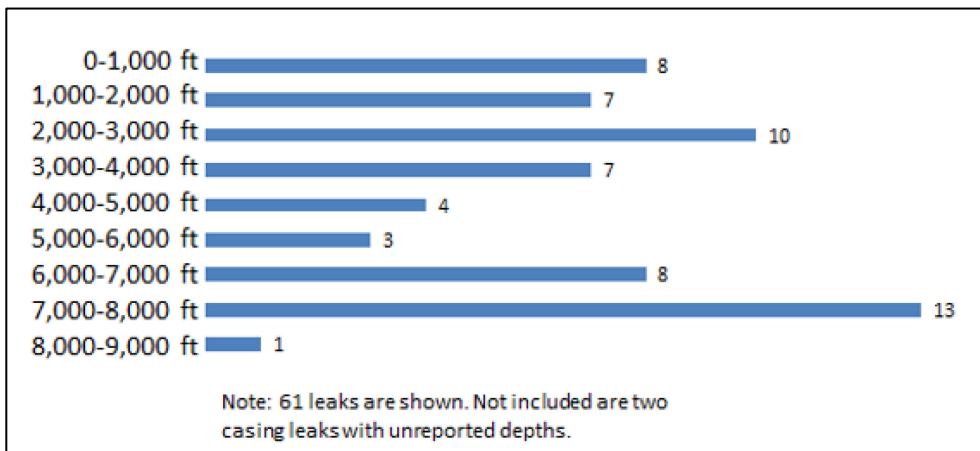
Figure 131: Casing Leak Count by Depth Range

Figure 131 shows the number of casing leaks by depth range. Our analysis shows that:

- 8 of 61 (13%) casing leaks occurred above 1,000 ft, including the one in SS-25.
- 52% of the leaks were between the surface and 4,000 ft with no trend of leak count vs. depth.
- Leaks in the lower part of the well were more numerous from 7,000 ft to 8,000 ft.
- 63 casing leaks occurred in 41 wells for an average of 1.5 leaks per well.

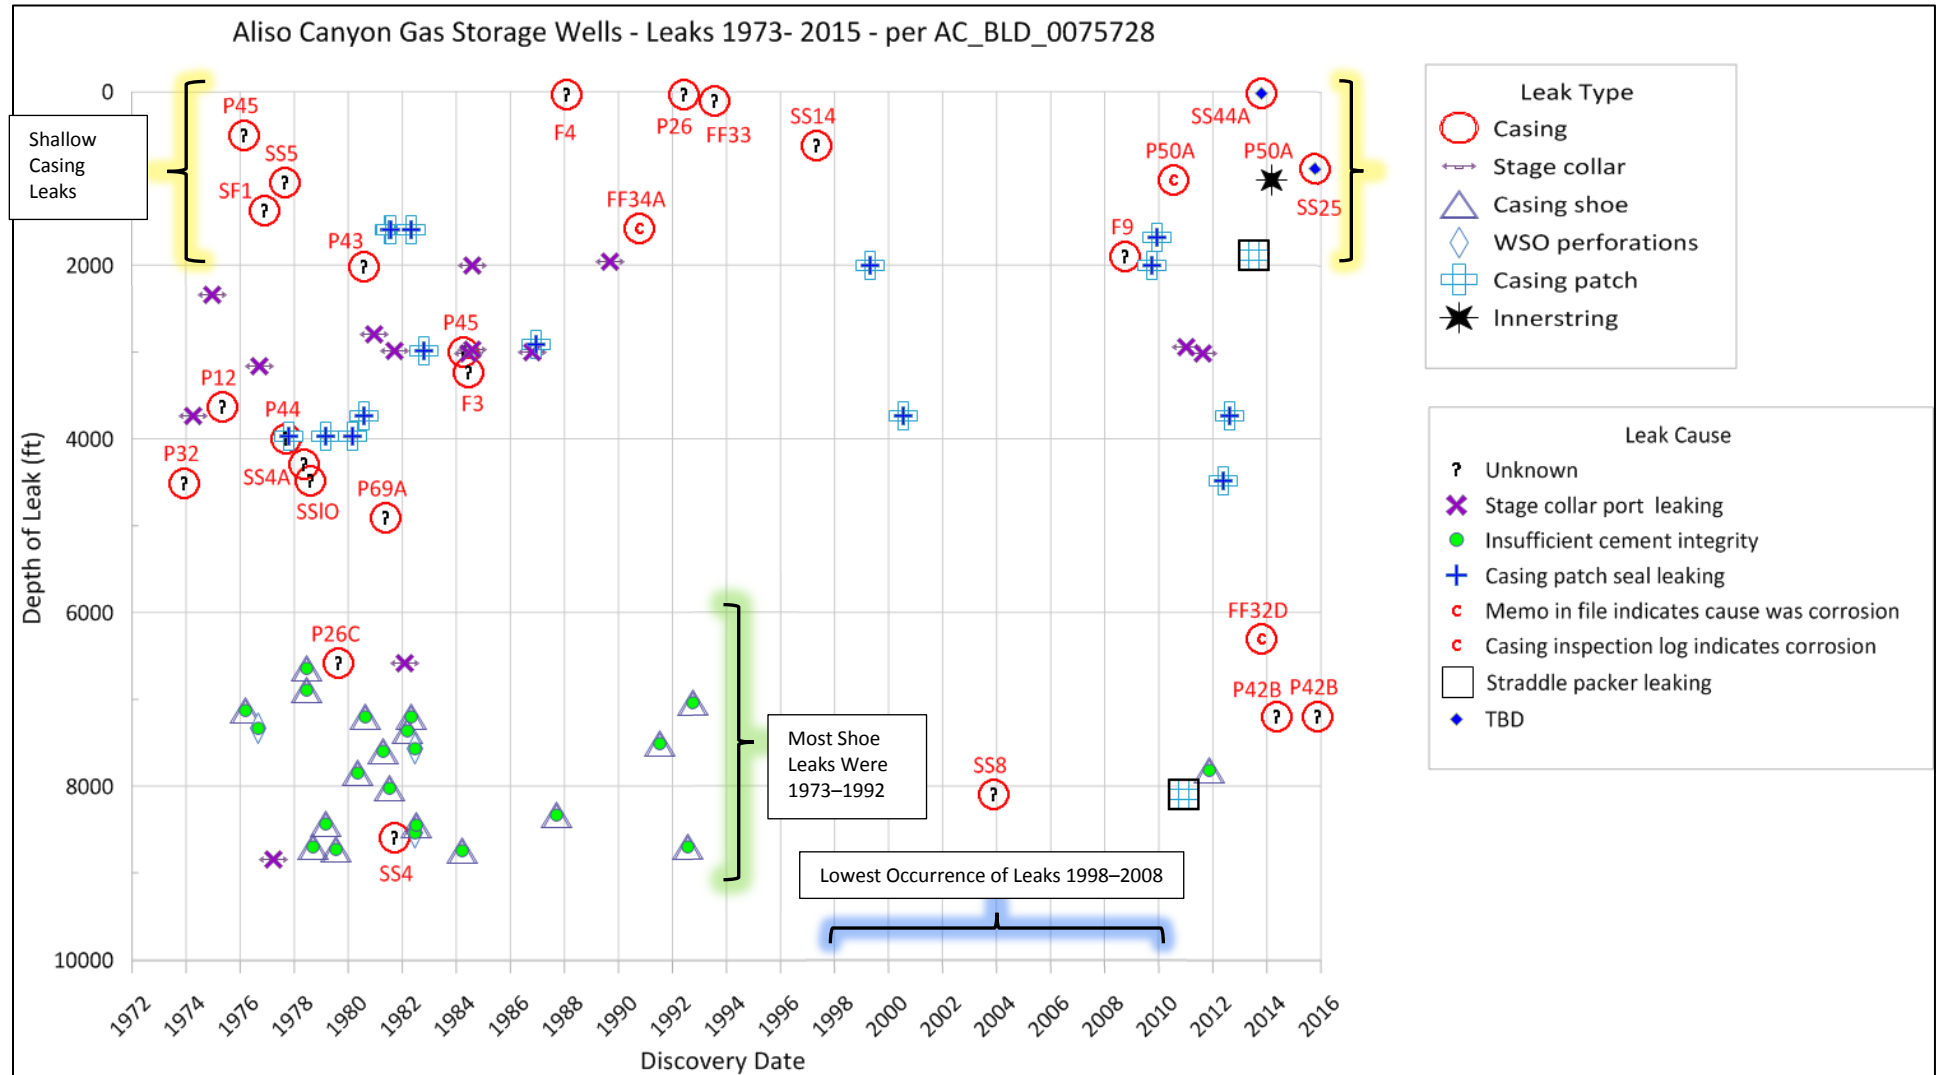
Figure 132: Leaks per SoCalGas Data [51]

Figure 132 shows the data from SoCalGas table graphically by leak discovery date on the x-axis and well depth on the y-axis. There are two legends: one for the leak type and a second one for the leak cause. A few trends are visible. What is apparent is that leaks of any type were most prevalent before the mid-1990s. For the casing shoe leak type, all but one leak occurred before 1992, denoted by a green brace. Although not of high importance to the RCA, numerous leaks in stage collars and casing patches (intended to cover the stage collars) are present. Most relevant to the RCA are the casing leaks denoted by red circles. Denoted within each circle are SoCalGas's determinations of the leak cause. The ? symbol denotes unknown causes. About half of the casing leaks are shallower than 2,000 ft and denoted by yellow braces. Most of the shallow casing leaks have unknown causes. There does seem to be a reduction in the number of leaks identified from around 1998 to 2008—denoted by a blue brace. We are not entirely sure why this was the case. There were no changes in the SoCalGas Monitoring Program (Appendix A.1).

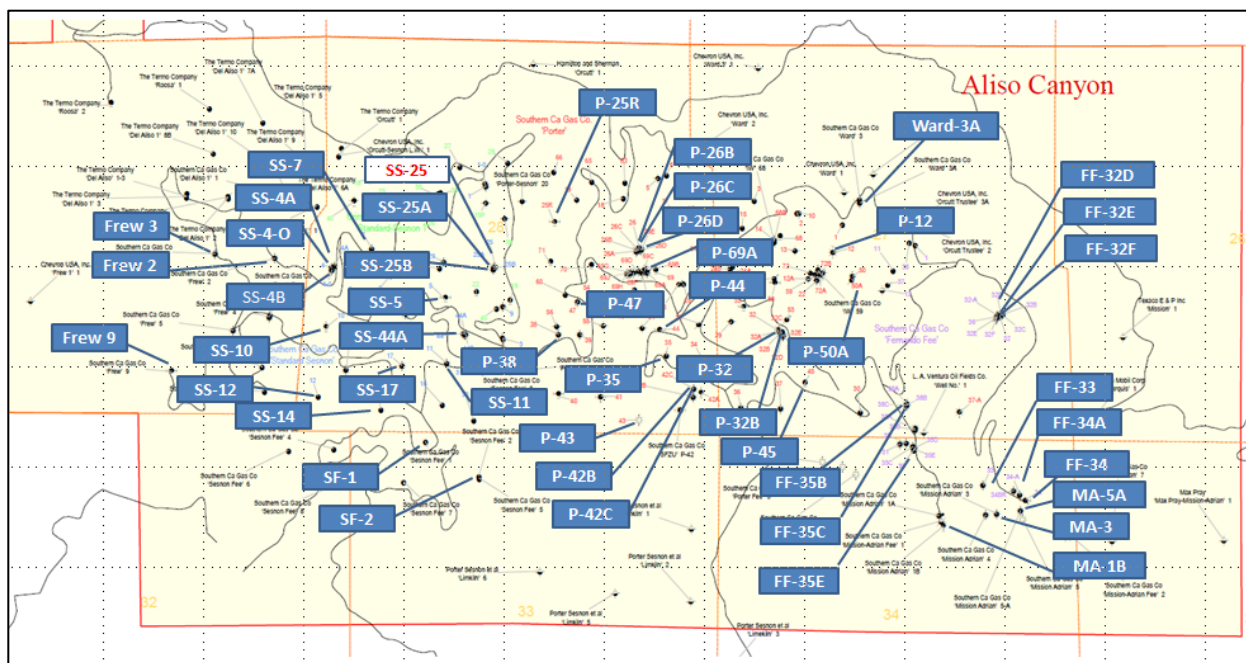
Figure 134: Map of Aliso Canyon showing Wells with Casing Failures

Figure 134 shows the Aliso Canyon wells with casing failures. The distribution of casing failures appears to be field-wide and not concentrated in a specific area of the Aliso Canyon Field. SS-25 is located in the western part of the field.

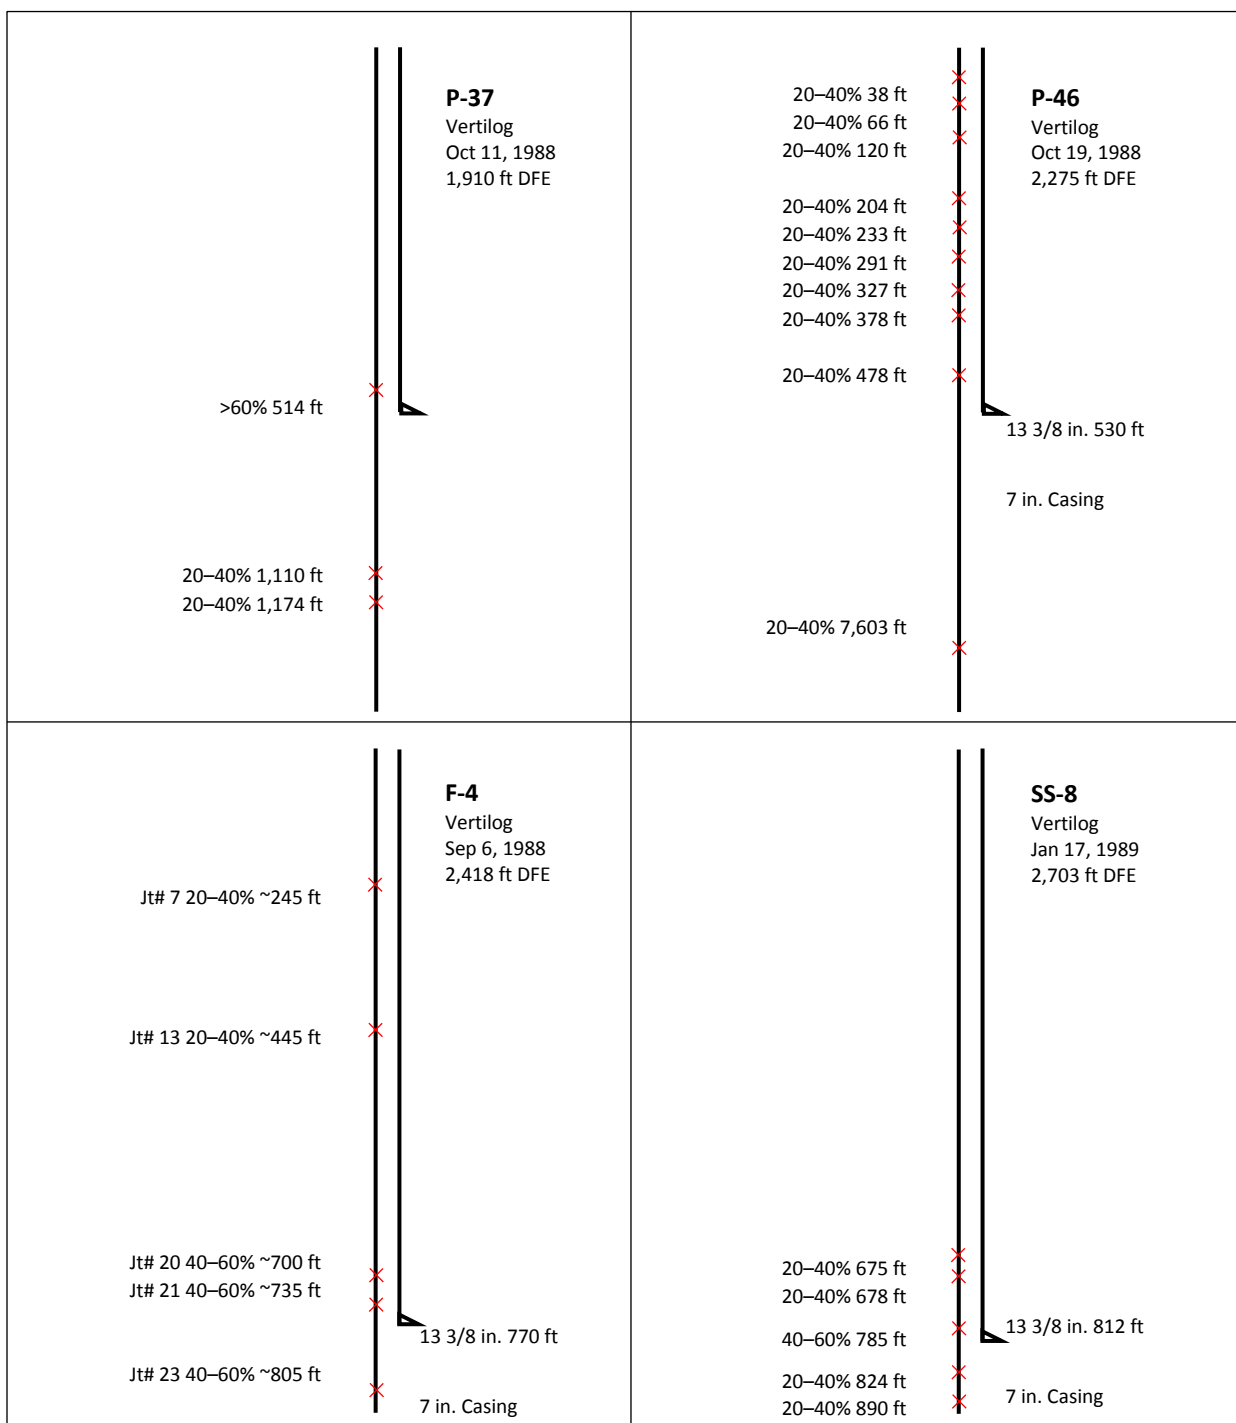
Figure 136: Wellbore Schematics Showing Vertilog Penetration Data

Figure 136 summarizes the percent penetration and depths from the Vertilog inspection results for wells P-37, P-46, F-4, and SS-8 production casings above and immediately below the surface casing shoe. The four wells were inspected in 1988 and 1989. The derrick floor elevation (DFE) above sea level is included and shows the significant variation in surface elevations among the wells. All of these wells had OD indications. P-46 had numerous metal loss indications above the shoe; and all of them had indications shallower than 1,000 ft. The behavior in these wells appears similar to SS-25.

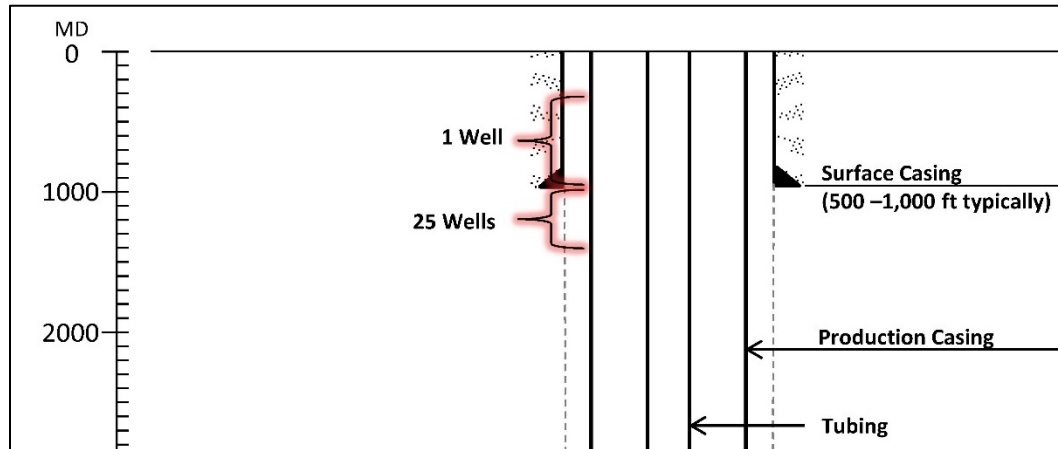
**Figure 139: Location of Shallow External Corrosion on Production Casing Not Including SS-25**

Figure 139 shows the location of the shallow external corrosion on the production casing for 26 wells. Almost all of the wells had production casing external corrosion present just below the surface casing shoe. One well, P-50A, had production casing external corrosion above the surface casing shoe. SS-25 was not included, but it was the only well that showed shallow corrosion above *and* below the surface casing shoe.

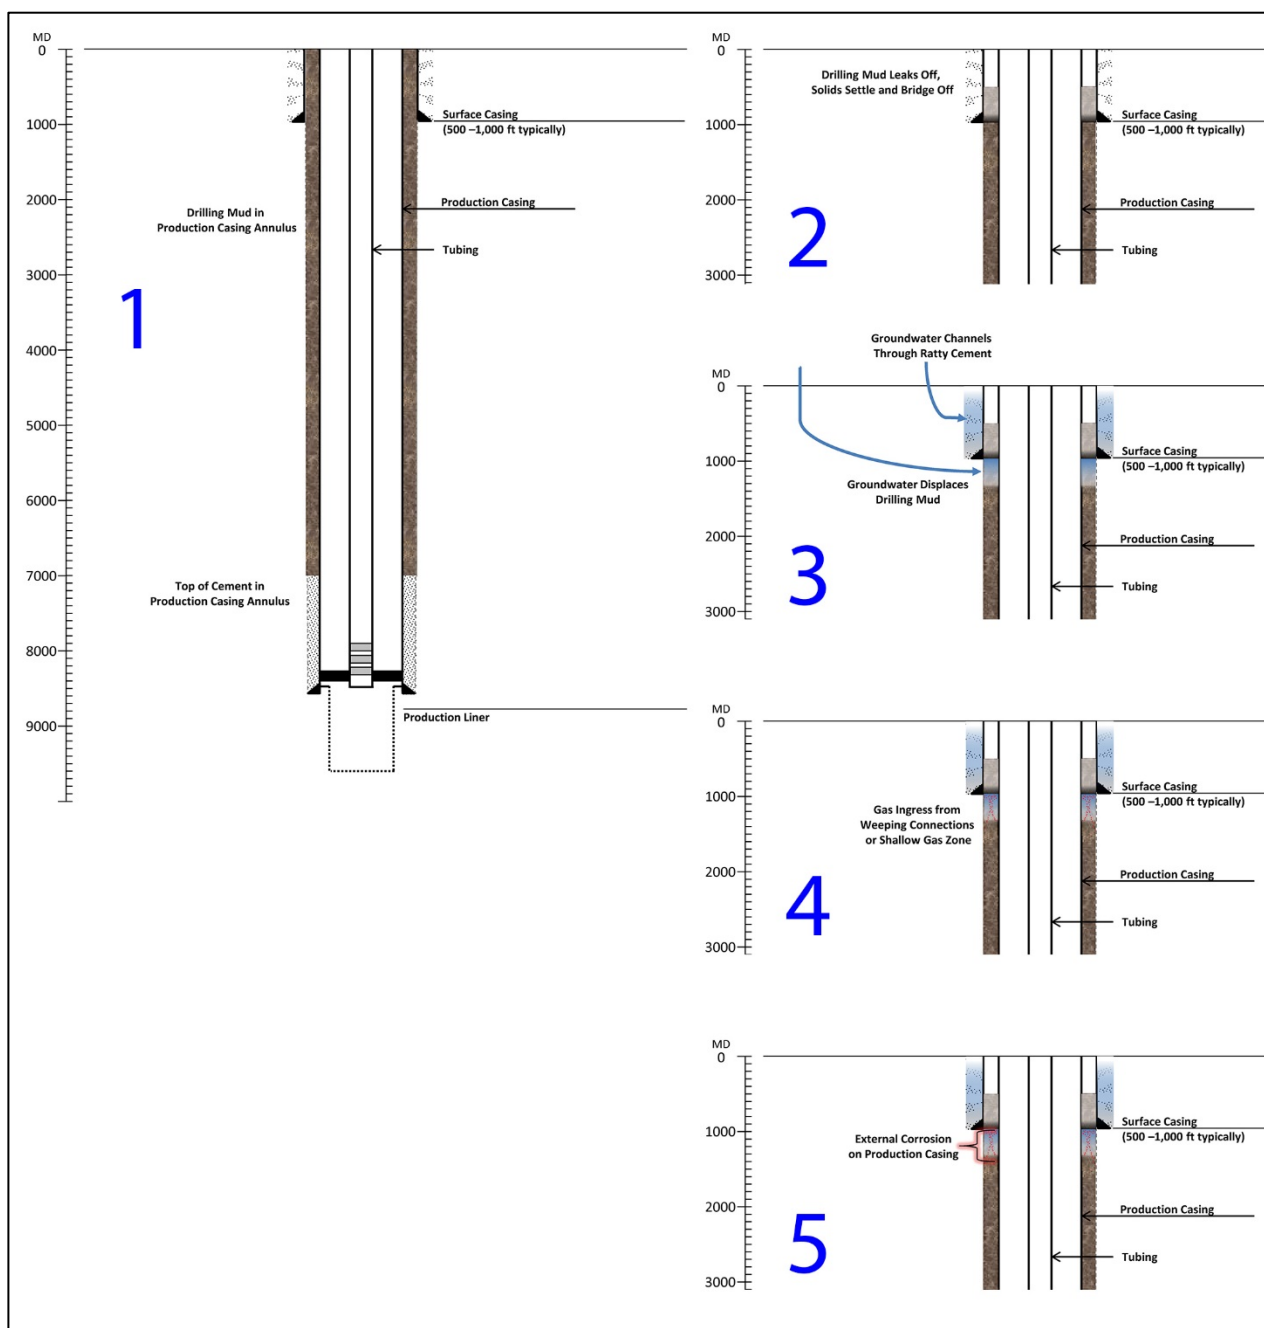
Figure 141: Hypothesis for the Shallow External Corrosion Mechanism

One area of investigation focuses on the location of corrosion near the surface casing shoe. This is common in a number of wells; this suggests a common corrosion mechanism. Figure 141 shows a possible corrosion mechanism supported by some of the observations discussed previously. Using the numbered inset images, the hypothesis is as follows:

5. Corrosion initiated and grew in the aqueous carbon dioxide environment. This process may have been assisted by microbes residing in the groundwater.

The hypothesis described above is consistent with the shallow corrosion observed across the 25 wells. Much of the shallow corrosion, unlike SS-25, was only observed below the surface casing shoe. Further analysis is necessary to develop this hypothesis and appropriately mitigate.

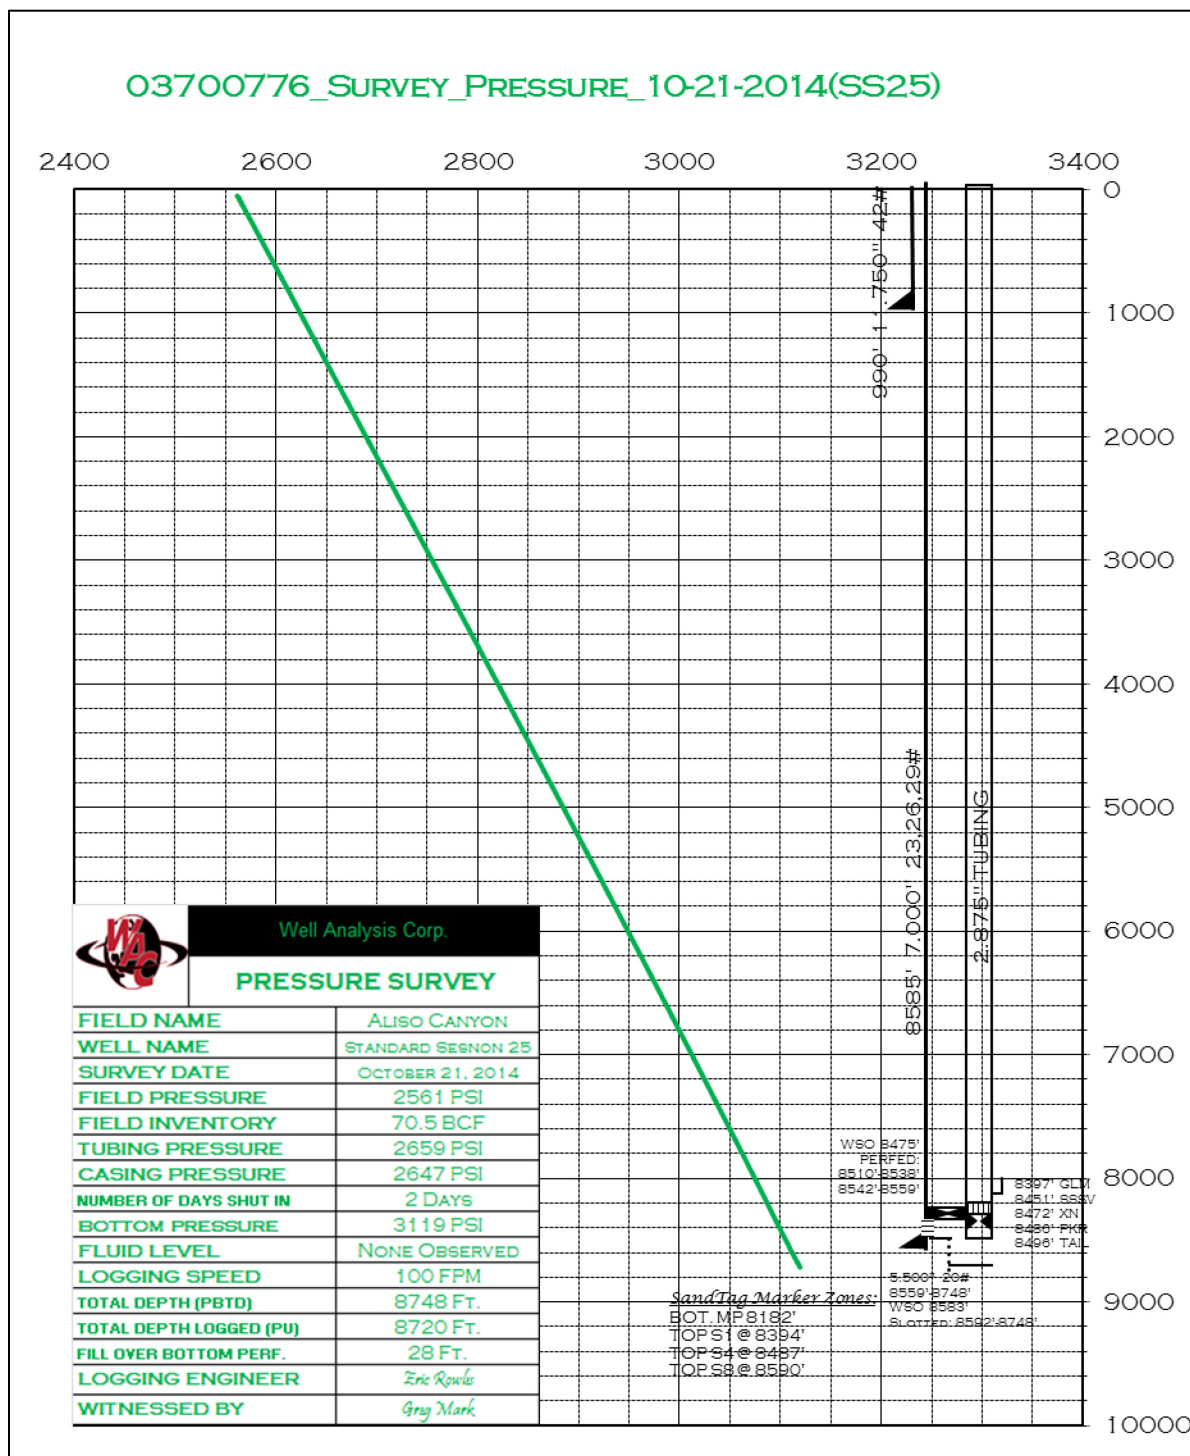
Figure 143: Most Recent SS-25 Pressure Survey, October 21, 2014

Although SoCalGas performed 41 pressure surveys in 41 years, neither the *DOGGR Project Approval Letter* [72] nor the *SoCalGas Gas Inventory-Monitoring, Verification, and Reporting Company Operations Standard Gas Operations* [73] required pressure surveys. Figure 143 shows the most recent pressure survey on October 21, 2014, to 8,720 ft, in which there seems to be a discrepancy; the title block entry for “Tubing Pressure” (2,659 psi) does not match the graphed data, which appears to be between 2,550–2,600 psi. Despite this discrepancy, no pressure anomalies are observed in the graphed data.

Blade’s interpretation of the pressures surveys is that they were not effective in determining the presence or location of a casing leak; small leaks would go undetected. From a casing integrity perspective, pressure surveys differ from pressure tests substantially. In pressure surveys, the well is open to the storage zone, and any gas that escapes into a casing leak is replenished by the storage zone. This is considerably different than a pressure test where all external sources of pressure are isolated. Additionally, the pressures observed during these pressure surveys are the shut-in pressures. The pressure profiles during shut-in are lower than during standard gas injection operations. In other words, pressure surveys are taken at times when the casing is under less pressure than during gas injection.

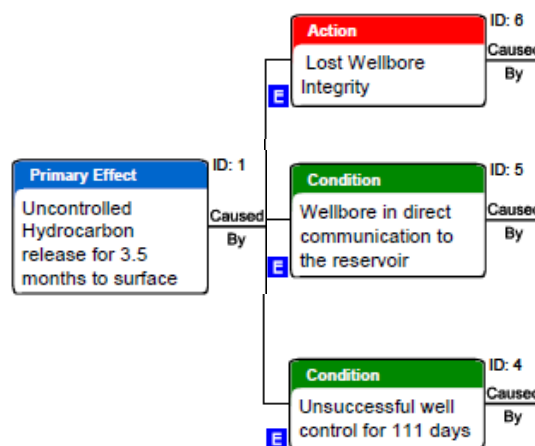
Figure 146: Causes of the SS-25 Incident

- The well-control efforts took 111 days to stop the reservoir gas from leaking to the surface. Seven attempts were made to stop the gas flowing up through the wellbore by pumping kill fluids down into the well from the surface. These top kill attempts were unsuccessful and, ultimately, a relief well had to be drilled to intersect the SS-25 wellbore at 8,534 ft and bring the gas flow to a stop by pumping kill fluid down the relief well to fill SS-25 with kill fluid from the bottom. If, for example, the first top-kill had been successful, the flow of gas to the surface would have been stopped within days. For example, had a successful well kill occurred by October 26, the cumulative volume leaked would have been 0.4 BCF instead of around 6 BCF.

Figure 146 shows the primary effect of the SS-25 incident and the three causes.

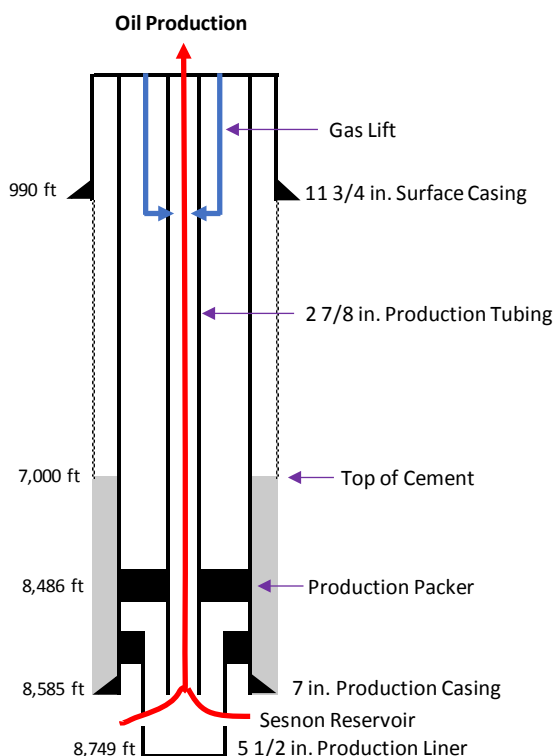
**Figure 148: Well Schematic from When SS-25 Was an Oil Well**

In 1954, SS-25 was drilled and then completed as an oil producing well. Figure 148 shows that a 7 in. production casing string was run from the surface to 8,585 ft, which was approximately 200 ft into the Sesnon oil reservoir. Below the 7 in. casing, a 200 ft 5 1/2 in. production liner was run across the Sesnon formation. This liner had slots cut along its length. A 2 7/8 in. production tubing string was run inside the 7 in. casing. At the bottom of the tubing string, a production packer isolated the annular space between the tubing and the 7 in. casing. During production the oil flowed from the Sesnon through the slots in the liner, up into the tubing, and up the tubing to the surface. The production packer prevented oil from flowing into the 7 in. x 2 7/8 in. annulus. Thus, the wellbore was in direct communication with the reservoir, allowing the oil to be recovered from the reservoir, which was the objective of the well. Note that the reservoir pressure was not high enough to force the oil all the way to surface. Several gas lift valves were therefore installed in the upper section of the tubing string. This allowed gas to be pumped down the 7 in. x 2-7/8 in. annulus, through the gas lift valves and into the tubing. The gas mixed with the oil making it lighter so that it would flow to the surface.

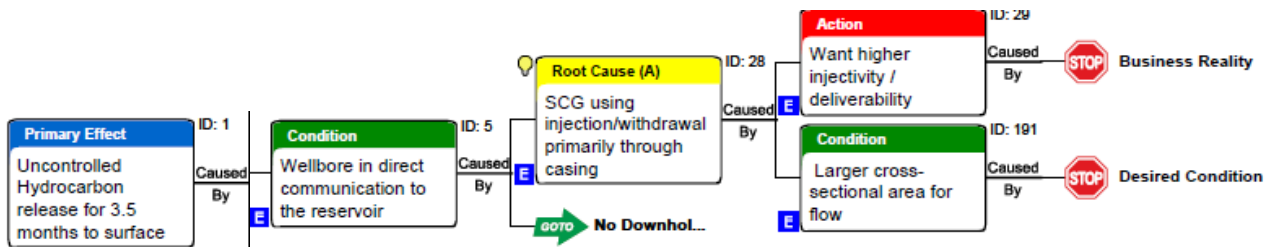
Figure 149: Causes—Wellbore in Direct Communication with the Wellbore

Having the wellbore in direct communication with the reservoir is a business reality. However, as Figure 149 shows, the effects of the incident were complicated by the fact that the well was configured for injection and withdrawal through the tubing and casing. In the 38 years SS-25 was used as a gas storage well, it was mostly used for injection, and most of that was done through the casing. Injecting gas through the casing allowed higher injection and withdrawal rates because it provided a larger flow area (than just the tubing), and a higher rate of gas could be injected through the casing. Maximizing the injection and withdrawal rates at lower pressures through each well is a business reality, reducing the need for additional storage wells. But this had an adverse impact on the wellbore integrity. Another impact of the well configuration was the absence of a functioning downhole annular flow safety system. Such a system had been initially installed but proved to be unreliable, and it was later removed. This is discussed in more detail in Section 5.2.3.

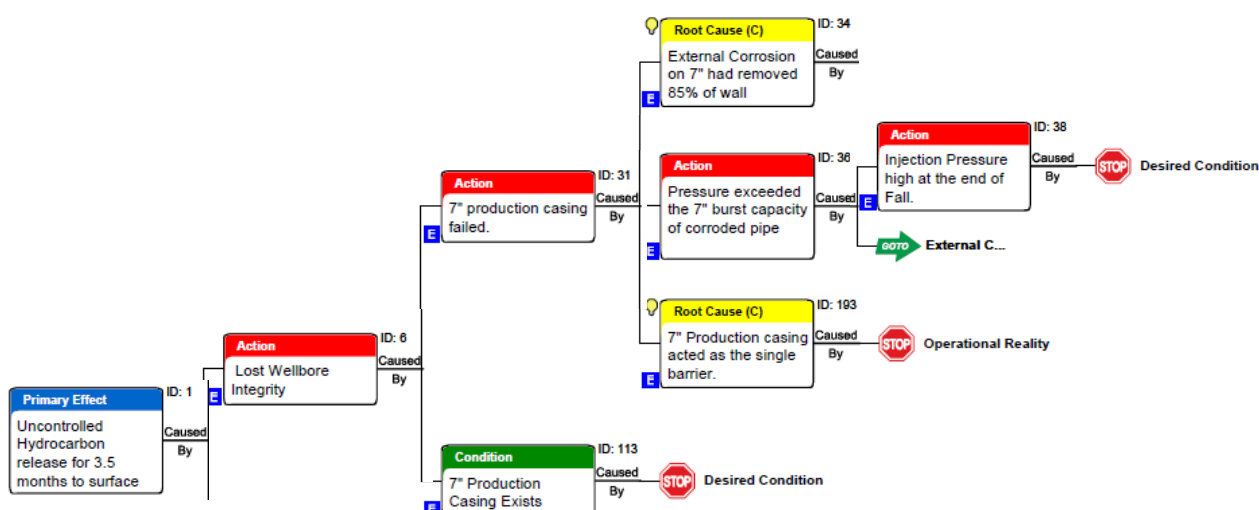
**Figure 150: Causes—Lost Wellbore Integrity**

At the time of the incident, gas was being injected into the reservoir. Wellbore integrity was lost when the 7 in. casing (which was being used to provide the conduit between the reservoir and the surface) ruptured and parted, allowing the pressurized gas to escape from the wellbore. Figure 150 shows that the following were the causes of the failure:

- The external corrosion on the 7 in. casing had removed 85% of the wall thickness.
- The pressure inside the 7 in. casing exceeded the burst capacity of the corroded casing.
- The 7 in. casing acted as a single barrier.

Rig operations during Phase 3 found that the 7 in. casing had parted at 892 ft. Blade examined the parted sections and found that external corrosion had removed 85% of the wall thickness, which consequently reduced the burst capacity of the 7 in. casing. At the time of the failure, the pressure of the gas being injected into the wellbore was 2,700 psi surface pressure. Blade developed a finite element model of the corroded region where the 7 in. casing failed by using the actual material properties and dimensions of the corroded section. The corroded region included sharp grooves causing a stress concentration that was approximated in the finite element model. The modeling predicted that the corrosion region would fail at a differential pressure between 2,327 and 2,836 psi. This is consistent with an internal pressure of 2,791 psi at the failure location. The surface injection pressure varies throughout the year and was at the highest level for the year. This was normal for the fall months, when more gas is stored for the upcoming winter demand.

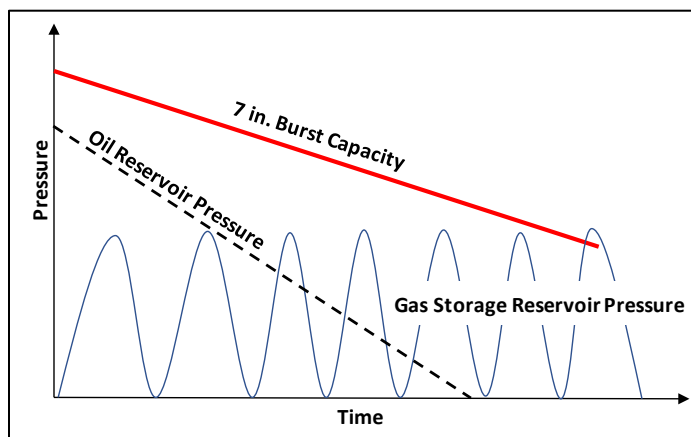
**Figure 151: Oil and Gas Storage Reservoir Pressures Compared**

Recall that SS-25 was originally designed to be an oil producer in 1954 and was converted to gas storage in 1973, 19 years later. Other wells in Aliso Canyon drilled after 1973 were designed specifically to be gas storage wells. A key difference between the two types of wells is that the reservoir pressure in an oil well decreases gradually over time, whereas the reservoir pressure in a gas storage well does not. An oil well experiences the highest pressures on the first day of production, and pressure then decreases over time. The pressures that gas storage wells are exposed to are cyclic as gas is injected and withdrawn normally on annual cycles (Figure 151). The cyclic pressure levels are approximately the same year after year; the 7 in. casing burst capacity decreased over time because of the effects of wall loss corrosion. A key tenet of ensuring wellbore integrity is that the casing be designed to withstand the pressures it will be exposed to over the complete life of the well.

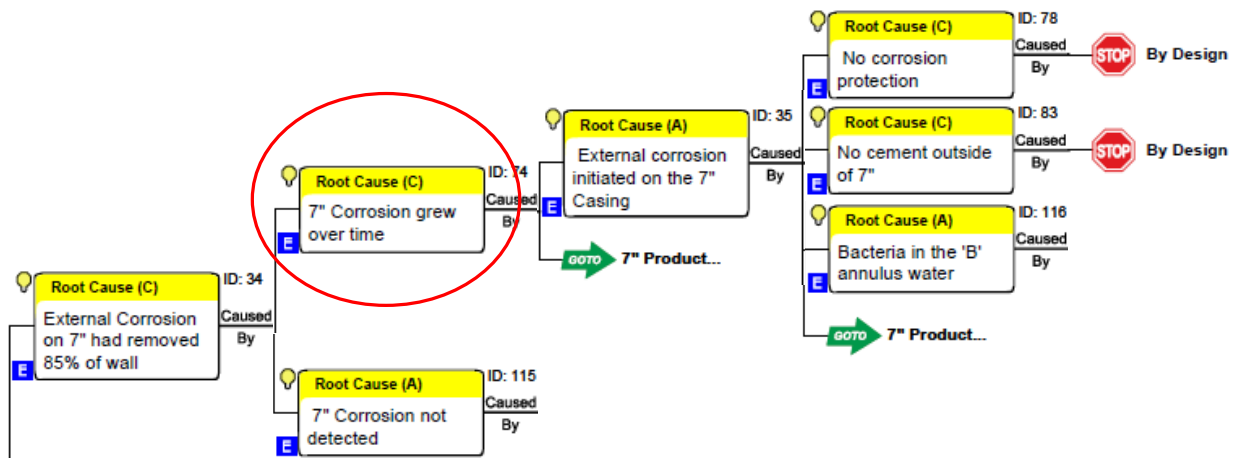
**Figure 152: Causes—Corrosion Growing Over Time**

Corrosion initiated on the OD of the 7 in. casing and continued to grow over time because there was neither corrosion protection for the OD nor cement outside the casing at 892 ft, and the environment in the 7 in. × 11 3/4 in. annulus was conducive to corrosion (Figure 152). Blade's laboratory analysis of the parted 7 in. casing showed that the wall thickness reduction was caused by microbiologically influenced corrosion (MIC).

For the 7 in. casing to have corroded, it must have been in direct contact with an environment that allowed the corrosion mechanism to exist, and a corrosion protection mechanism must have been absent. Cathodic protection systems, for example, are commonly used to protect pipelines from corrosion and are sometimes used on surface casing strings. While a cathodic protection system would have provided corrosion protection to the 11 3/4 in. casing, it would not have protected the 7 in. casing inside the 11 3/4 in. casing. Therefore, the most common method for providing corrosion protection for casing strings is to manage the environment or to modify the casing metallurgy. The presence of bonded cement outside of the 7 in. casing would have mitigated external corrosion. However, there was no cement around the 7 in. casing at 892 ft, because when the well was originally drilled, the cement around the 7 in. casing was intentionally brought up to 7,000 ft and not to surface. The environment outside of the 7 in. casing, above 7,000 ft, would therefore have originally consisted of the drilling fluid used while drilling the well.

The drilling fluid that was left behind the 7 in. casing had a pH ranging from 10 to 12 and would not have caused corrosion. Over time, the drilling fluid leaked off and was displaced by groundwater. The fluid level in the annulus rose and fell with the groundwater level. The groundwater had a microbial environment that resulted in slow corrosion of the OD of the 7 in. production casing (Figure 153).

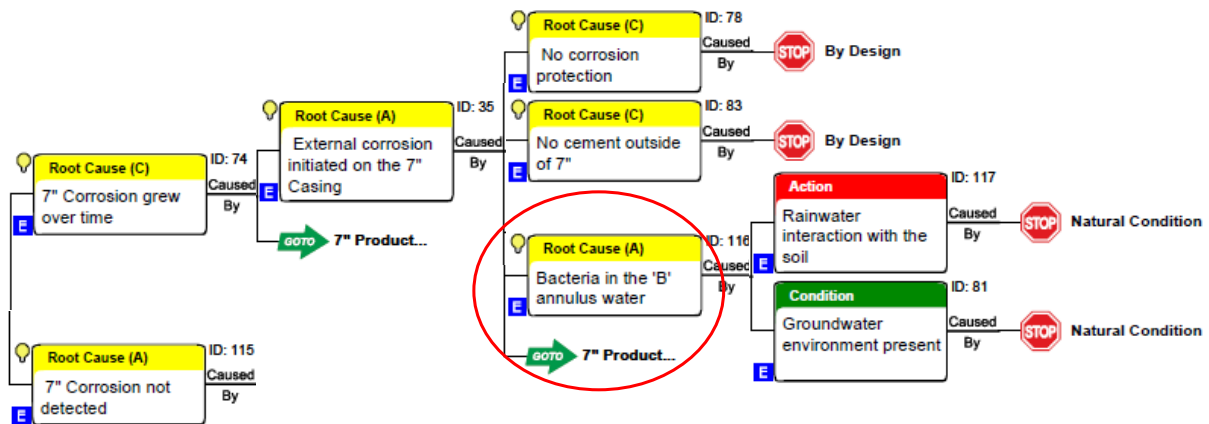
Figure 153: Causes—Annulus Fluid Corrosion Mechanism

The metallurgical analyses documented that the failure location had corroded due to MIC. The evidence supporting the interpretation of MIC included metallurgical, scale and corrosion product chemistry, and scale microbial analyses. The metallurgical assessment demonstrated the presence of tunnels, striations and the microbial nature of the corrosion scale. The Raman and XRD analyses demonstrated the predominance of magnetite and modified hematite. The microbial analyses of the scale demonstrated the consistent and predominant presence of methanogen strains that likely caused corrosion. Finally, many of

the 7 in. Speedtite connections exhibited slow leaks, and this seepage of gas likely introduced carbon dioxide, a nutrient for the methanogens.

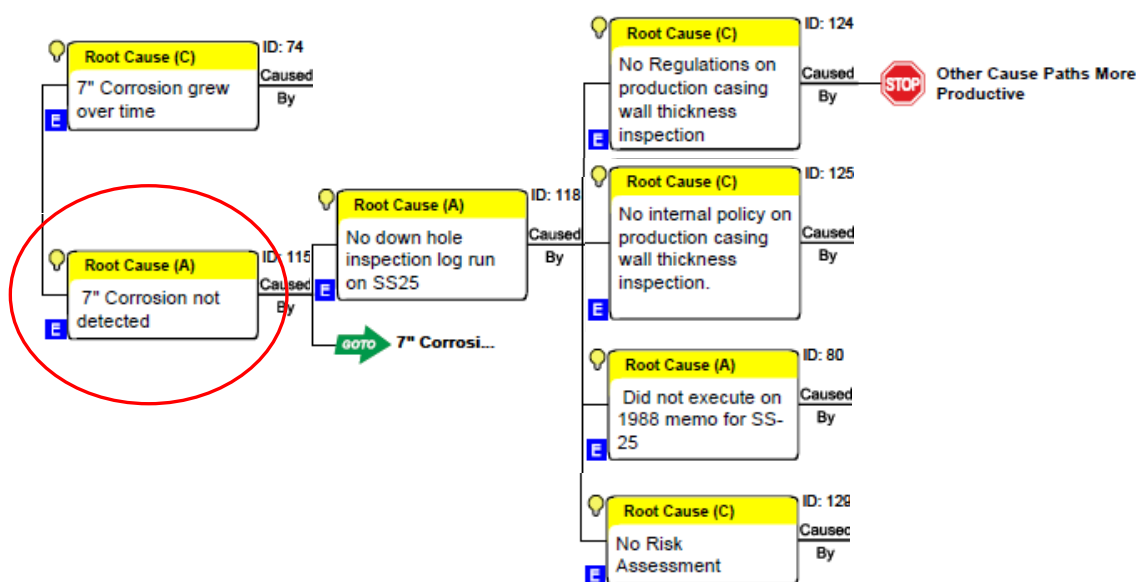
Figure 154: Causes—Corrosion Not Detected

Corrosion was not detected because the 7 in. casing wall thickness had never been inspected; therefore, the fact that the 7 in. casing was undergoing wall loss corrosion was unknown. Various acoustic and electromagnetic based tools can be run in a well with wireline to measure wall thickness along the entire length of a casing or tubing string. These logs were not run in the 7 in. casing because (Figure 154):

- No regulations were in place requiring them at the time.
- No internal SoCalGas policy addressed wall thickness inspections at the time.
- No action from SoCalGas was taken on a 1988 memo recommending that a wall thickness inspection be done at SS-25.
- No risk assessment was performed.

The 2015 DOGGR regulations required periodic MITs, and annual temperature surveys were approved to meet the MIT requirements. Annual temperature surveys and periodic noise logs were run in SS-25 from 1974 to 2014, and no anomalies were found. This type of monitoring program is not capable of detecting corrosion or the growth of corrosion over time (irrespective of whether it is on the ID or OD). The temperature and noise surveys do not measure wall thickness; they will only detect a leak and are consequently after-the-fact, reactive techniques.

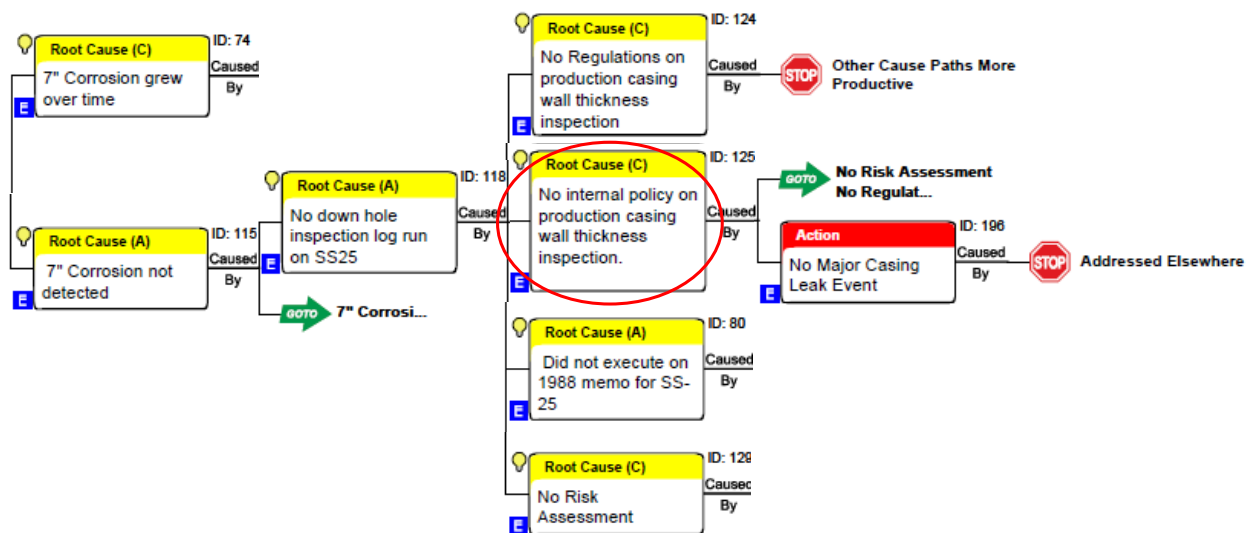
Figure 155: Causes—No Policy on Wall Thickness Inspections

The company assumed that regulatory compliance was being adhered to by running annual temperature surveys per the Aliso Canyon Monitoring Plan and the project approval letter dated 1989 requiring an annual MIT. There were no regulatory requirements for wall thickness measurements to be done. The MIT monitoring system did find casing leaks on other wells in the field, which were successfully repaired or remediated. But again, no failure analysis or risk assessment was ever done on previous wells that had leaks or corrosion. In addition, there had not been an event of similar severity to what happened on SS-25 (Figure 155). Further, since no formal risk assessment was conducted regarding well integrity, wall thickness inspection was not identified as a monitoring technique.

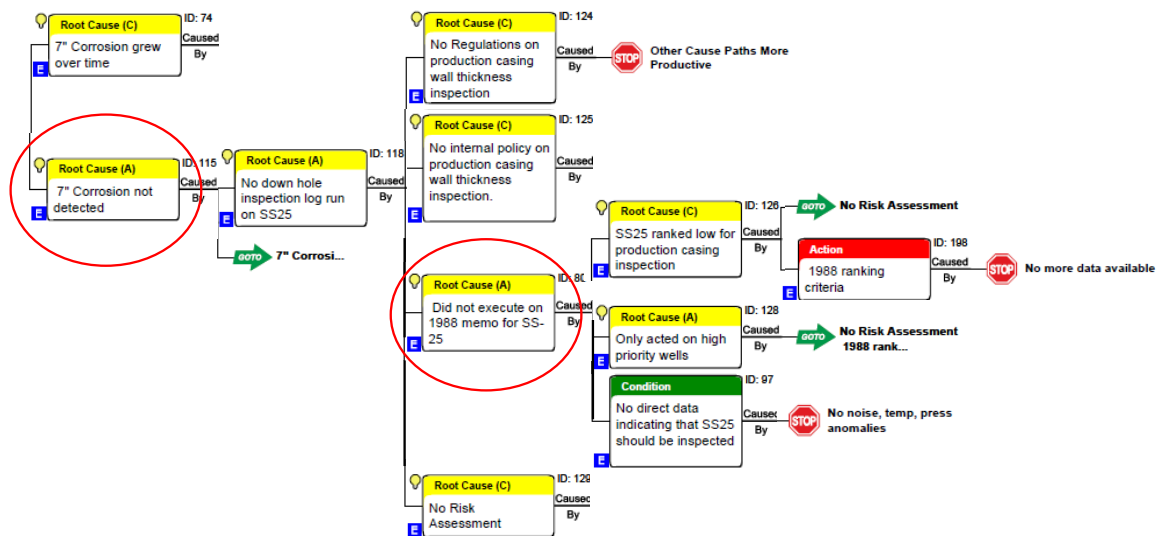
Figure 156: Causes—Not Executing on the 1988 Memo

The 20 wells recommended for a casing wall thickness inspection were originally oil wells completed between 1944 and 1956. The recommendation was to use a Vertilog inspection tool that used magnetic flux leakage measurements to measure casing wall thickness. The recommendation for conducting the survey was approved with the work to be done over the following two years. During that time, 7 of the 20 wells ended up being inspected (5 were high priority, 1 was medium, and 1 had already been scheduled for a workover). The inspection logs showed metal loss, and an inner casing string was run in some of the wells to mitigate the wall loss. However, 13 of the 20 wells were not inspected within the recommended 2-year window. SoCalGas stated that the remaining 13 wells were not inspected because the Vertilog technology available in 1988 “proved to be less effective at identifying casing leaks than the well diagnostic tests that SoCalGas routinely performed on its underground gas storage wells (e.g. annual temperature surveys, noise logs, etc.) [76].” At the time, there were no anomalies or direct evidence from the noise and temperature log monitoring program that SS-25 needed a wall thickness inspection (Figure 156).

A wall thickness inspection provides a leading indicator of possible casing integrity issues. The noise and temperature logs results are trailing indicators because the leak has to already have happened to be detected. Seven of the wells were inspected, and many of them had OD metal loss indications. There was no follow-up investigation of these anomalies. Further, there was no investigation of why these wells exhibited OD corrosion and why the remaining thirteen wells did not require further analyses (the remaining thirteen wells had been ranked as medium and low priority).

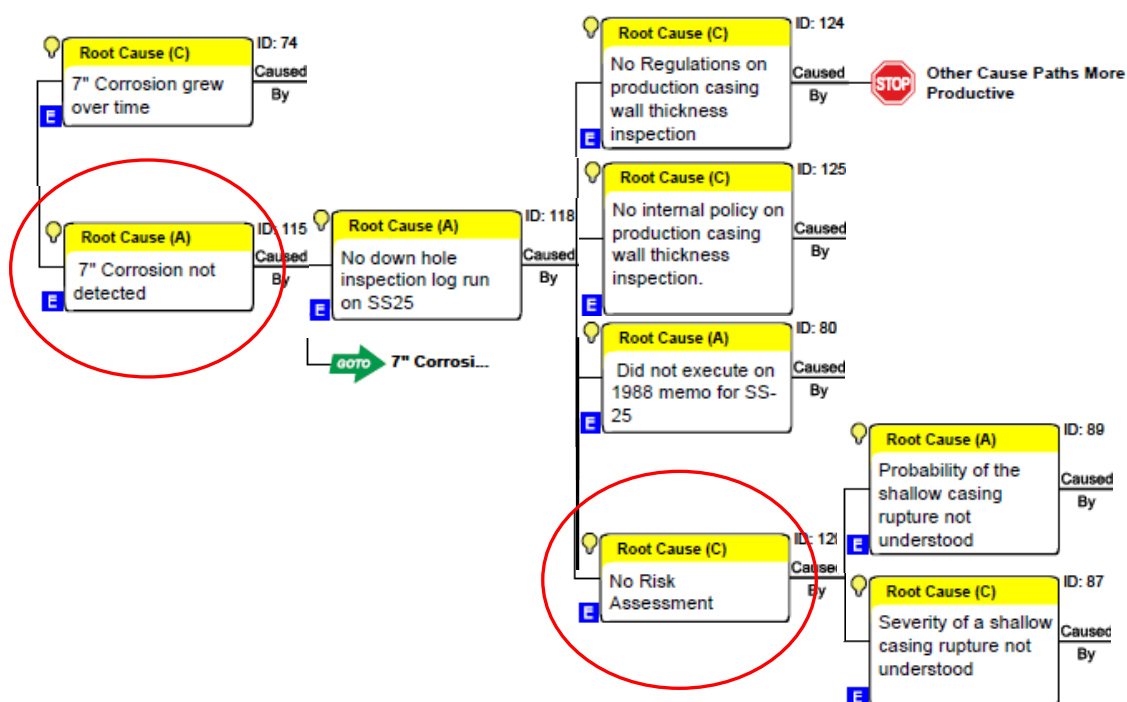
Figure 157: Causes—No Risk Assessment

Despite this, there is no evidence that SoCalGas conducted a formal failure analysis or follow-up risk assessment on any of the casing failures to determine why they occurred. Nor was there an investigation of the reasons for, and the potential consequences of, the corrosion. It is deduced that the reasons for this are because (Figure 157):

- The probability of a shallow casing rupture was not understood
- The severity of a shallow casing rupture was not understood
