# Root Cause Analysis of the Uncontrolled Hydrocarbon Release from Aliso Canyon SS-25

May 16, 2019

Root Cause Analysis Report

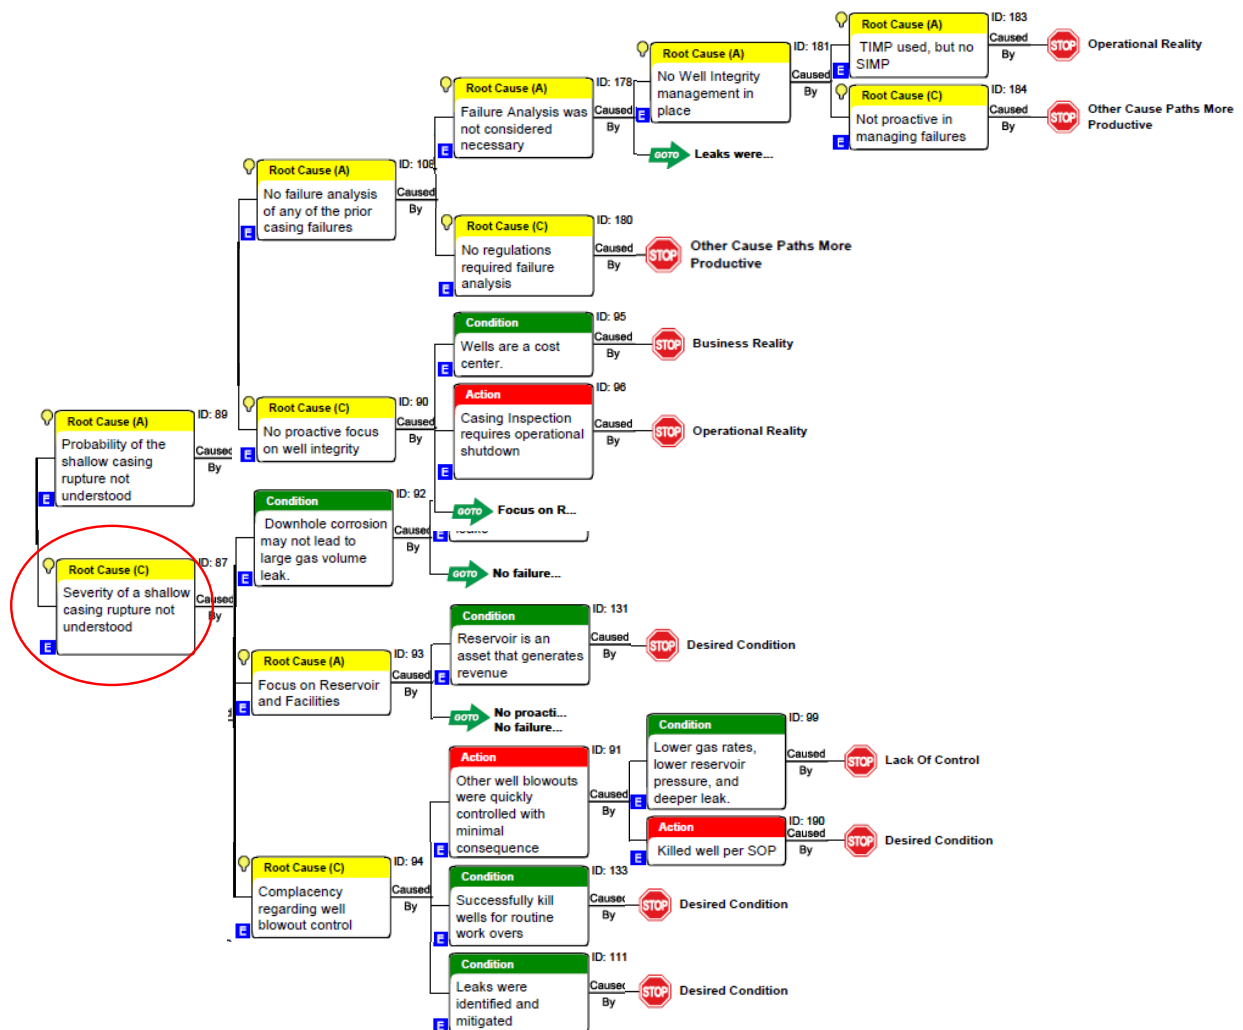
Figure 158: Causes—Probability and Severity of Shallow Casing Rupture Not Understood

The probability of a shallow casing rupture was likely not understood (Figure 158). A key reason for this was that historically, leaks had been detected and were successfully mitigated, but on an individual well basis. The mitigation efforts appeared to be focused on fixing the problem, getting the well back in operation, and then moving on. Also, no regulations required failure analyses to be done. In 2004, the Federal Pipeline and Hazardous Material Safety Administration (PHMSA) began requiring gas transmission companies, including SoCalGas, to develop and implement a Transmission Integrity Management Program (TIMP). In 2006, PHMSA began requiring distribution companies, including SoCalGas, to develop and implement a Distribution Integrity Management Program (DIMP). The concept of an integrity management system is that it proactively identifies potential problems, determines the associated risks, and then implements actions to prevent the problem from occurring or mitigates the risks. There was no equivalent program that involved well integrity, and the response to casing leaks or well failures was reactive instead of proactive. This is consistent with the view espoused by SoCalGas in their 2014 testimony for the 2016 GRC [2] and the lack of formal or informal investigation of casing leaks.

The severity of a shallow casing rupture was likely not understood because there was complacency with respect to well blowout control (Figure 158). The monitoring program had identified casing leaks, which were successfully mitigated. Wells were top-killed for routine workovers or intervention work. The Frew-3 and FF-34A underground blowouts were quickly controlled with minimal consequences—they occurred with a lower reservoir pressure and flow rate, and leaks were deeper when compared to SS-25's. The Sesnon and Frew reservoir properties are generally benign. The temperature is normal, and the reservoir pressure is sub-hydrostatic, that is, the pressure is less than the hydrostatic pressure of water at an equivalent depth. The reservoir gas is not corrosive and consists predominantly of methane with a small amount of CO<sub>2</sub> and no H<sub>2</sub>S. Under normal conditions, the wells can be killed with water. Complex well-control techniques or high density kill fluids are not required. Kill operations were therefore fairly straightforward and had become a routine standard operating procedure. Wells do not require constant daily maintenance or observation unlike a compressor or other complex machinery. They can be operated

It also must be acknowledged that downhole corrosion is not unusual and does not automatically lead to catastrophic failures and large gas volume leaks. If monitored accordingly, corrosion can be managed and mitigated, but the causes and associated risks need to be formally evaluated and understood in order to define safe operating limits of a well.

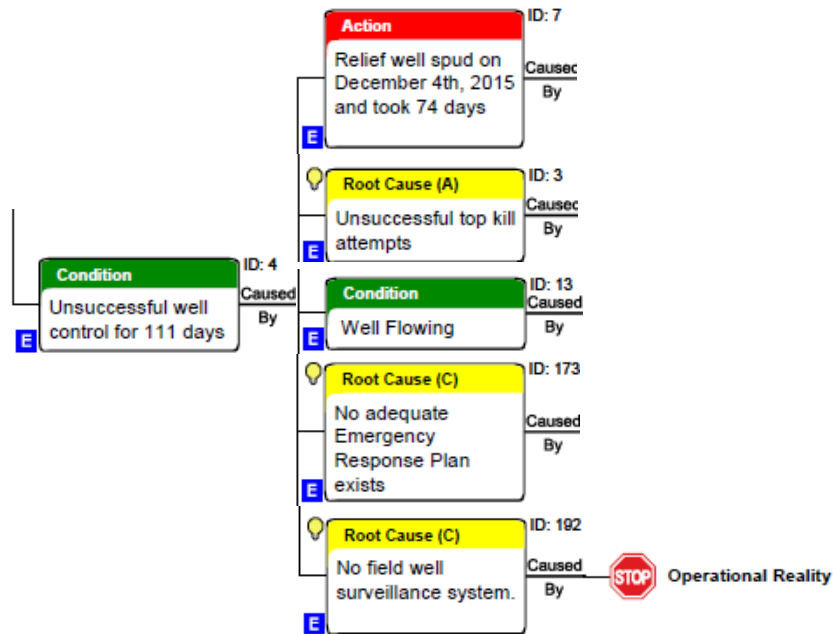
Figure 159: Causes of Unsuccessful Well Control

Seven attempts were made to top kill the well without success. A relief well had to be drilled to intersect SS-25 at 8,534 ft, and kill fluid was pumped down the relief well and into SS-25 from the bottom, which killed the well. It took 111 days to kill the well because (Figure 159):

- The top kill attempts were unsuccessful.
- The well was flowing.
- The emergency response plans were inadequate.
- There was no field well surveillance system.
- The relief well started on December 4, 2015, and took 69 days to complete (74 days including rig up time).

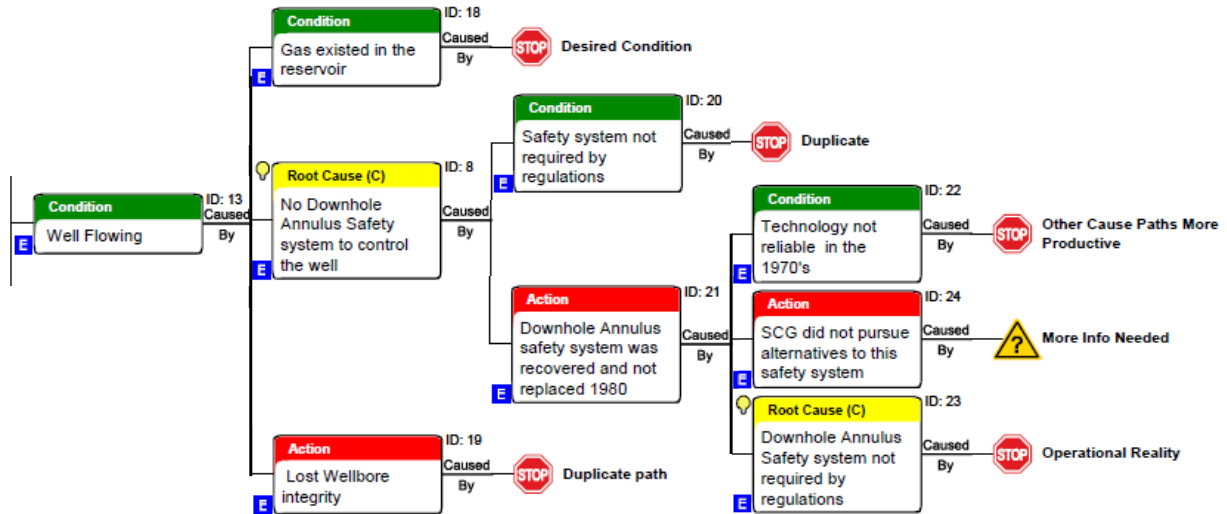
Figure 160: Causes—Well Flowing

The well was flowing because wellbore integrity was lost when the 7 in. casing failed at 892 ft and a downhole annular safety system was not in place to control the well (Figure 160). At the time of the failure, gas was being injected through the casing and into the reservoir. Just after the casing had failed, the injected gas started exiting the well, and gas from the reservoir began flowing up the well and out through the failed casing. Once the leak was discovered, the gas injection was stopped, and the well was shut in at the surface, but gas continued to flow from the reservoir and out the failed area.

A Camco annular flow safety system was installed in SS-25 in July 1976. This system was intended to shut off gas flow in the tubing-casing annulus in the event of a leak in the casing or uncontrolled flow at surface. It was run with the completion tubing and packer and placed deep in the well, above the packer, near the reservoir to provide deep isolation. The safety system was removed and replaced in February 1979. Another attempt was made to repair and test the system in January 1980, when it was concluded that the system did not function as designed. The internal components were then removed, rendering the annular flow safety system inoperable. There are numerous documents in the Aliso Canyon well files indicating problems with this type of safety system. Two systems were tried in various wells in the field; one provided by Camco and the other by Otis. Use of these devices was discontinued in the 1980s,

according to SoCalGas, because they did not work as designed and were unreliable. This is discussed in more detail in the *SS-25 Annular Flow Safety System Review* supplementary report [77].

SoCalGas did not pursue or implement alternatives to the safety system. However, viable deep-set downhole annular safety systems for gas or gas storage wells do not exist even today. Shallow-set systems run in the tubing string that shut off the gas flow in the event of a tubing failure are in common use today, but deep-set annular flow safety systems are not. A shallow-set system would have not prevented SS-25 from flowing either because what failed was the casing and not the tubing. The 2015 regulations did not require a subsurface safety device for non-critical wells.

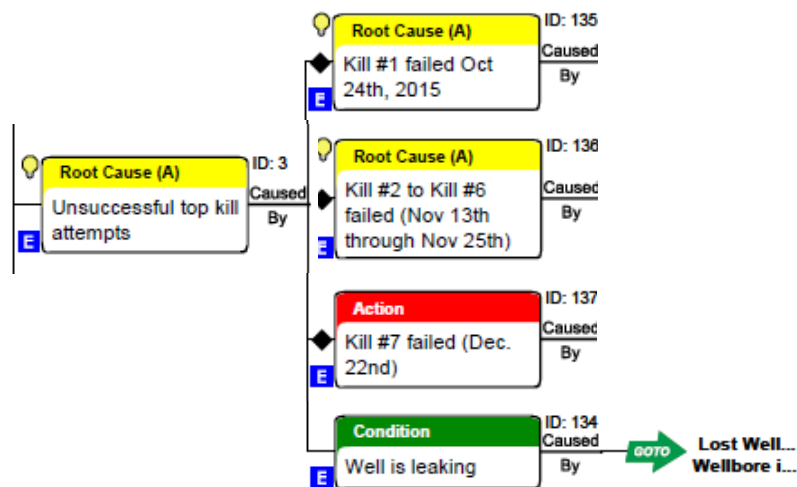
Figure 161: Causes—Unsuccessful Top-Kill Attempts

The leak was detected on October 23, 2015. The first top kill attempt was made on October 24. Because it was unsuccessful, and the well continued to flow; SoCalGas contracted a well-control company to provide technical and operational support. Over the next 39 days, six other top kill attempts were made, all of which were unsuccessful (Figure 161). Table 41 shows the dates of each kill attempt.

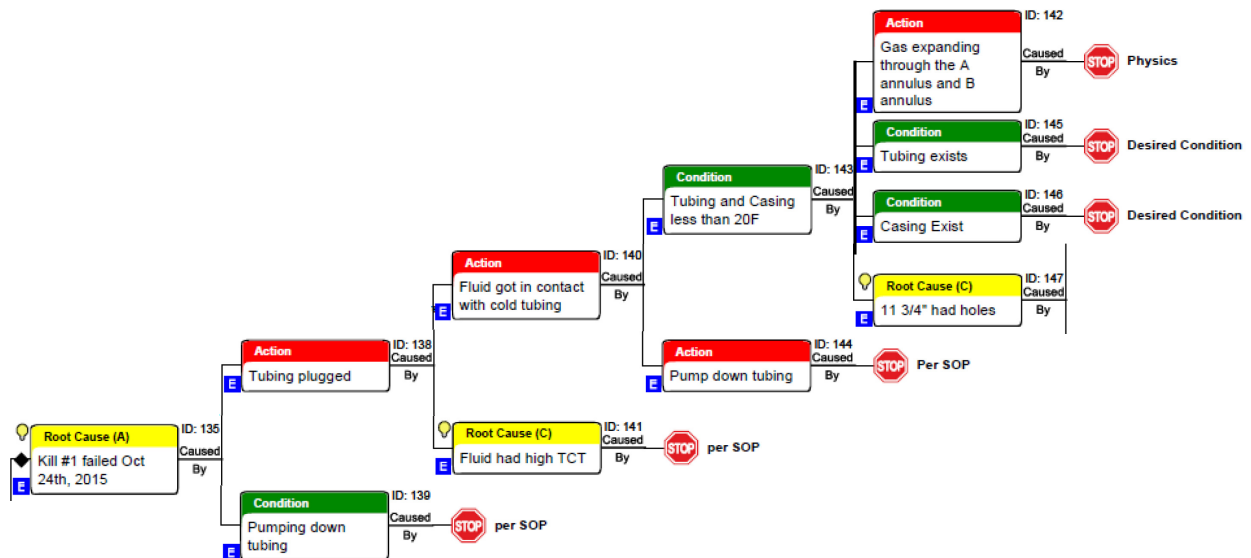
**Figure 162: Causes—Unsuccessful Kill Attempt #1**

Initially, the nature and depth of the leak were unknown. The plan for the first kill attempt was to pump 10 ppg polymer brine kill fluid down the tubing to stop the flow of gas and to displace the gas in the 7 in. x 2 7/8 in. annulus with kill fluid to finish killing the well. On October 24, after pumping 11.8 bbl of the polymer brine, the pump pressure jumped to 3,500 psi, and pumping was stopped. During this time the pressure in the 7 in. x 2 7/8 in. annulus remained constant at 290 psi, indicating that there was no communication between the tubing and the annulus, and the tubing was plugged. The pumping was then switched over to the 7 in. x 2 7/8 in. annulus. After pumping 89 bbl of brine, gas started to break through to the surface through cracks in the ground around the well and pumping was stopped. These results suggested a wellhead seal leak or a shallow leak in the 7 in. casing existed.

Because of the Joule-Thomson effect, the flowing gas cooled to approximately 20°F by the time it reached the area where the 7 in. casing parted. The cooling of the gas then cooled the tubing causing the brine being pumped down the tubing to freeze and form a plug in the tubing. The freezing happened because TCT of the brine was higher than the temperature of the tubing. TCT is the temperature at which salt begins to precipitate, causing the brine solution to solidify. The first top-kill attempt was therefore unsuccessful because the tubing became plugged, preventing the kill fluid from being pumped down the tubing (Figure 162).

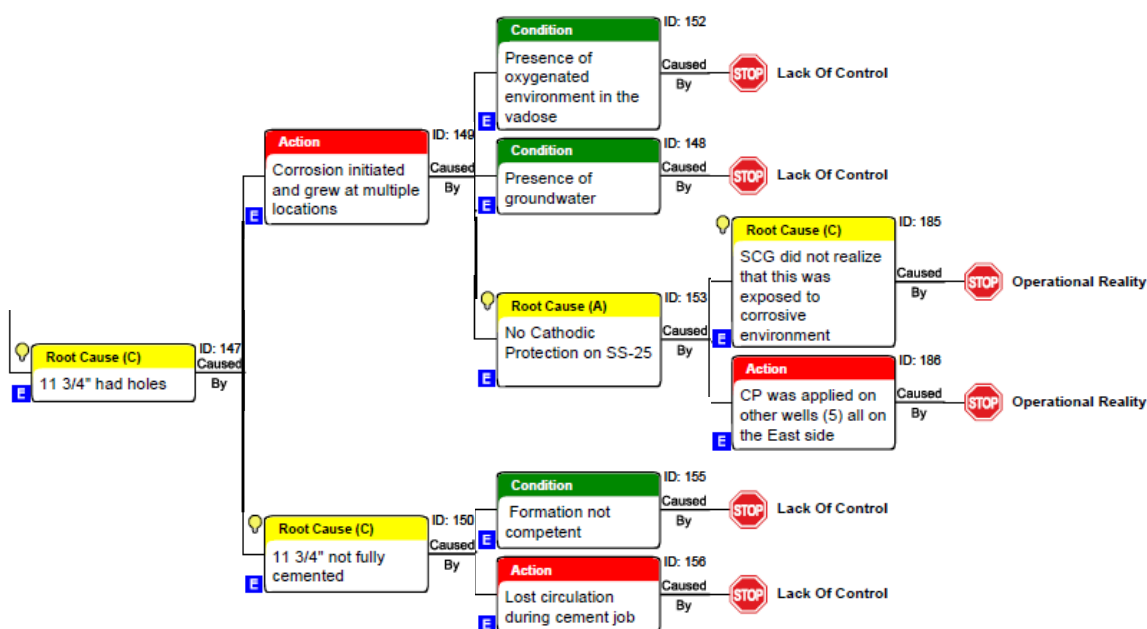
**Figure 163: Causes—Holes in 11 3/4 in. Surface Casing**

During the Phase 3 evaluation of the condition of the 11 3/4 in. surface casing, holes in the casing were found between 134 and 300 ft. These holes were caused by the escaping gas pressure following external corrosion because the casing was neither fully cemented nor cathodically protected leaving the casing exposed to an environment conducive to corrosion (Figure 163). This environment consisted of the undersaturated vadose zone containing air and some water, from surface to 300–400 ft, and then groundwater in the deeper formations.

Lost circulation occurred at 169 ft when the 11 3/4 in. hole section was originally drilled in 1953. This was because the strength of the formations being drilled is low, as is frequently the case in the first several hundred feet in a well. The hydrostatic pressure of the drilling fluid being used exceeded the formation strength, causing lost circulation. Lost circulation also occurred when the 11 3/4 in. was run and was being cemented so that cement was not circulated to surface. Cement was pumped from the surface, and it was assumed that the annulus around the casing had been filled with cement. However, when cement integrity logs were run in the 11 3/4 in. during the Phase 3 operations, fair cement was only found outside the casing from 606 to 660 ft and from 950 to 985 ft, leaving the majority of the casing exposed (Figure 163). Surface casing cathodic protection had been applied to five other wells at Aliso Canyon, but not to SS-25.

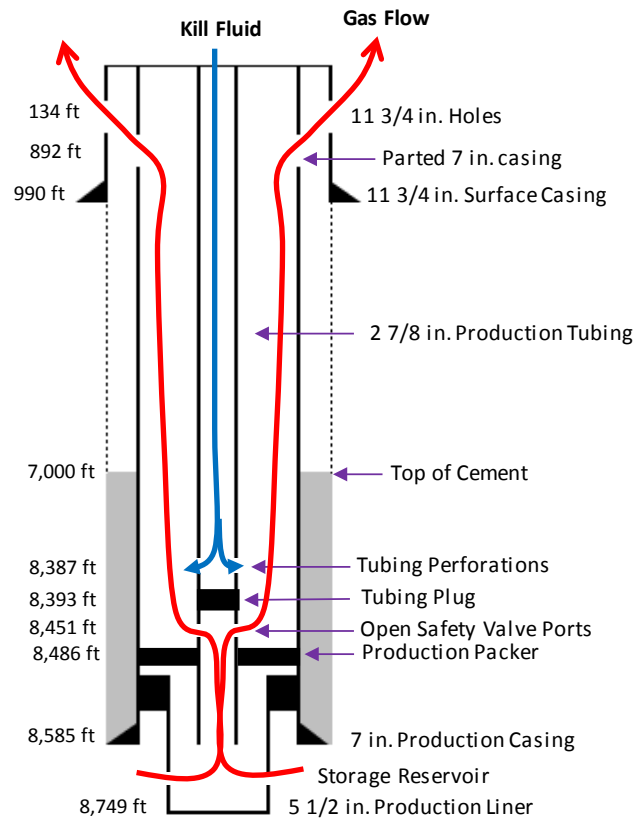
**Figure 164: Top-Kill Well Configuration**

To kill the well, a column of kill fluid with a hydrostatic pressure higher than the reservoir pressure had to be established in the annulus to stop the gas from flowing; then any gas remaining in the well needed to be displaced out of the well. The height of the column of kill fluid needed would depend on its density. A longer column with a lower density fluid or a shorter column with a higher density fluid would be needed. Kill fluid needed to be pumped down the tubing, out the holes at 8,397 ft, and into the casing where the gas was flowing up the casing. The flowing gas would tend to either blow the kill fluid back up out of the well or dilute it, thereby reducing the fluid density. The right combination of kill fluid density and pump rate and volume would therefore be needed to overcome the effects of the gas flow. Figure 164 shows the well configuration during the top kill attempts.

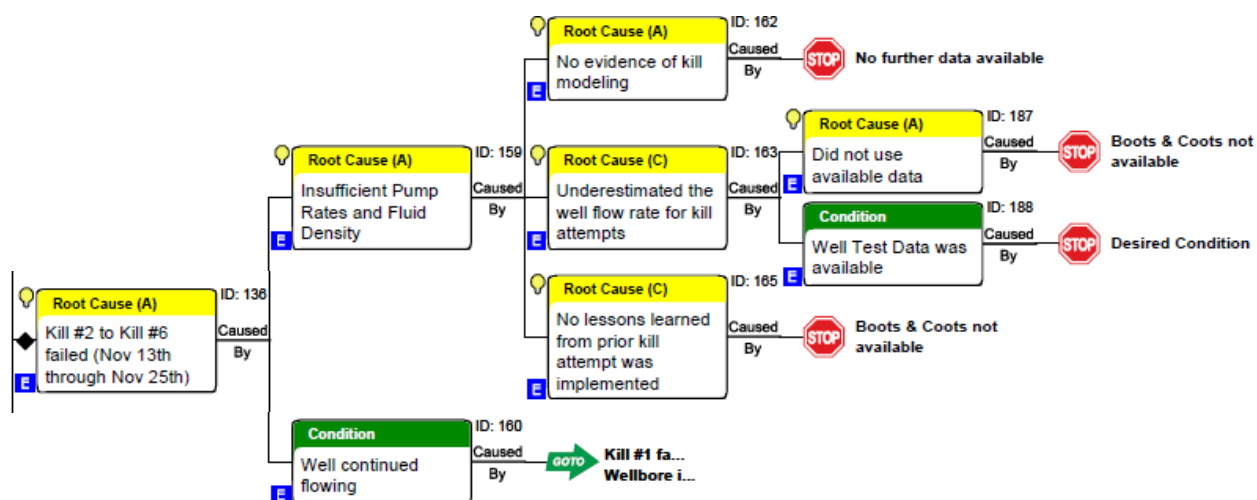
Figure 165: Causes—Unsuccessful Kill Attempts #2 Through #6

Kill attempts #2 through #6 occurred from November 13 through November 25 and were unsuccessful fundamentally because the pump rates and fluid densities used were insufficient to stop the well from flowing (Figure 165). Various combinations of kill fluid densities and volumes were pumped at various rates without success. Gas, oil, and kill fluid were observed flowing to surface through fissures in the ground, and a large crater began to form around the well. Each kill attempt was a variation of the previous one. It appears that lessons from previously unsuccessful attempts were not applied to refine the future attempts. Gas flow rate leaking from the well appeared to be underestimated, based on later kill modeling. There is no evidence that any kill modeling was done to predict the optimum kill fluid density, volume, and pump rates to design kill operations. Models are estimates and have errors,

depending on how much actual data is available and what assumptions need to be made. However, modeling a well kill is the only way to get a reasonable idea of what would be required to kill the well given the complexity of the fluid and gas flow paths, the high gas flow rate, and the shallow leak depth.

The flow rate data is critical to designing a well kill. For example, during kill attempt #2, the Blade estimated flow rate was 83 MMscf/D. The 9.4 ppg kill density fluid could not kill this well; however, 12 ppg at a flow rate of 9 to 10 bbl/min would have gotten the well under control. There is no documentation to indicate that any modeling or analyses were ever performed for kill attempts #2–6. The decisions appeared to be based on the static reservoir pressure and this would be inadequate and inappropriate for designing kills [3]. SoCalGas-provided information suggested that the well-control company was using 30 MMscf/D as the well flow rate [40]. It is unclear whether this information was ever used in any modeling. Flow rate and kill fluid density have to be designed by using established industry modeling tools before preparing an operational plan to ensure the well is killed.

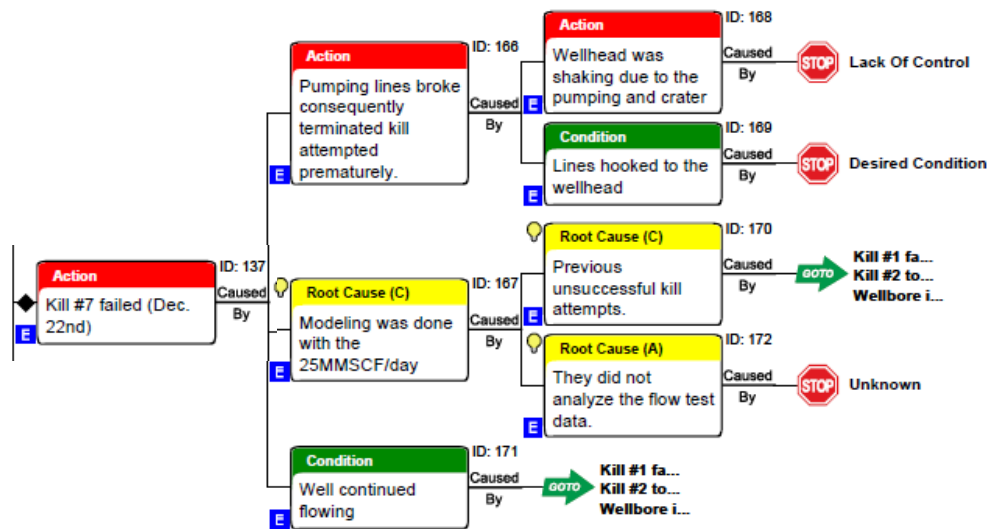
**Figure 166: Causes—Unsuccessful Kill Attempt #7**

There is data indicating that the design of kill attempt #7 was modeled ahead of time. The well-control company appeared to assume a gas flow rate of around 25–30 MMscf/D, whereas Blade-estimated flow rate was 60 MMscf/D. However, the annulus pressure dropped to 0 psi for a time indicating that the well had likely been killed, but pumping had to be stopped because of severe vibrations of the wellhead. The wellhead movement caused pumping lines to break off, and operations were stopped to prevent damage to the wellhead itself (Figure 166). The inability to continuously fill the well allowed the production zone to resume flowing. No further attempts were made to top kill the well.

The underestimation of the gas flow rate was a deficiency in planning the kill attempts. Flow rate modeling by Add Energy in February 2016 and later by Blade, using the data that were available at the time of the incident, has estimated the gas flow rate to be 80 and 93 MMscf/D, respectively. Records show that the flow rate used for modeling kill attempt #7 was 25 MMscf/D. However, Blade's estimate for kill attempt #7 was a gas flow rate of 60 MMscf/D.

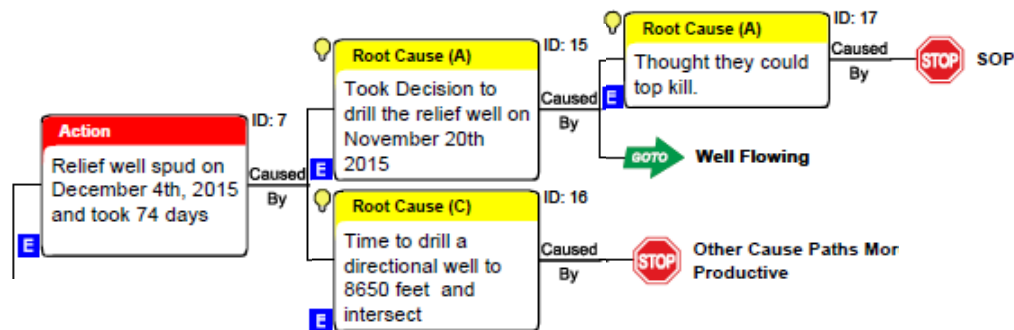
Figure 167: Causes—Relief Well Drilling

The decision to start drilling the relief well was made on November 20, 2015, after four unsuccessful top-kill attempts (Figure 167). The objective of the relief well was to drill down and intersect (i.e., drill into) the SS-25 well at 8,534 ft just below the packer and the top of the 5 1/2 in liner. This would allow kill fluid to be pumped down the P-39A well and into SS-25 near the bottom of the wellbore. The drilling of the P-39A relief well began on December 4, 2015. It took 69 days (74 days including rig up time) to drill down and intersect SS-25. The gas flow was stopped on February 11, 2016, and the well was declared secure on February 18, 2016.

The top-kill attempts would have been successful if:

The above observations are supported by the near success of kill attempt #7. The operational issues, such as enlargement of the crater and unstable wellbore, resulted in early termination of kill attempt #7. Proper design and execution of prior kill attempts could have controlled SS-25 earlier.

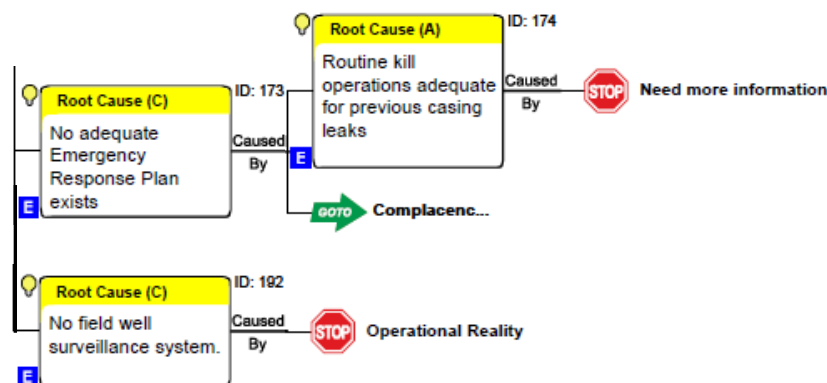
Figure 168: Causes—Emergency Response Plan and Field Surveillance

This suggests that the emergency response plan for this kind of incident was inadequate, and that it was assumed that the routine kill operations were adequate for any scenario (Figure 168). The tubing and casing pressures were measured manually on a weekly basis for all the Aliso Canyon wells. If these pressures had been monitored in real-time with a field surveillance system, then the initial leak in SS-25 would have been detected immediately and injection stopped. This could have prevented the brittle circumferential parting from occurring.
