**IN-FIELD SERVICES**  
**GEIS Pipeline Integrity Team NDE**

**Pacific Gas & Electric Company**  
**Hydrostatic Test Dig from November 8, 2011 to January 0, 1900**  
**T30\_L132\_Leak\_MP-15.0029**  
**Documents Contained Within:**

H-Form Report T30\_L132\_Leak MP-15.0029  
NDE Reports of T30\_L132\_Leak MP-15.0029  
Photo Report of T30\_L132\_Leak MP-15.0029

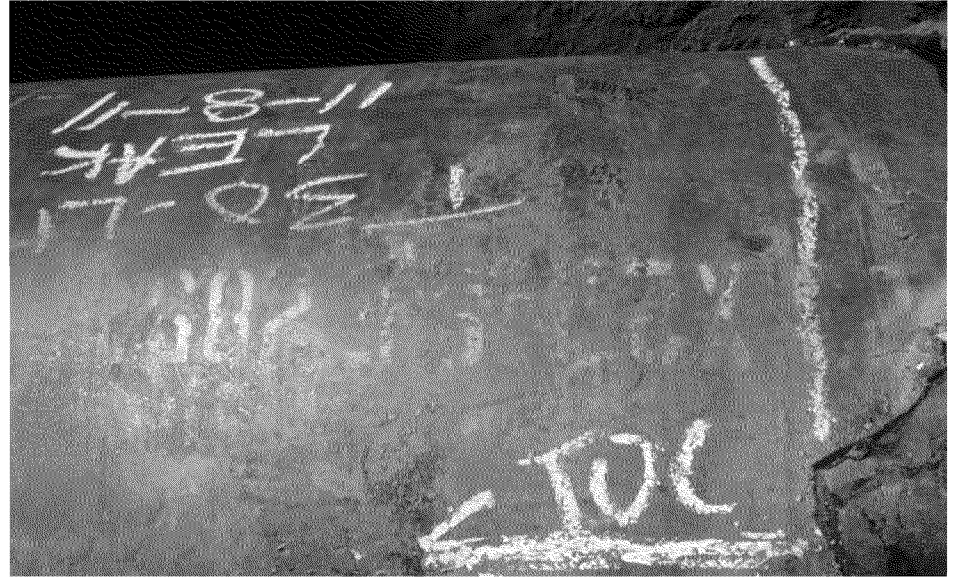
Close up of leak

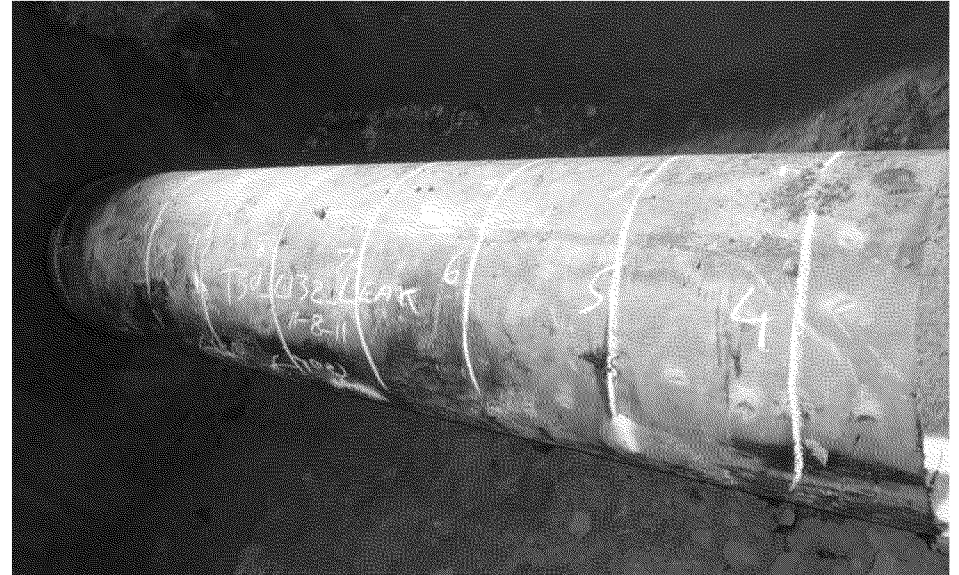
Overview of deposits layout 3.50ft to 12.35ft, 3:00 position

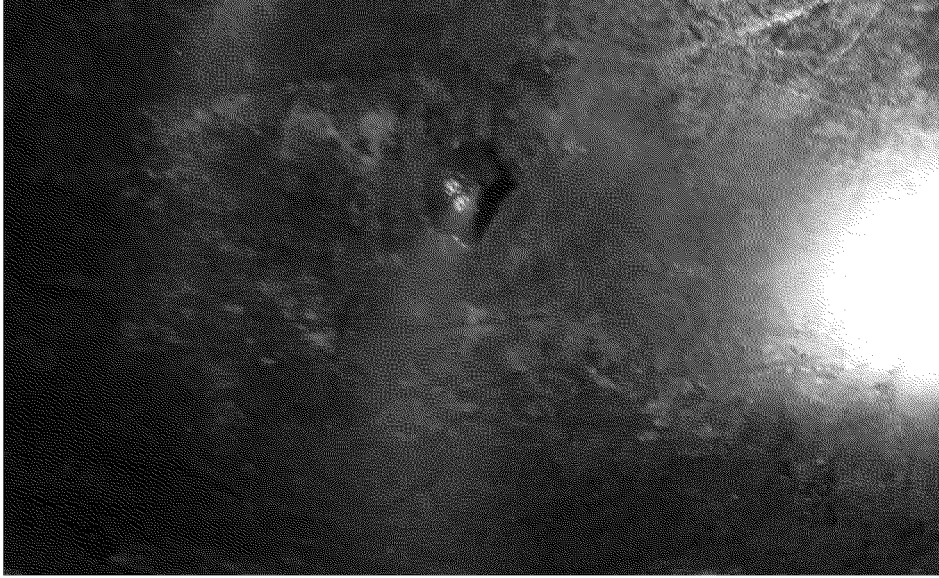
Close up of DEP-01

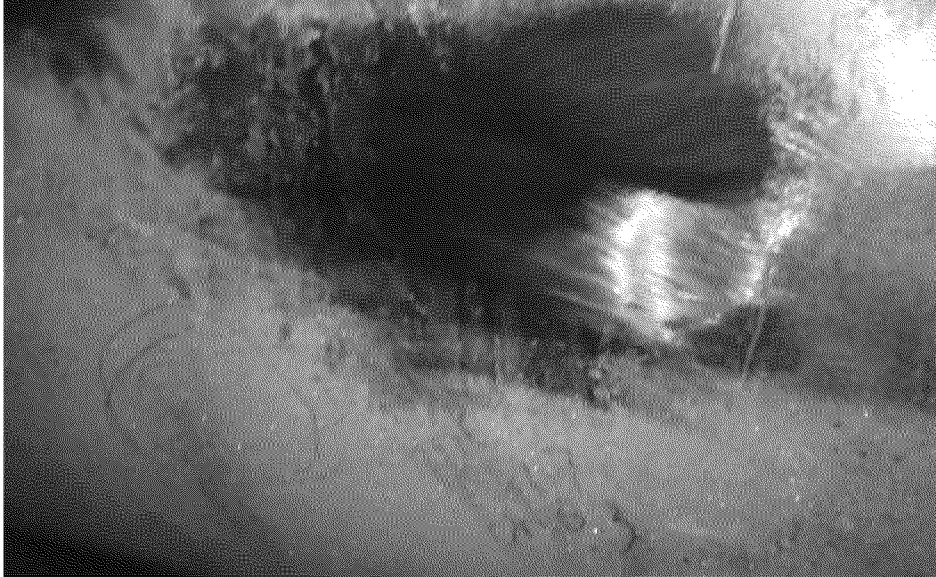
Overview of pre buff area (RWT) LIN-04

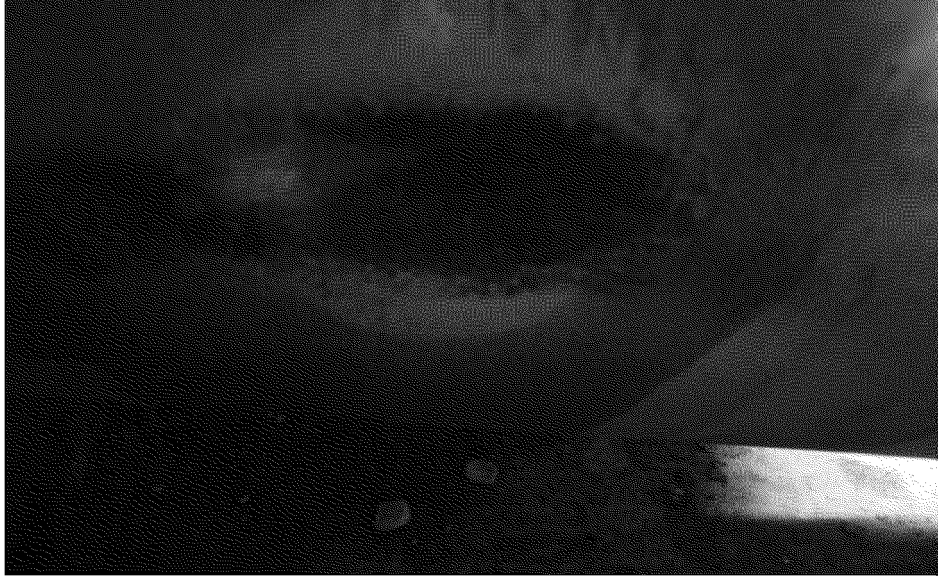
Close up post grind (RWT) of LIN-06

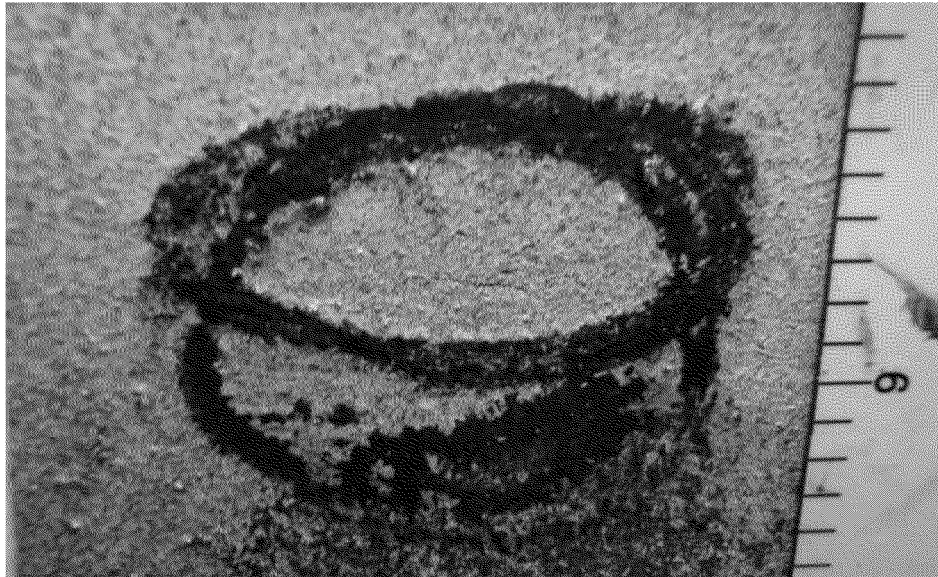
Overview of second inspection MT Indications of LIN-06

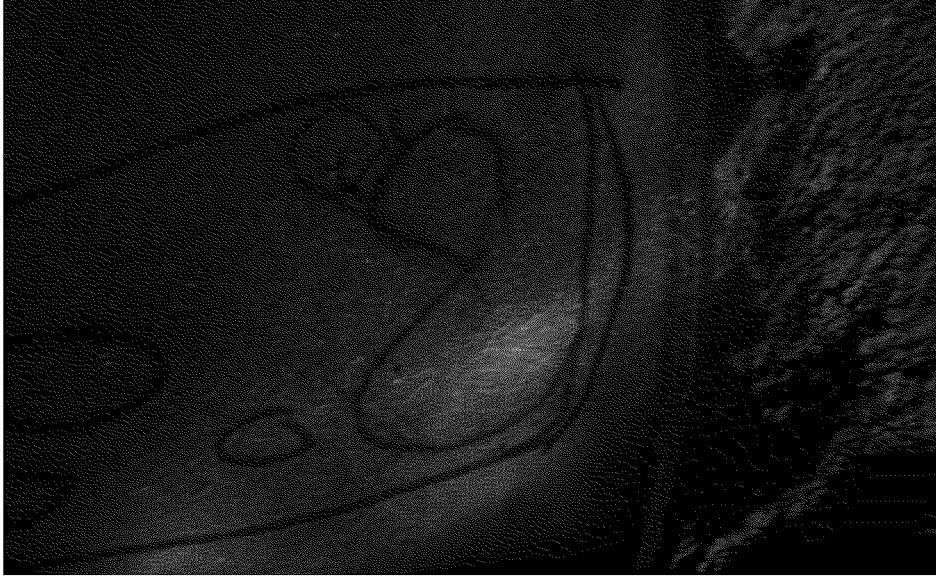
Overview of second inspection MT Indications of LIN-08

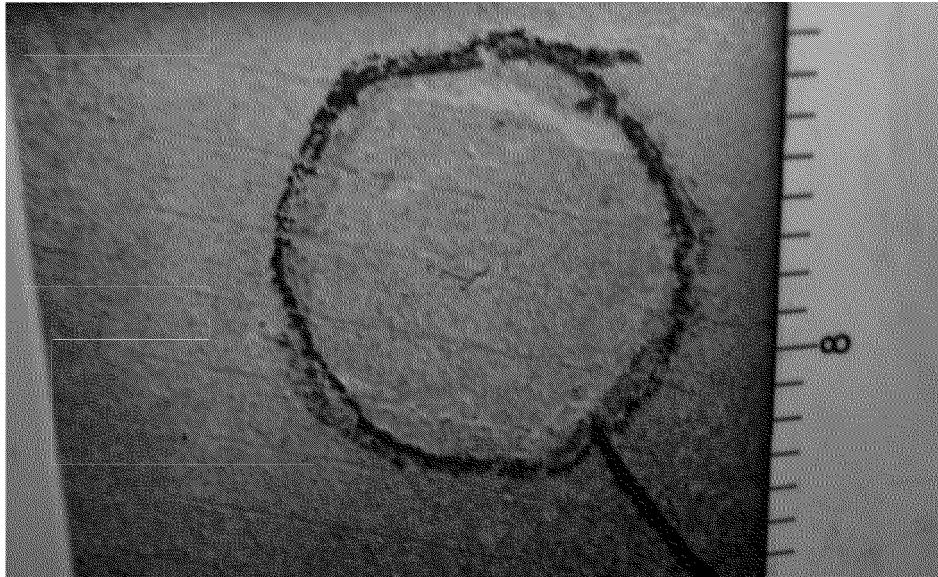
Overview of second inspection MT Indications of LIN-18

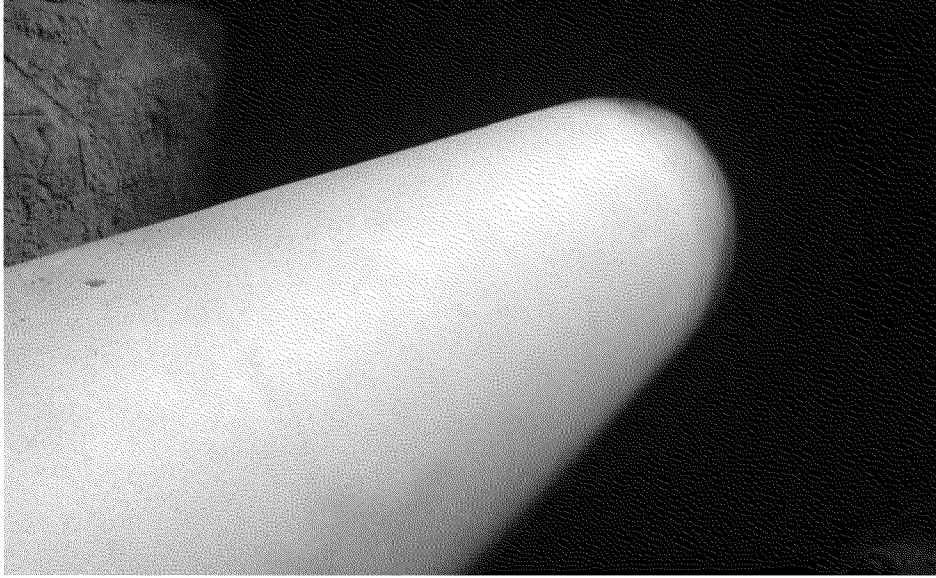
Overview of clean blasted inspection area prior to repair activities
