Investigation of a Failure of Line 300 at Mile Post 284.14 during Hydrostatic Test 117

MJ Rosenfeld, PE
March 16, 2012

PACIFIC GAS & ELECTRIC COMPANY

0215-1116

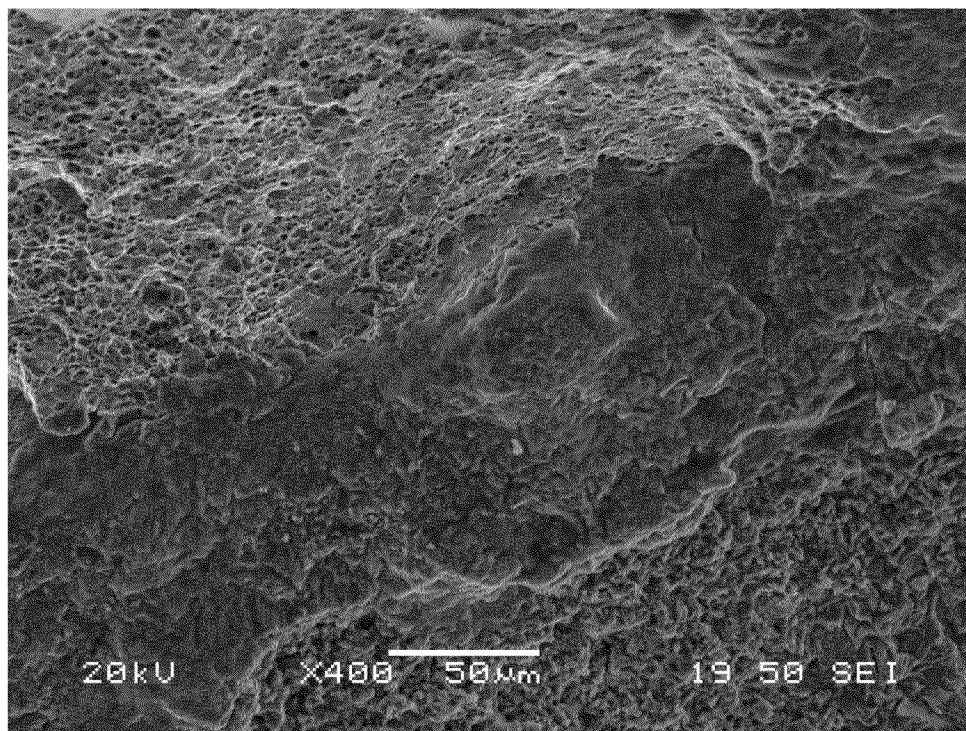
Figure 14. Local Extension of Zone 2 to Exterior Surface, 20X

Figure 12 shows the typical surface in Zone 2. Zone 2 in Figure 12 and in the lower portion of Figure 10 exhibits the columnar structure of the apparent hot crack in the weld. Figure 13 is a detail of Zone 2 at high magnification. The surface is coated with an adherent oxide. Figure 14 shows a region where Zone 2 penetrates through Zone 1 to the pipe exterior surface (at bracket). The arrow identifies what appears to be extension of the flaw. Figure 15 is a detail of the extension feature at high magnification with Zone 1 in the upper left and Zone 2 in the lower right. While the feature between the two zones lacks the columnar structure of Zone 2, it is coated with an adherent oxide like Zone 2 suggesting that it experienced a similar environmental history as Zone 2. The identified region is interpreted as extension of the hot crack that occurred while the material was still hot.

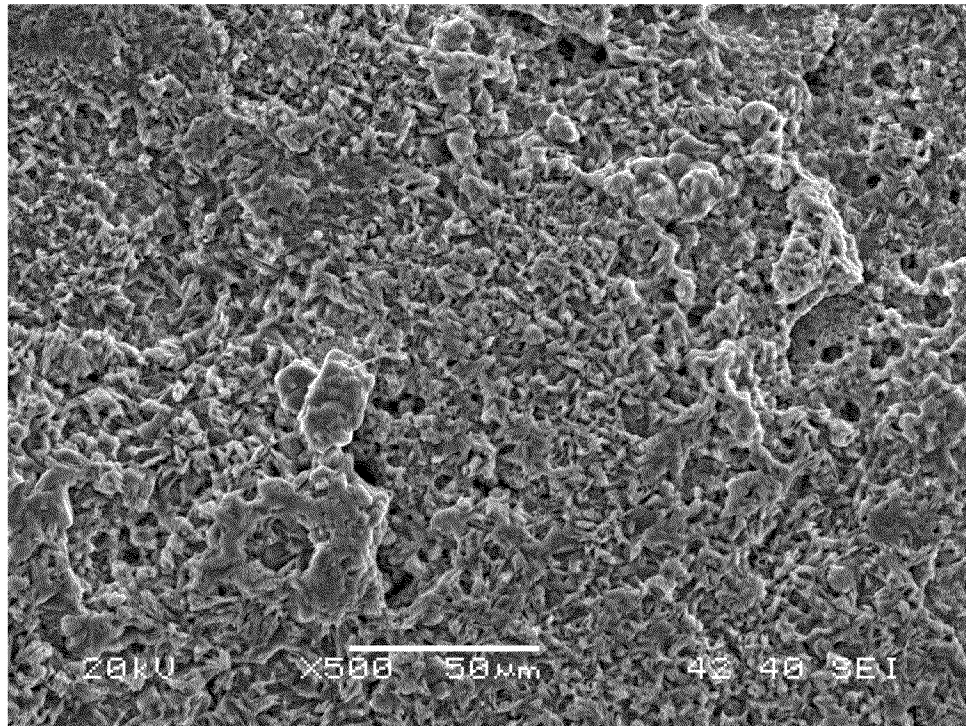
Figure 17. Detail of Zone 3, 500X

Figure 16 shows the unfused surface comprising Zone 3 and representing the lack-of-penetration between the inner and outer weld beads. Zone 2 is in the upper part of the photo and Zone 4 is in the lower part. Figure 17 is a detail of Zone 3 at high magnification. The surface is covered with an adherent oxide.

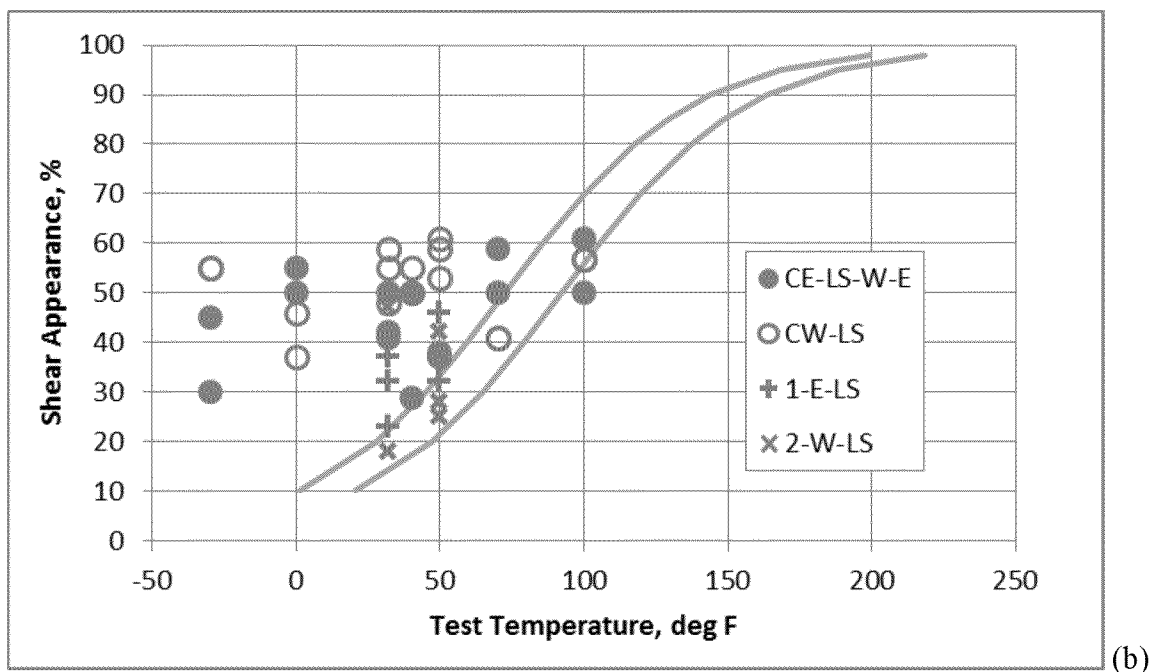
Figure 28. CVN Test Results for Seam Weld Specimens

The absorbed impact energy and shear appearance are shown in Figures 28(a) and 28(b) for the seam weld specimens, and in Figures 29(a) and 29(b) for the pipe body specimens. The weld shear appearance results exhibited more scatter than the plate specimens.

The tests were not performed to a sufficiently high temperature to capture the full toughness transition curve up to the ductile upper shelf or 100% shear appearance. For purposes of interpretation, the full transition curves were extrapolated using an empirical technique.⁵ The extrapolated curves were prepared using the averaged test results at the two warmest test temperatures, 70 F and 100 F. Extrapolations from these two temperatures were fairly consistent.
