**PG&E Hydrotest Rupture
Line 300B Metallurgical
Examination**

Exponent Failure Analysis Associates
149 Commonwealth Drive
Menlo Park, CA 94025

March 2012

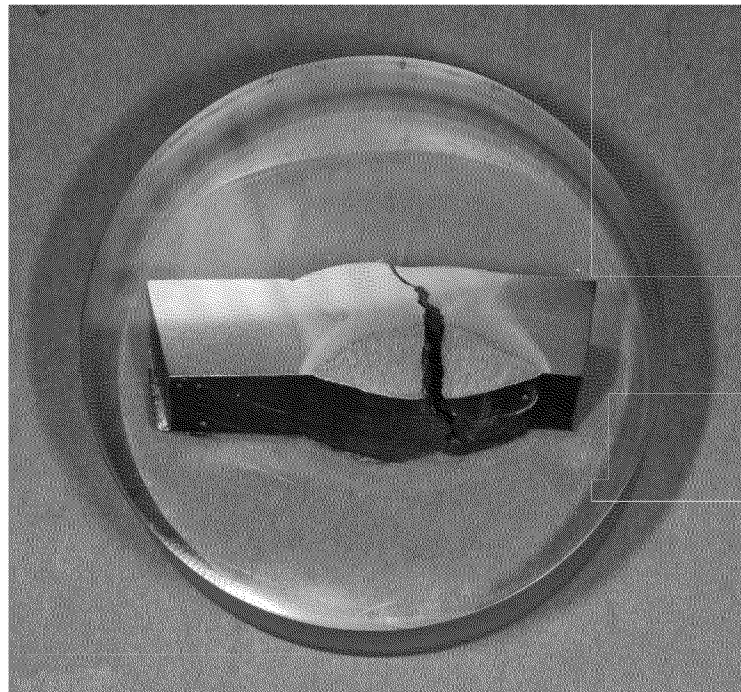
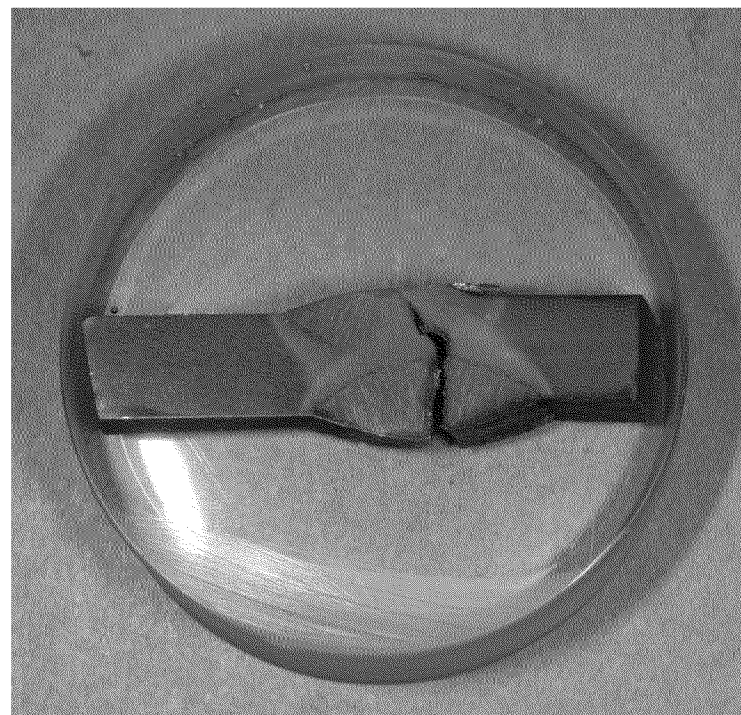
Figure 15. Images that show the metallographic specimens from the rupture area.

Metallographic specimens were removed from the rupture area, as well as from portions of the intact seam weld, girth welds, base metal, and discontinuities found during visual and non-destructive inspection. Specimens were matched and removed from both sides of the rupture for metallographic analysis, shown in Figure 15. The rupture faces on these samples were placed together, and the specimens were ground and polished perpendicular to the fracture plane. Low magnification analysis of the cross section indicates that the OD weld was made first, and the ID weld was made second on the subject seam weld. Misalignment between the inner and outer welds was observed, shown in Figure 16. Along with small weld sizes, the misalignment contributed to the observed lack of penetration. The current version of API 5L specifies that the maximum misalignment of the weld beads shall not exceed 3 mm (0.1 inch) for pipe with specified wall thicknesses less than 0.8 inch¹. Metallographic analysis of the base metal indicated a proeutectoid ferrite/pearlite base metal microstructure, typical for API X52 base metal material, shown in Figure 17.

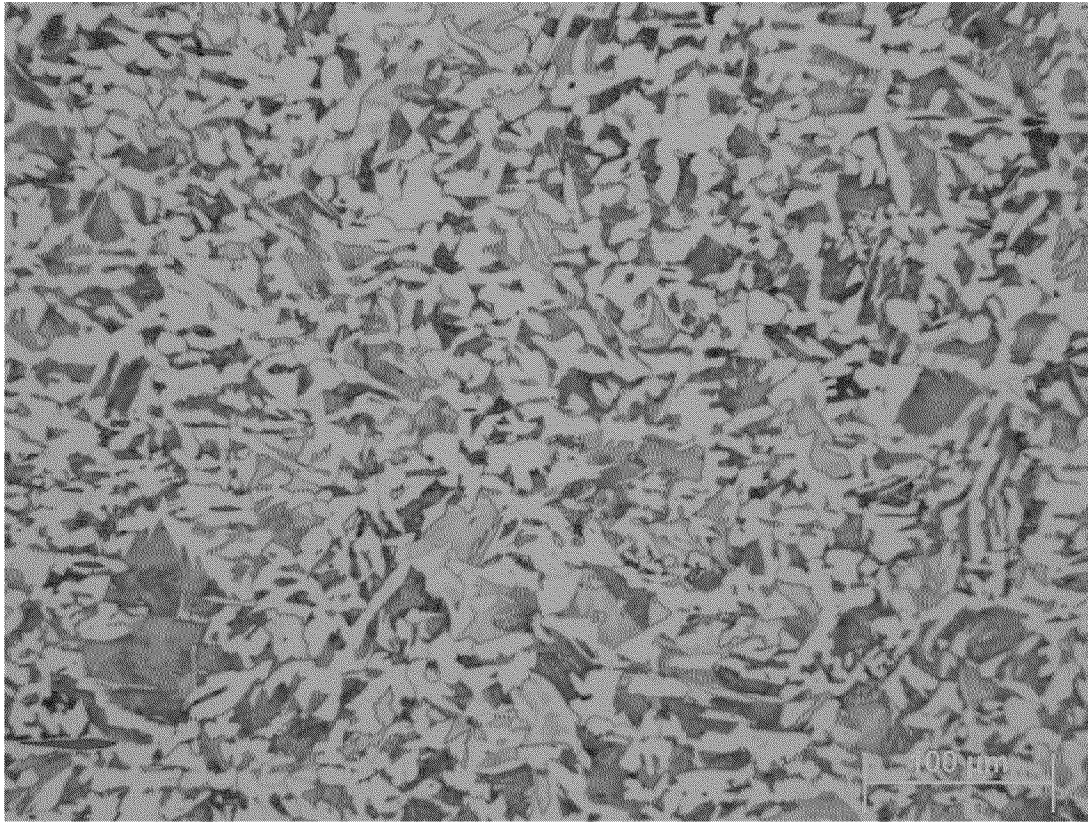
Figure 17. Metallographic image of the subject pipe base metal microstructure.

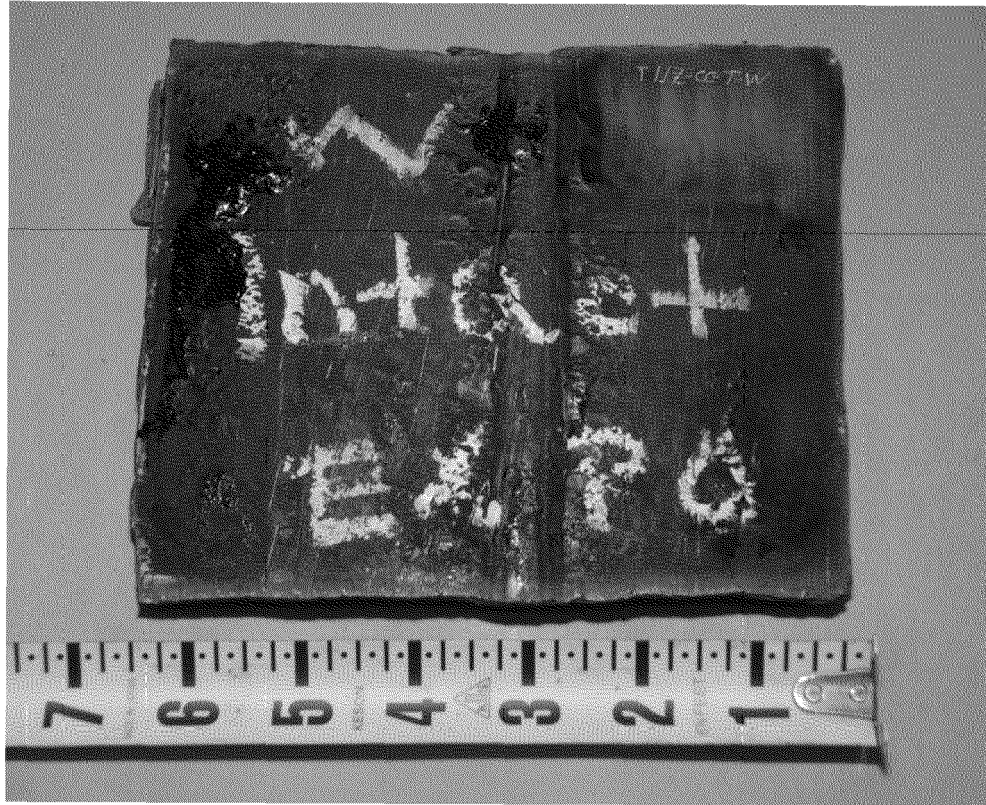
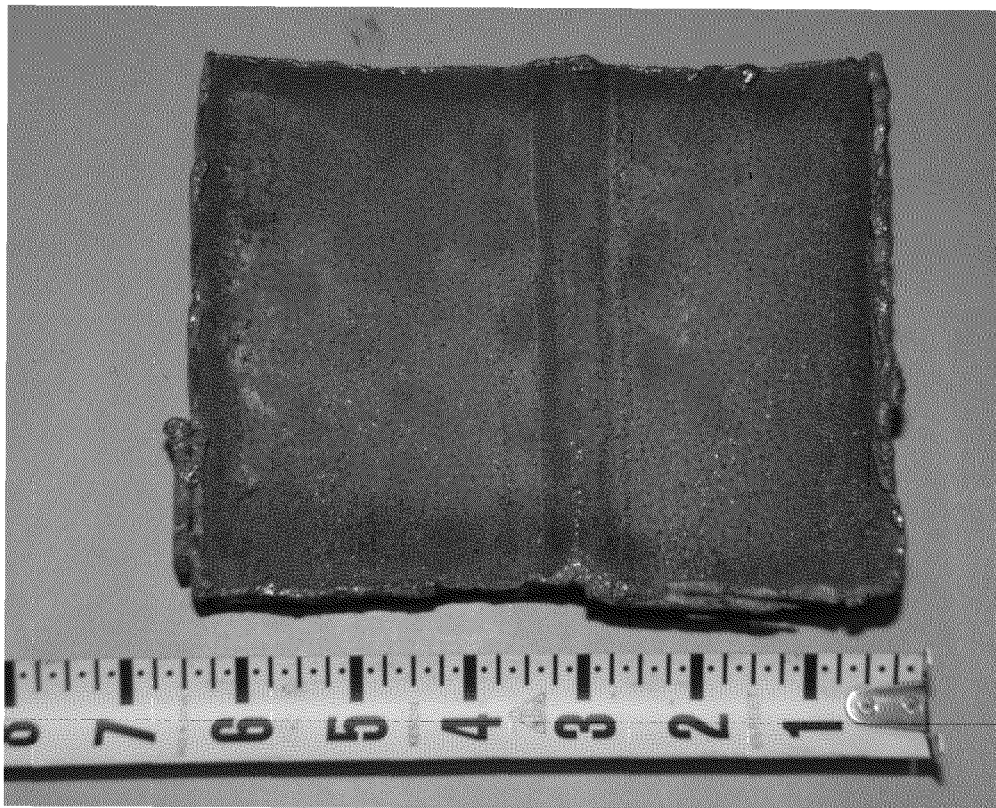
Figure 18. Images of sample T117-CC-T-W.

An intact seam weld sample (T117-CC-T-W) was removed from just west of the rupture, shown in Figure 18. A portion of the sample was ground and polished on a plane perpendicular to the length of the weld. Inner and outer weld misalignment and lack-of-penetration was observed, shown in Figure 19. Lack of penetration was observed at the center of the weld, shown in Figure 20, and a relatively small area of solidification cracking was observed within the OD weld, shown in Figure 21.

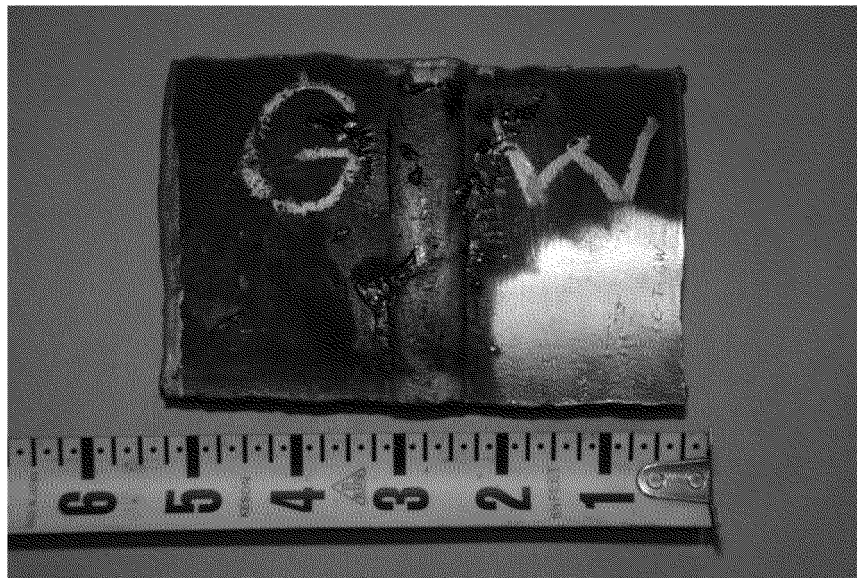
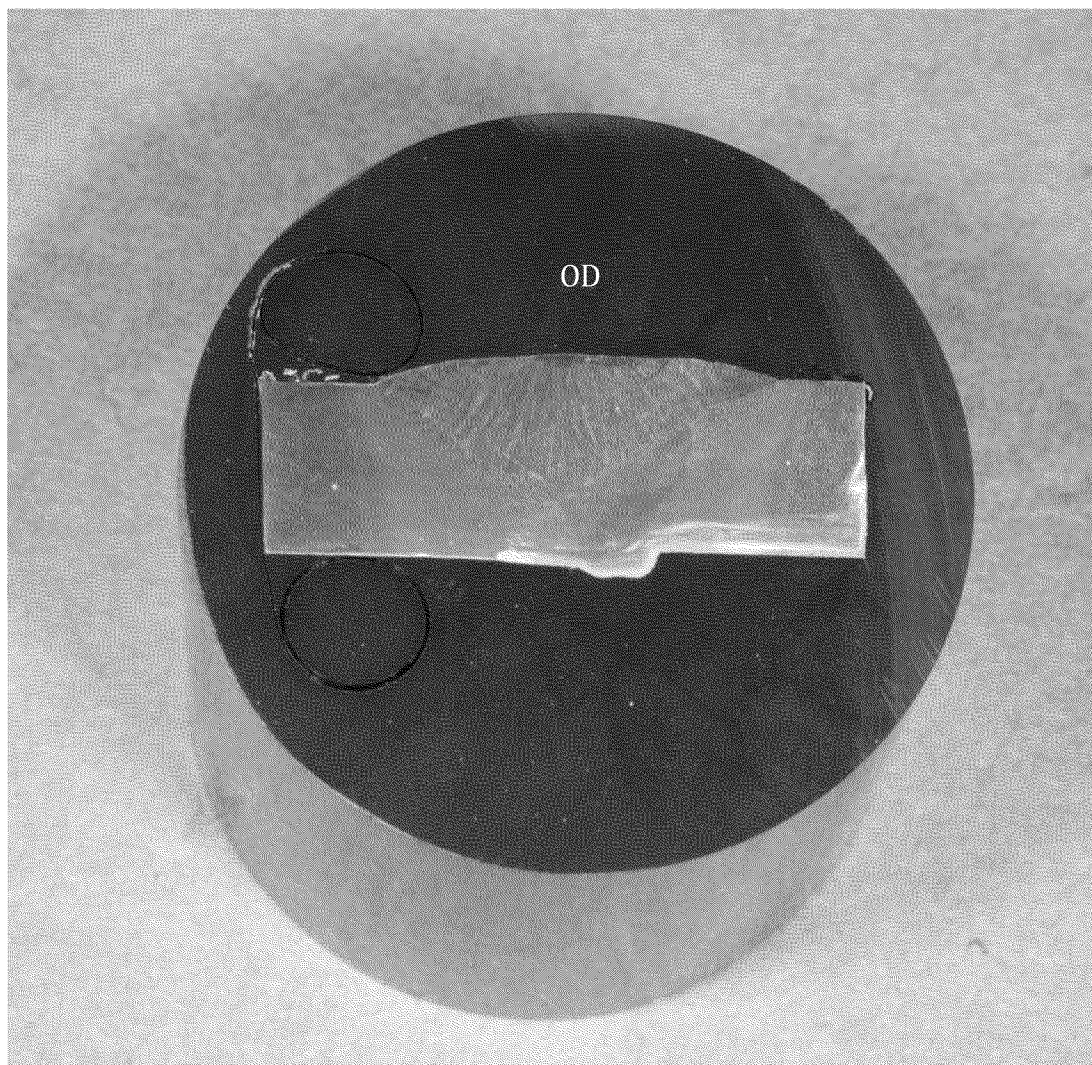
An intact portion of the factory girth weld just upstream of the fracture origin was also sectioned and removed for metallurgical analysis, shown in Figure 22. The weld was sectioned on a plane parallel to the axis of the pipe to allow inspection transverse to the welding direction (parallel to the longitudinal axis of the pipe). Metallographic analysis indicated that the girth weld was a multi-pass weld.

Figure 22. Photographs of factory girth weld.
