Form H: Direct Examination Data Sheet - Page 1 of 10

<u>DA/ILI</u>		<u>DA</u>		<u>ILI</u>	
Route Number:	T47_L153_A	N-Segment:	NA	ILI Log Distance:	NA
Date of Excavation:	7/9/2011	IMA Number:	NA	RMP-11 Ref. Section:	Table 5.6.2
Mile Point:	Redacted	Region Number:	NA	Reference Girth Weld:	NA
Examination Performed By:	Redacted	Subregion # (ICDA):	NA	Distance From Girth Weld:	NA
PG&E Project Manager:	Redacted	Stationing:	NA		
Approved By:	NA				
Order Number:	NA

MAGNETIC PARTICLE EXAMINATION REPORT							<input type="checkbox"/> Nuclear	<input checked="" type="checkbox"/> Non-Nuclear	
To: Pacific Gas & Electric Company				From: Redacted		Date: 7/9/2011			
Project: T-47-L153-A									
Purchase Order No:				GEIS Job No: LAPI0005

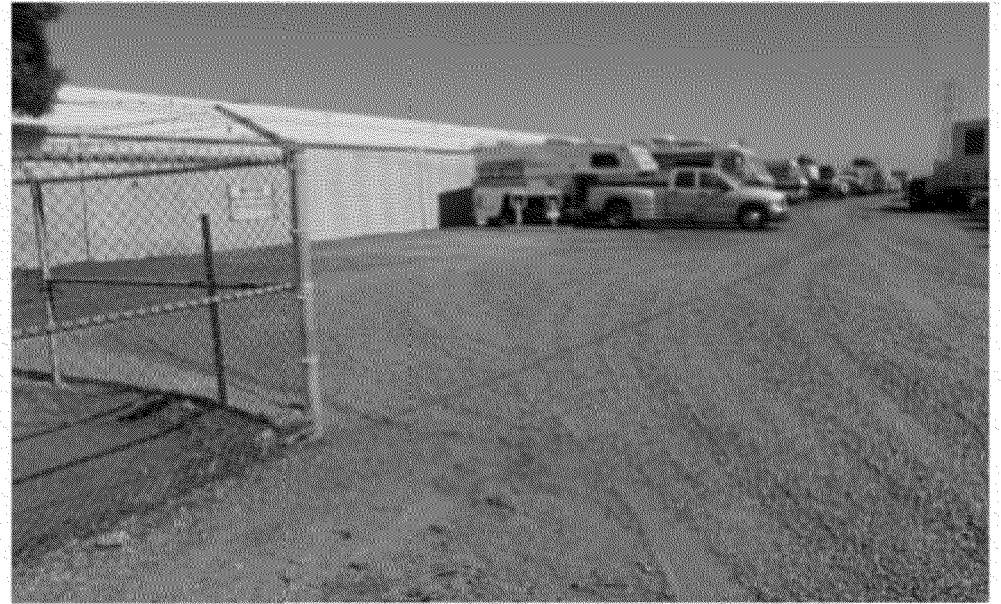
Overview of completed cover looking upstream

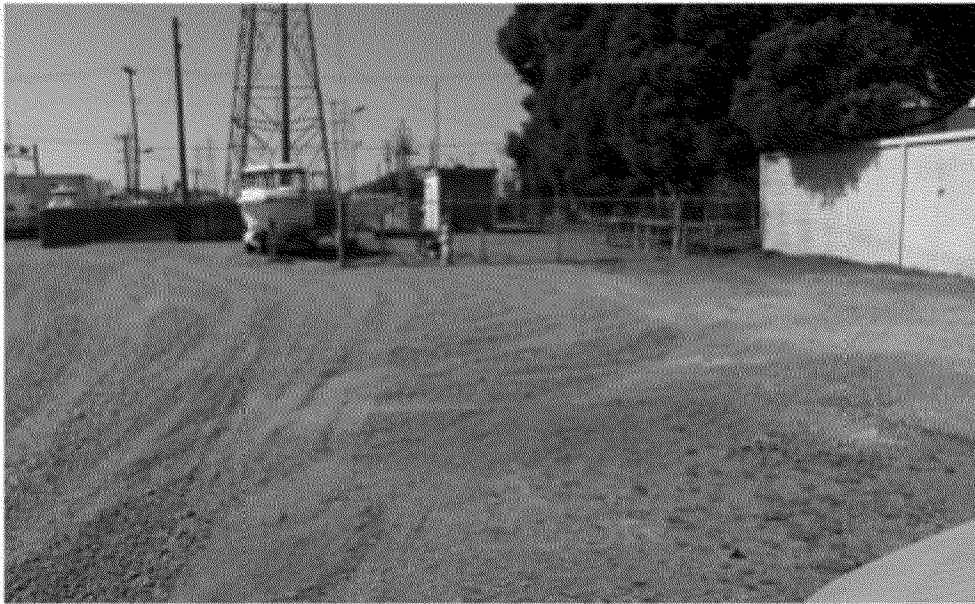
Overview of completed cover looking downstream
