Investigation of a Failure of Line 300 at Mile Post 284.14 during Hydrostatic Test 117

MJ Rosenfeld, PE
March 16, 2012

Kiefner & Associates, Inc.
585 Scherers Court
Worthington, Ohio 43085

PACIFIC GAS & ELECTRIC COMPANY

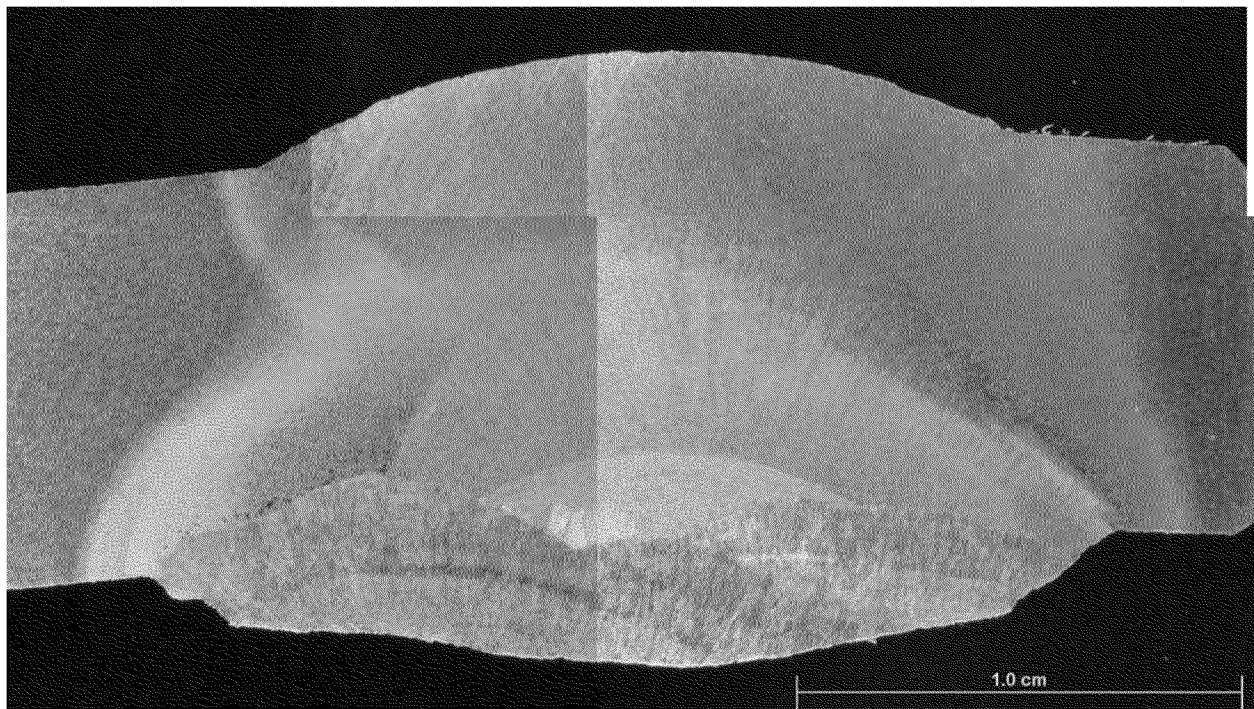
Figure 32. Seam Repair, T117-CE-LS-W, Section B

Figure 30 shows a repair made to the inside weld deposit of the longitudinal seam in Piece T117-CE-LS-E. The repair was approximately 2 inches long. Two metallographic sections across the repaired area were made. These are shown in Figure 31 and Figure 32.
