Encroachment Pilot Report of Findings

Gas Transmission Line 153 Encroachment Pilot Projects

Report of Findings for Line 153
Gas Pipeline Encroachment Pilot Program
Final Report: Redacted

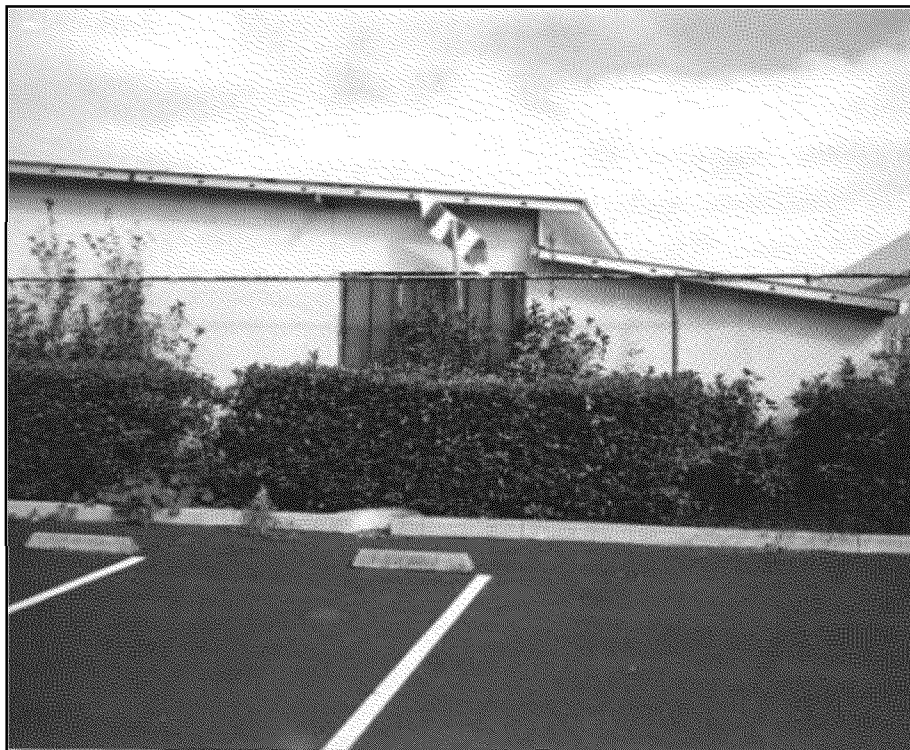
Building is over the easement.
