**Root Cause Analysis Report:
Worker Fatality
PG&E - Kern Power Plant Demolition
Bakersfield, CA**

Location of Incident: Kern Power Plant, Bakersfield, California
Date of Incident: Tuesday, June 19, 2012, approximately 9:20 a.m.
Type of Incident: Worker fatality; struck by collapsing tank wall

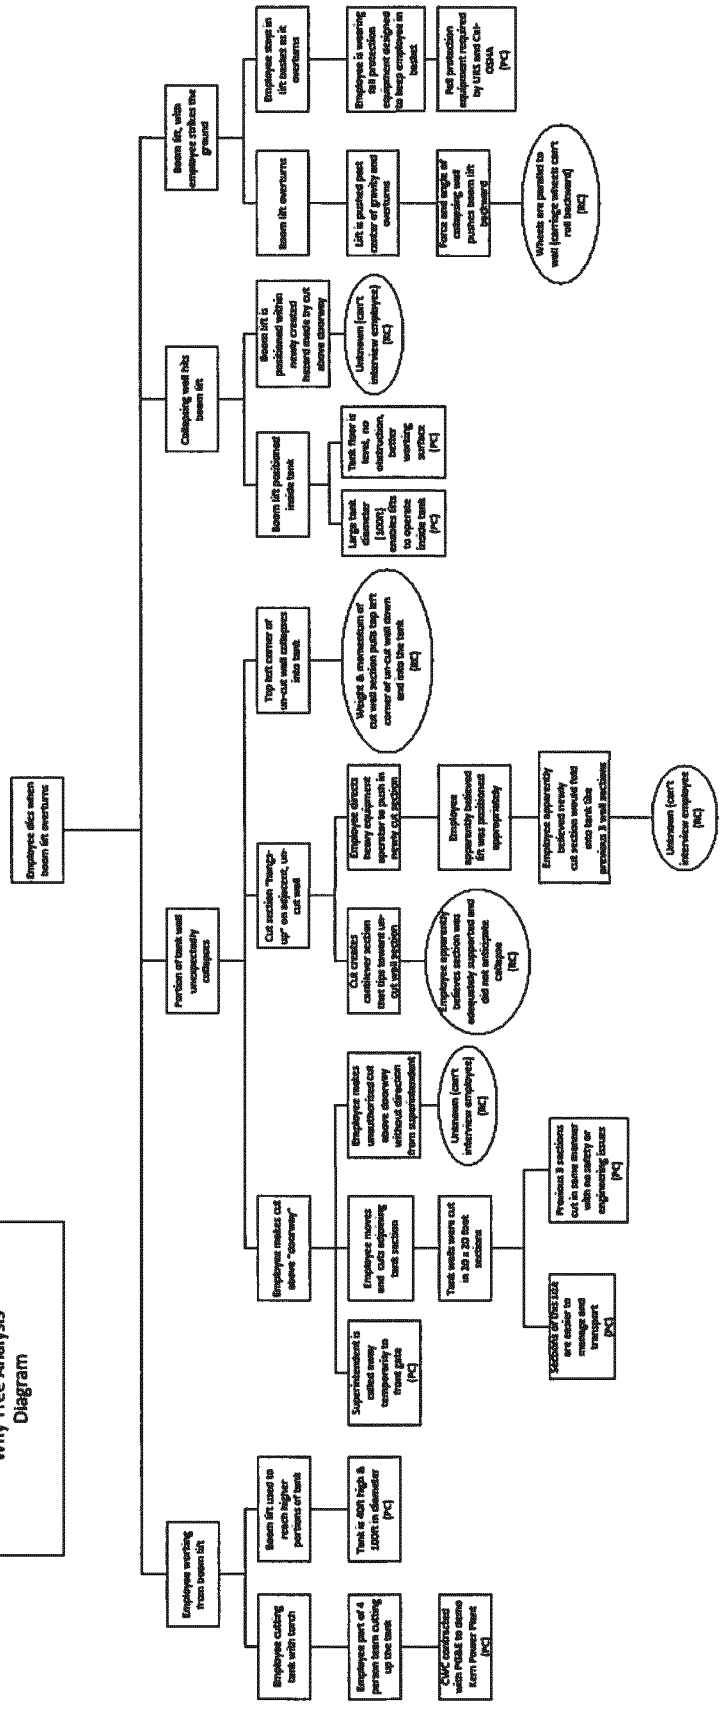
Figure 2
PG&E Kern Fatality
Why Tree Analysis
Diagram

The Incident Timeline is provided in Figure 1. The "Why Tree Analysis" Diagram is provided in Figure 2. The Program Enhancement plan is provided in Appendix A.
