**NTSB, Pipeline Accident Report: Natural Gas Pipeline Rupture and Fire Near Carlsbad, New Mexico, August 19, 2000 (Feb. 11, 2003)**

# Natural Gas Pipeline Rupture and Fire Near Carlsbad, New Mexico August 19, 2000

**NTSB/PAR-03/01  
PB2003-916501  
Notation 7310B  
Adopted February 11, 2003**

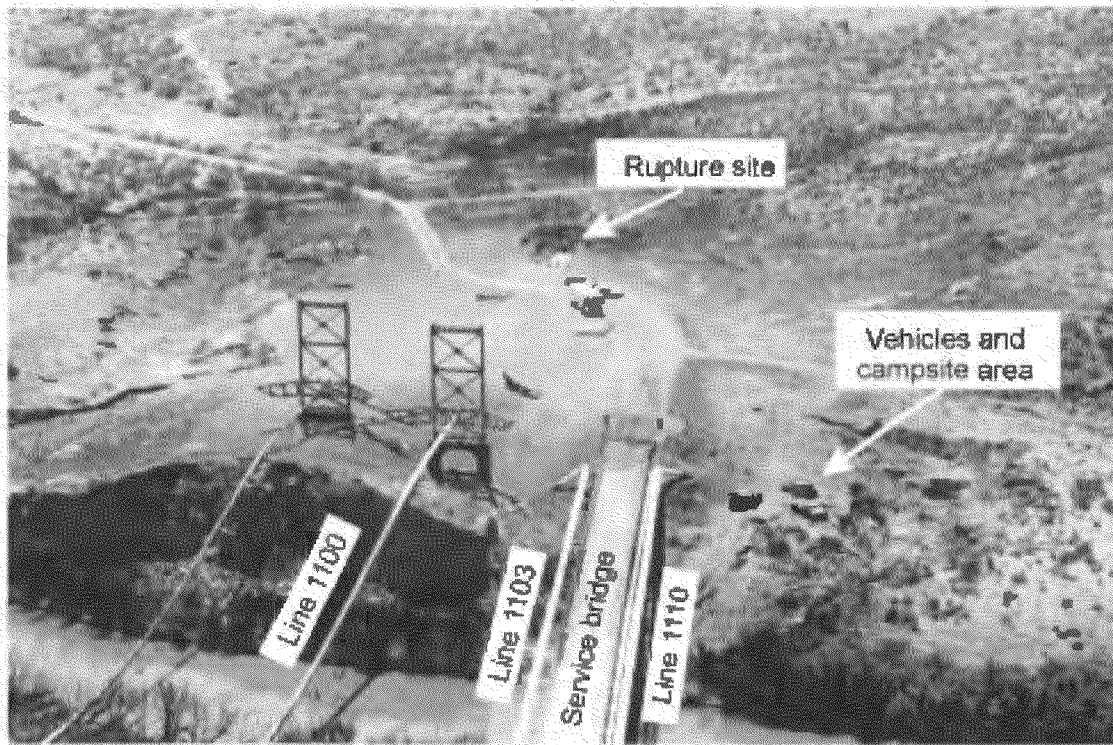
Figure 4. Aerial view of accident site looking east.

At the time of the accident, 12 members of an extended family were camping on the east bank of the Pecos River near the service bridge.<sup>1</sup> (See figure 4.) A locked wire rope and a “Private Right of Way—No Trespassing” sign at each entrance to the bridge restricted access to the bridge above the campsite. Two “Caution—High Pressure Gas Line” signs were posted near the east entrance to the service bridge. Also, a sign reading as follows:

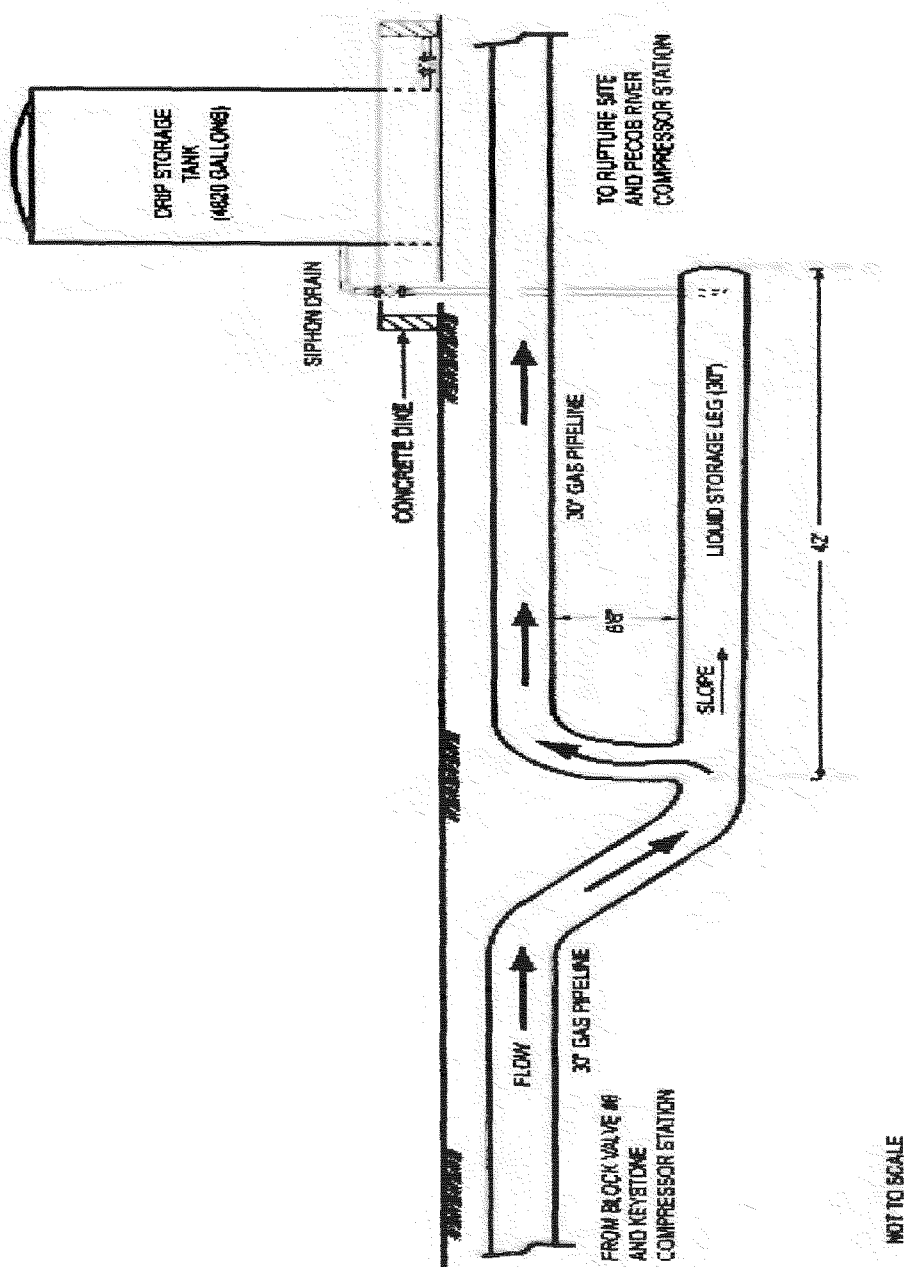
Figure 11. Diagram of line 1103 drip.

**Line 1103 Drip Assembly.** About 990 feet downstream/west of block valve No. 6 was a drip, a liquid collection leg buried beneath the pipeline that consisted of about 40 feet of 30-inch pipe. (See figure 10.) The leg was buried approximately 7 feet directly below the gas pipeline and sloped downward toward a dead end equipped with a siphon drain. The leg functioned to collect liquids and solids during normal transportation or after pigging operations. Also at this location was a liquid storage tank consisting of a 4,620-gallon aboveground steel tank installed within a concrete dike. The siphon drain in the liquid collection leg of the drip assembly emptied into this tank. (See figure 11.) The tank was fitted with piping and valves for loading the collected liquids into a truck for disposal. The drip assembly was installed during the original construction of the pipeline. Because of the location and design of this drip, cleaning pigs could not be run in the section of pipeline that ruptured. After the removal of the line 1100 drip in 1989, liquids and solids moving down line 1100 toward the Pecos River compressor station during both normal operations and pigging operations in line 1100 could enter line 1103 upstream of the drip.

There was no pig launcher at block valve No. 6 and no pig receiver at Pecos River compressor station. For that reason, and because of a reduced port valve<sup>22</sup> and other pipeline features, including the drip, in the section of the pipeline between block valve No. 6 and the Pecos River compressor station, that portion of the pipeline (which included the rupture location) could not be pigged.
