NTSB, Pipeline Accident Report: Natural Gas Pipeline Rupture and Fire Near Carlsbad, New Mexico, August 19, 2000 (Feb. 11, 2003)

Natural Gas Pipeline Rupture and Fire Near Carlsbad, New Mexico August 19, 2000

**NTSB/PAR-03/01
PB2003-916501
Notation 7310B
Adopted February 11, 2003**

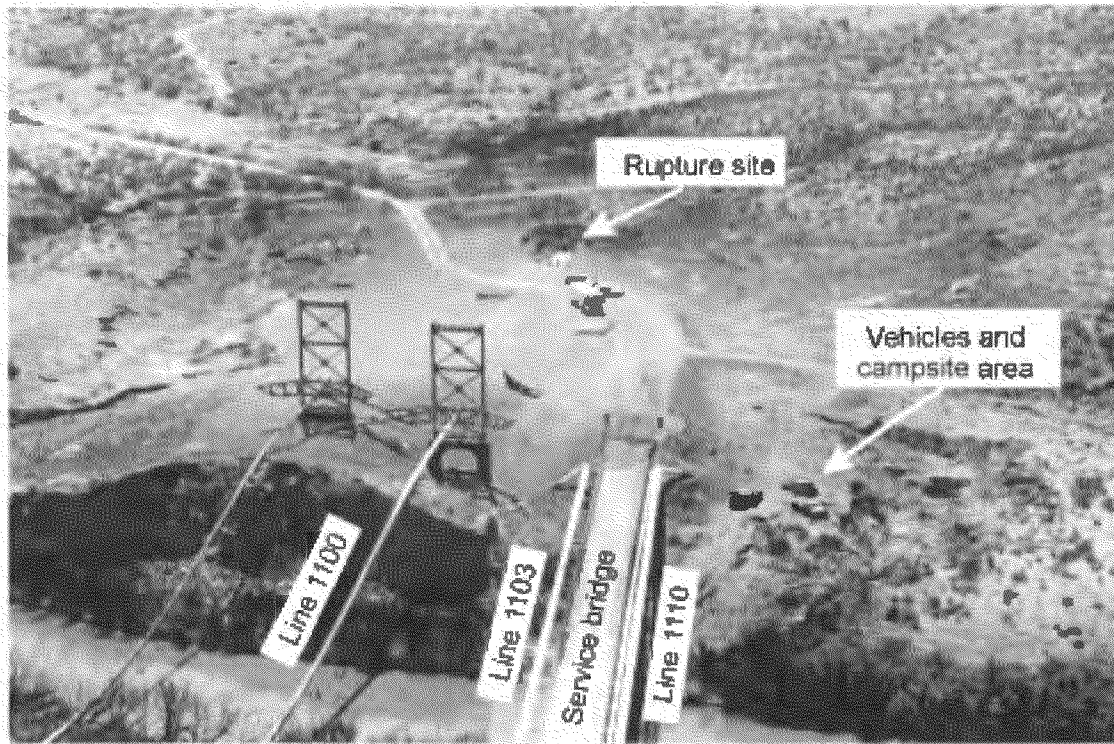
Figure 4. Aerial view of accident site looking east.

At the time of the accident, 12 members of an extended family were camping on the east bank of the Pecos River near the service bridge.¹ (See figure 4.) A locked wire rope and a “Private Right of Way—No Trespassing” sign at each entrance to the bridge restricted access to the bridge above the campsite. Two “Caution—High Pressure Gas Line” signs were posted near the east entrance to the service bridge. Also, a sign reading as follows:

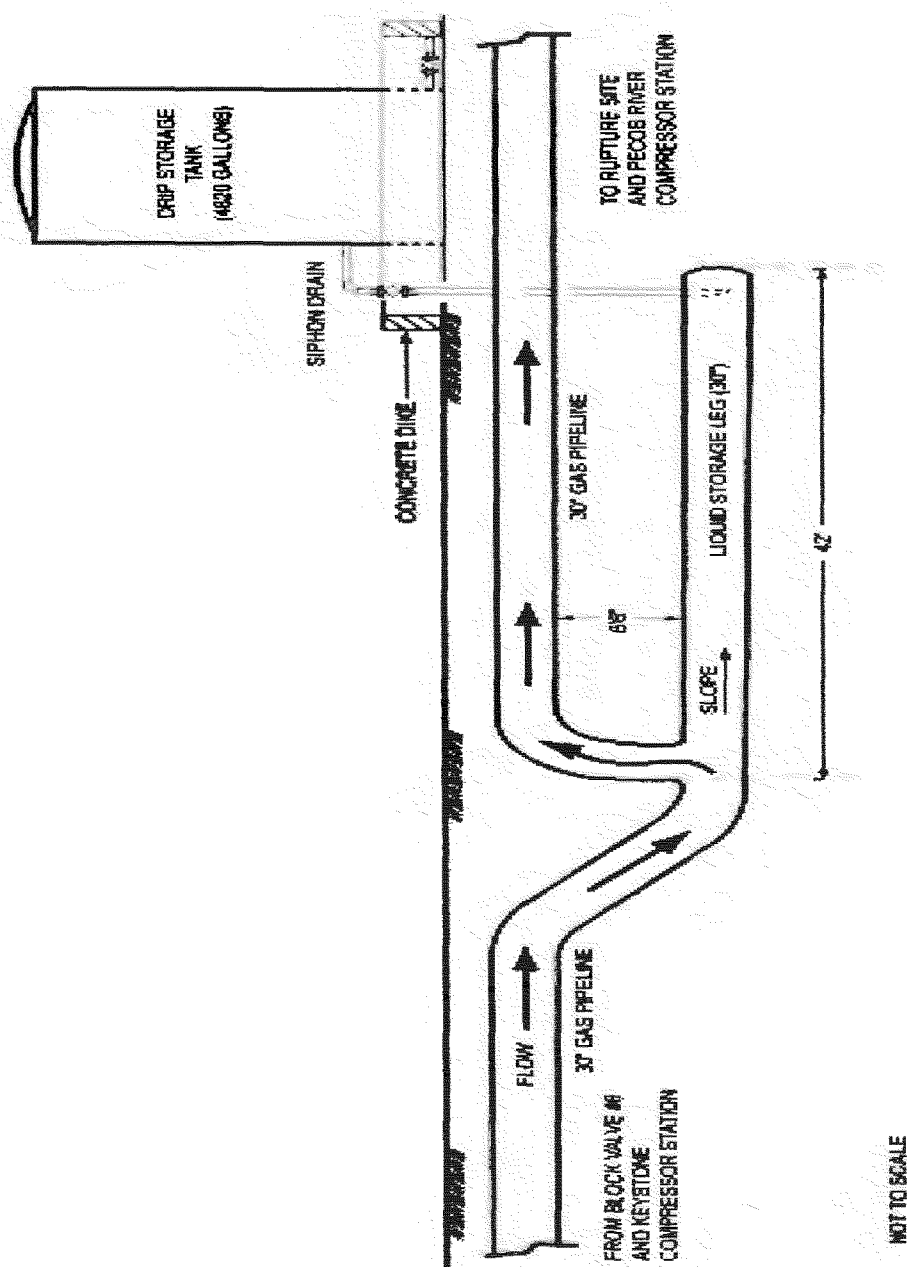
Figure 11. Diagram of line 1103 drip.

There was no pig launcher at block valve No. 6 and no pig receiver at Pecos River compressor station. For that reason, and because of a reduced port valve²² and other pipeline features, including the drip, in the section of the pipeline between block valve No. 6 and the Pecos River compressor station, that portion of the pipeline (which included the rupture location) could not be pigged.
