Report No. 5004.9268

September 6, 2013

**METALLURGICAL EVALUATION OF A SECTION FROM  
L-147 MP 2.2 BRITTAN AVE. AND ROGERS AVE., SAN CARLOS**

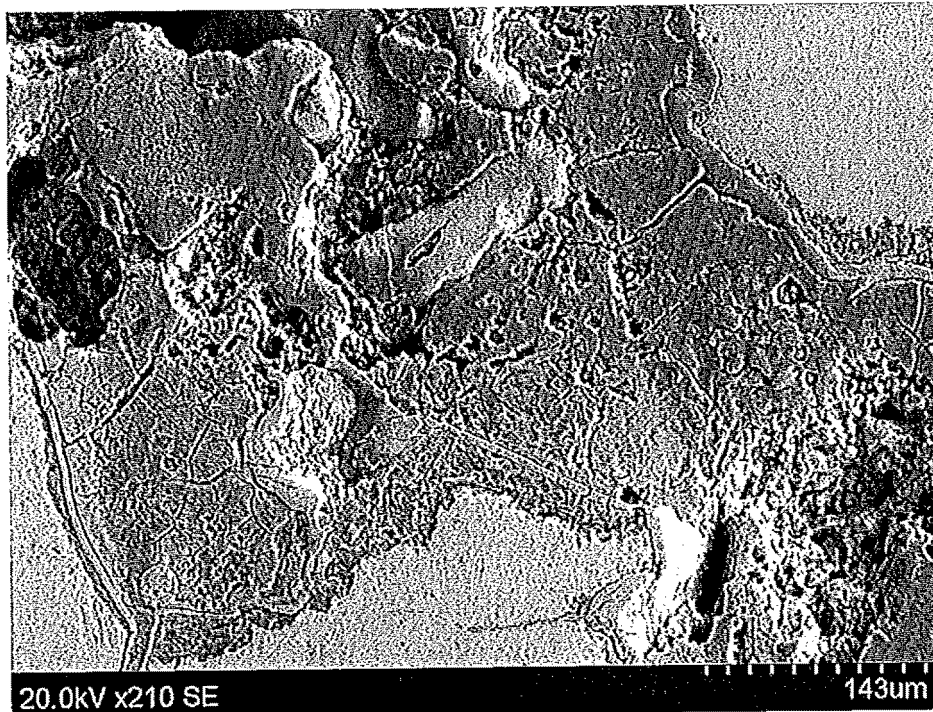
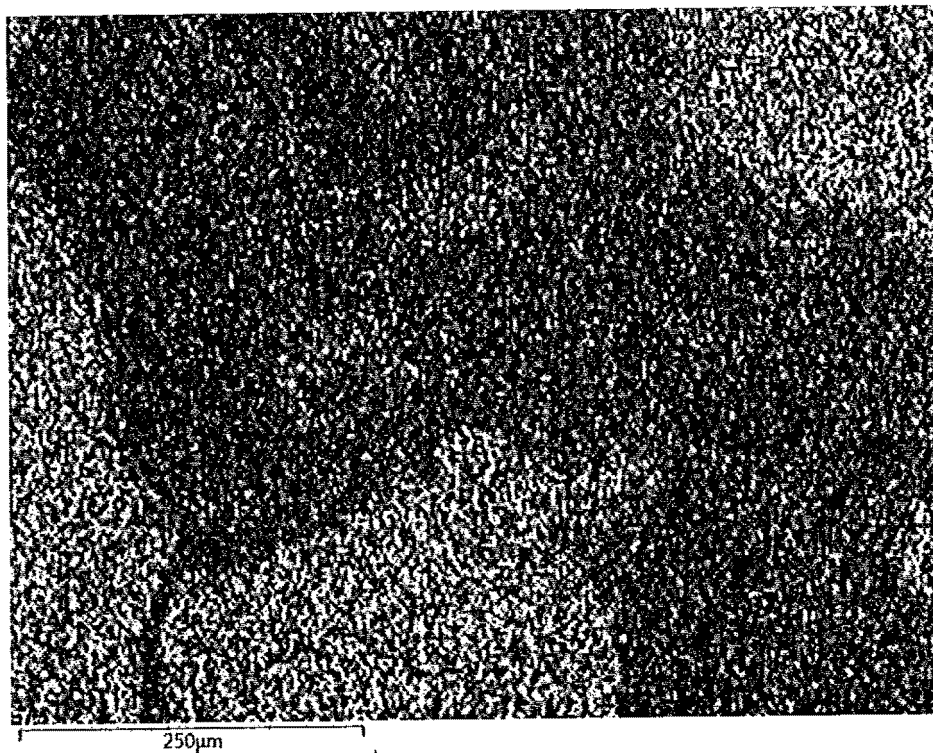
Figure 22 SEM image and EDS dot map for iron from the specimen prepared for metallography, section 1c.

Scanning electron microscopy (SEM) and energy dispersive X-ray spectroscopy<sup>2</sup> (EDS) was performed on the section 3 polished and etched surface. A composite SEM micrograph of the crack is shown in Figure 20. Much of the crack was filled with oxide, indicated by the morphology and chemical composition of primarily iron and oxygen, with sulfur present, likely from mercaptan in the gas stream.

(a) SEM micrograph

(b) EDS dot map for iron from the area indicated in (a)
