Report No. 5004,9268 Rev. 1

**METALLURGICAL EVALUATION OF A SECTION FROM
L-147 MP 2.2 BRITTAN AVE. AND ROGERS AVE., SAN CARLOS**

One section of 20-inch diameter gas transmission pipe identified as L-147 MP 2.2 Brittan Ave. and Rogers Ave., San Carlos was submitted by PG&E for metallurgical evaluation. The subject section had a PLIDCO weld cap permanent repair, and an A. O. Smith longitudinal seam weld. The section was cut out to perform a root cause investigation of a reported leak under the PLIDCO cap. It was reported the subject passed hydrotest as part of L-147 on October, 24, 2011, at a pressure of 600-psi, or 1.5 times the desired Maximum Allowable Operating Pressure (MAOP) of 400-psi, and the PLIDCO cap was located at the six o'clock position, on the bottom of the section. The purpose of this evaluation was to determine the metallurgical condition of the pipe wall under the PLIDCO cap, and perform Charpy impact testing of the A. O. Smith weld and unaffected base metal.

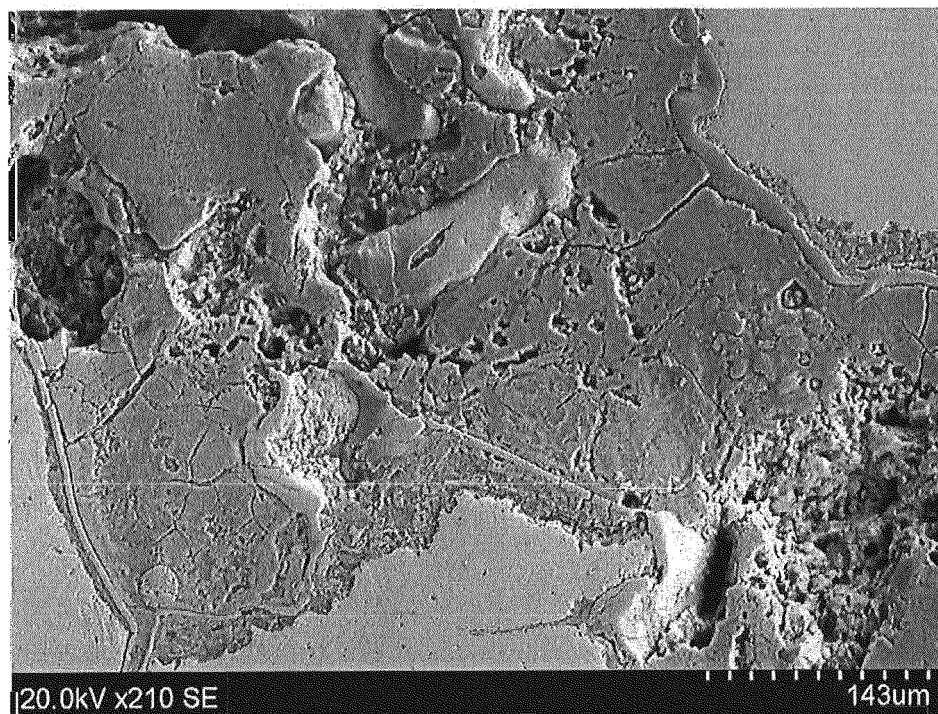
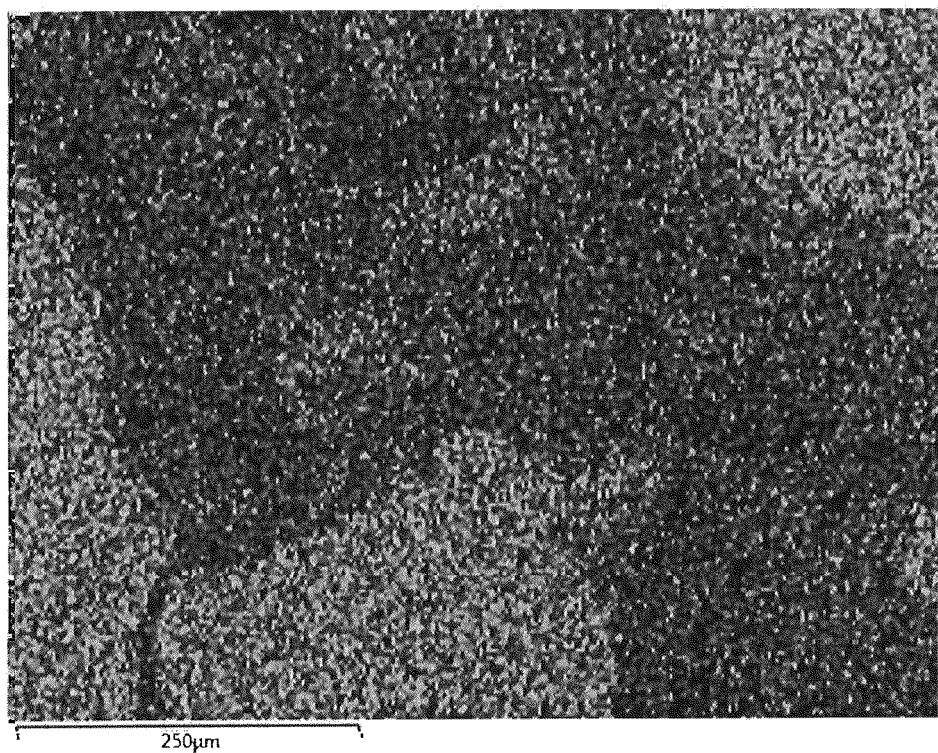
Figure 22 SEM image and EDS dot map for iron from the specimen prepared for metallography, section 1c.

Scanning electron microscopy (SEM) and energy dispersive X-ray spectroscopy² (EDS) was performed on the section 3 polished and etched surface. A composite SEM micrograph of the crack is shown in Figure 20. Much of the crack was filled with oxide, indicated by the morphology and chemical composition of primarily iron and oxygen, with sulfur present, likely from mercaptan in the gas stream.

(a) SEM micrograph

(b) EDS dot map for iron from the area indicated in (a)
