DECLARATION OF SUMEET SINGH

Report No. 5004.9268

**METALLURGICAL EVALUATION OF A SECTION FROM
L-147 MP 2.2 BRITTAN AVE. AND ROGERS AVE., SAN CARLOS**

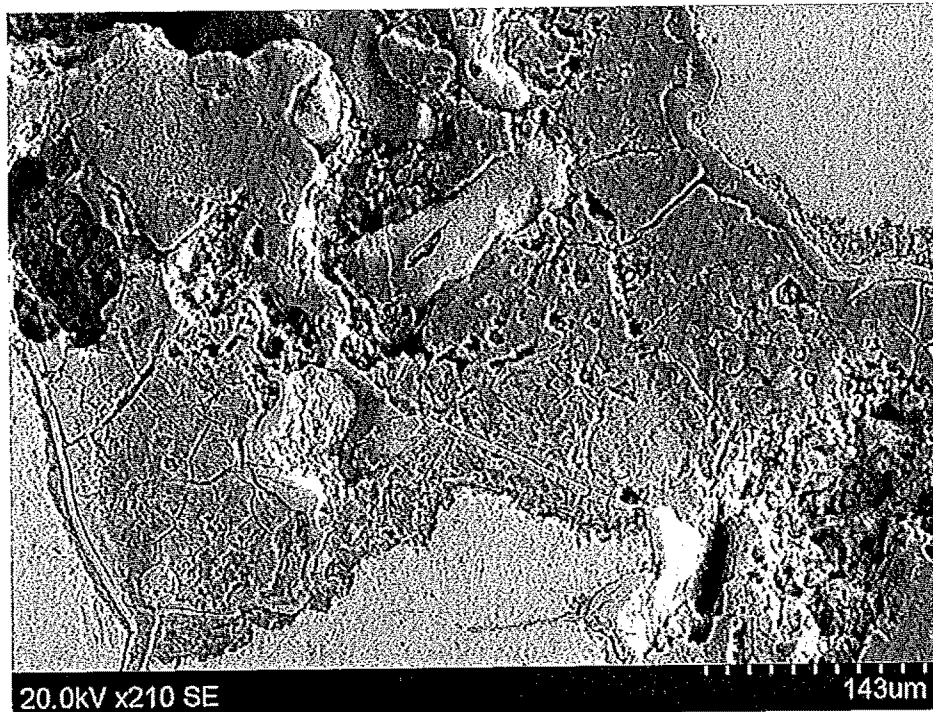
(a) SEM micrograph

Scanning electron microscopy (SEM) and energy dispersive X-ray spectroscopy² (EDS) was performed on the section 3 polished and etched surface. A composite SEM micrograph of the crack is shown in Figure 20. Much of the crack was filled with oxide, indicated by the morphology and chemical composition of primarily iron and oxygen, with sulfur present, likely from mercaptan in the gas stream.

Figure 22 SEM image and EDS dot map for iron from the specimen prepared for metallography, section 1c.
