Report No. 5004.9268 Rev. 1

**METALLURGICAL EVALUATION OF A SECTION FROM
L-147 MP 2.2 BRITTAN AVE. AND ROGERS AVE., SAN CARLOS**

One section of 20-inch diameter gas transmission pipe identified as L-147 MP 2.2 Brittan Ave. and Rogers Ave., San Carlos was submitted by PG&E for metallurgical evaluation. The subject section had a PLIDCO weld cap permanent repair, and an A. O. Smith longitudinal seam weld. The section was cut out to perform a root cause investigation of a reported leak under the PLIDCO cap. It was reported the subject passed hydrotest as part of L-147 on October, 24, 2011, at a pressure of 600-psi, or 1.5 times the desired Maximum Allowable Operating Pressure (MAOP) of 400-psi, and the PLIDCO cap was located at the six o'clock position, on the bottom of the section. The purpose of this evaluation was to determine the metallurgical condition of the pipe wall under the PLIDCO cap, and perform Charpy impact testing of the A. O. Smith weld and unaffected base metal.

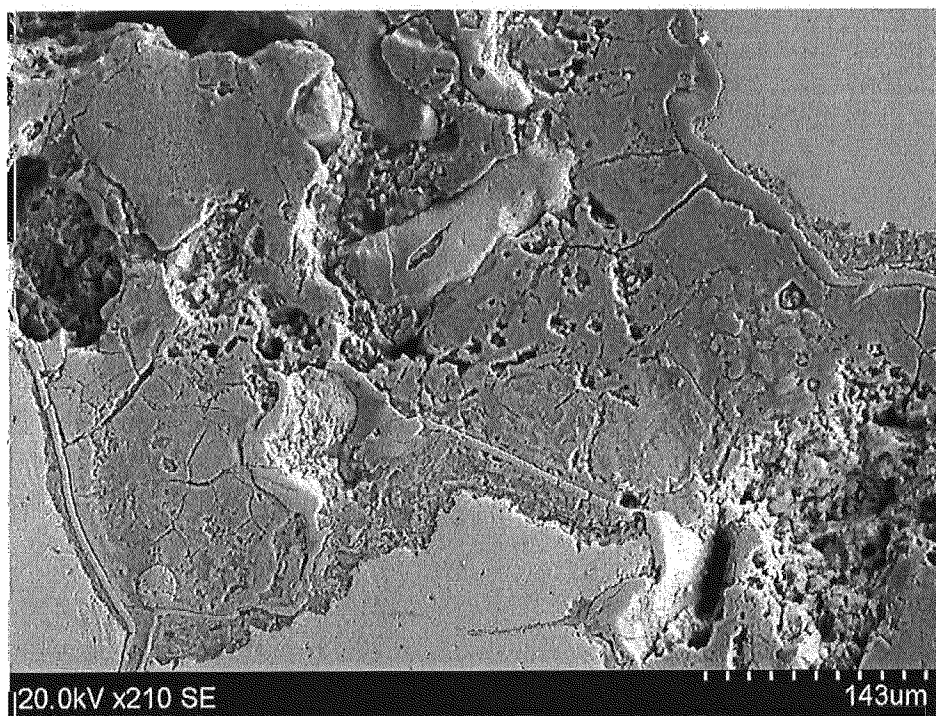
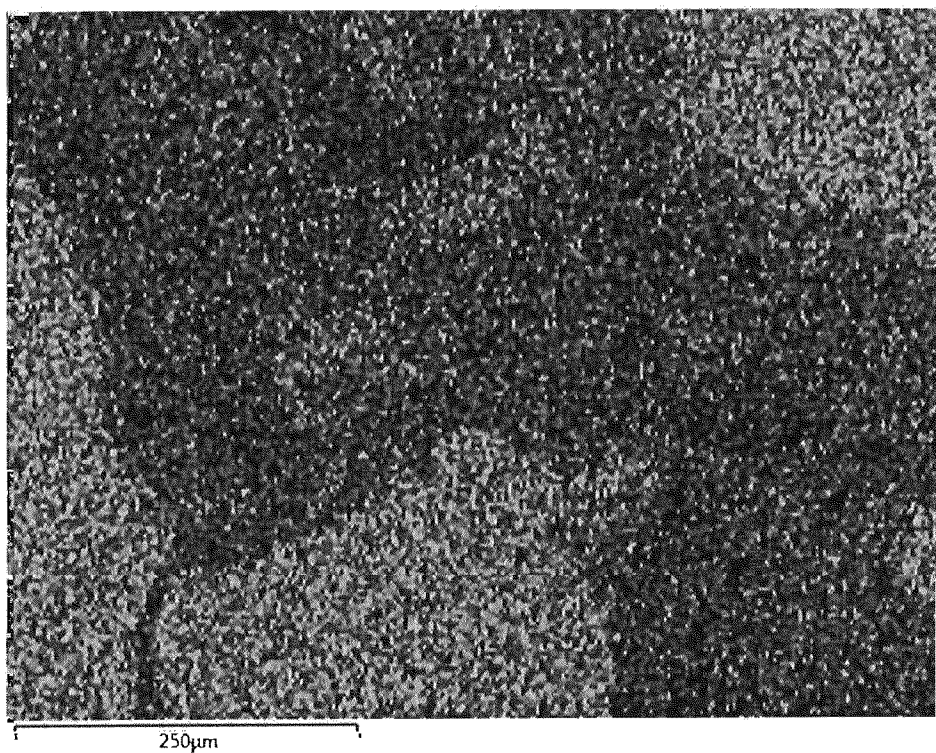
Figure 22 SEM image and EDS dot map for iron from the specimen prepared for metallography, section 1c.

(a) SEM micrograph

(b) EDS dot map for iron from the area indicated in (a)
