Order Instituting Rulemaking on the
Commission's Own Motion to Adopt New
Safety and Reliability Regulations for Natural
Gas Transmission and Distribution Pipelines
and Related Ratemaking Mechanisms

**DECLARATION OF SUMEET SINGH
SUPPLEMENTING THE VERIFIED STATEMENT OF
PACIFIC GAS AND ELECTRIC COMPANY'S VICE
PRESIDENT OF GAS TRANSMISSION MAINTENANCE
AND CONSTRUCTION IN RESPONSE TO RULING OF
ASSIGNED COMMISSIONER AND ASSIGNED
ADMINISTRATIVE LAW JUDGE.**

Report No. 5004.9268

**METALLURGICAL EVALUATION OF A SECTION FROM
L-147 MP 2.2 BRITTAN AVE. AND ROGERS AVE., SAN CARLOS**

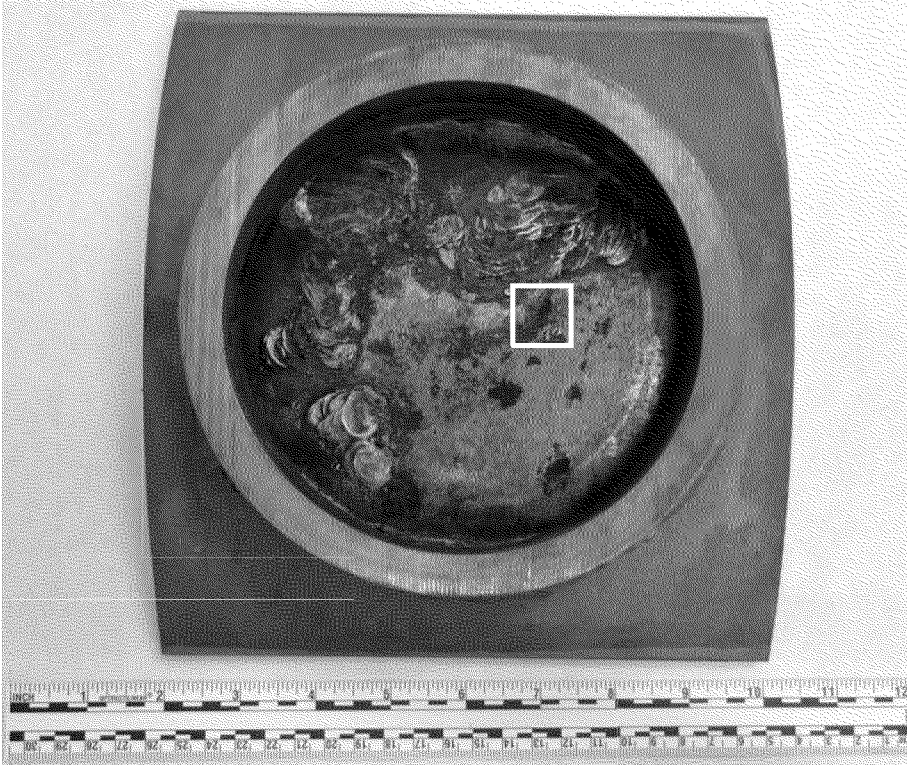
Figure 6 Photographs of the PLIDCO cap area after sectioning.

The region containing the PLIDCO cap was sectioned from sample A and the cap was cut off to expose the outside surface of the pipe wall. The outside surface was covered with rust and had a slightly oily feel. Both surfaces were cleaned with dilute Oakite® 33 and a wire brush. The outside surface is shown before and after cleaning in Figure 6. Several regions of weld metal were visible on the outside surface. Examination using low-power optical microscopy revealed a pit consistent with corrosion on the outside surface, indicated in Figure 7. The inside surface is shown after cleaning in Figure 8. Indications of heat exposure were visible on the inside surface, corresponding to the weld metal on the outside surface. No evidence of weld burn through was detected, and fine grooves typical of wrought steel surfaces were continuous across the region, which indicated that repairs did not extend to the inside surface. Examination using low-power optical microscopy revealed a crack-like feature on the inside surface within the heat affected zone of a weld deposit, as shown in Figure 8b.

Both sides of the cap sample shown in Figure 6 were thoroughly cleaned with acetone and dried with compressed air. A liquid penetrant test was performed by applying developer to the inside surface, and penetrant was liberally applied to the outside surface in the area covered by the cap. After 1.5-hours, no indication of penetrant was visible on the inside surface.

The sample shown in Figure 6 was returned to PG&E for radiography. A digital radiograph of the sample is shown in Appendix A along with a photograph of the sample. A crack indication was found that corresponded to the crack-like feature detected visually on the inside surface, shown in Figure 8b.
