Order Instituting Rulemaking on the  
Commission's Own Motion to Adopt New  
Safety and Reliability Regulations for Natural  
Gas Transmission and Distribution Pipelines  
and Related Ratemaking Mechanisms

**DECLARATION OF SUMEET SINGH  
SUPPLEMENTING THE VERIFIED STATEMENT OF  
PACIFIC GAS AND ELECTRIC COMPANY'S VICE  
PRESIDENT OF GAS TRANSMISSION MAINTENANCE  
AND CONSTRUCTION IN RESPONSE TO RULING OF  
ASSIGNED COMMISSIONER AND ASSIGNED  
ADMINISTRATIVE LAW JUDGE.**

Report No. 5004.9268

**METALLURGICAL EVALUATION OF A SECTION FROM  
L-147 MP 2.2 BRITTAN AVE. AND ROGERS AVE., SAN CARLOS**

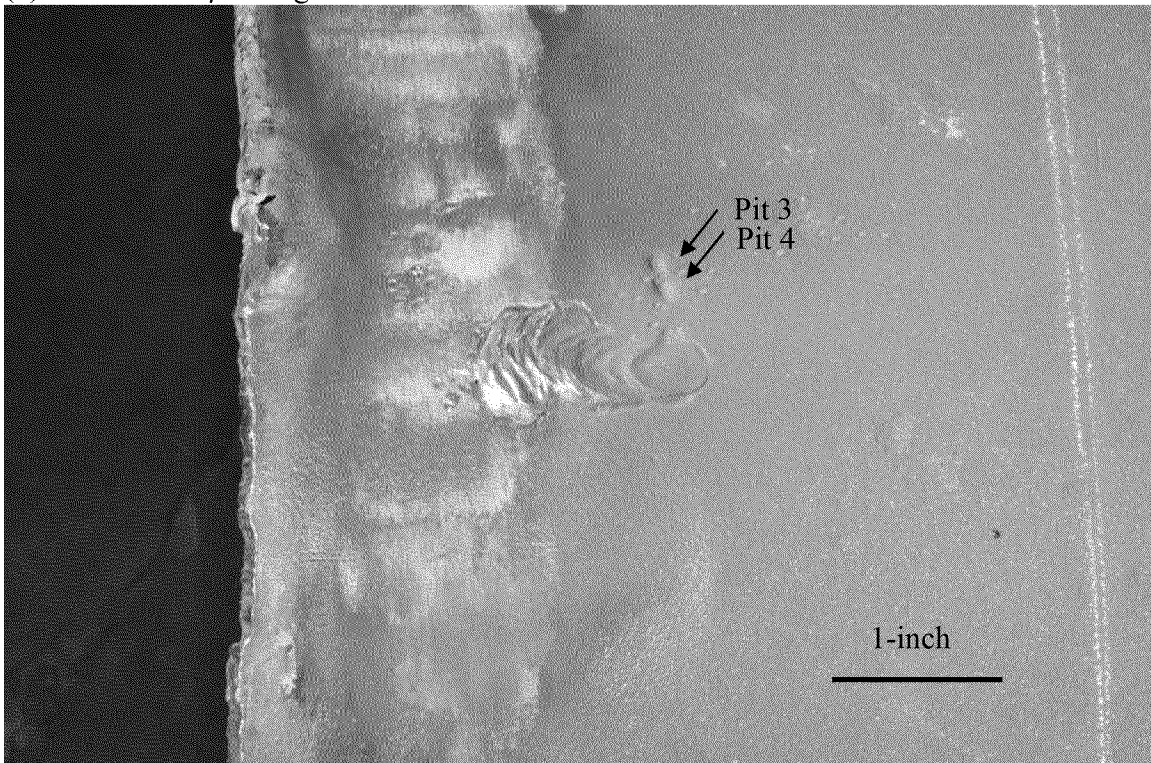
(a) Boxed area  $\beta$  in Figure 1a

(a) Boxed area  $\gamma$  in Figure 1a

Figure 2 Photographs of the outside surface of sample half A as-received.

The subject sample of L-147 was received sectioned into two halves along the longitudinal axis, with the outside surface grit blasted, as shown in Figure 1 through Figure 5. The section half with the PLIDCO cap was arbitrarily labeled A and the other section was labeled B, in the laboratory. Based on the reported position of the cap, the longitudinal flame cuts were located at three o'clock and nine o'clock positions. Wall thickness measurements were made with a pointed anvil micrometer and the results are listed in Table 1. Small regions of weld metal and a few shallow hemispherical pits were present near the cap, as shown in Figure 2. Pits were also present just past the three o'clock position toward the cap, indicated in Figure 1. Pit depths were measured with a pit gage, and the results are listed in Table 2. No evidence of a leak location or repair was visible to the unaided eye on the inside surface of the pipe under the cap.

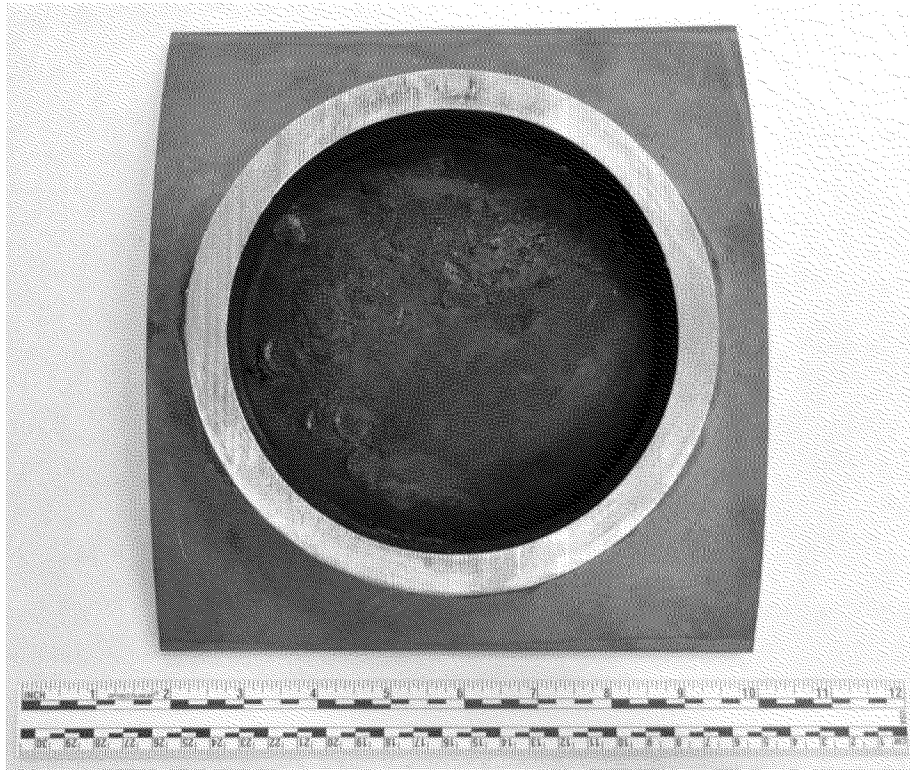
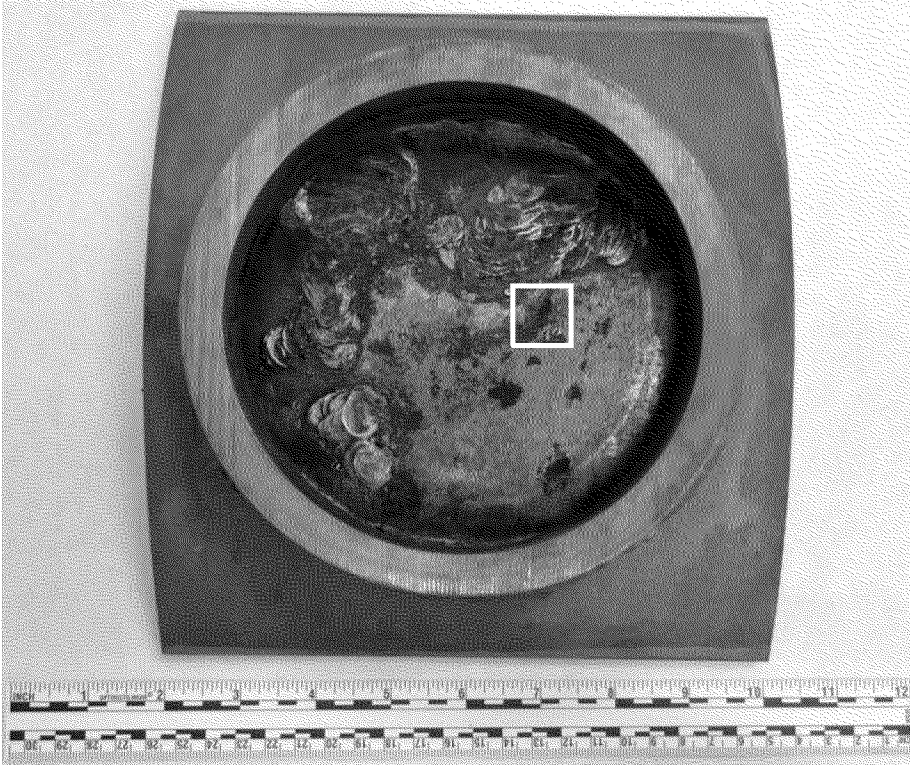
(a) Before cleaning

(b) After cleaning

Figure 6 Photographs of the PLIDCO cap area after sectioning.

The region containing the PLIDCO cap was sectioned from sample A and the cap was cut off to expose the outside surface of the pipe wall. The outside surface was covered with rust and had a slightly oily feel. Both surfaces were cleaned with dilute Oakite® 33 and a wire brush. The outside surface is shown before and after cleaning in Figure 6. Several regions of weld metal were visible on the outside surface. Examination using low-power optical microscopy revealed a pit consistent with corrosion on the outside surface, indicated in Figure 7. The inside surface is shown after cleaning in Figure 8. Indications of heat exposure were visible on the inside surface, corresponding to the weld metal on the outside surface. No evidence of weld burn through was detected, and fine grooves typical of wrought steel surfaces were continuous across the region, which indicated that repairs did not extend to the inside surface. Examination using low-power optical microscopy revealed a crack-like feature on the inside surface within the heat affected zone of a weld deposit, as shown in Figure 8b.

Both sides of the cap sample shown in Figure 6 were thoroughly cleaned with acetone and dried with compressed air. A liquid penetrant test was performed by applying developer to the inside surface, and penetrant was liberally applied to the outside surface in the area covered by the cap. After 1.5-hours, no indication of penetrant was visible on the inside surface.

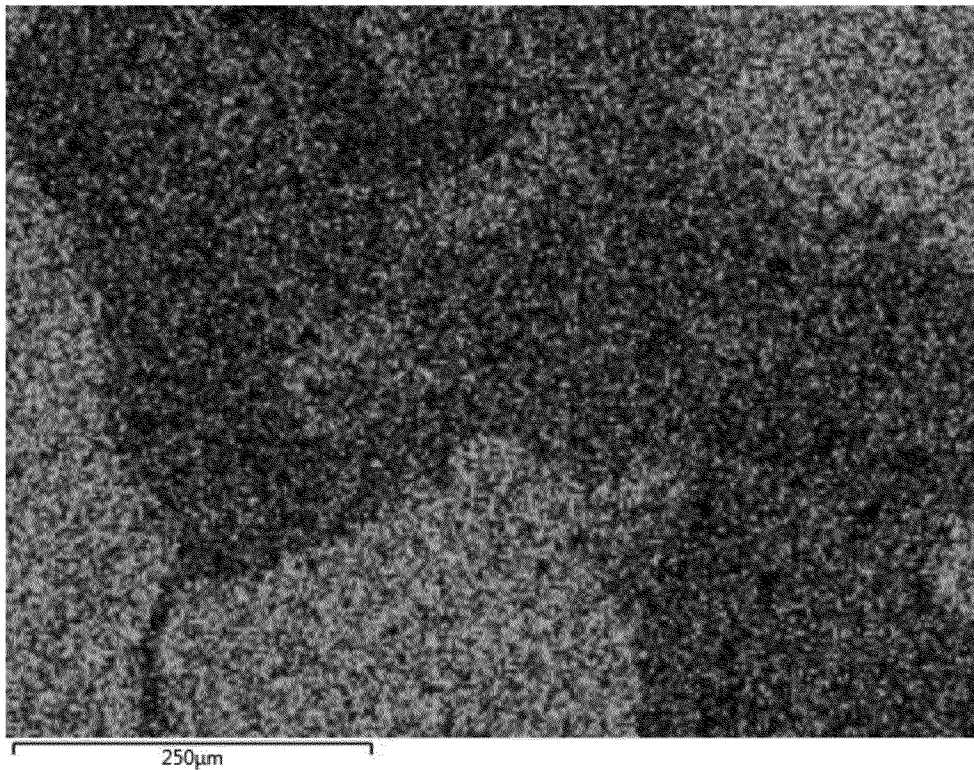
(a) SEM micrograph

(b) EDS dot map for iron from the area indicated in (a)

Figure 22 SEM image and EDS dot map for iron from the specimen prepared for metallography, section 1c.

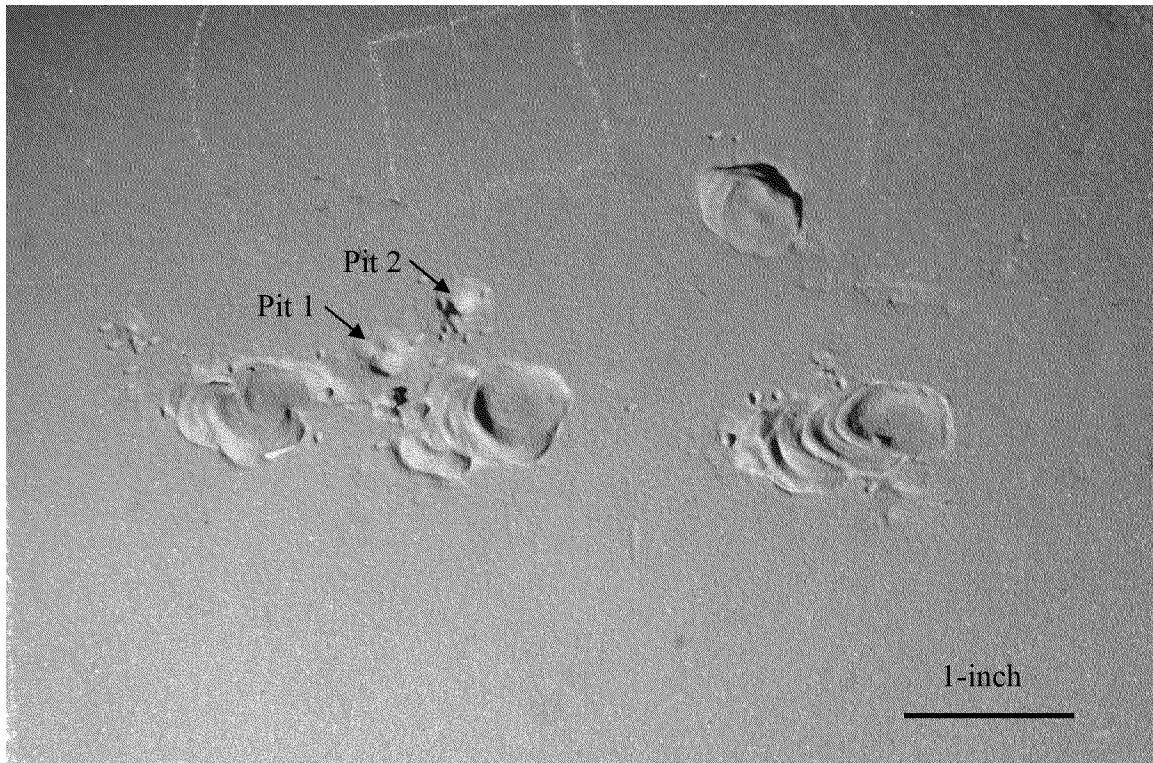
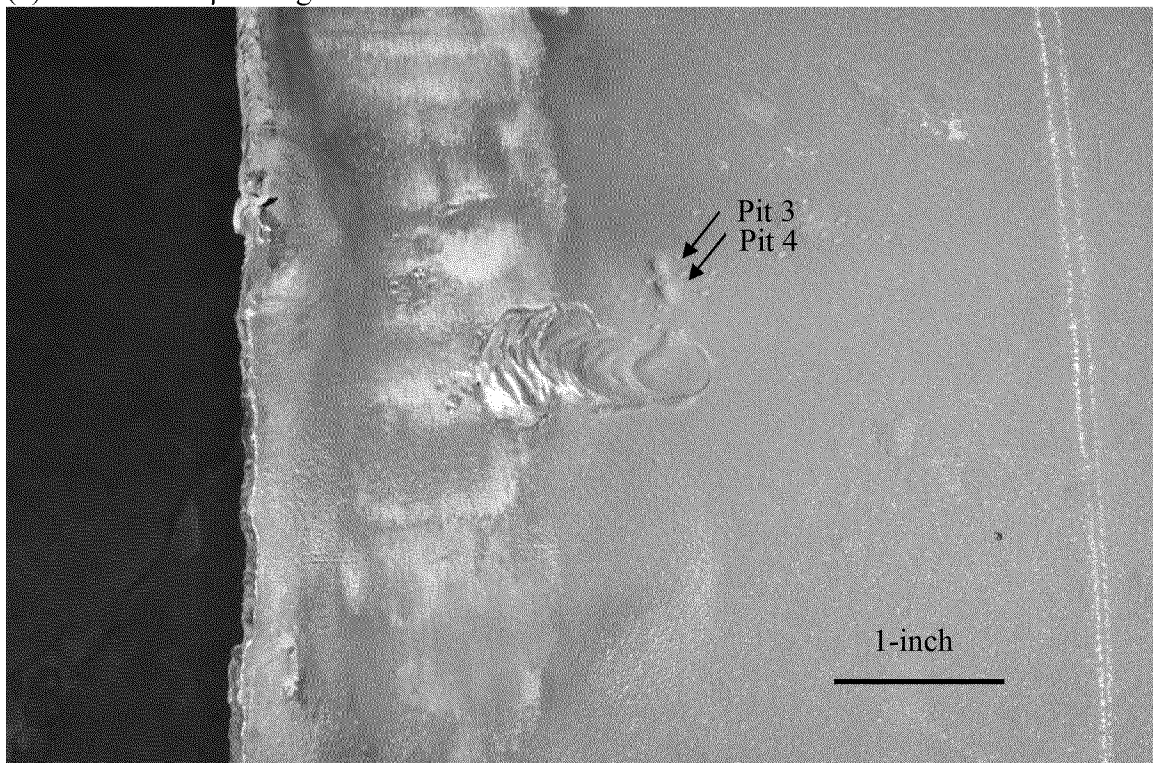
(a) Boxed area  $\beta$  in Figure 1a

(a) Boxed area  $\chi$  in Figure 1a

Figure 2 Photographs of the outside surface of sample half A as-received.

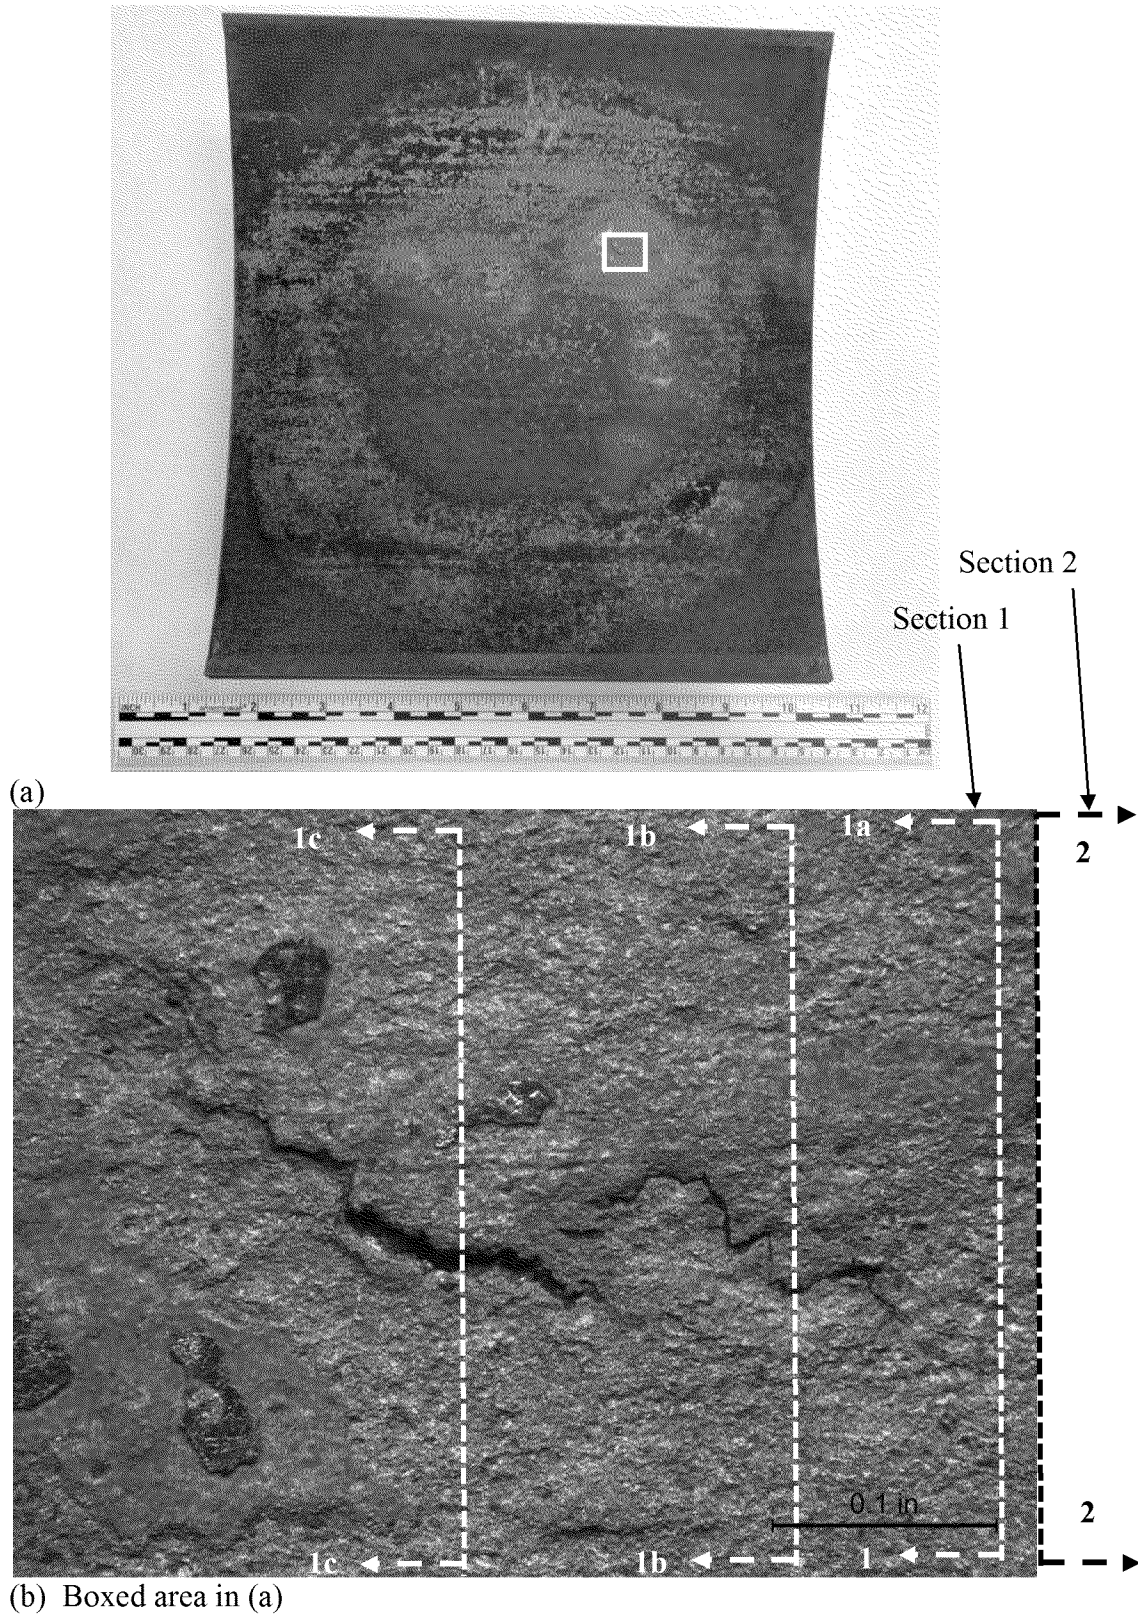
The sample shown in Figure 6 was returned to PG&E for radiography. A digital radiograph of the sample is shown in Appendix A along with a photograph of the sample. A crack indication was found that corresponded to the crack-like feature detected visually on the inside surface, shown in Figure 8b.

Specimens were prepared for metallography from section 1 and 2 indicated in Figure 8b. Weld crater cracks and heat affected zone liquation cracks were present in the sections. Serial grinding and polishing was performed on section 1, referred to as sections 1a, 1b, and 1c. As shown in Figure 10 through Figure 20, a weld crater crack extended from the outside surface into the weld heat affected zone in section 1a, but did not penetrate through the wall at this location. Shrinkage porosity was present near the outside surface, and intergranular cracks consistent with grain boundary liquation were present in the heat affected zone.

Figure 8 Photograph (a) and macrograph (b) of the inside surface of sample half A under the PLIDCO cap, after cleaning.

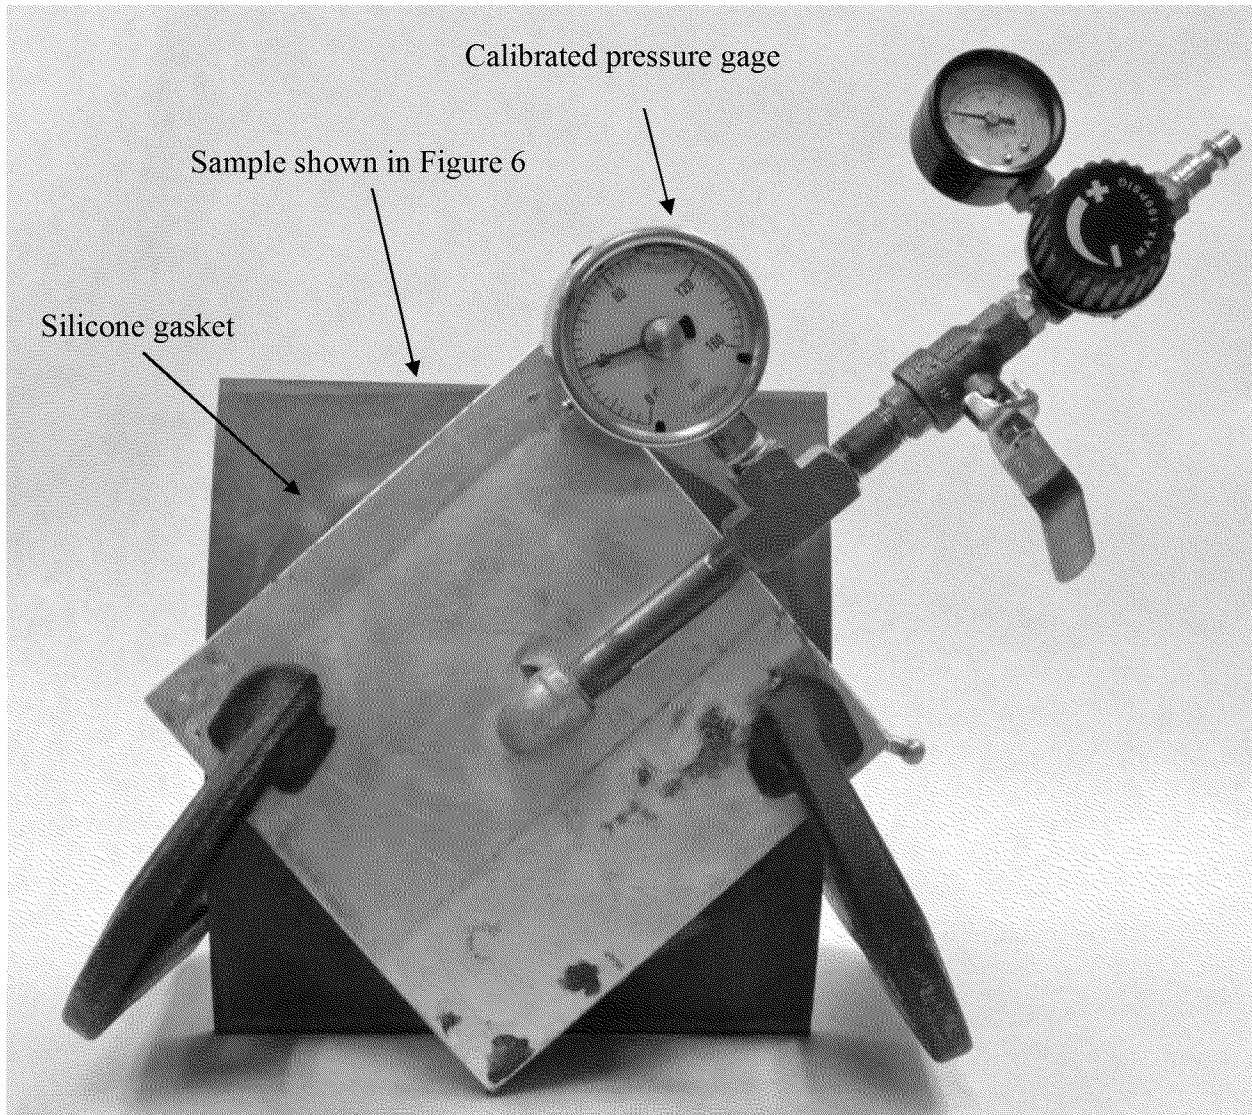
A pressure test was performed by clamping a plate over the sectioned cap, sealed with a silicone gasket, and introducing 40-psig of compressed air. Snoop® liquid leak detector was applied to the inside surface. No leaks were detected. The compressed air was valved-off, and no pressure drop from 40-psig was detected after 45-minutes.

Figure 9 Pressure test setup.

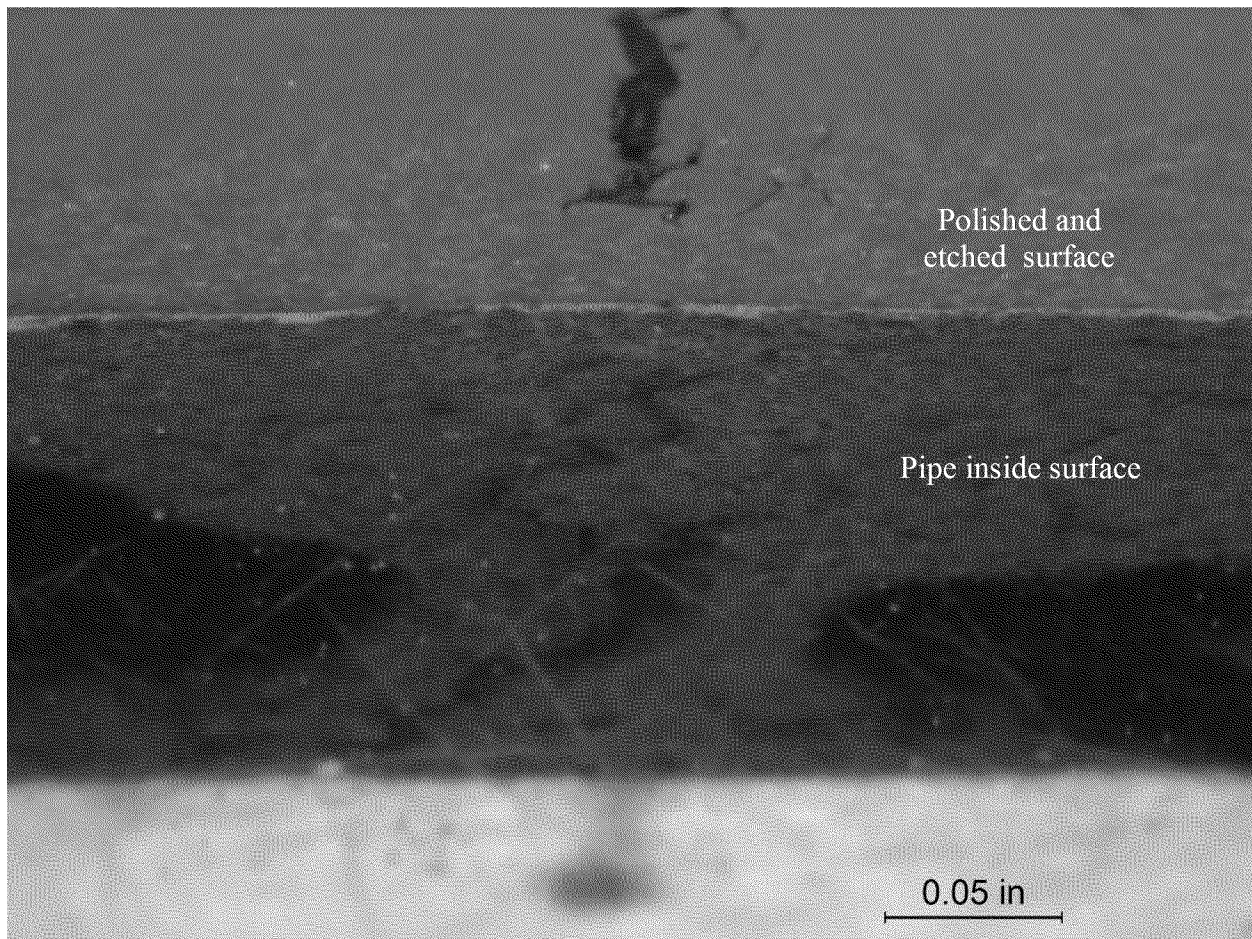
Figure 10 Images of the specimen prepared for metallography, section 1a. Etched with 2% nital.

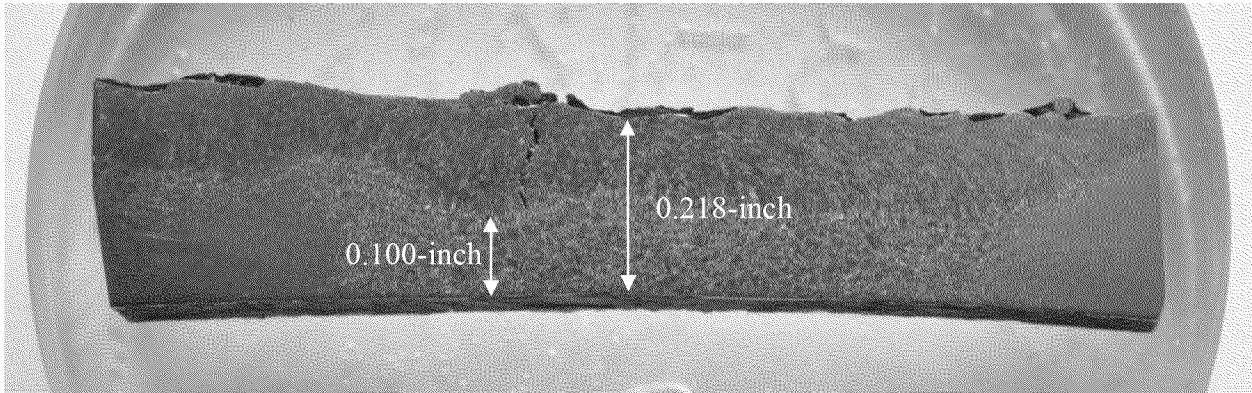
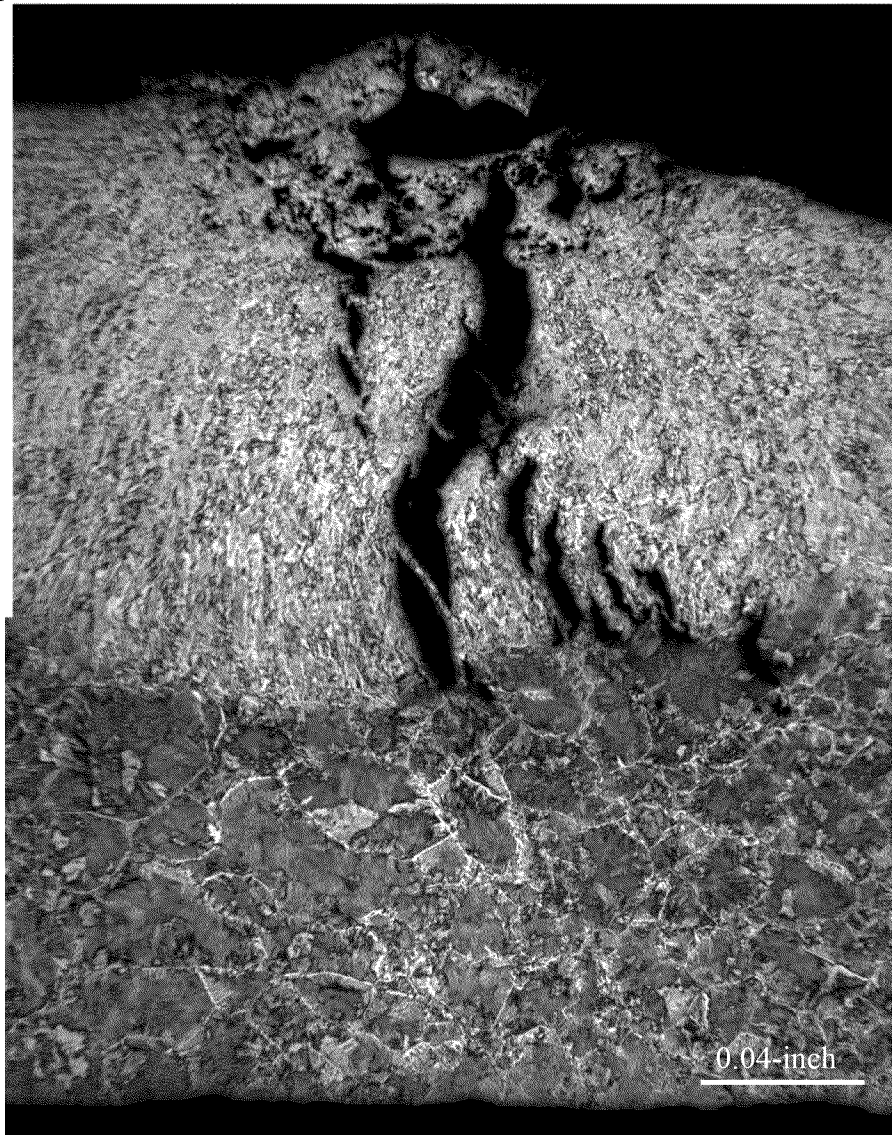
(a) Photograph

(b) Composite optical micrograph

Figure 19 Photograph and composite micrograph of section 2. Etched with 2% nital.
